U.S. CHEMICAL SAFETY AND HAZARD INVESTIGATION BOARD

# INVESTIGATION REPORT

## E.I. DUPONT DE NEMOURS & Co., INC.

BELLE, WEST VIRGINIA

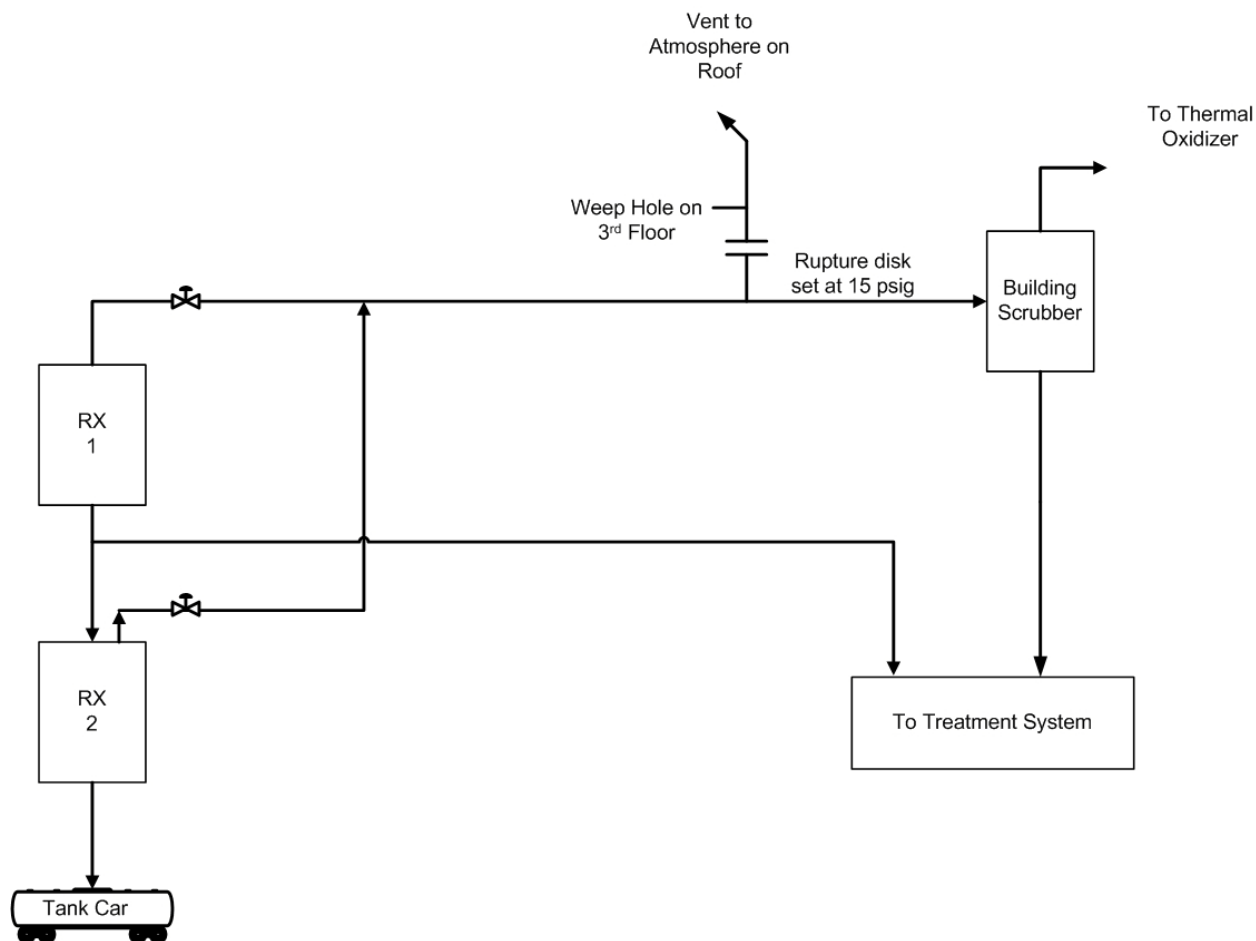
Figure 2. Simplified thermal oxidizer and rupture disc block flow diagram

The Belle plant's F3455 unit manufactures the intermediate F3455, a chemical that is shipped to another DuPont facility to make the herbicide Velpar<sup>®</sup>. Due to the exothermic reaction in the first reactor, dissolved methyl chloride vaporizes and normally exits through the reactor vent line along with carbon dioxide, nitrogen, and trace amounts of dimethylamine (DMA) vapor through a process scrubber and then to a thermal oxidizer for emission control. To avoid damage to the scrubber<sup>6</sup> if excessive pressures occur, a piping connection upstream of the vent line is routed to a rupture disc that will burst and allow venting outside on the roof of the building which contains two reactors (Figure 2). However, due to a lack of safety considerations during installation, a 0.5-inch weep hole<sup>7</sup> was placed on the vent line inside the building; consequently, dangerous chemicals vent inside the building if the rupture disc bursts.

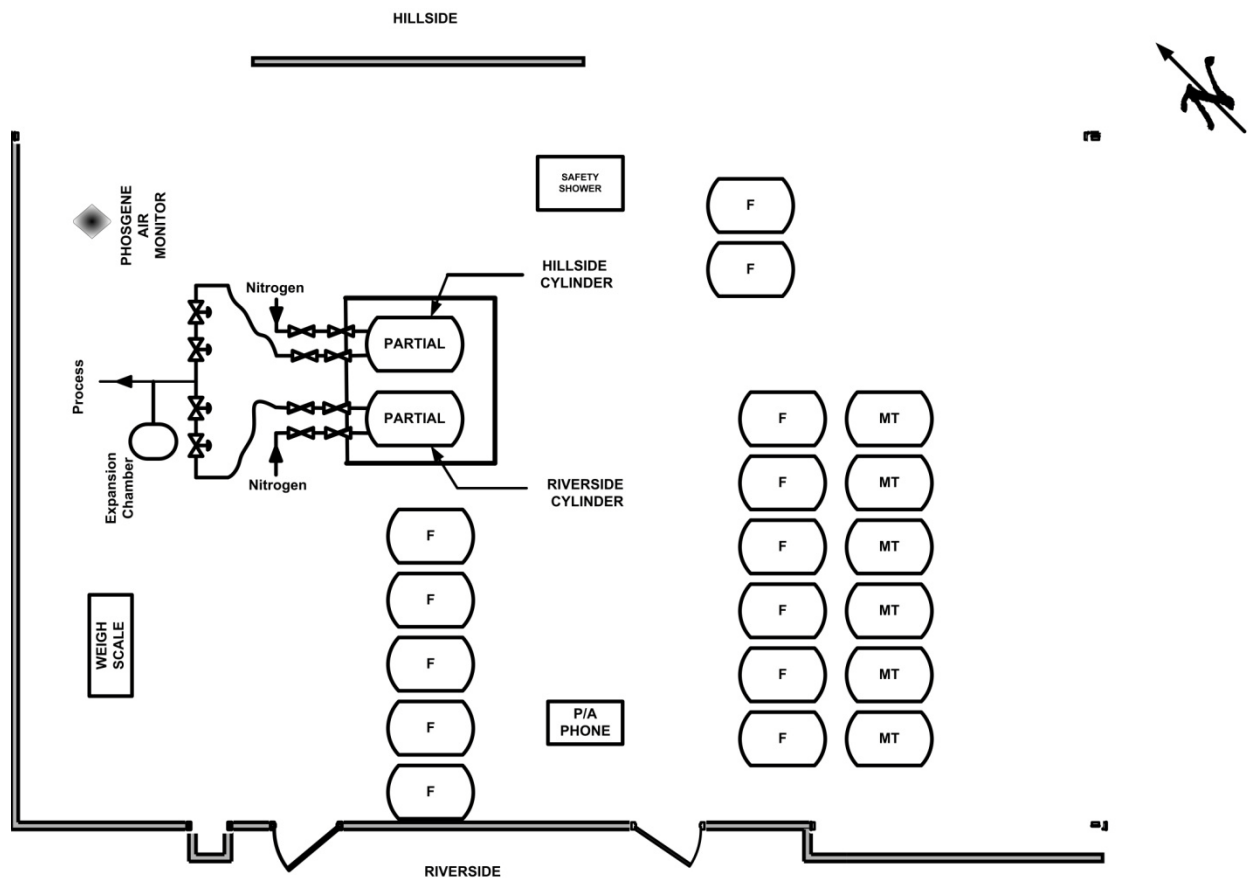
Figure 12. Phosgene shed and full (F) and empty (MT) cylinder locations on day of incident (not to scale)

During normal operation, two cylinders are staged on weigh scales and each is connected to the process with two 0.25-inch diameter by 48-inch long PTFE-lined, 304 stainless steel overbraid hoses. One hose transfers liquid phosgene to a steam vaporizer and one provides 70-psig nitrogen to the cylinder. The scales record the weight of the in-service cylinder and when the container is nearly empty, an alarm notifies the board operator, who then directs operators to switch to a full cylinder. This switch is completed by opening valves to the full cylinder and closing valves to the empty cylinder. The hoses remain coupled in this operation, and plant SOPs do not require enhanced PPE such as a fully encapsulated suit and breathing air. Under normal operating conditions, the process consumes two to three cylinders of phosgene per day.

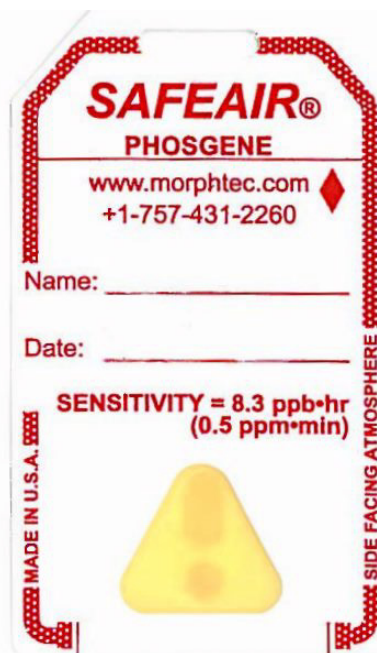
Figure 13. SafeAir Phosgene Dosimeter Badge<sup>37</sup>

Immediately after the operator was sprayed, he called for assistance on the SLM unit public address phone in the phosgene shed. A coworker who responded to the call noticed that the victim's phosgene dosimeter badge (Figure 13) was discolored, indicating an exposure. The coworker directed the exposed worker to a plant truck to transport him to the plant's medical center for assessment and treatment. As they drove to the medical center, the two workers were met by the Shift Supervisor and the exposed worker was transferred to the shift supervisor's vehicle to complete the trip. While en route to the plant's medical center, the front gate guard was radioed and advised to call Metro 9-1-1 and request that an ambulance respond for a medical emergency. The exposed worker, while at the medical center waiting for the ambulance, chose to wash his face and hands, but there is no evidence or record that he was placed in a safety shower to wash off, as instructed by the emergency procedures, or that any decontamination activity took place beyond the hand and face washing. He was given a change of coveralls to put on in exchange for the work clothes he was wearing. The gate guard called Metro 9-1-1 at 1:59 p.m., requesting transport for a medical emergency patient to the hospital. The 9-1-1 dispatcher asked if there was a chemical release; however, the gate guard, who was unaware of the situation, responded that there was no release and that the response was for a medical emergency. As part of the Metro 9-1-1 emergency response protocol, the dispatcher asks for specific information to ensure that responders are as informed as possible prior to arrival at the scene. At 2:03 p.m., an ambulance was dispatched from the KCEAA. At 2:08 p.m., responding EMTs asked Metro dispatchers if more information was available about the victim. When Metro called DuPont to get more information, the line was busy. EMTs also wanted to know if there was a chemical exposure, but Metro 9-1-1 could not get that information from DuPont. Six minutes later, the EMTs arrived at the DuPont gates.

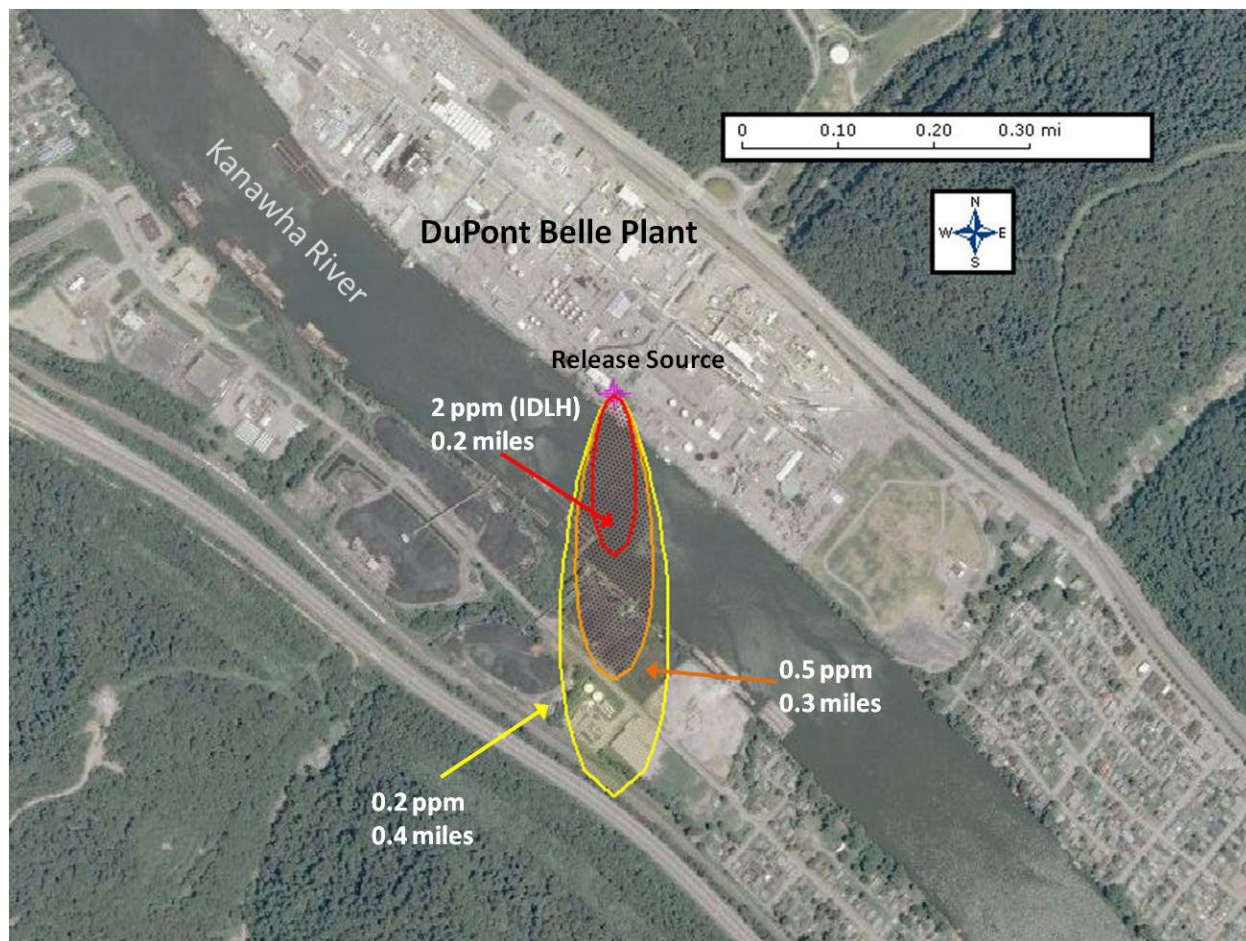
Figure 19. ALOHA estimate of phosgene concentrations with MARPLOT GIS overlay

The ALOHA program generated a display of concentration “threat zones” over a distance downwind from the source of the release. Using the EPA MARPLOT program, threat zones are displayed over a satellite map of the area using a GIS interface (Figure 19).

The release estimates from the ALOHA program are based on the weather conditions recorded at the Charleston Yeager Airport around the time of the January 23, 2010, phosgene release, but may not accurately represent atmospheric conditions at the plant. The ALOHA program also does not consider the topography or terrain surrounding the plant. The fence line monitors south and southwest of the phosgene shed recorded phosgene concentrations between 0 and 0.27 ppm, suggesting phosgene vapor may have traveled south of the DuPont Belle plant fence line toward the river. The ALOHA threat zone overlay in Figure 19 displays a model of the worst case release conditions indicating that IDLH concentrations of phosgene could have been present on the Kanawha River shortly after the release and lower concentrations could have traveled across the river. The community reported no odors or exposure symptoms the afternoon of the phosgene release incident.
