U.S. Chemical Safety and Hazard Investigation Board

US Ink/Sun Chemical Corporation

Ink Dust Explosion and Flash Fires in East Rutherford, New Jersey

No. 2013-01-I-NJ

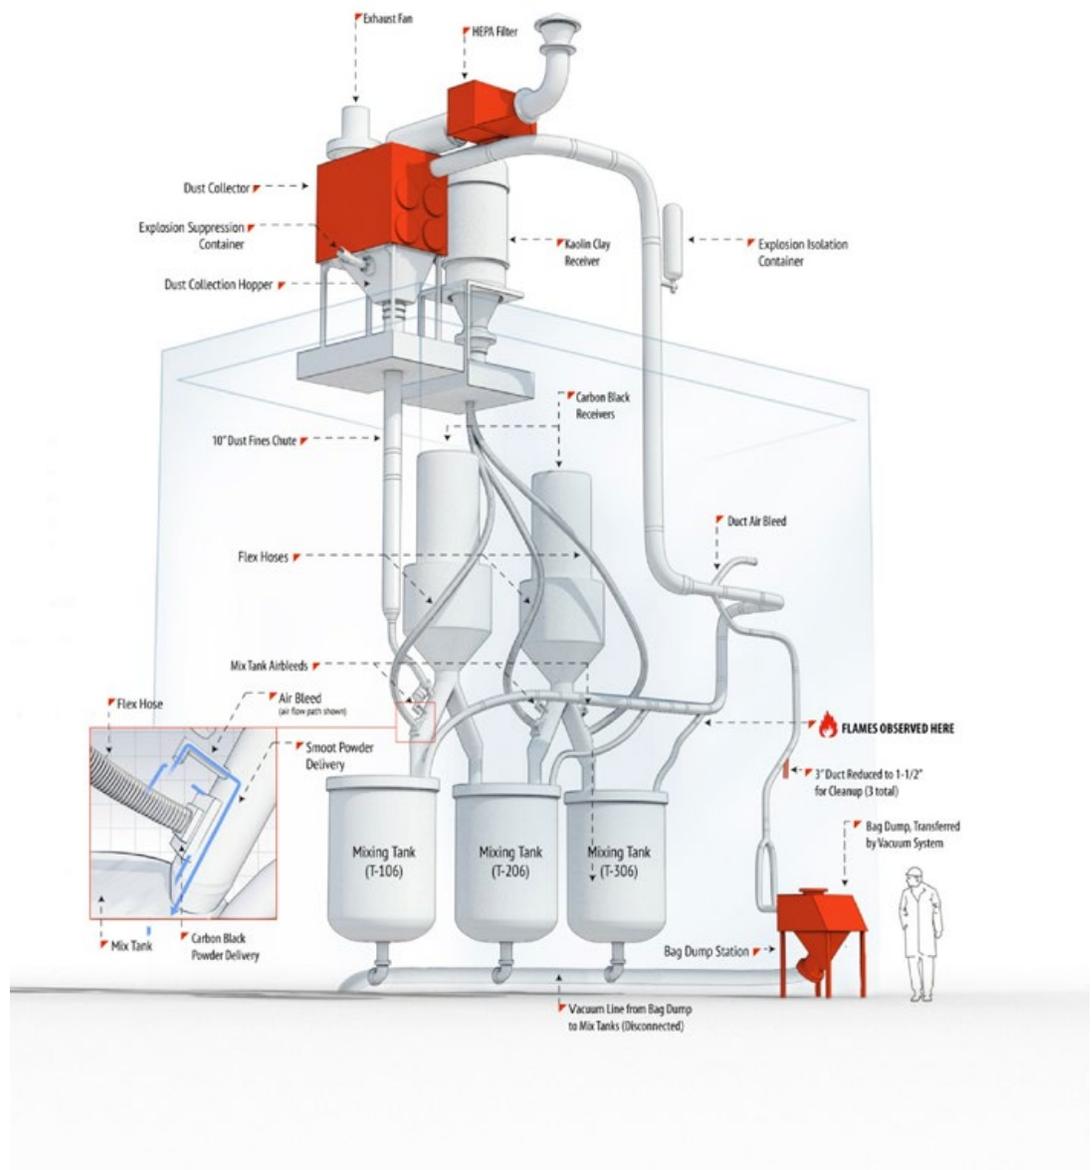
FIGURE 3

Overview of the newly installed dust collection system

On the basis of analytical testing of the materials in the ductwork (summarized in Section 4), the CSB concluded that excessive quantities of condensable vapors were released into the ductwork of the dust collection system during its operation. An essential consideration in the design of a dust pickup of a dust collection system is how air enters the pickup and travels to the connected duct. In a closed system such as the mix tanks, air from the tanks is displaced when the tanks are filled with liquid or powders, and air must be drawn into the tanks as the liquid ink mixture is pumped out of the tank. At the US Ink East Rutherford facility, each of the three mixing tanks in the pre-mix room had a small air bleed duct (1.5 inches in diameter) on the rectangular powder fill chute from the carbon black delivery systems. Also attached was a flexible hose for delivering kaolin clay to the mixing tank. The tank was connected to the dust collection system through a flexible duct (6 inches in diameter) a few feet from the powder delivery chute (depicted in Figure 3).

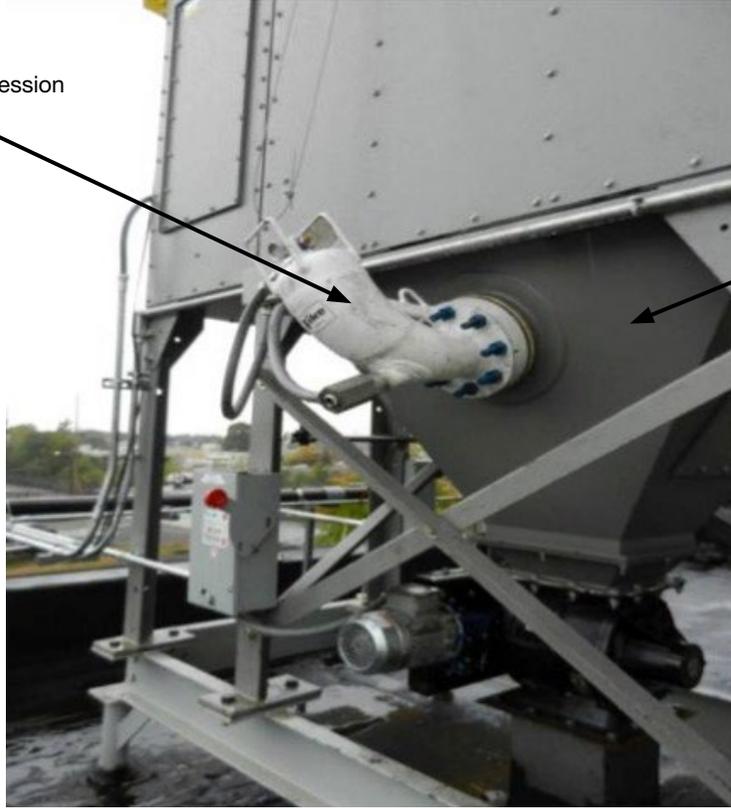
¹¹ The explosion suppression system would actuate and inject sodium bicarbonate via an independent suppression container and chemical isolation container located at two injection points in the system: the dust collector hopper (Figure 4) and the collector inlet riser (Figure 5). The suppressant was designed to be injected if a rapid pressure rise occurred in the dust collector and was intended to suppress a flame front from propagating from the dust collector back through the riser into the interconnected ductwork and pre-mix room.

Explosion suppression container

Dust collector hopper

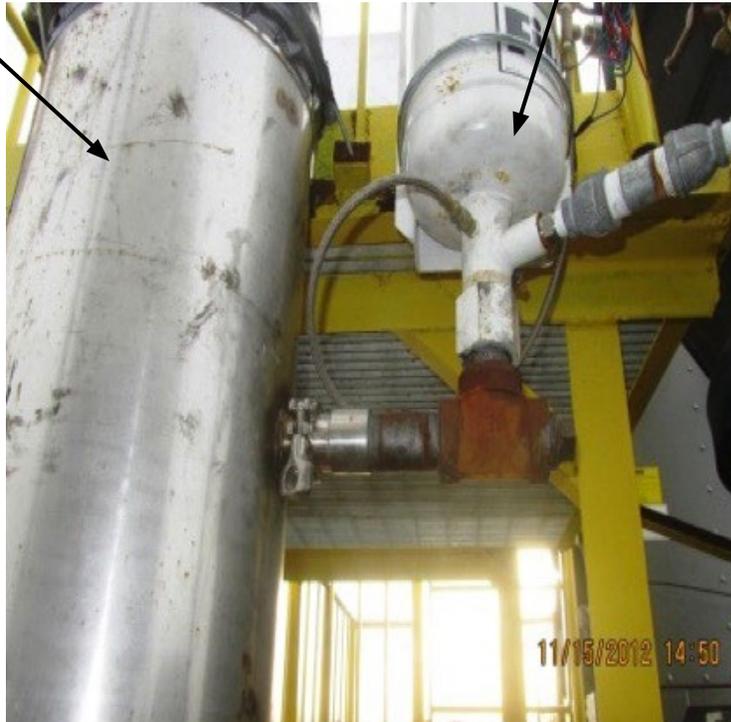
FIGURE 5

Inlet riser (to dust collector)

Explosion isolation container

Dust collector inlet with explosion isolation
