Report No. 5005.0486A

**METALLURGICAL EVALUATION OF TANK COUPON T396-F/S9/10 FROM
FREEDOM INDUSTRIES, CHARLESTOWN, WEST VIRGINIA**

Customer Authorization: CSB2014-01-I-WV

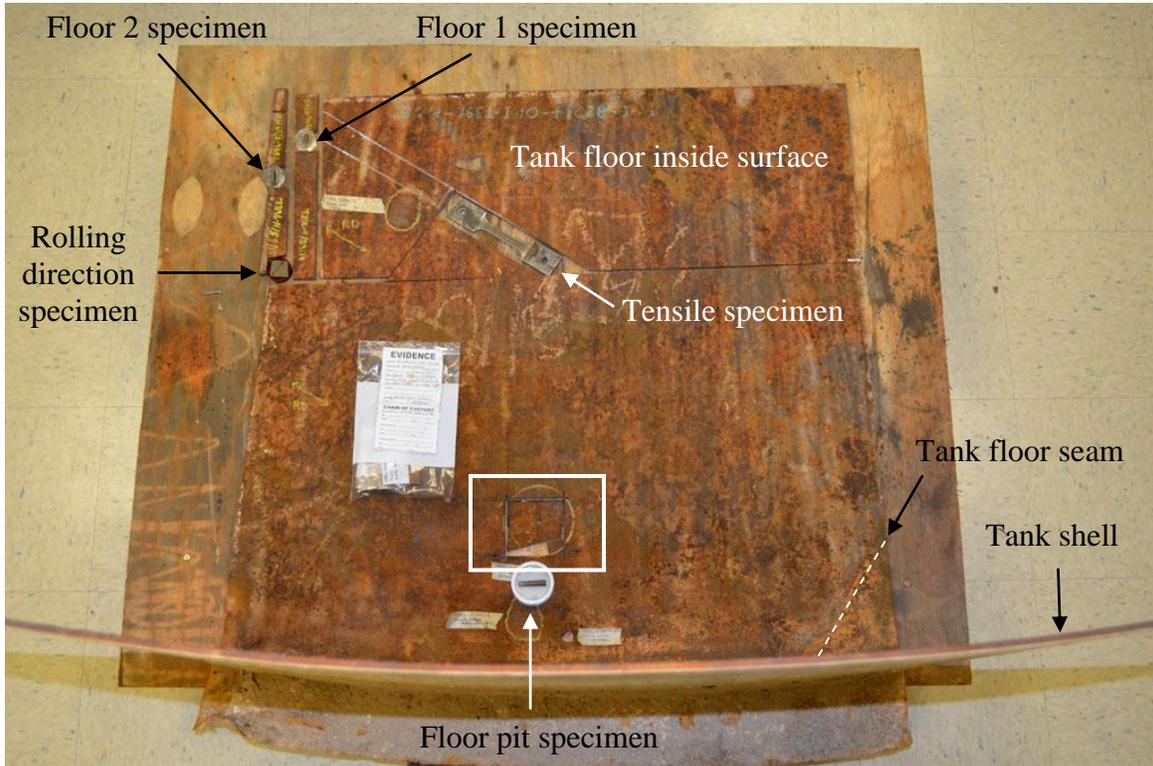
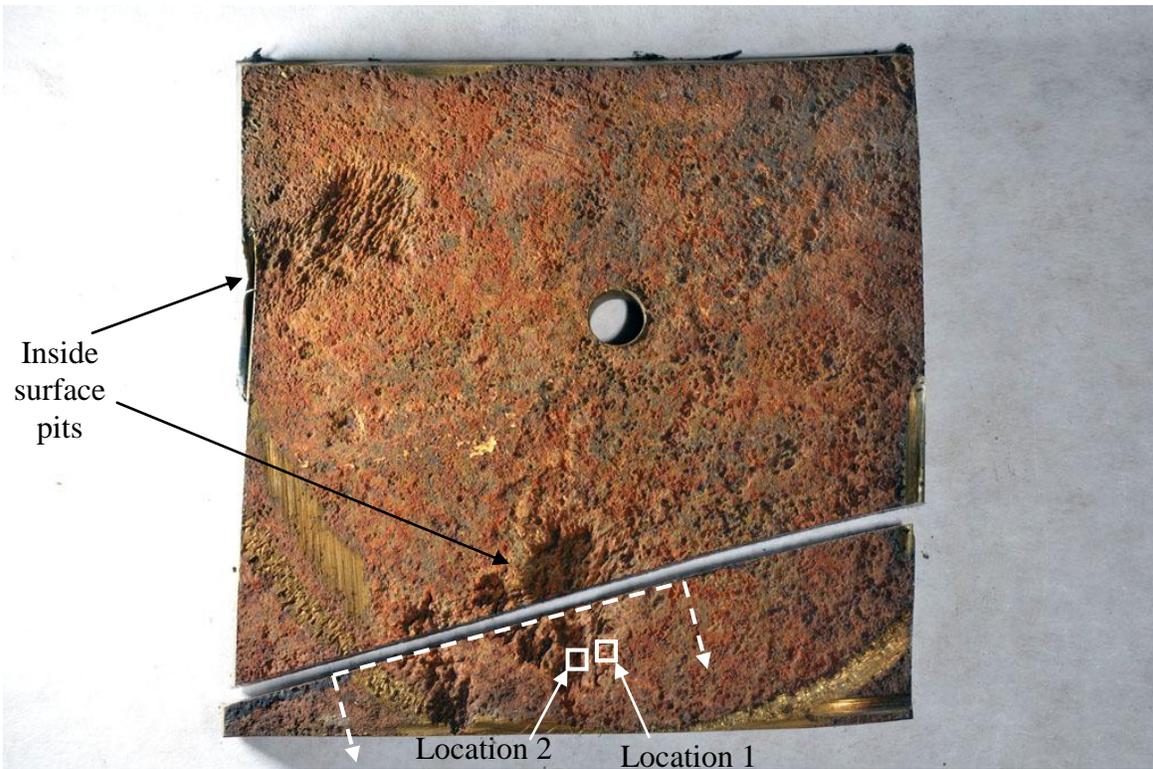
Specimens were prepared for metallography from the floor sections indicated in Figure 13. The specimen labeled floor pit is shown as-polished in Figure 14. This sample illustrated the general differences between inside surface and soil side surface corrosion morphology. Within the broad pits on the inside surface, corrosion advanced in cells of localized attack, as shown in Figure 14 and Figure 15.

Figure 13 Photographs of sections and specimen locations on the floor of the coupon. The dashed lines in (b) indicate the floor pit section that was prepared for metallography.

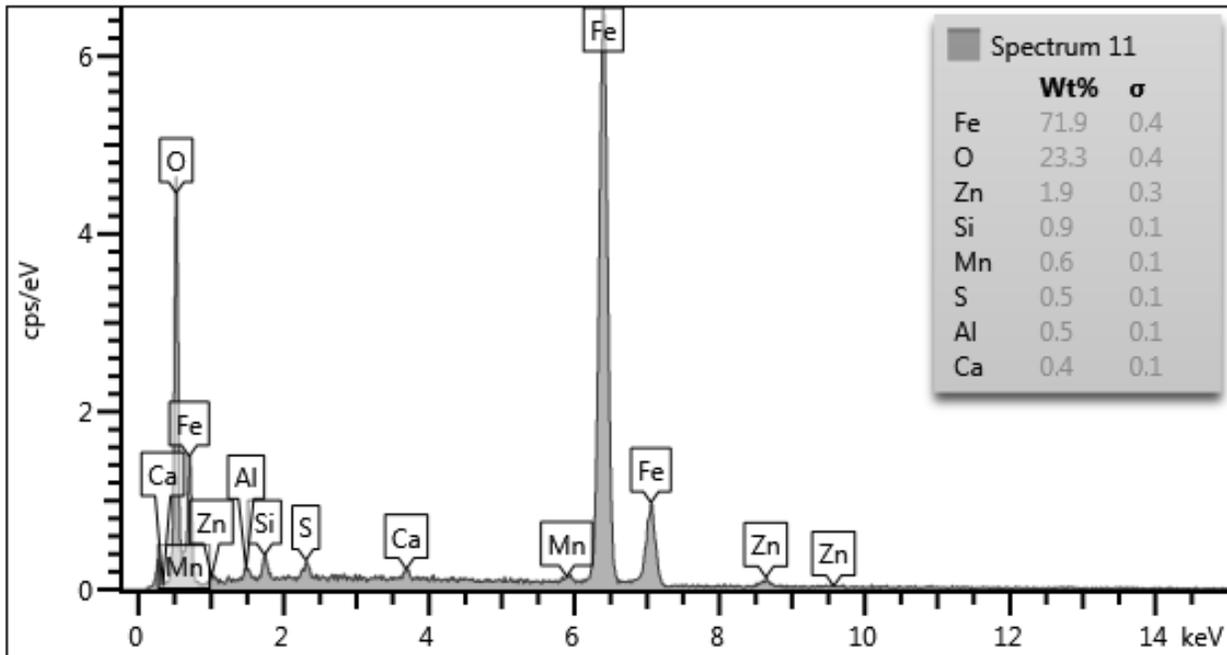
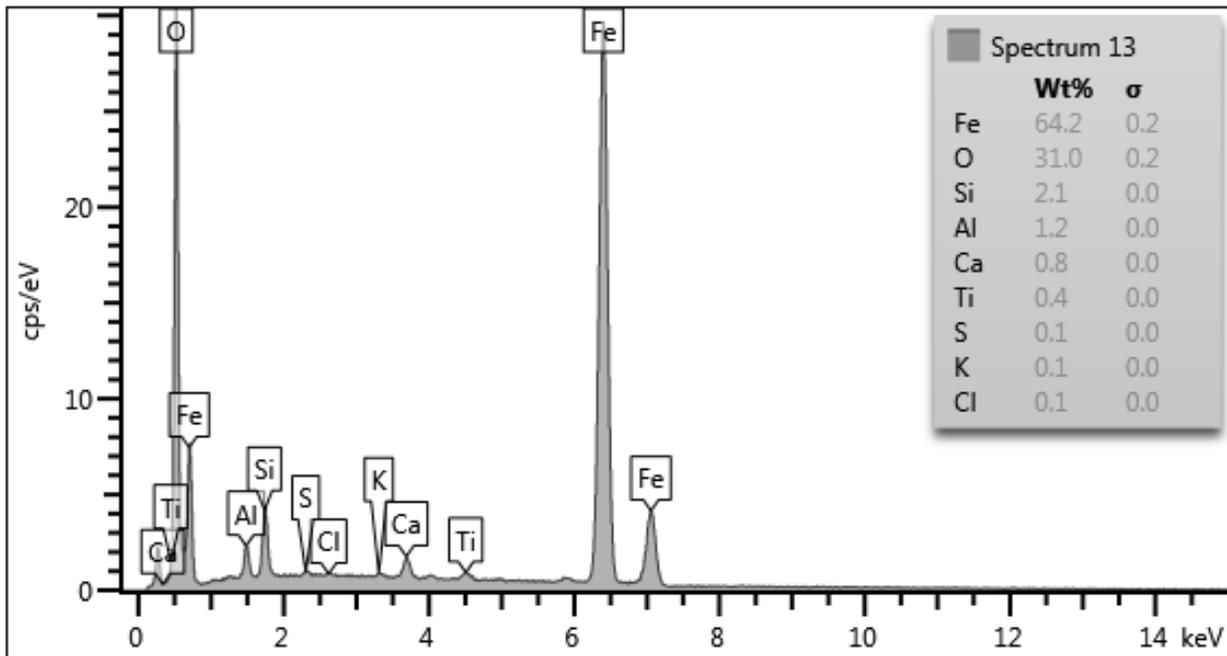
indicated in Figure 13b are shown in Figure 23. Silicon (Si), aluminum (Al), calcium (Ca), titanium (Ti), sulfur (S) potassium (K) and chlorine (Cl) were detected in the corrosion product. The floor pit cross section was analyzed as-cut with a dry band saw, and representative EDS maps and spectra are shown in Figure 24 and Figure 25. Zinc (Zn) was detected within pit corrosion product and mapping showed a correlation between the zinc and sulfur. Mapping indicated chlorine was equally distributed in the corrosion product and on the steel surface. Similar results were obtained from the as-polished surface of the floor pit specimen, as shown in Figure 26 and Figure 27.

Figure 23 EDS spectra from the inside surface of the floor pit at the locations indicated in Figure 13b.

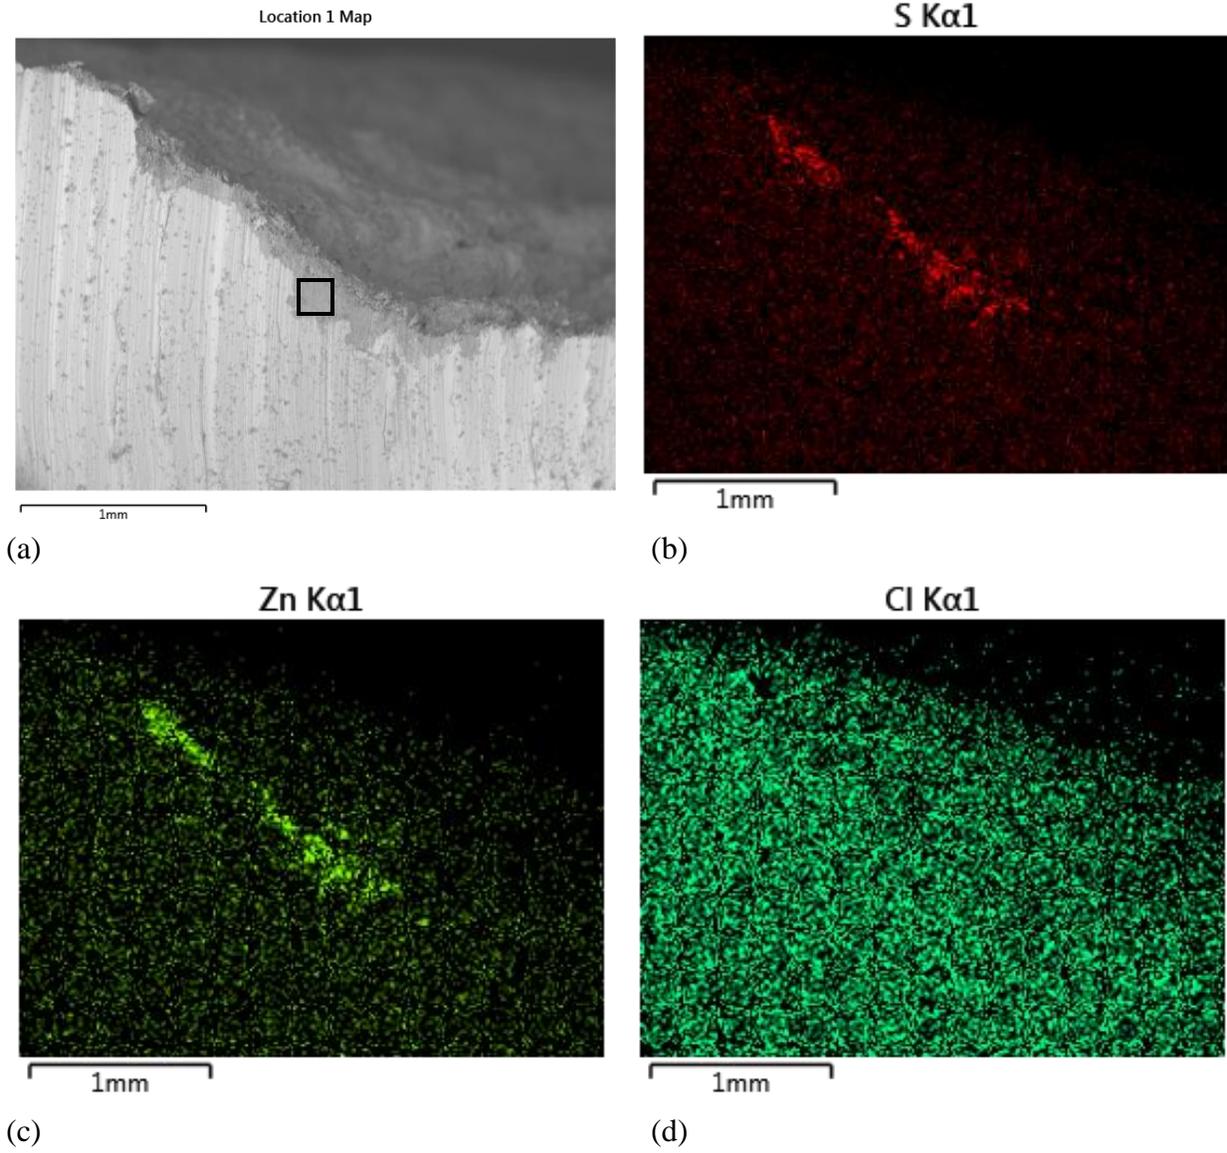
Figure 24 SEM image and EDS maps of the floor pit cross section in the as-cut condition.

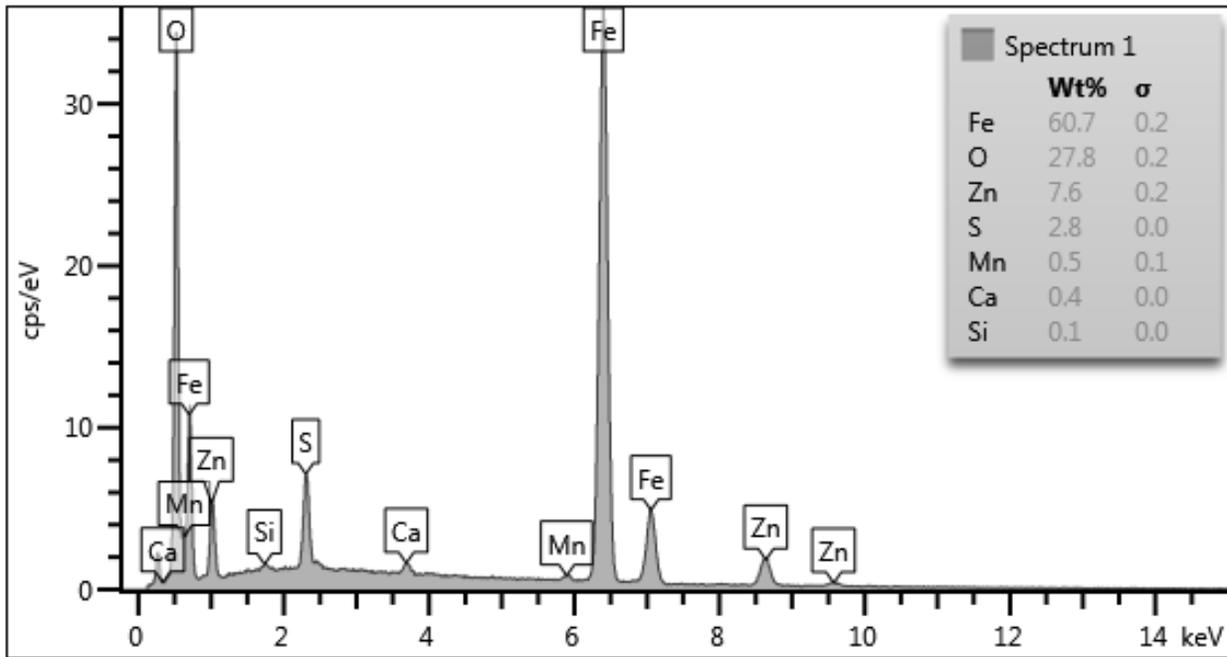
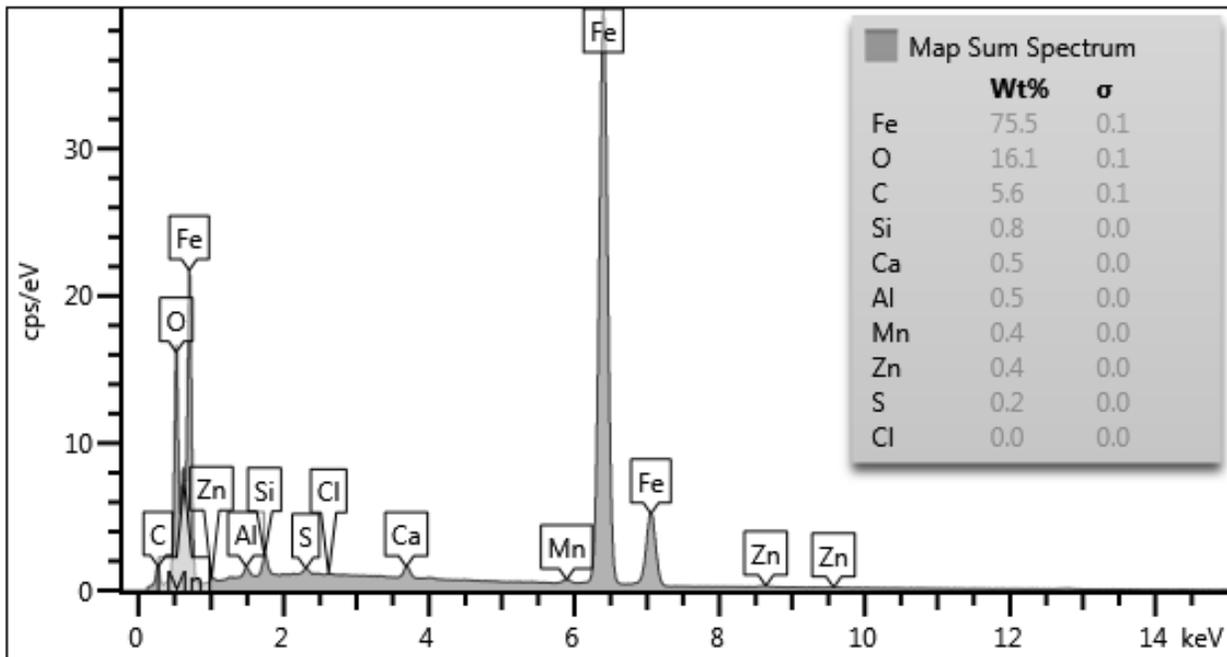
Figure 25 EDS spectra from the cross section location shown in Figure 24.

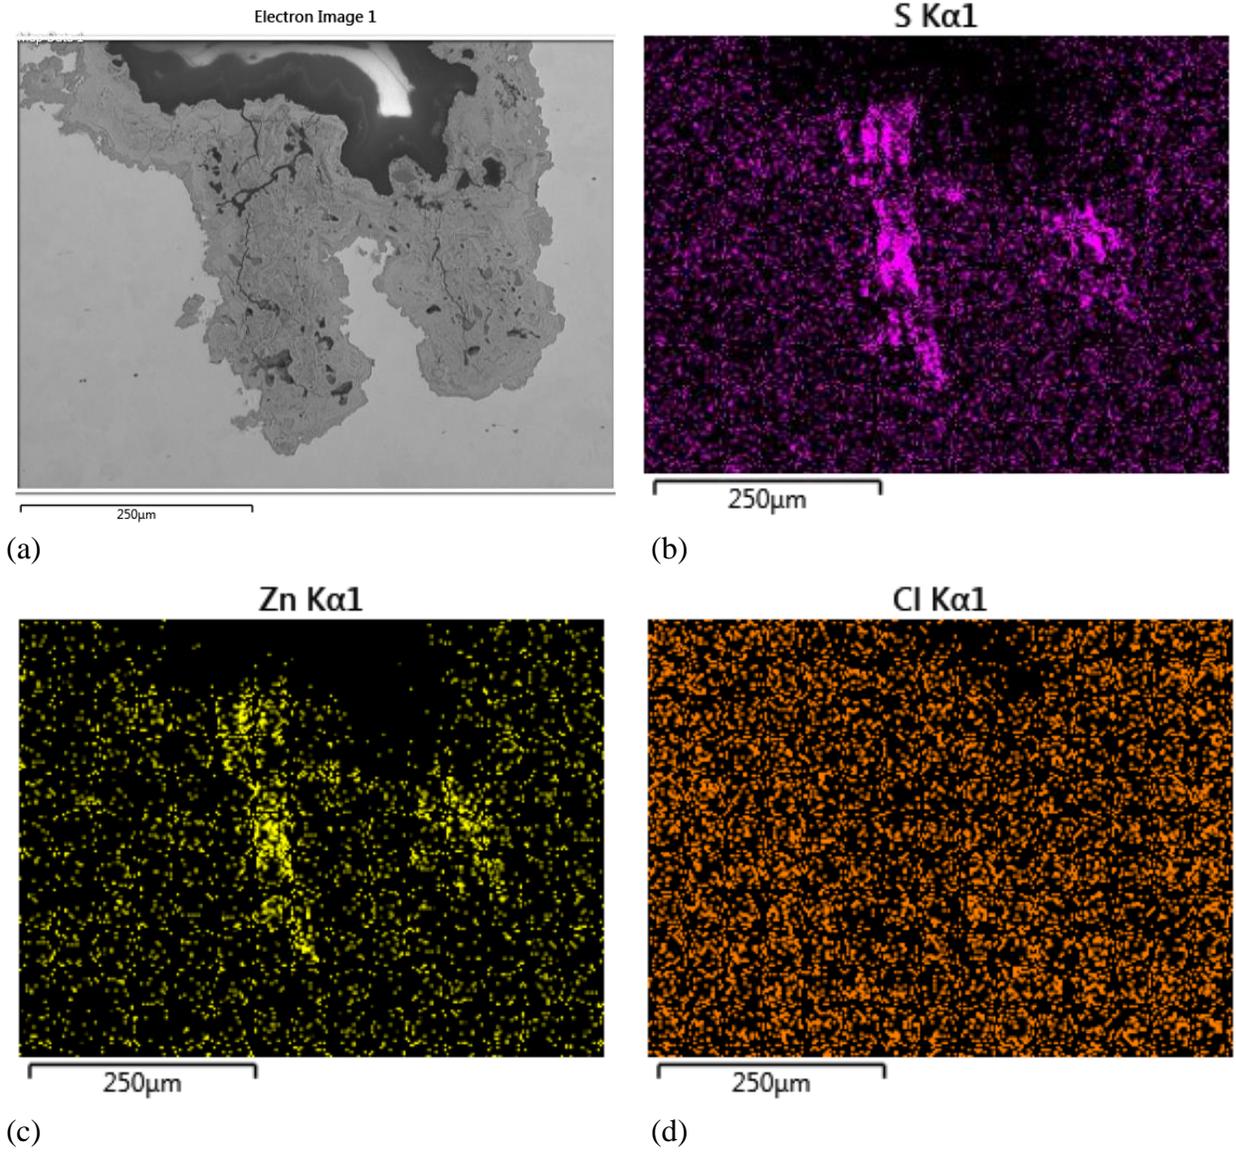
Figure 26 EDS maps from the as-polished specimen floor pit, location shown in Figure 15a.

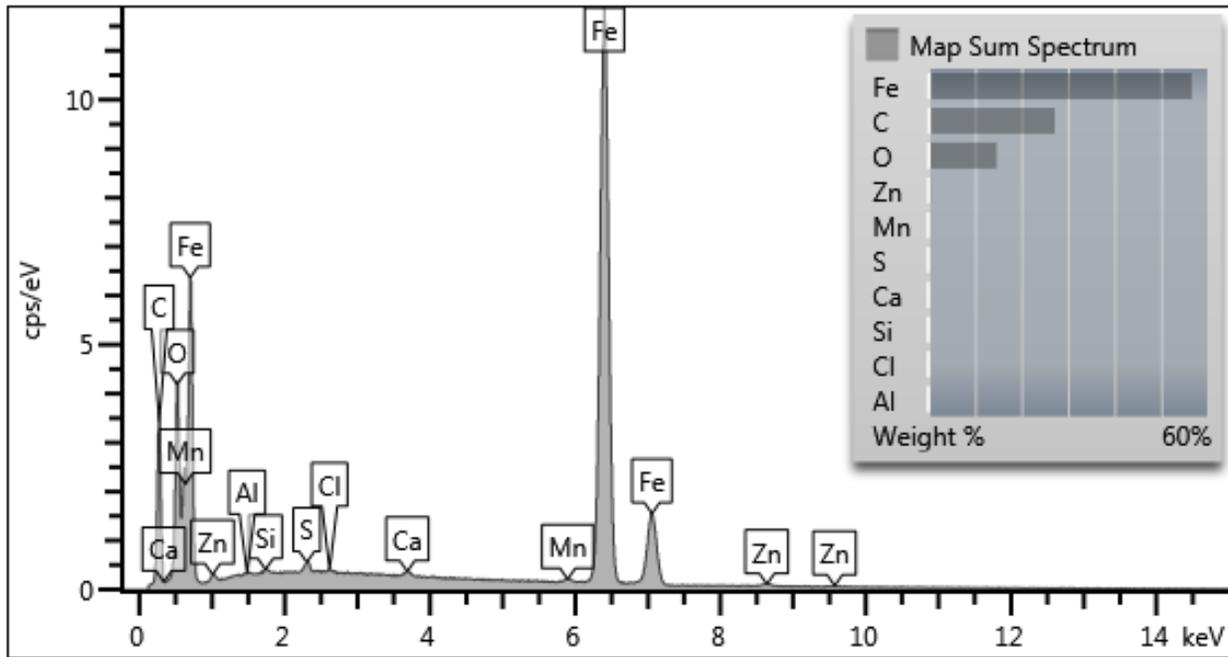
Figure 27 EDS sum spectrum from the as-polished specimen floor pit area mapped in Figure 26.

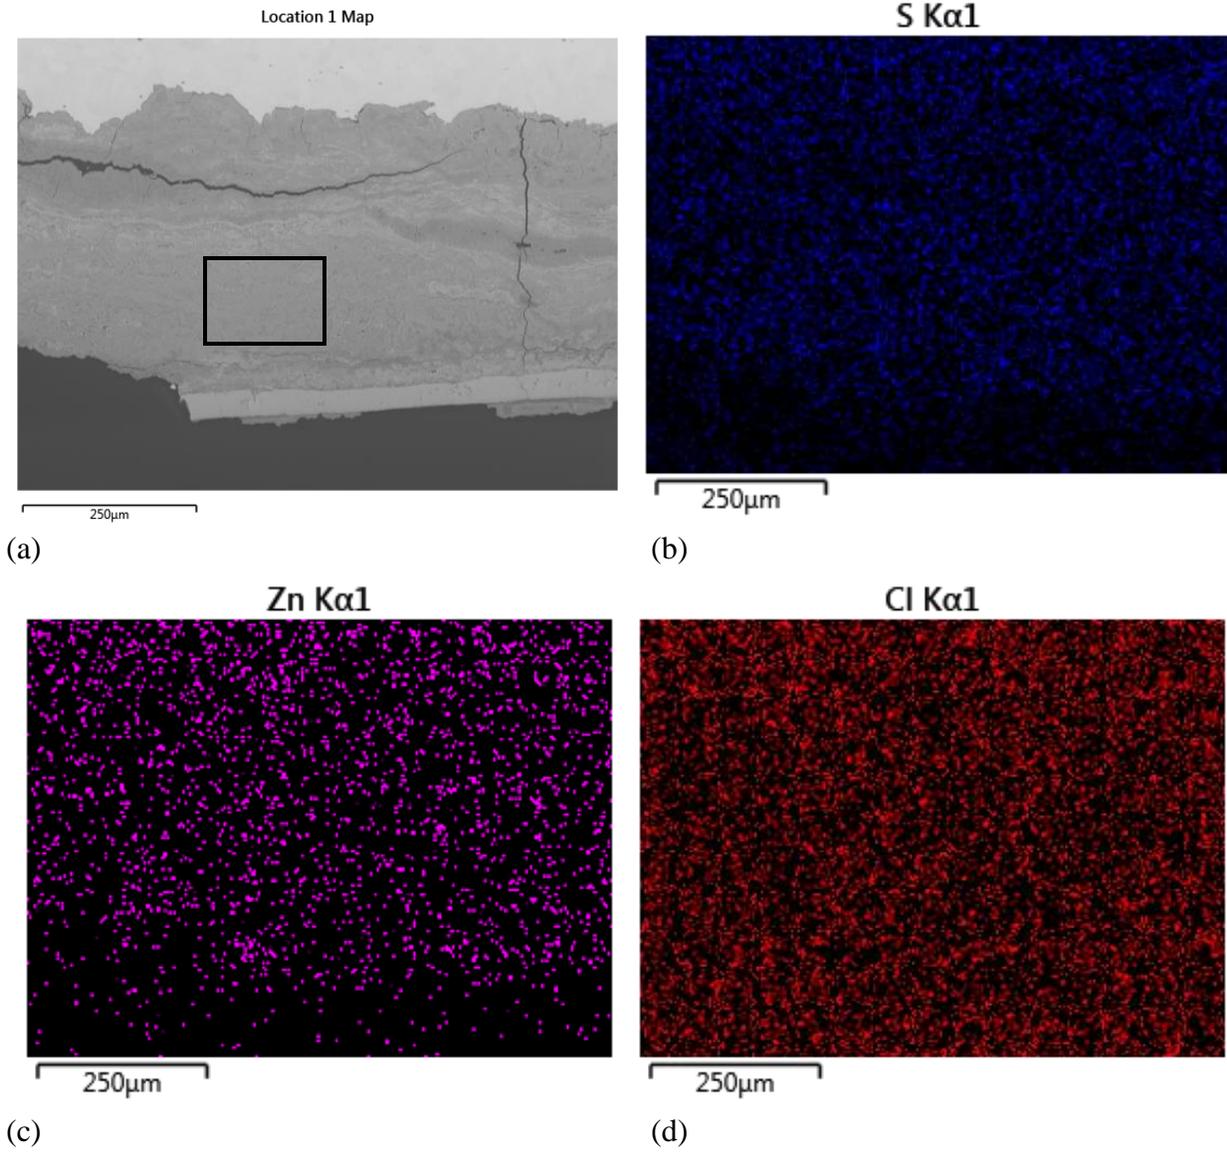
Analysis results of the soil side corrosion product of specimen floor 1 are shown in Figure 28 and Figure 29. Sulfur and low levels of zinc were evenly distributed in the mapped area.

Figure 28 EDS maps from the floor 1 specimen area indicated in Figure 19a.

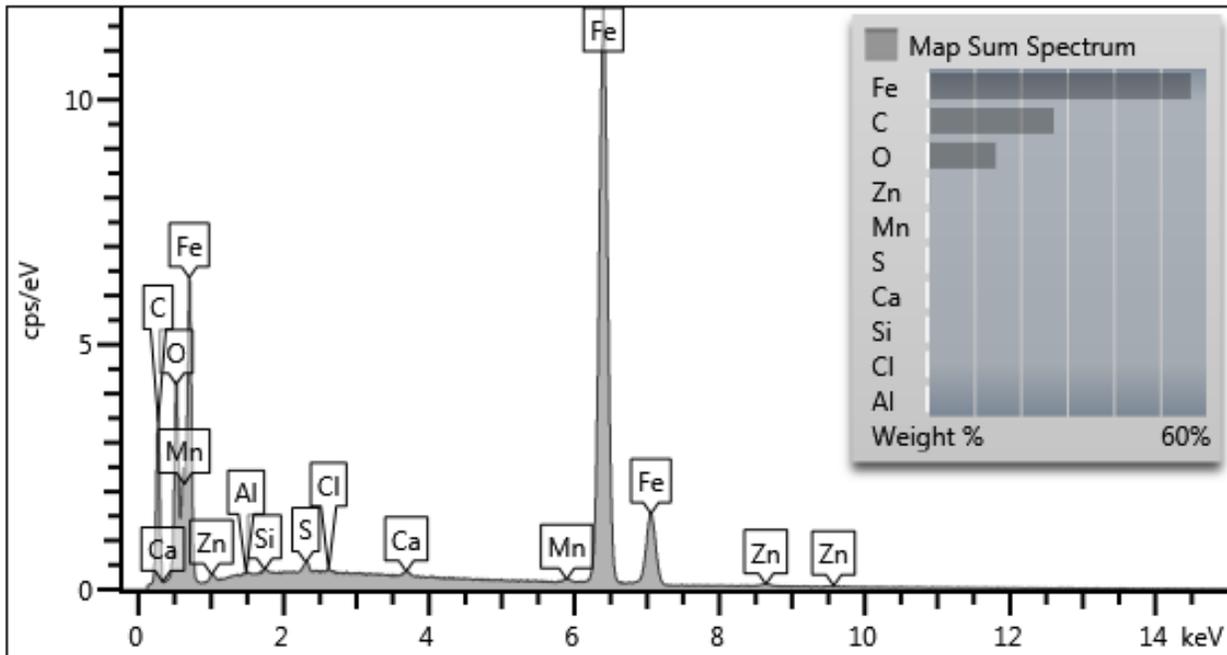
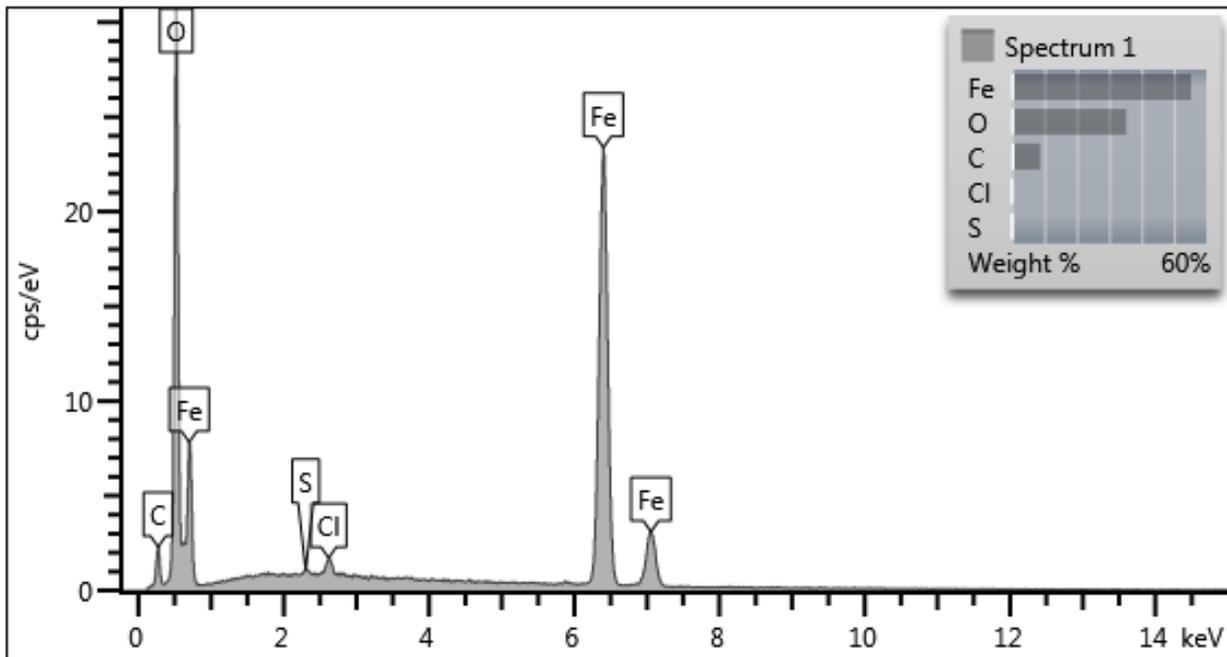
Figure 29 EDS spectra from the as-polished floor 1 specimen.

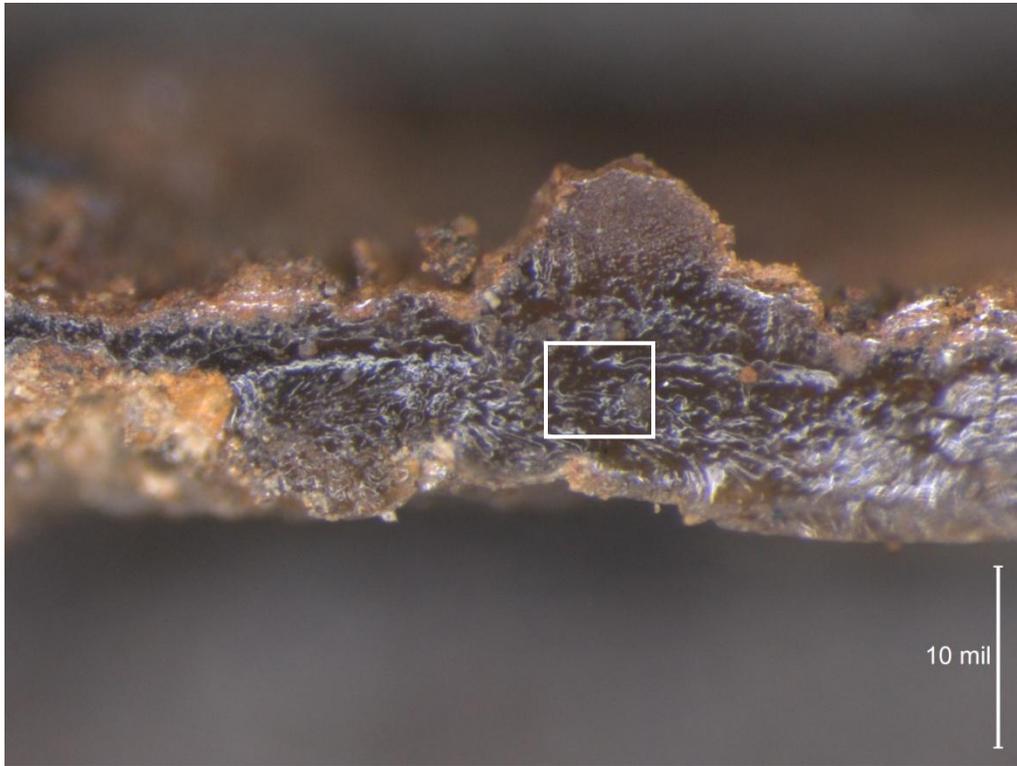
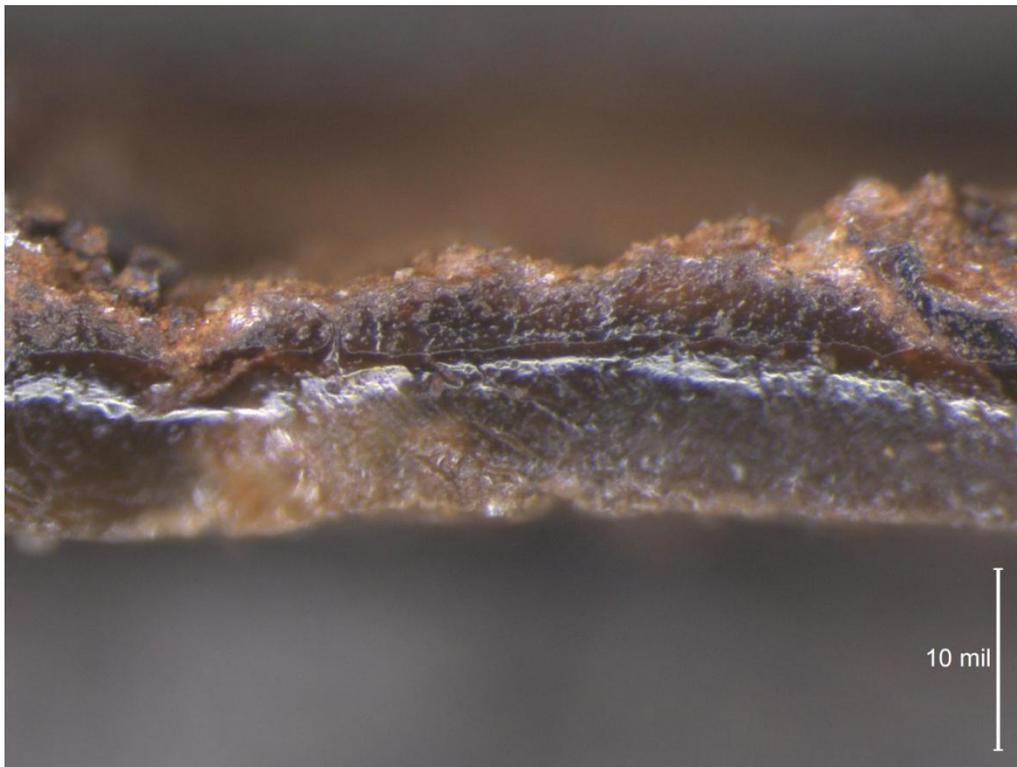
Specimens of the inside surface coating were analyzed by infrared spectroscopy (FTIR). Macrographs of inside surface coating specimen cross sections are shown in Figure 30. Analysis was performed on translucent amber spectrum are shown in Figure 31. The inside surface coating was identified as a vinyl acetate. Similar spectra and spectra library matches, Figure 32, were obtained from a sample identified as EV-CSB2014-01-1-WV-T396 LATEX, FROM BOTTOM OF T396, which consisted of several pounds of material collected from the floor of Tank 396 during initial stages of the investigation at the Freedom Industries site.

Figure 30 Cross sections of floor inside surface coating.

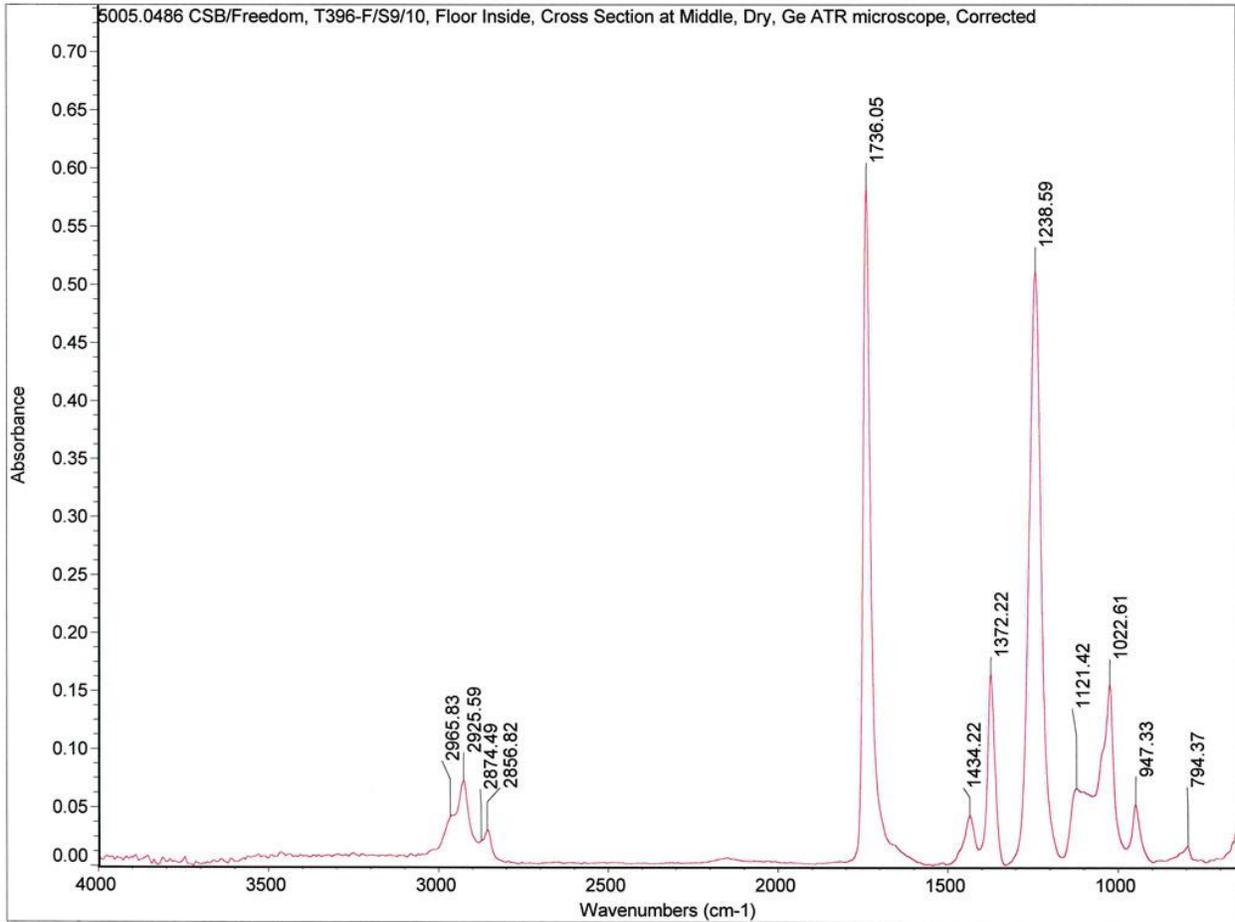
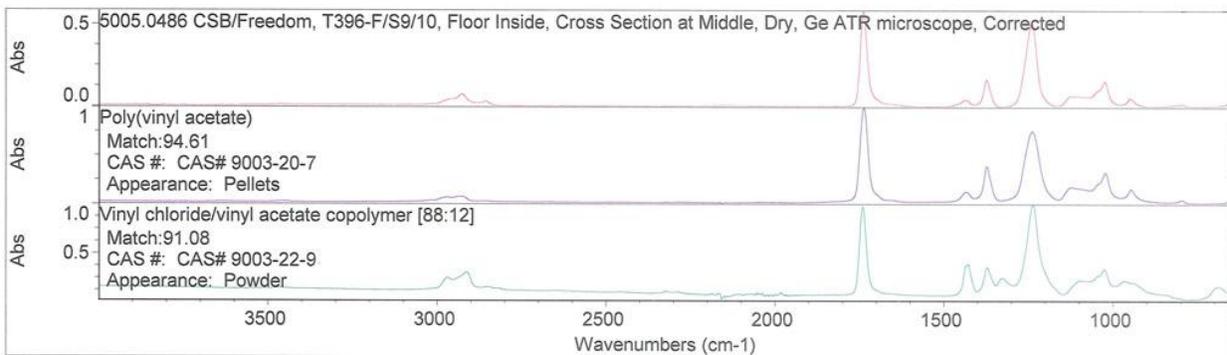
Figure 31 FTIR results for the floor inside surface coating.

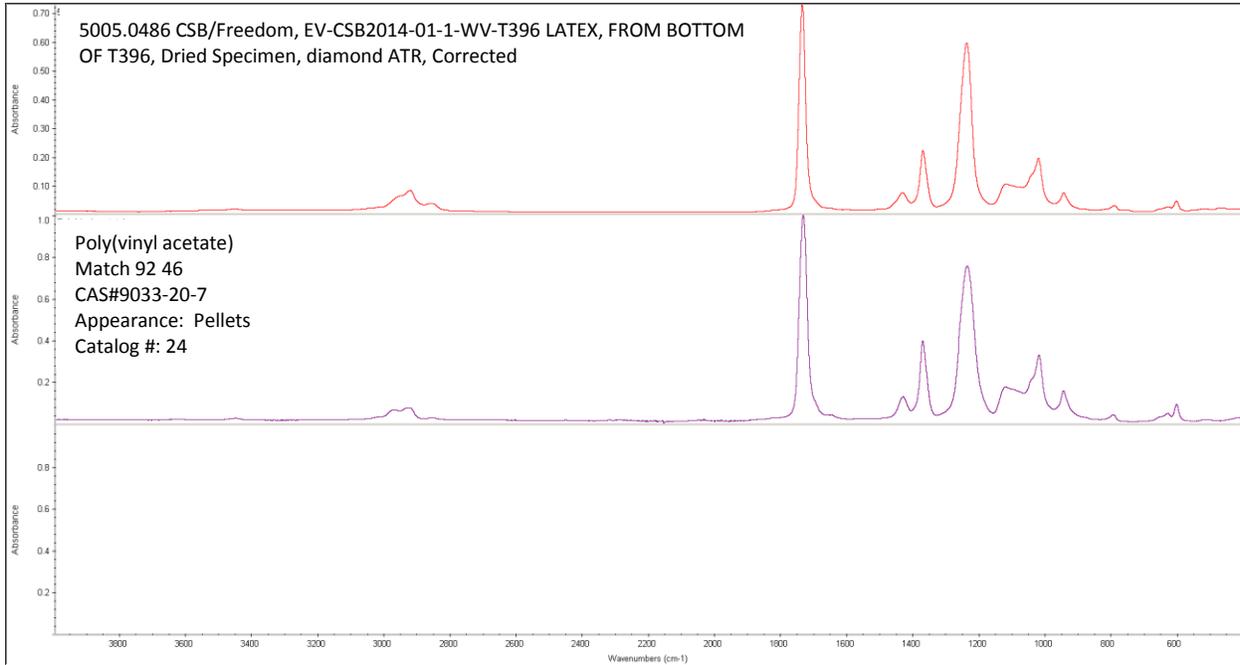
Figure 32 FTIR absorption spectrum and spectrum library match for a specimen of sample labeled EV-CSB2014-01-1-WV-T396 LATEX, FROM BOTTOM OF T396. The specimen spectrum and match were the same as for specimens from the T396-F/S9/10 floor inside surface coating.

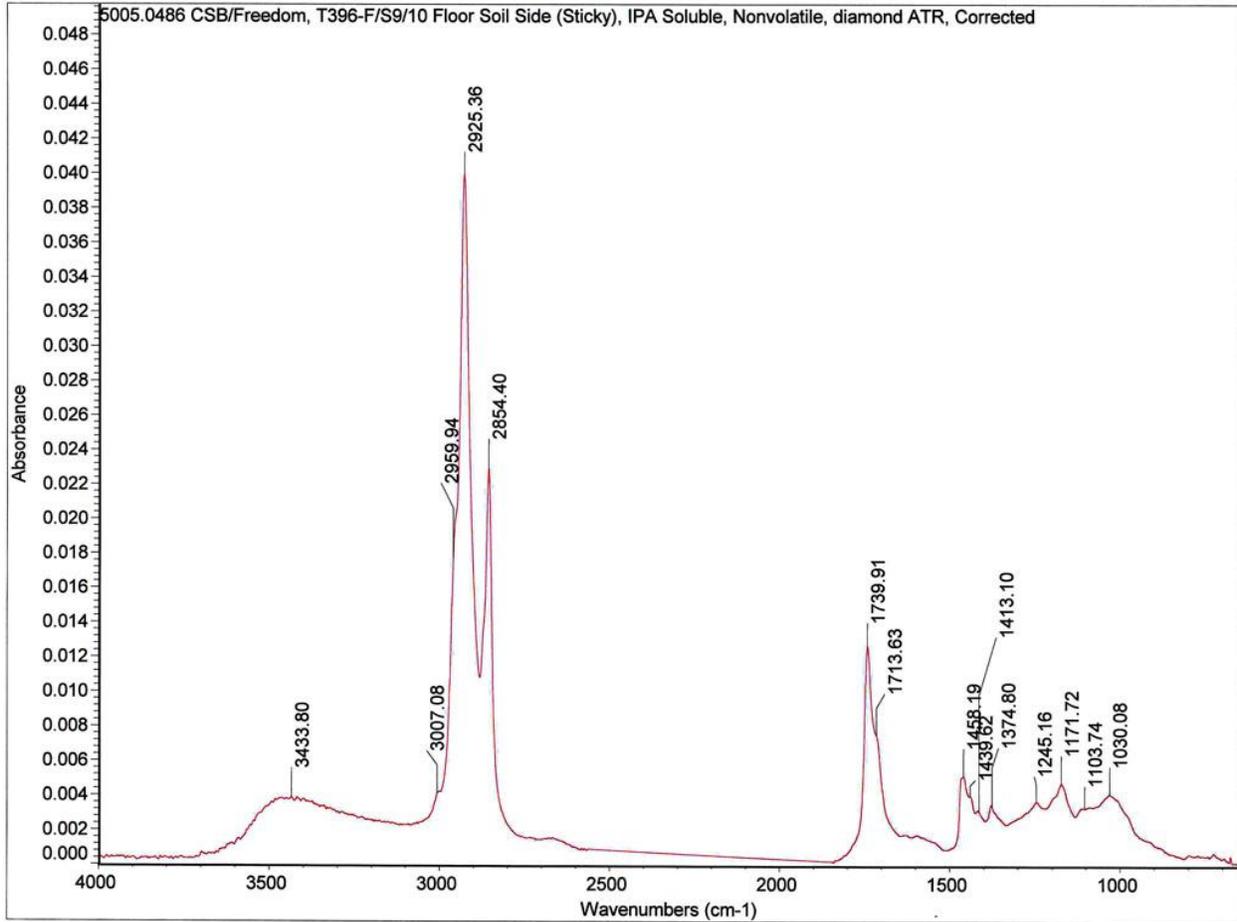
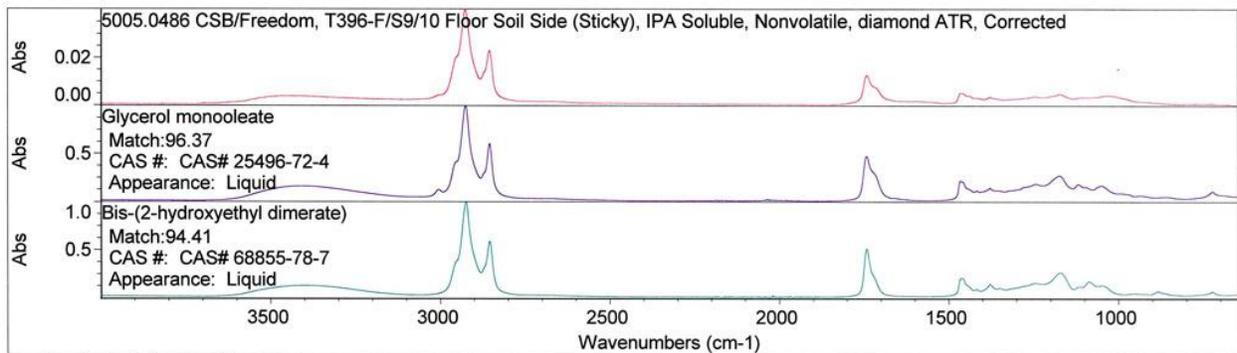
A specimen of the floor soil side sticky area adjacent to the holes was analyzed by FTIR. An absorption spectrum and spectra library matches are shown in Figure 33. The best fit library match was to glycerol monooleate and the second best match was to Bis-(2-hydroxyethyl dimerate). There is no obvious correlation between the sticky substance on the floor soil side and inside surface corrosion pits that lead to release of the tank contents.

Figure 33 FTIR results for the sticky soil side floor specimen.

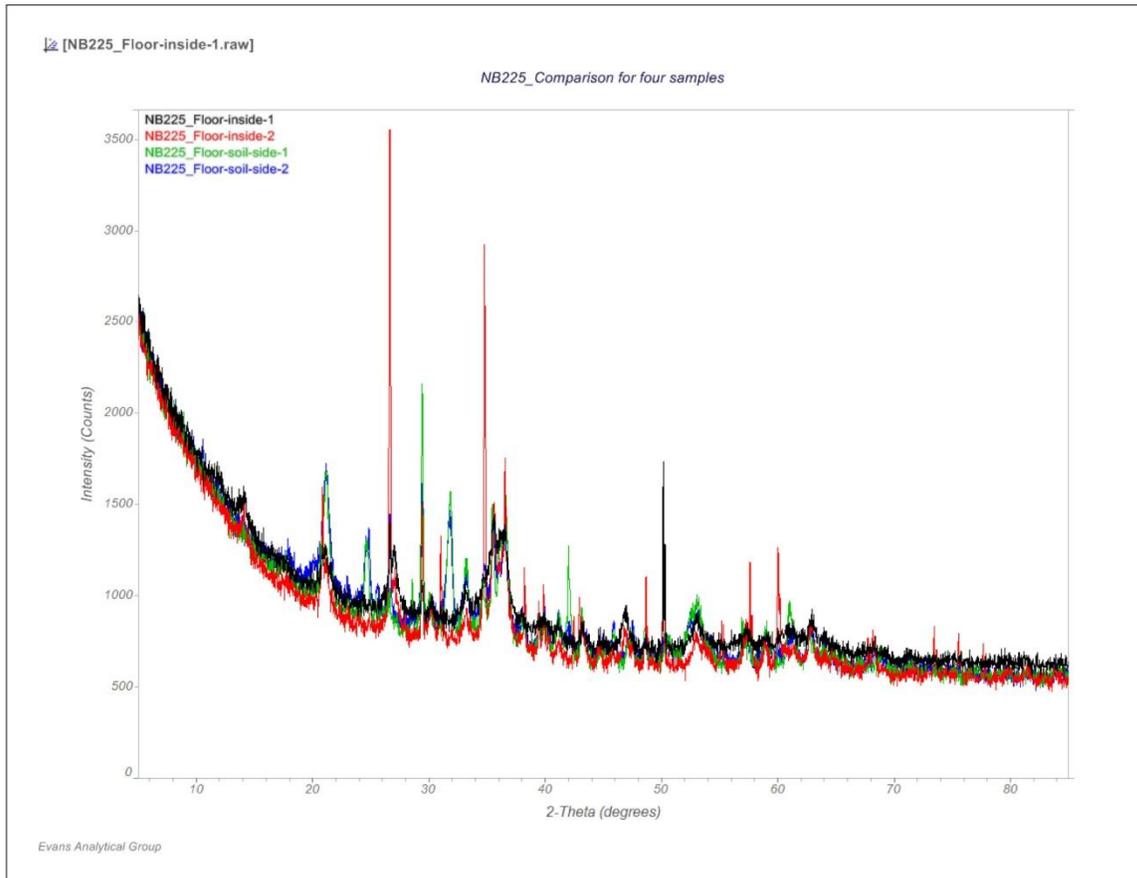
Figure 1 compares the XRD raw data from all four samples. There are significant differences between these patterns in terms of overall intensities, peak shape and peak positions.

Figure 1: Comparison for four samples

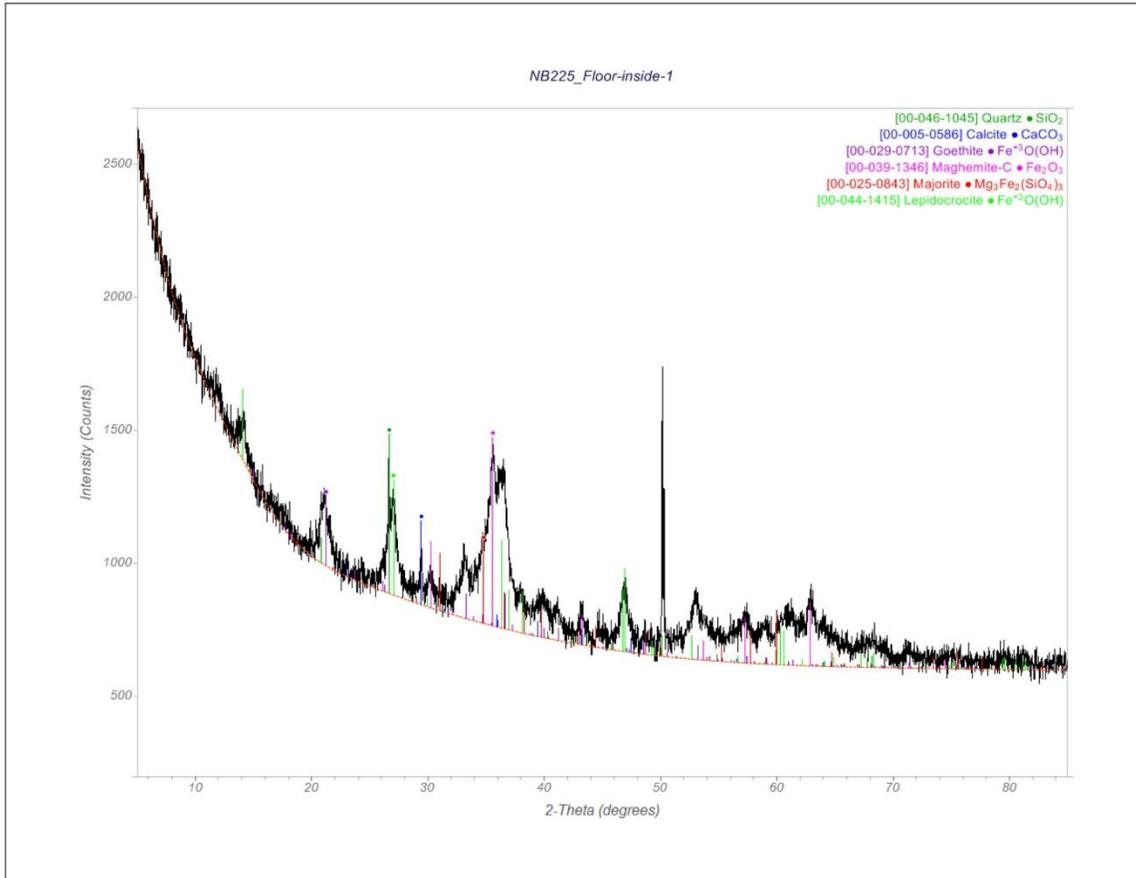
and sample 2 (Floor inside surface #2). The Maghemite cubic phase is the major phase in sample 1. Majorite and Quartz are the major phases observed in sample 2 while they are detected as minor phases in sample 1. Two polymorphs of Iron Oxy-hydroxide phases (FeO(OH) α (Goethite) and γ (Lepidocrocite) as well as Calcite are present as trace phases in these two samples as well.

Figure 2: Phase identification for sample 1 (Floor inside surface #1)

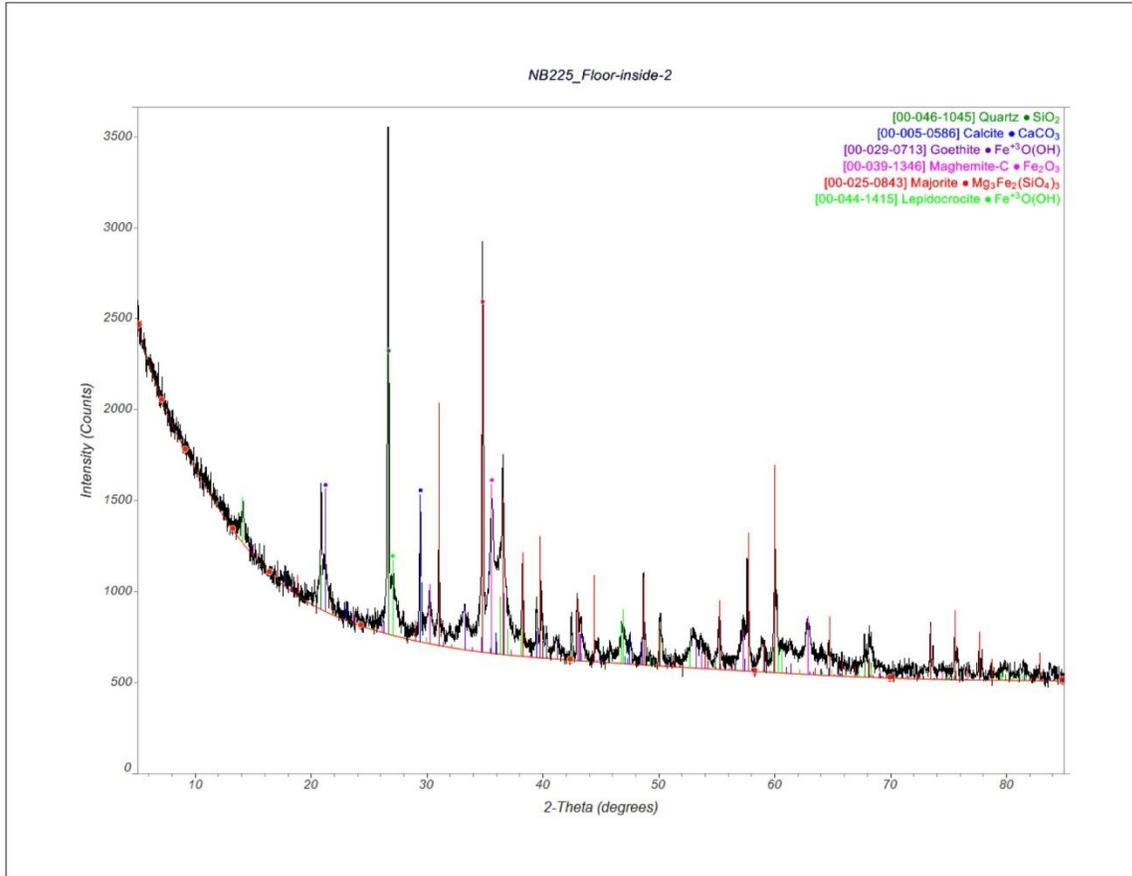
Figure 3: Phase identification for sample 2 (Floor inside surface #2)

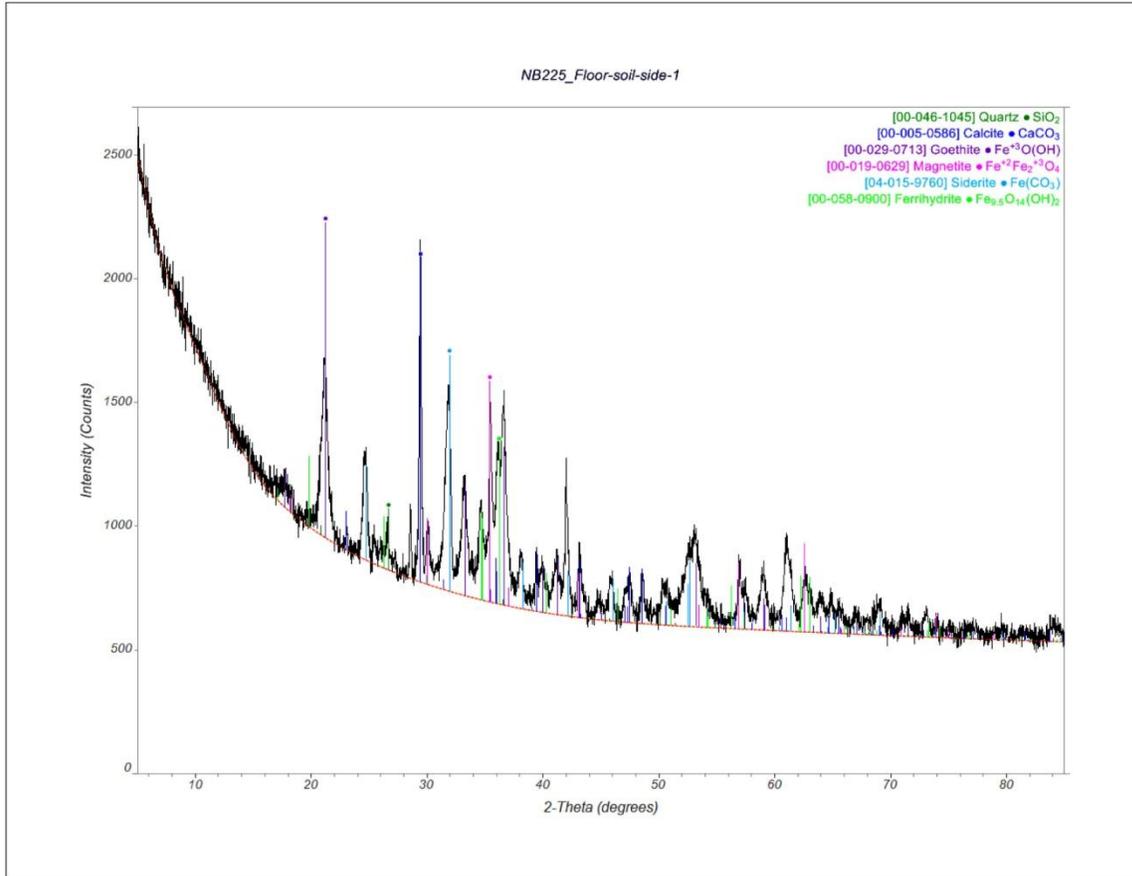
The phase identification results for sample 3 (Floor soil side #1) and sample 4 (Floor soil side #2) are shown in [Figure 4](#) and [Figure 5](#), respectively. Goethite and Siderite are the primary phases in both of these samples. Maghemite is a good match in sample 4 while Magnetite agrees well with most of the minor peaks in sample 3. Calcite is also identified as a minor phase in sample 3 at a greater concentration than in sample 4. Several weak peaks in both samples matched Quartz and Ferrihydrite, but these should be considered speculative matches due to the many peak overlaps present. In addition, there are few weak peaks that could not be matched in both samples.

Figure 4: Phase identification for sample 3 (Floor soil side #1)
