Report No. 5005.0486A

**METALLURGICAL EVALUATION OF TANK COUPON T396-F/S9/10 FROM
FREEDOM INDUSTRIES, CHARLESTOWN, WEST VIRGINIA**

Customer Authorization: CSB2014-01-I-WV

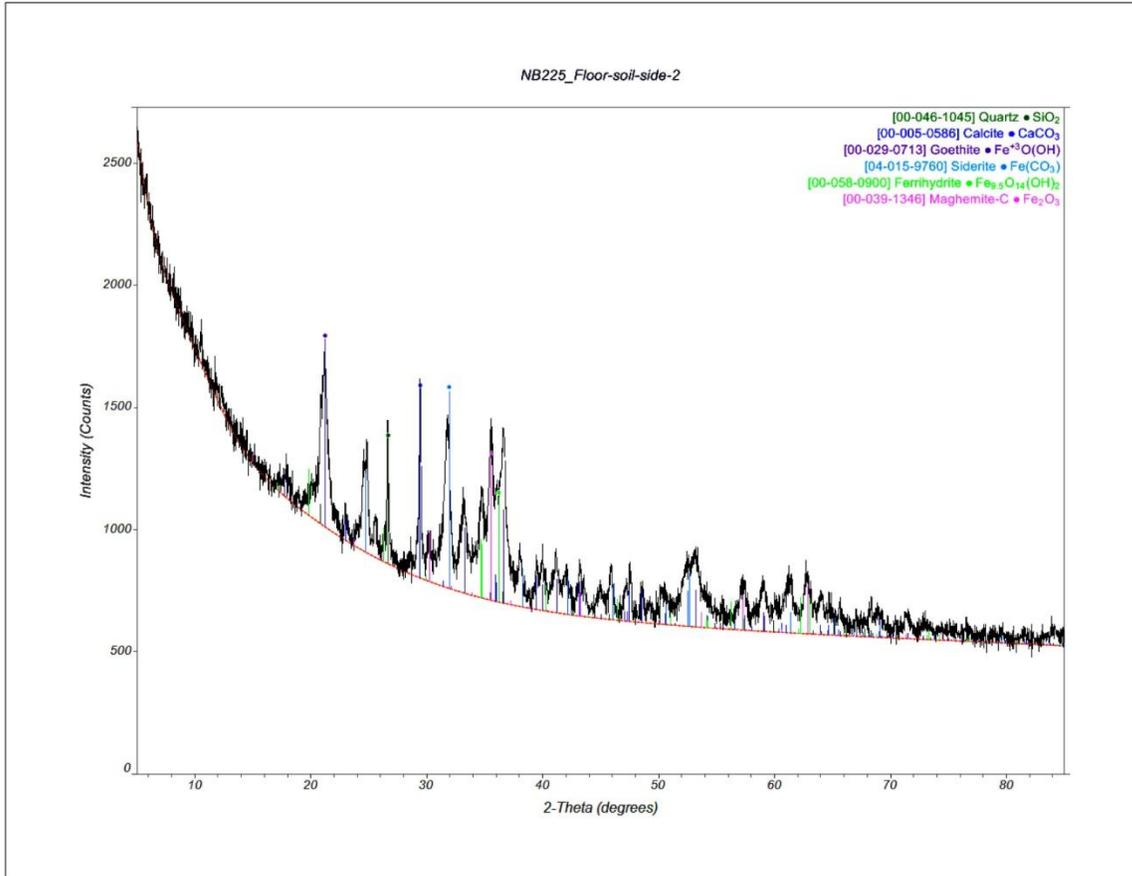
The phase identification results for sample 3 (Floor soil side #1) and sample 4 (Floor soil side #2) are shown in [Figure 4](#) and [Figure 5](#), respectively. Goethite and Siderite are the primary phases in both of these samples. Maghemite is a good match in sample 4 while Magnetite agrees well with most of the minor peaks in sample 3. Calcite is also identified as a minor phase in sample 3 at a greater concentration than in sample 4. Several weak peaks in both samples matched Quartz and Ferrihydrite, but these should be considered speculative matches due to the many peak overlaps present. In addition, there are few weak peaks that could not be matched in both samples.

Figure 5: Phase identification for sample 4 (Floor soil side #2)
