U.S. CHEMICAL SAFETY AND HAZARD INVESTIGATION BOARD

# INVESTIGATION REPORT

## LPG FIRE AT VALERO – MCKEE REFINERY

REPORT NO. 2007-05-I-TX

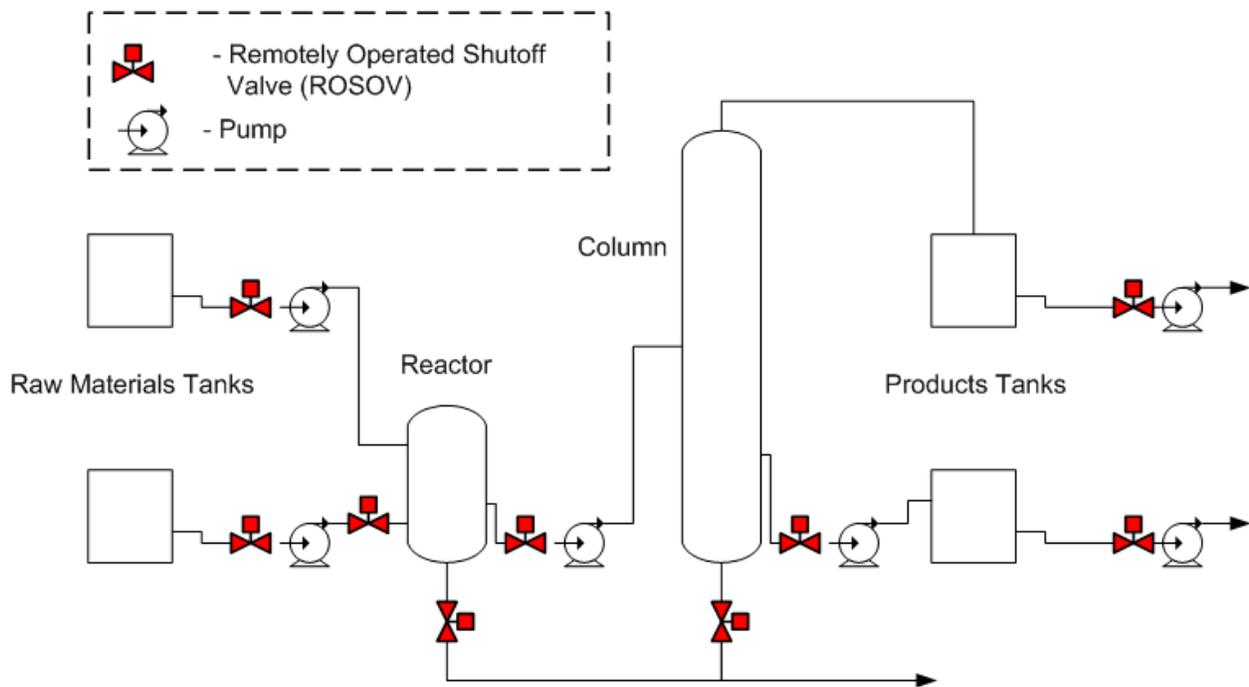
Figure 12. Insurer-recommended locations for ROSOVs

Although the PDA unit contained large inventories of high-pressure propane, it was not equipped with remotely operable shut-off valves (ROSOVs)<sup>37</sup> to rapidly stop propane releases. ROSOVs should be used in facilities, such as the PDA unit, where fast and effective isolation is needed to reduce the impact of major hazardous releases (HSE, 1999).

Figure 12 shows insurer-recommended ROSOV locations for a typical process unit. ROSOVs should be installed on large inventories of highly flammable materials,<sup>38</sup> especially when downstream pumps are present that could produce pressurized releases. Such pumps should be interlocked to shut down when ROSOVs are closed.

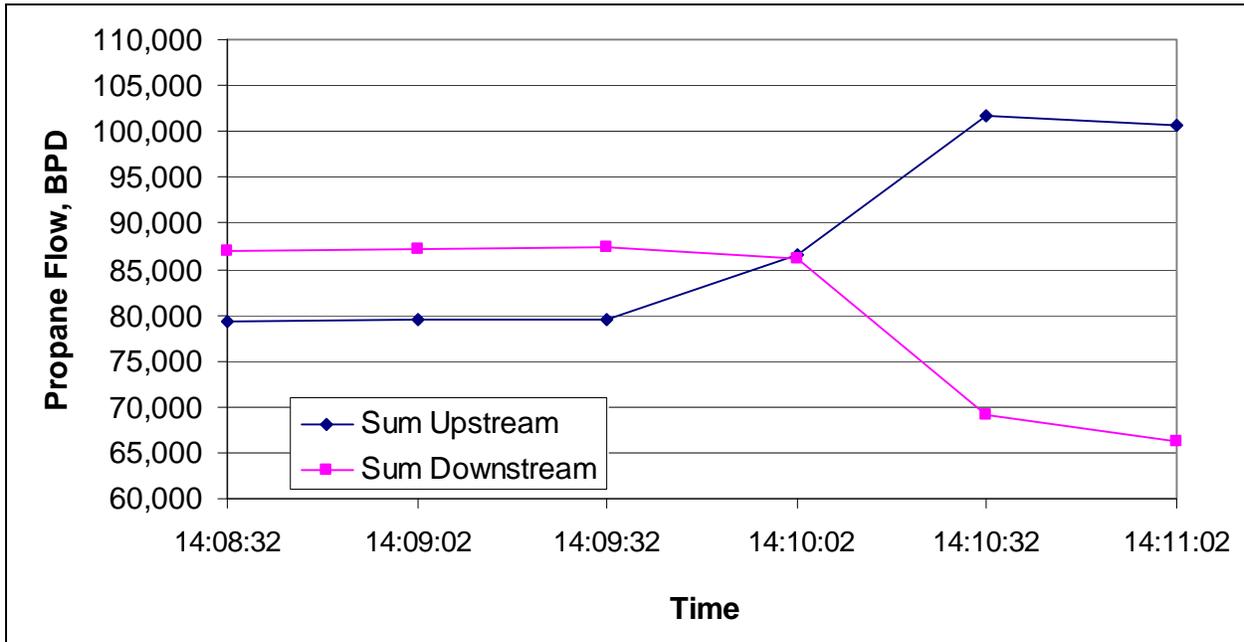
Figure D- 1. Changes in propane flows upstream and downstream of the cracked elbow

Figure 1 plots the sum of the upstream and downstream flow meter readings, in bpd.<sup>2</sup> The offset prior to the incident is due to an unmeasured process flow between the low- and high-pressure propane supplies upstream of the leak point. Assuming that this offset was fixed during the incident is conservative – the actual release rate was likely modestly higher than estimated here.

$$[21,900] + [19,500] = 41,400 \text{ bpd.}$$

Based on a liquid propane density of 27.7 lb per cubic foot at process conditions, the CSB estimated an initial release rate of 4,500 lb/min.

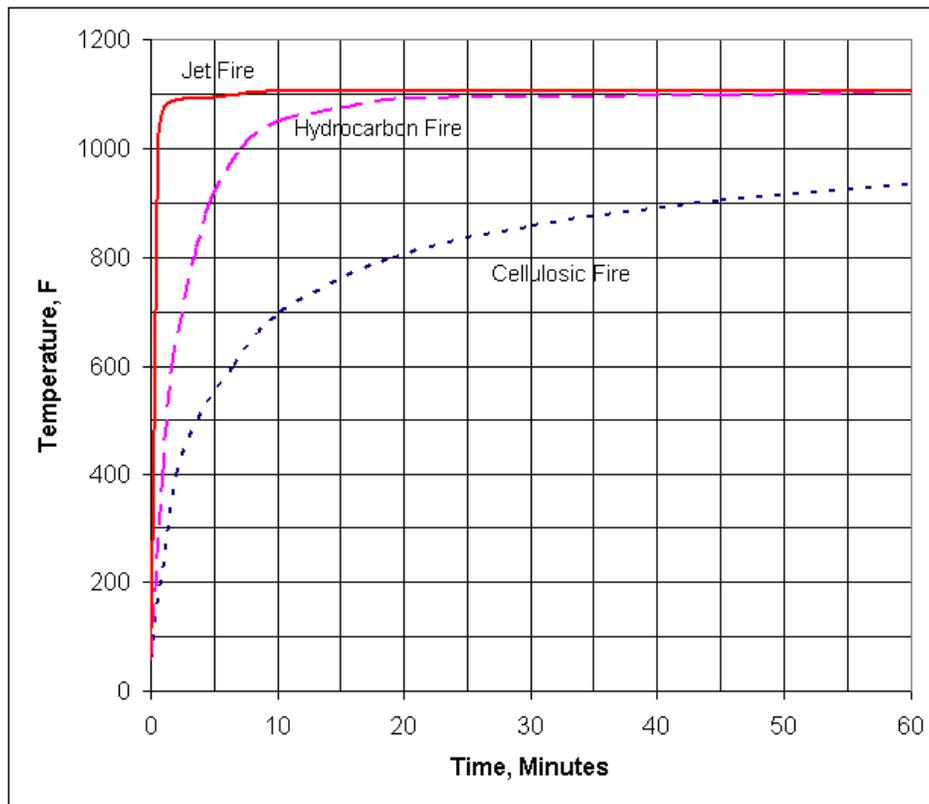
Figure E-1. Time temperature curves for fire tests (CCPS, 2003)

*Facilities* discusses the importance of fireproofing during the early stages of a fire, when “if non-fireproofed equipment and pipe supports fail due to fire related heat exposure, they could collapse and cause gasket failures, line breaks, and equipment failures, resulting in expansion of the fire.” This type of knock-on damage was a significant factor in the damage caused by the PDA unit fire. As Figure E-1 illustrates, exposure to a jet fire, as can occur in pressurized LPG fires, can lead to rapid heating and the failure of exposed steel within a few minutes.<sup>1</sup>

In this incident, the severity of the fire caused rapid knock-on damage before fuel supplies could be isolated or effective water sprays established. The use of ROSOVs, combined with fireproofed pipe rack supports, would likely have significantly reduced the damage caused by this fire.
