U.S. CHEMICAL SAFETY AND HAZARD INVESTIGATION BOARD

CHLORINE RELEASE

DPC ENTERPRISES, L.P.

REPORT NO. 2004-02-I-AZ

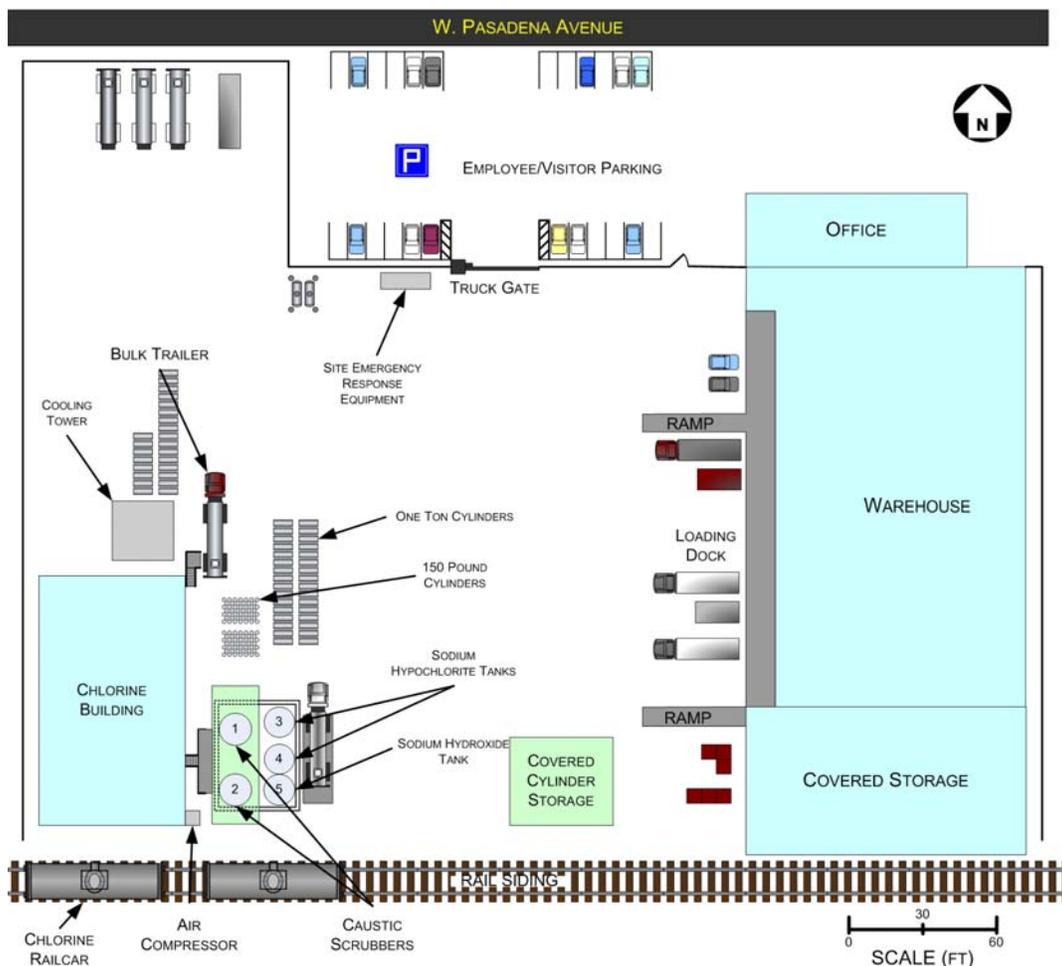
Figure 2. DPC-Glendale plot plan

At the site, DPC receives liquid chlorine in railcars and repackages it into smaller containers to distribute to local customers, and also manufactures sodium hypochlorite (or bleach). Figure 2 is a plot plan of the site, and shows the location of the major equipment involved in the November 17, 2003, incident. The caustic scrubbers used to control chlorine emissions are located in the southwest section, adjacent to the chlorine railcar unloading and bulk road trailer loading area. The chlorine building contains cylinder loading and bleach manufacturing facilities.

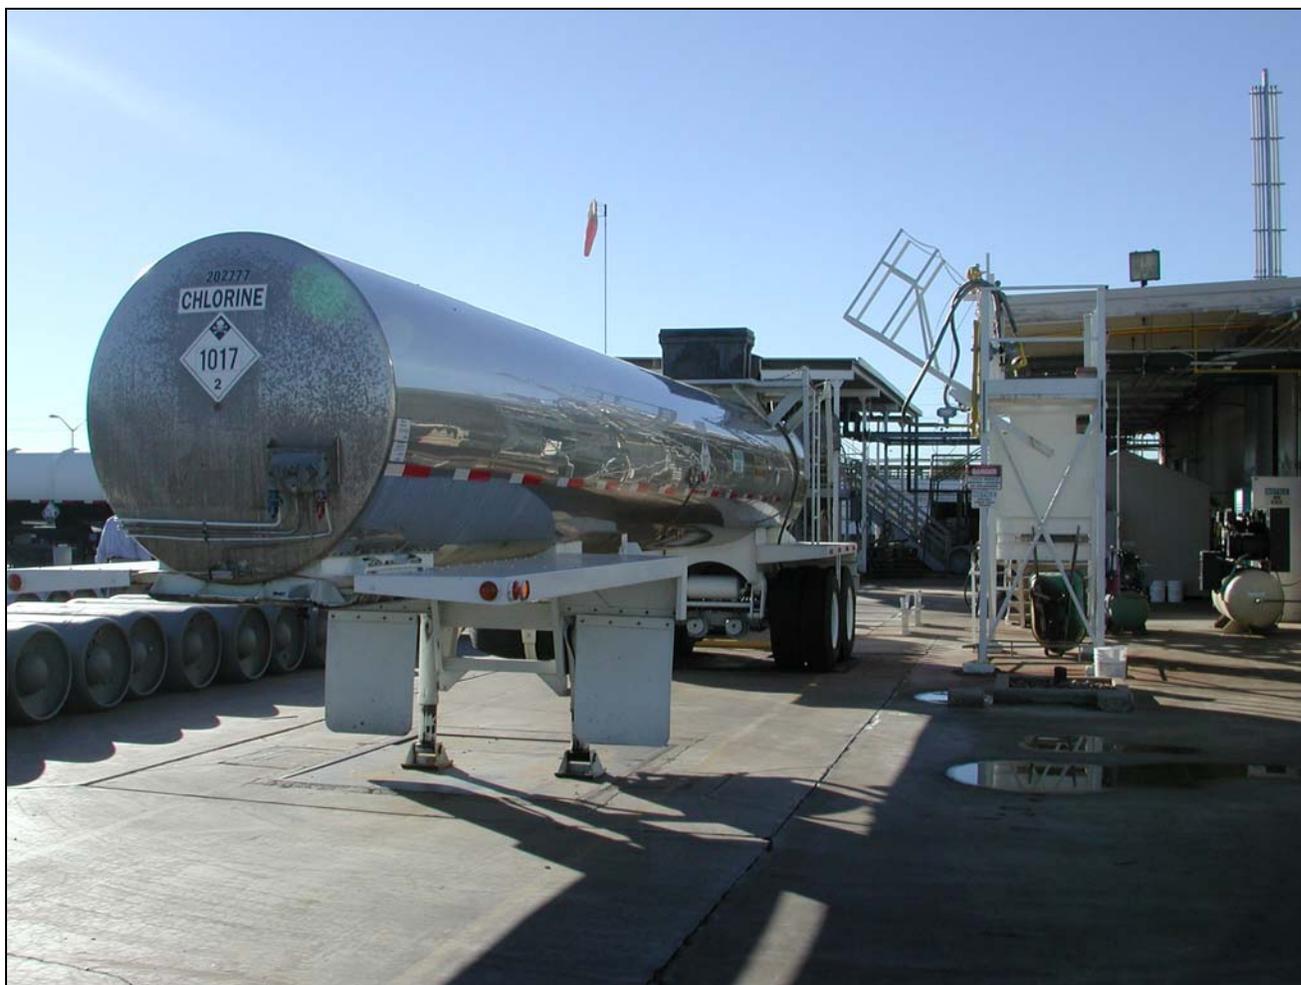
Figure 4. Chlorine bulk road trailer

About once a month, DPC supplies a bulk road trailer of chlorine to a local municipal water treatment facility. To transfer the chlorine, hoses specifically designed for chlorine service connect the chlorine railcar and the bulk road trailer (Figure 3 and Figure 4) to the transfer piping system. Remotely operated valves on each end of the hoses shut off chlorine flows in an emergency.⁶ The railcar initially contains

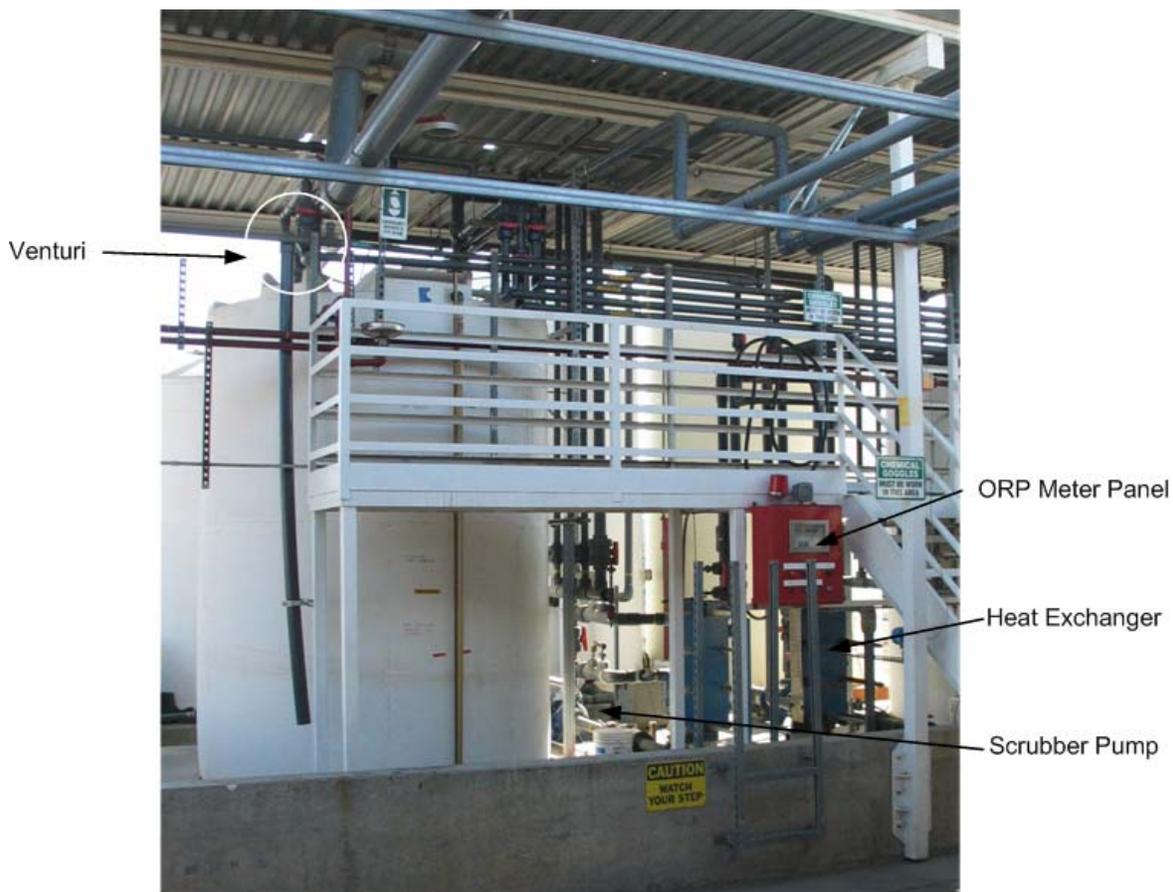
Figure 5. Caustic scrubber (typical)

The two Glendale scrubbers are 4,000 gallon, fiberglass reinforced plastic tanks (Figure 5). They operate as batch chemical reactors, with one unit receiving chlorine (the online scrubber), and the other operating as a backup (the standby scrubber).⁸ Operators initially fill a scrubber with an aqueous solution containing 21 percent caustic.⁹ Chlorine vented from repackaging operations is fed to the scrubber until the caustic concentration reaches 0.2-0.5 percent, as required by customer specifications for bleach.¹⁰ The chlorine flow is then manually switched to the standby unit, the product bleach transferred to storage, and the depleted scrubber charged with fresh caustic solution.

on a local panel (Figure 5). The ORP meter readings increase as the residual caustic concentration in the scrubber solution decreases. The correlation between ORP readings and caustic concentration is normally highly repeatable, but can be affected by a variety of factors, such as temperature, fouling, and the initial caustic concentration (see section 4.1). Each ORP meter is equipped with two alarms to help operators track the depletion of caustic in the bleach batch (Table 2); however, no automated control actions occur based on the ORP meters' outputs.
