U.S. CHEMICAL SAFETY AND HAZARD INVESTIGATION BOARD

# INVESTIGATION REPORT

## CHLORINE RELEASE

**DPC ENTERPRISES, L.P.**

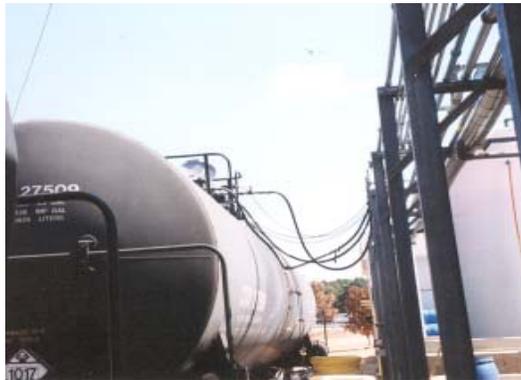
Figure 1. Railroad tank car unloading station #3.

Around 9:20 am on Wednesday, August 14, 2002, a 1-inch chlorine transfer hose (CTH) used in a railroad tank car unloading operation at the DPC Enterprises, L.P., facility, near Festus, Missouri, catastrophically ruptured (Figures 1 and 2). The facility is located in an unincorporated area of Jefferson County. The hose rupture initiated a sequence of events that led to the release of 48,000 pounds of chlorine. The release continued unabated for nearly 3 hours.

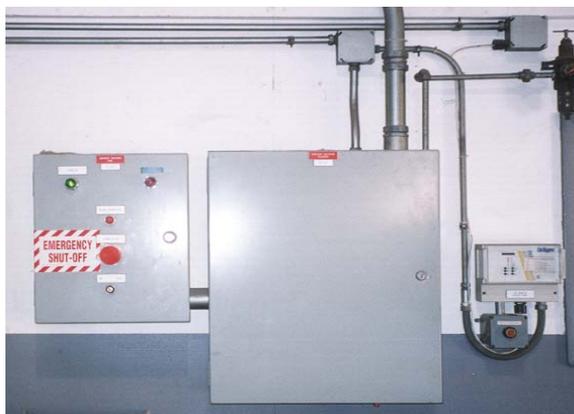
Figure 15. ESD panel with emergency shutdown button.

magnitude and intensity of the release, the employees evacuated the building. The operations manager pushed the ESD button (Figure 15) as he exited in an attempt to manually shut off the chlorine release.

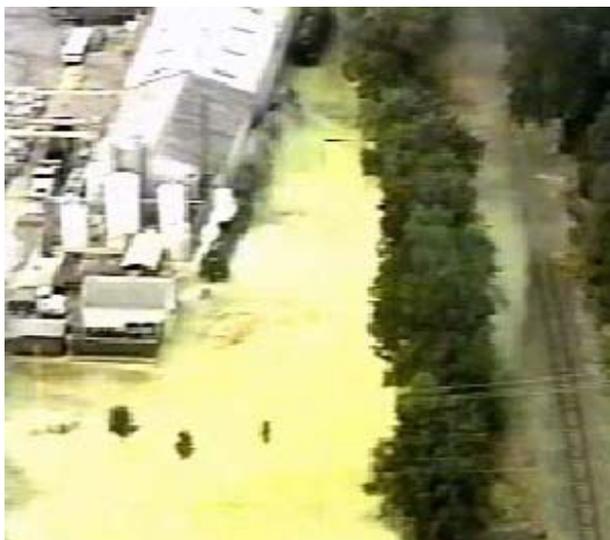
Figure 16. Movement of chlorine plume offsite.

Wind speed was generally 3 to 5 miles per hour (mph) on the morning of August 14. The chlorine plume (Figure 16) moved primarily east-to-southeast in the direction of Goodwin Brothers Construction and Intermodal Tire, though it is likely that it migrated into the adjacent Blue Fountain mobile home park

when there was no wind. As indicated by dispersion modeling,<sup>9</sup> chlorine concentrations of 3 ppm could have extended to approximately 3.7 miles from the point of release (Trinity Consultants, 2003).

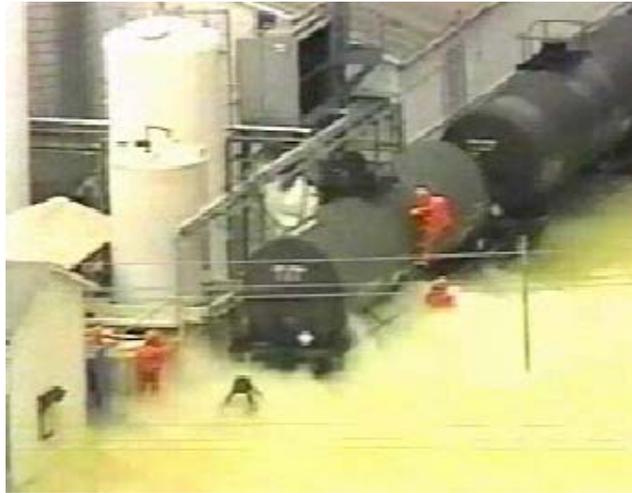
Figure 17. HAZMAT personnel accessing the top of tank car to close valves.

Three HAZMAT personnel and one DPC employee (who had specialized HAZMAT training) entered the release area around noon, where a yellowish-green fog about 4 feet high covered the area surrounding the tank car. Visibility was very poor. Two HAZMAT personnel climbed the tank car ladder to access the top of the car (Figure 17). They closed the liquid valve that supplied the ruptured hose (valve A), but the release did not stop. They then closed the other liquid valve (valve C) and vapor valve D halfway; then they completely closed both valves. The release stopped when valve C was closed.

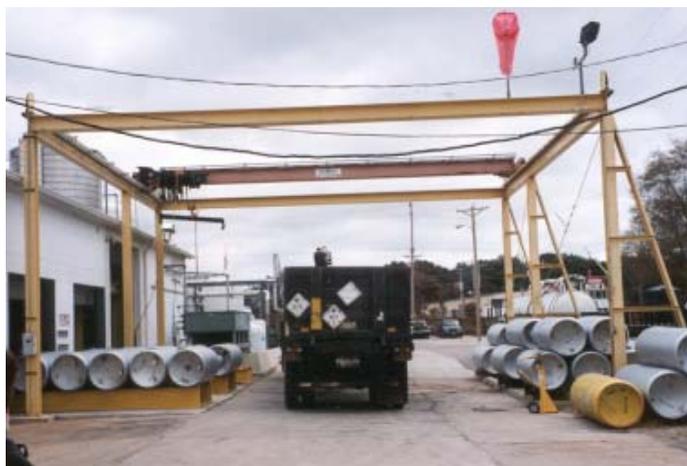
Figure 26. Truck loading station at DPC Festus.

Another incident at DPC Festus, in January 1999, demonstrated the need for improved community notification. In that incident, a 1-ton container of chlorine was dropped as it was being loaded onto a truck (Figure 26). The fall damaged the container valves and released 1,500 pounds of chlorine. Twenty-two residents and two DPC employees sought medical evaluation due to exposure; one person was admitted and released the following day. Several residents and community officials interviewed by CSB in the course of the 2002 investigation indicated that DPC had committed to update its community notification procedures and implement a notification system as result of the 1999 incident. However, DPC did not follow through on this commitment.
