U.S. Chemical Safety and
Hazard Investigation Board

Fire During Hot Work at Evergreen Packaging Paper Mill

Canton, NC | Incident Date: September 21, 2020 | No. 2020-07-I-NC

Investigation Report

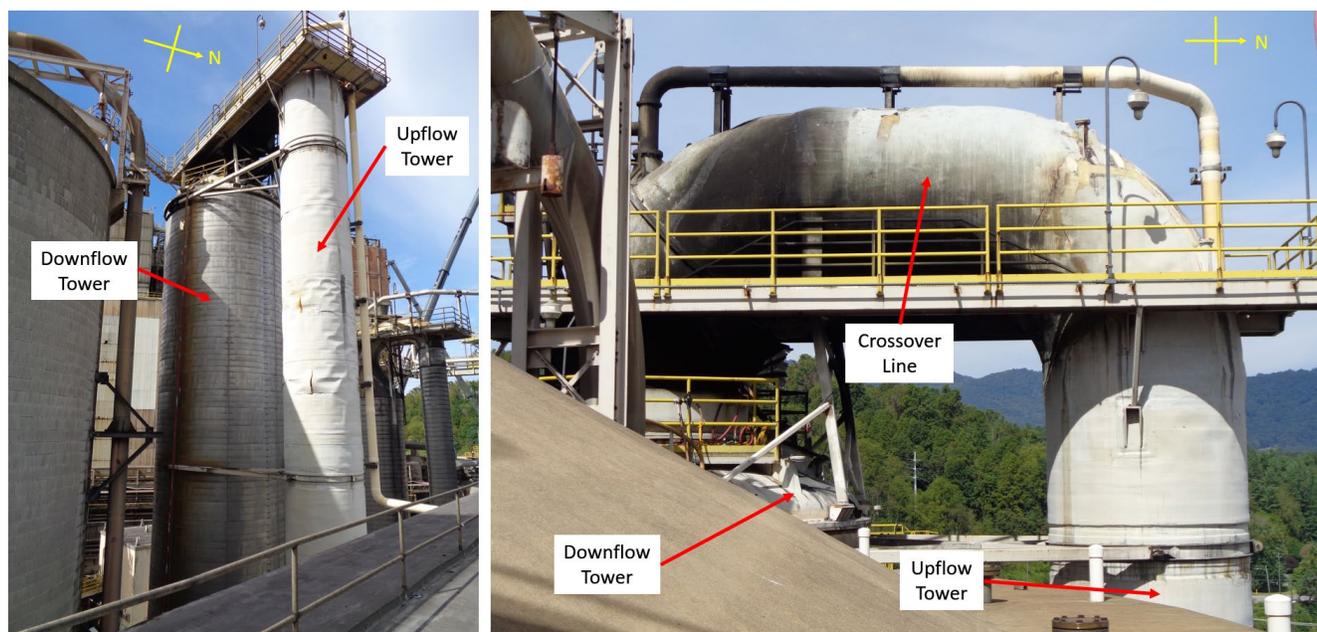
The incident occurred in one of Evergreen's bleaching units, called the #2 Fiber line bleaching unit, which removes color from wood pulp to make white paper products. The bleaching process occurs in three reaction stages. Each stage consists of a pair of process vessels: the first, called the "upflow tower" and the second, called the "downflow tower." The two vessels are connected at the top by a large diameter pipe, called the "crossover line" (Figure 1).

Figure 1. Typical bleach reaction stage at Evergreen. (Credit: CSB.)

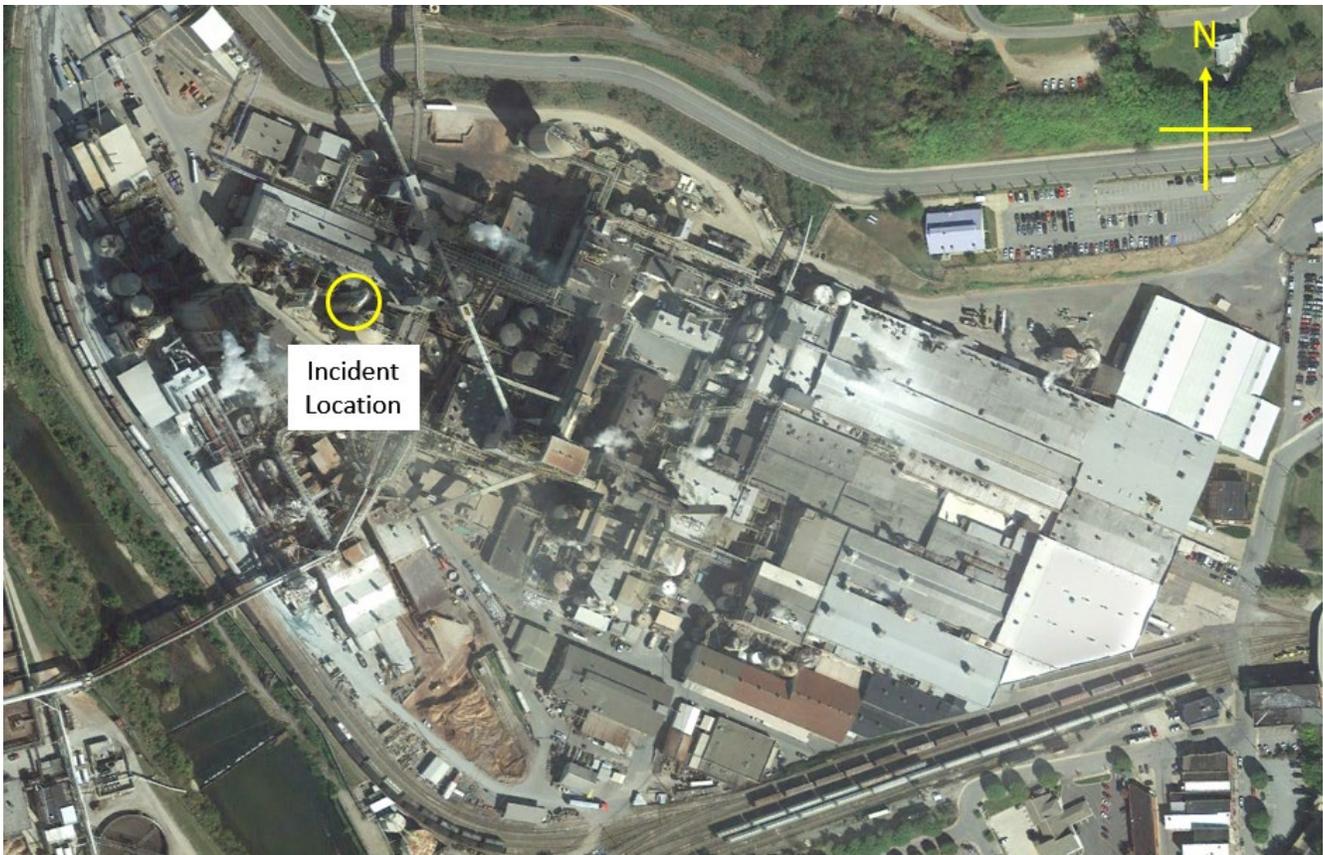
Figure 2. Overhead view of the Evergreen Packaging Canton Mill. (Credit: Google. Annotated by CSB.)
