U.S. Chemical Safety and Hazard Investigation Board

Safety Bulletin

Key Lessons from the ExxonMobil Baton Rouge Refinery Isobutane Release and Fire

No. 2016-02-I-LA

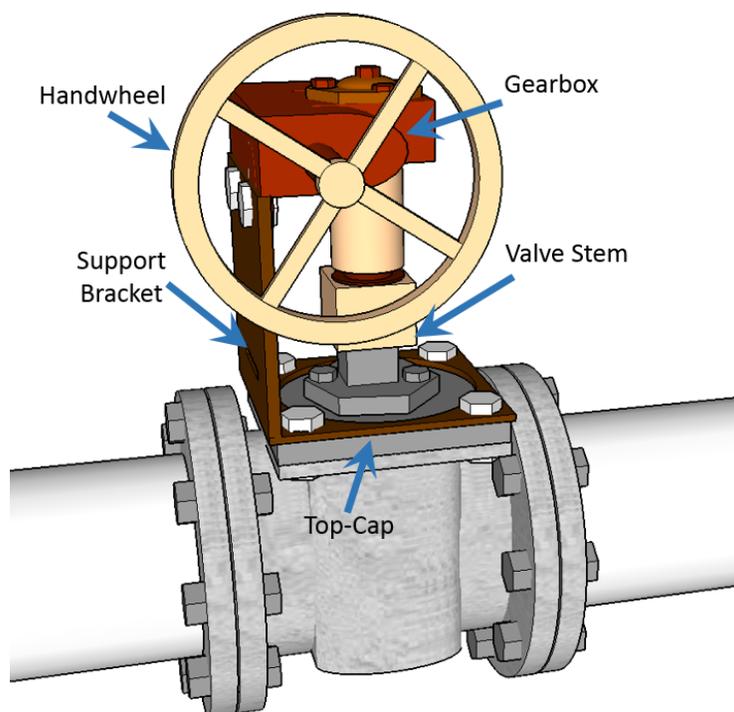
Figure 2. Illustration showing an alkyl unit plug valve with gearbox, valve stem, top-cap, support bracket, and handwheel similar to the one involved in the incident.

Infrequently used plug valves like this one are often operated manually. An operator turns a handwheel connected to a gearbox to open or close the valve.⁸ (Figure 2). The handwheel rotates gears to turn the valve stem into the open or closed position, and a support bracket attaches the gearbox to the valve body using bolts. On the afternoon of the incident, one of the operators attempted to open the plug valve to the spare pump using the handwheel attached to the valve. But the gearbox was not operating properly, and although the handwheel turned, the valve did not open.⁹

⁹ ExxonMobil operators described the handwheel as “free spinning,” meaning the gearbox was inoperable - the handwheel freely turned but did not turn the stem of the plug valve. At times, some plug valve gearboxes broke down and required replacement.

Gearbox support brackets (see example in Figure 2) on 15 plug valves located in the Baton Rouge refinery’s alkylation unit were attached using the same four vertical bolts that secure the pressure-retaining top-cap to the valve body. This gearbox (a 30-plus year-old design), however, could be removed by taking off the two horizontal bolts without disturbing the critical top-cap bolts.

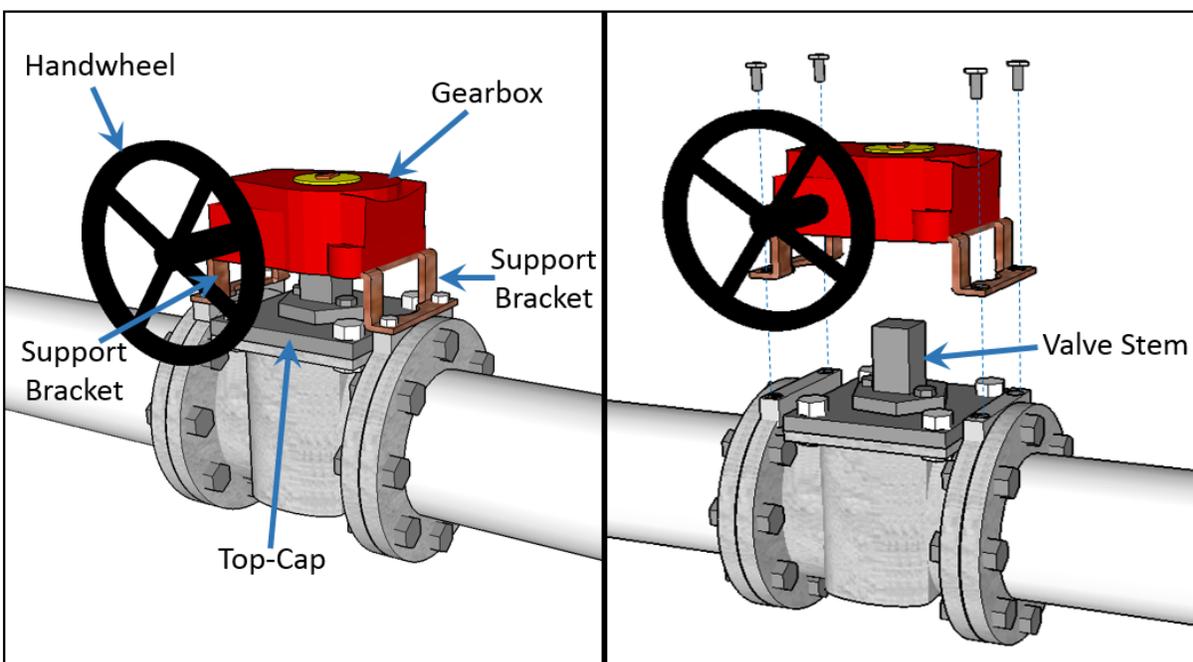
Figure 9. The post-1984 plug valve design, showing how one type of gearbox connects to all four dedicated attachment points on the valve flanges that are not pressure-retaining parts.

The newer plug valve more broadly used in the alkylation unit is a better design. The redesign addressed the potential to have a chemical release when removing the gearbox assembly. The valve designers provided four additional connection points to secure the gearbox support brackets and these attachment locations are not pressure-retaining components. (Figure 9). With the newer and improved valve design, if a worker completely removes the gearbox and its support bracket(s), a chemical release cannot occur.

The location of the bolts on the newer valve design may have also contributed to the operator removing pressure-retaining bolts. On the newer design, the bolts connecting the support bracket to the valve are vertical, and are usually removed in order to remove the gearbox and handwheel. In describing how to remove a gearbox from this type of plug valve, an alkylation unit operator explained, “I would only have to pull those [vertical] bolts right there and the whole thing would come off.” Although another operator recognized that there were two different ways to remove the plug valve gearbox, there was not a preferred method. While looking at a photo of a plug valve to explain how to remove the gearbox, the operator said either the horizontal or the vertical bolts could be removed.

For the less common, older valve design, the vertical bolts were the pressure-retaining bolts and should not be removed; instead, the horizontal bolts should be removed to disassemble the gearbox and handwheel safely. (Figure 9 and Figure 10). It could appear as though these critical vertical bolts had to be removed to take the inoperable gearbox off the valve. Although other bolts allowed for gearbox removal without touching the critical pressure-retaining bolts, this design can lead to potentially

- Survey valves to identify gear-operated plug valves with gearbox support brackets attached to pressure-retaining components (“susceptible valves”);
- Perform a hazard analysis and risk assessment on susceptible valves using the hierarchy of controls to establish a mitigation strategy;
- Consider upgrading to a newer plug valve design and attach the gearbox support bracket to the valve flanges (see Figure 9) or otherwise address the potential hazard;
- For susceptible valves identified for future upgrades, develop an interim hazard mitigation plan to control hazards and protect workers;
- Provide written procedures and training to ensure workers can safely remove the gearbox from the plug valve; and
- Consider expanding this guidance beyond manual gear operators to evaluate other devices such as motors or actuators that may attach to pressure-retaining valve components.
