U.S. Chemical Safety and Hazard Investigation Board

ExxonMobil Torrance Refinery

Electrostatic Precipitator Explosion Torrance, California

No. 2015-02-I-CA

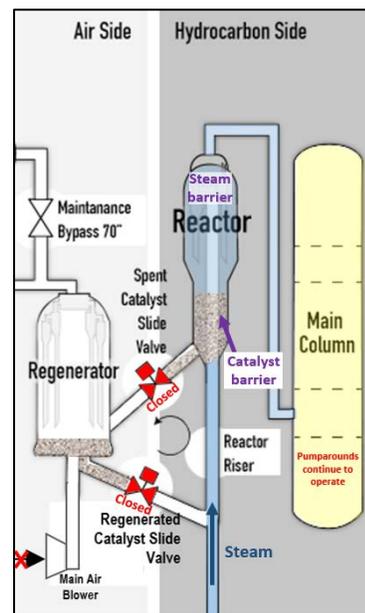
Leading to the incident, both safeguards failed, allowing hydrocarbons from the main column to enter the air side of the FCC unit.

FIGURE 12
In Safe Park configuration, the accumulated catalyst on top of the SCSV and steam pressurizing the reactor are intended to act as safeguards preventing hydrocarbons in the main column from backflowing through the reactor and to the regenerator.

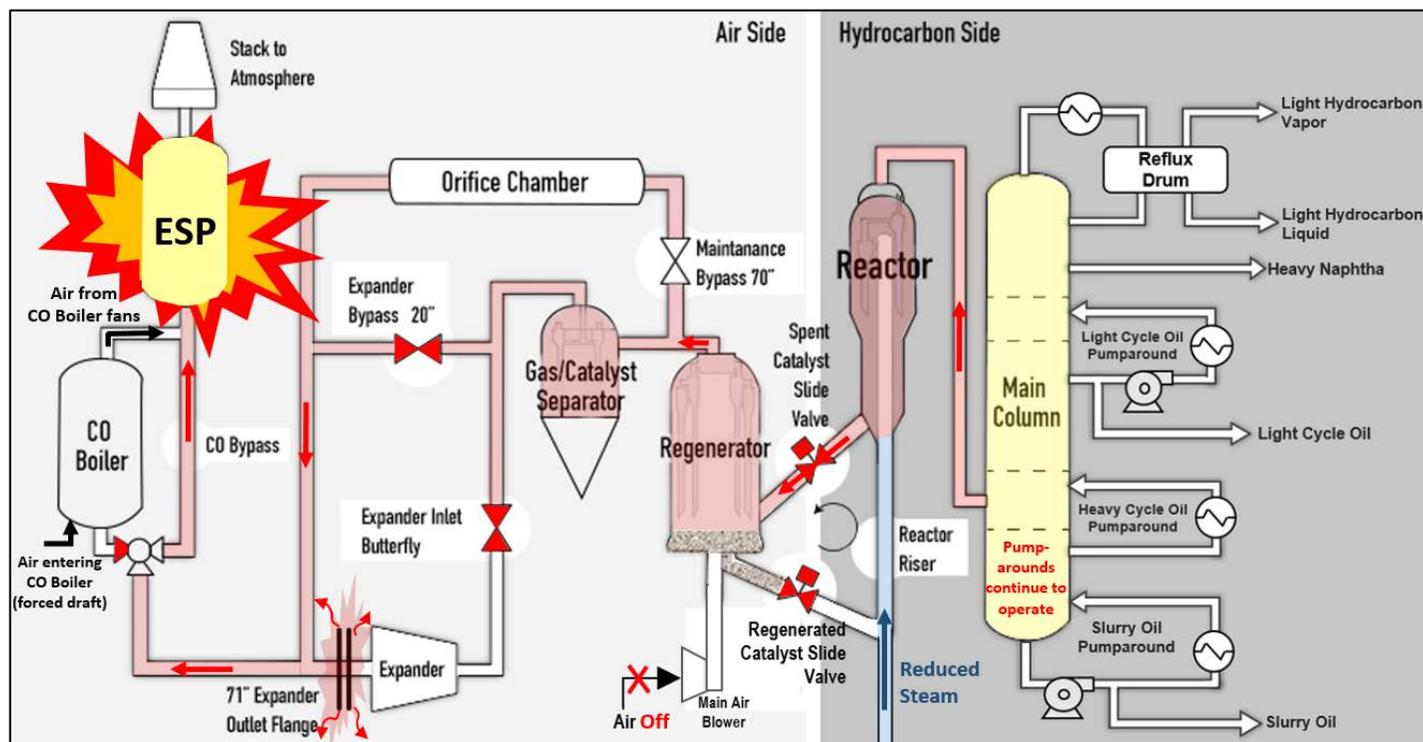
FIGURE 17

When steam flow rate was reduced through the reactor riser, reactor pressure could no longer prevent hydrocarbon backflow from the main column. Hydrocarbons leaked through closed SCSV, through FCC unit air side piping and equipment, and to the energized ESP. A hydrocarbon/air mixture ignited inside of the ESP.

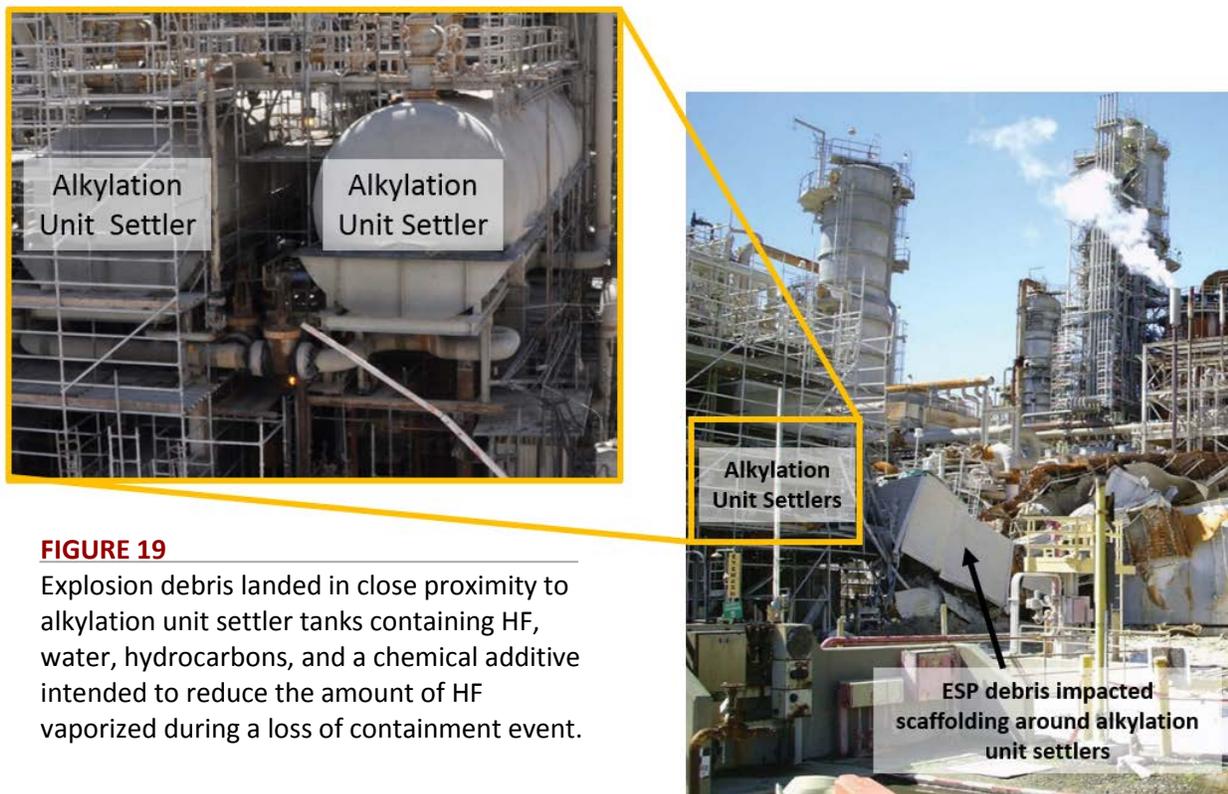
FIGURE 19

A large piece of debris from the explosion fell on scaffolding³⁸ around two settler tanks, each containing hydrofluoric acid (HF), water, hydrocarbons, and a chemical additive intended to reduce the amount of HF vaporized during a loss of containment event³⁹ (Figure 19). Pure HF is a highly toxic chemical that can seriously injure or cause death at a concentration of 30 ppm.⁴⁰ ExxonMobil resisted CSB requests for safety information pertaining to the potential release of HF in the event the tanks were struck by explosion debris. ExxonMobil continues to refuse to provide the CSB with information detailing safeguards to prevent or mitigate a release of HF. The CSB has issued subpoenas for this information, and is pursuing enforcement in US Federal district court.⁴¹

Explosion debris landed in close proximity to alkylation unit settler tanks containing HF, water, hydrocarbons, and a chemical additive intended to reduce the amount of HF vaporized during a loss of containment event.

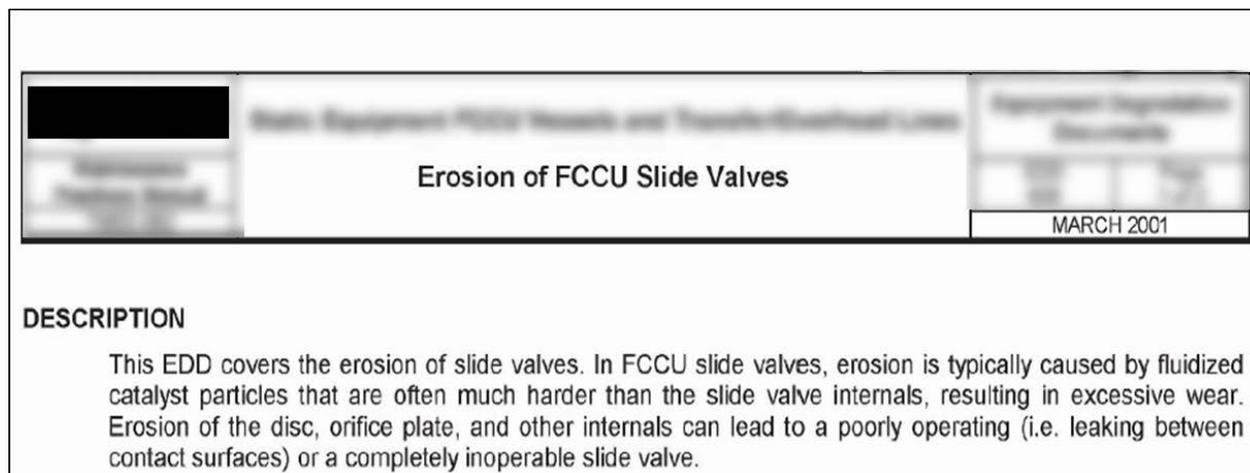
FIGURE 24
ExxonMobil Equipment Degradation Document

The SCSV operates in a severely erosive service. The continuous flow of abrasive fluidized catalyst particles during normal operation erodes the slide valve internals, which can prevent the valve disc from sealing. ExxonMobil repaired the SCSV internals during turnarounds in 2000, 2004, and 2009 because the valve had eroded. An ExxonMobil “Equipment Degradation Document” details the likelihood of SCSV inability to seal due to erosion of the valve (Figure 24).

The Equipment Degradation Document predicts the probability of failure of the SCSV due to erosion, based upon a four- to five-year run length of the FCC unit between turnarounds. To ensure effective operability of the valve, ExxonMobil assigned it a testing interval of every four years to make sure the valve could function as required to prevent a flow reversal during normal operation. To meet the four-year testing requirement, ExxonMobil periodically partially closed the SCSV while the unit operated to verify that the mechanical valve components functioned properly. While an important mechanical testing strategy, this testing method did not evaluate whether the valve was eroded, or test whether the SCSV could close and seal. ExxonMobil therefore relied on the

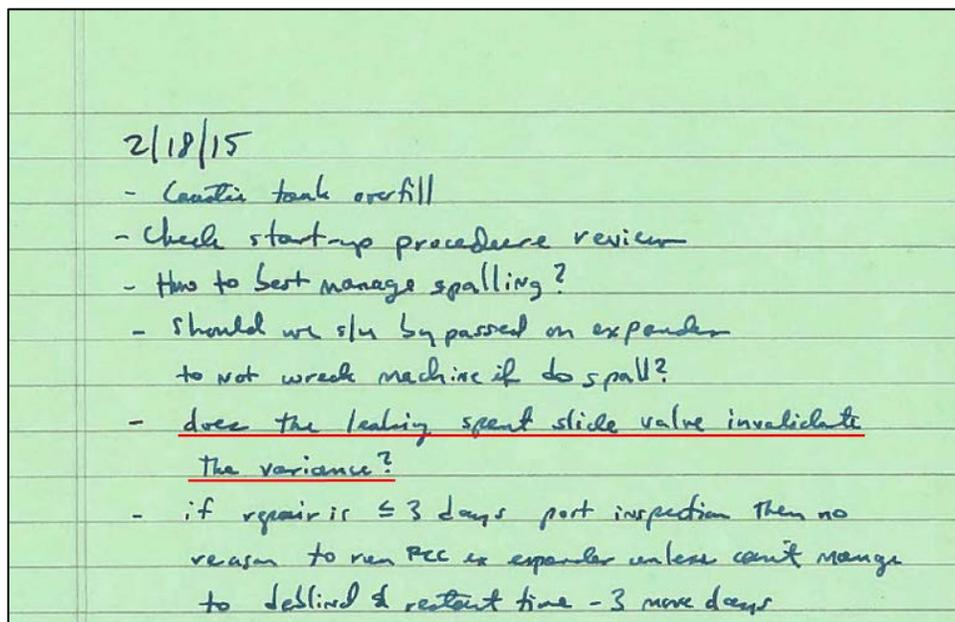
FIGURE 26

ExxonMobil management knew the SCSV was leaking leading up to the incident. Notes from meetings of management personnel questioning “Does the leaking spent slide valve invalidate the variance?” (Figure 26) and CSB interviews demonstrate that managers knew and discussed that the SCSV was leaking on the day of the incident. The catalyst level in the reactor—showing zero level—was displayed on the FCC unit console, measurements of high temperature downstream of the slide valve indicated that steam was leaking through the slide valve, and steam was visually observed leaking from multiple locations on the air side of the FCC unit.

Notes from day of incident show that ExxonMobil knew of leaking SCSV. (emphasis added)

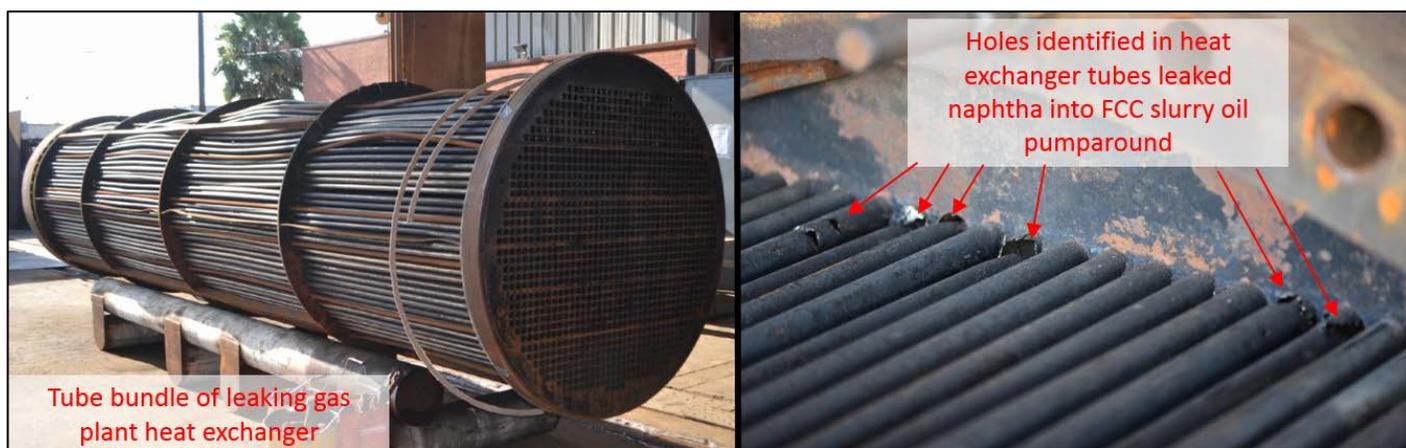
FIGURE 29

In 2015, the column pressure had increased because a heat exchanger—that had an extended operation—on the slurry oil pumparound loop was leaking naphtha into the slurry oil (Figure 28 and Figure 29). The high temperature of the slurry oil vaporized the more volatile naphtha, which increased the pressure of the main column.

Post-incident photos of heat exchanger tube bundle that leaked naphtha into main column slurry oil pumparound

In its Equipment Strategy document, ExxonMobil personnel previously identified that the heat exchanger tubes could corrode and/or erode and leak naphtha into the slurry oil, but they did not identify that such a leak could have negative safety consequences during Safe Park (Figure 31), and identified only a minor economic consequence (“Consequence IV” in Figure 31 is an internal ExxonMobil financial consequence category).

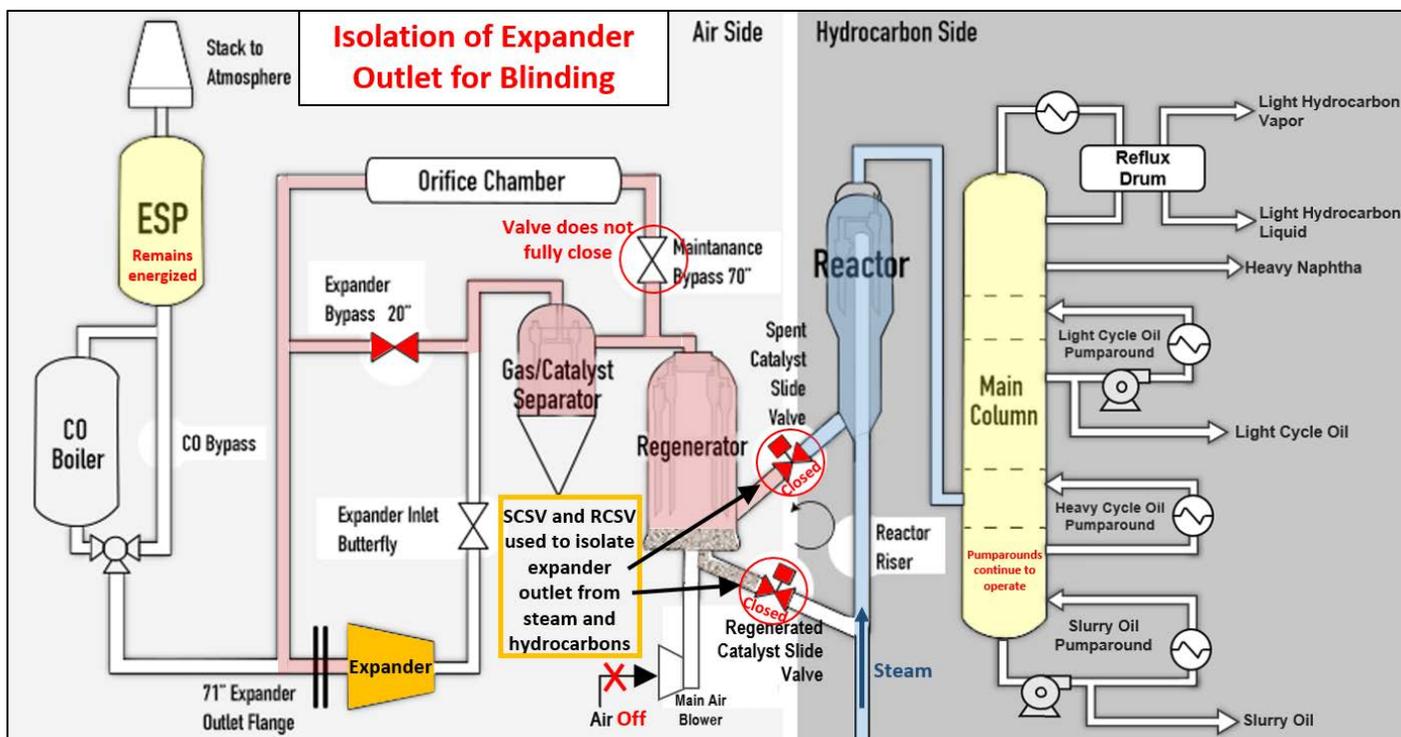
The piping leading to the expander outlet flange was not designed to allow double block and bleeding. The maintenance bypass valve shown in Figure 34 could not be used to isolate the expander from the process because it had a hole designed into it for overpressure protection purposes.⁵⁴ ExxonMobil, therefore, had to perform a single block and bleed to isolate the expander from the process. The only valves available to isolate the expander outlet from process fluids (steam and hydrocarbons) were the SCSV and RCSV. These valves, however, are control valves that throttle the flow of catalyst. ExxonMobil does not consider control valves to be energy isolation devices that can be used to isolate equipment for opening (Figure 33). Control valves typically should not be used as block valves because fluid flow through a partially open control valve can cause damage to the valve that can limit its ability to fully seal. The site therefore did not comply with refinery standards when attempting to insert the blind into the expander outlet. If ExxonMobil management had adhered to the Lock Out Tag Out procedure, they would not have been able to use the SCSV and RCSV to isolate the expander from process fluids, and the expander outlet flange would not have been able to be opened while the unit was in Safe Park. Alternatively, ExxonMobil could have developed a Variance to depart from the typical safety practice and conducted a detailed hazard evaluation to evaluate the safety of the proposed isolation strategy. ExxonMobil did not, however, develop a Variance for this operation. In this instance, opening the expander outlet flange led to the decision to reduce reactor steam flow, which led to the ESP explosion.

FIGURE 34
Configuration used to isolate expander outlet for blinding

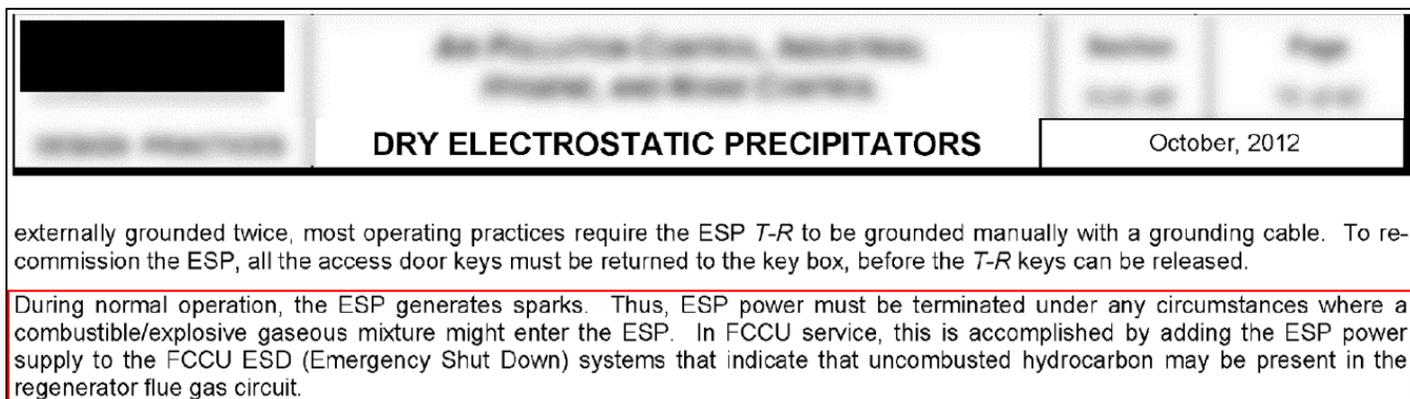
FIGURE 35

The ESP generates sparks during normal operation. ExxonMobil corporate design practices therefore require ESPs to be shut down when a flammable gas mixture might enter them (Figure 35). On the day of the incident, however, the Torrance refinery ESP was not shut down when hydrocarbons flowed toward and entered the energized ESP. As a result, sparks within the operating ESP ignited the flammable mixture, resulting in the explosion. This section discusses CSB findings of why the ESP was not automatically shut down when hydrocarbons entered the flue gas piping leading to the ESP.

ExxonMobil corporate design practices require ESPs to be shut down when an explosive mixture might enter them. (emphasis added)

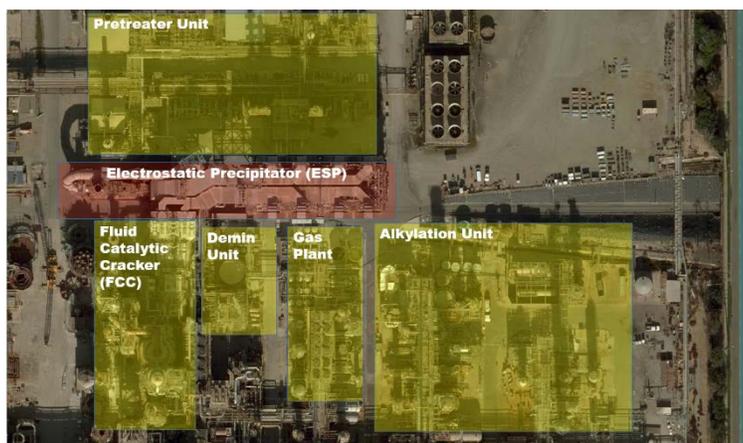
The ESP was installed in the FCC unit in 2009, to comply with new environmental regulations.⁶⁴ ExxonMobil constructed the ESP adjacent to the FCC unit and in close proximity to other units (Figure 39). For example, the distance from the ESP to the alkylation unit is approximately 80 feet. From the ESP to the Pretreater Unit⁶⁵ is less than 50 feet. And from the ESP to the Demineralization Unit, located directly south of the ESP, is also less than 50 feet away.

FIGURE 39 Overhead view of a portion of the Torrance refinery

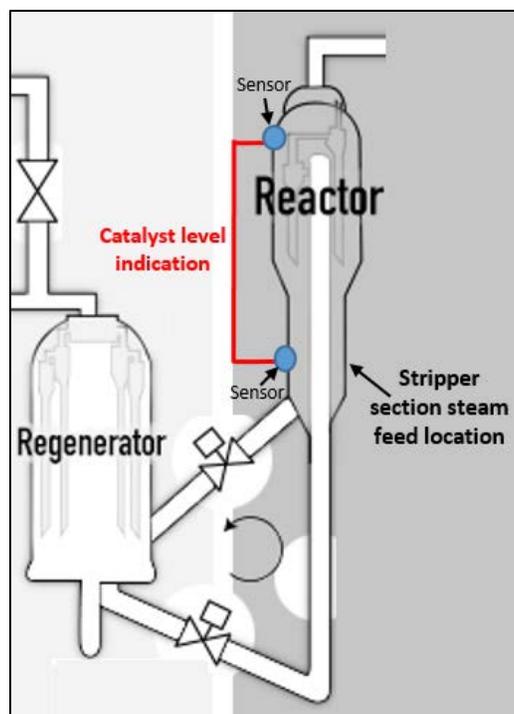
At the Torrance refinery, the level of the fluidized catalyst bed in the reactor is measured, using the two sensors shown in Figure A-1. During normal operation and during Safe Park, the catalyst in the reactor is fluidized by steam fed to the reactor stripping section. The fluidizing steam feed location is also shown in Figure A-1.

In both the 2012 and 2015 transitions to Safe Park, when the Spent Catalyst Slide Valve (SCSV) closed, the reactor catalyst level fell below the bottom sensor shown in Figure A-1. In 2012, it took 20 minutes for the catalyst level to fall below the bottom sensor, and in 2015 it took 9 minutes (see Figure A-2). This likely indicates that the fully closed SCSV was leaking both in 2012 and 2015. The leak rate in 2015 was likely faster due to the advanced erosion of the SCSV. Industry experts have informed the CSB that SCSVs may leak, even when the SCSV is new and has not been eroded by catalyst.

FIGURE A-1
Reactor catalyst bed level measurement

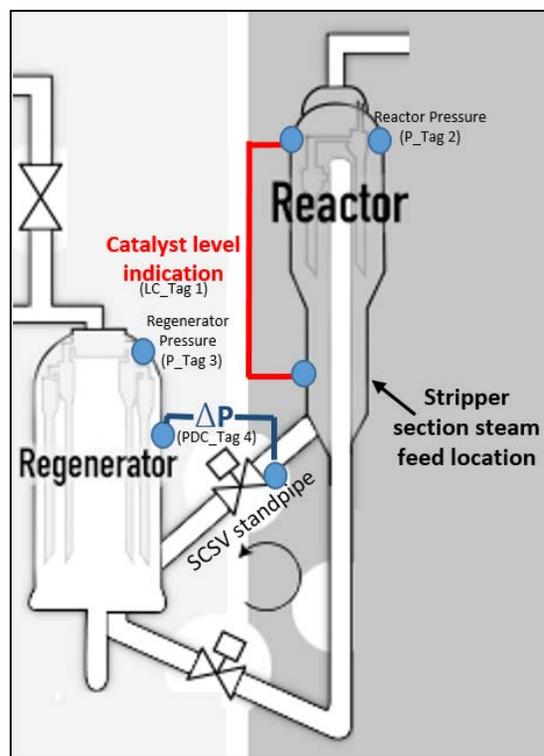
ExxonMobil measured the reactor pressure (**P_Tag 2** shown in Figures A-3, A-4, A-5) and regenerator pressure (**P_Tag 3** in Figures A-3, A-4, A-5) in addition to the SCSV standpipe/regenerator differential pressure (**PDC_Tag 4** in Figures A-3, A-4, A-5). In 2012, the measured SCSV standpipe/regenerator differential pressure (**PDC_Tag 4**) was approximately 5 psi greater than the calculated pressure difference between the reactor and regenerator (**P_Tag 2** minus **P_Tag 3**) (Figure A-4). In 2012, ExxonMobil engineers compared the **PDC_Tag 4** differential pressure indicator reading to the calculated pressure difference between the reactor pressure and the regenerator pressure (**P_Tag 2** minus **P_Tag 3**). They identified the 5 psi pressure difference, and concluded that a catalyst level had developed above the closed SCSV and was exerting 5 psi of pressure, providing a barrier between the reactor and regenerator.

FIGURE A-3
SCSV standpipe / regenerator differential pressure instrument used to determine catalyst level above closed SCSV

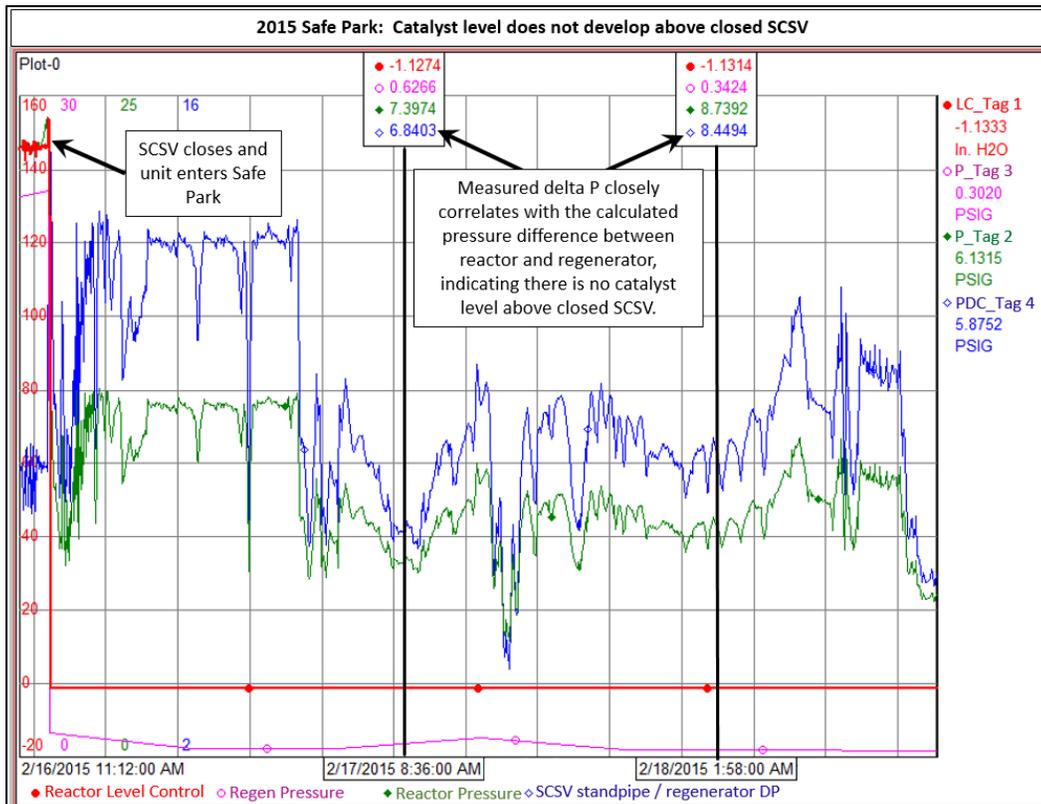
FIGURE A-5

In 2015, the measured SCSV standpipe/regenerator differential pressure closely correlated with the calculated pressure difference between the reactor and the regenerator (Figure A-5). This could have served as an indication that a catalyst level had not developed on top of the closed SCSV, meaning that the anticipated catalyst safeguard was not available. ExxonMobil refinery management, however, did not monitor the **PDC_Tag 4** differential pressure reading during preparation to enter the expander during the days leading to the incident, and this important information was not analyzed or considered prior to the incident.

In 2015, measured SCSV standpipe/regenerator differential pressure closely matched the calculated reactor/regenerator differential pressure, indicating that catalyst had not accumulated above the closed SCSV.
