U.S. Chemical Safety and Hazard Investigation Board

## E.I. DuPont de Nemours & Co Inc.

### Flammable Vapor Explosion

Welding on Tank Containing Vinyl Fluoride (1 Killed, 1 injured)

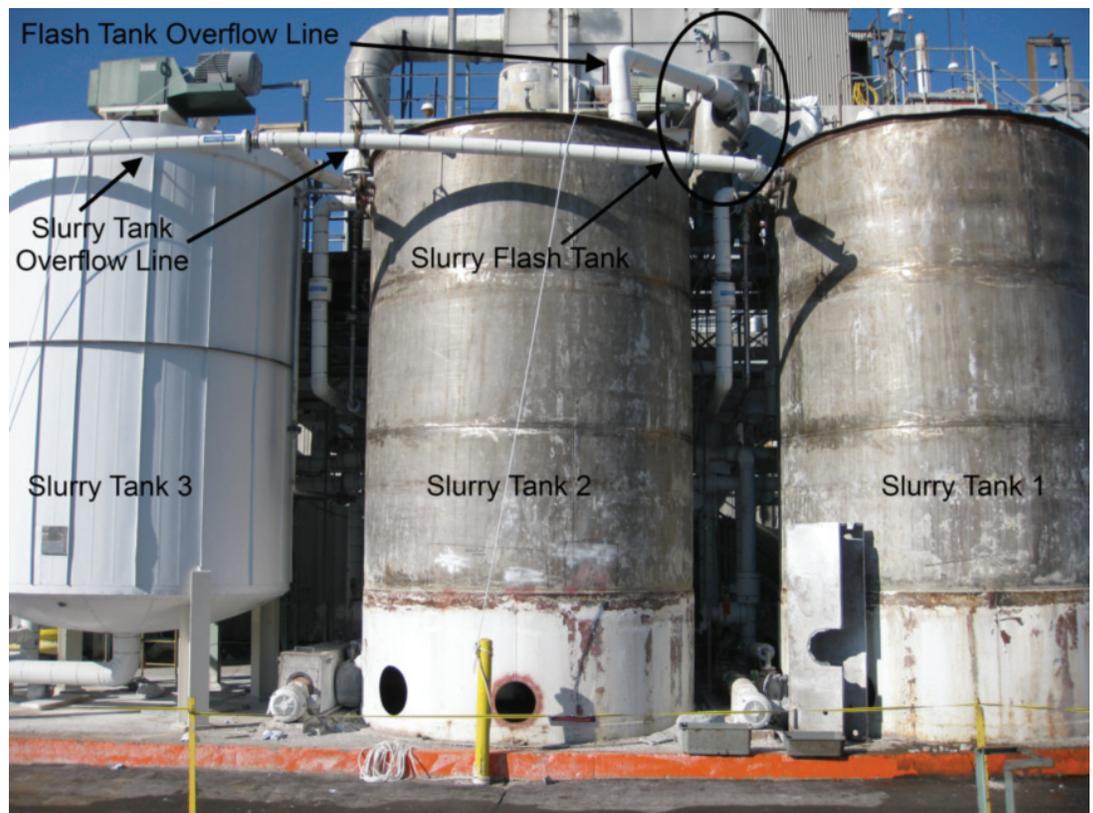
FIGURE 2

The flash tank and three slurry tanks are located in a tank farm adjacent to the Tedlar manufacturing building. The slurry tanks are 11 feet in diameter, 19 feet tall, and have a capacity of 10,800 gallons (Figure 2). The tank shell and top are one-quarter inch thick stainless steel. Each tank top has a hinged, unsealed steel cover on a 24-inch diameter manway and a large agitator motor drive and gearbox<sup>5</sup>. The agitator assembly is bolted to structural steel beams that are welded directly to the tank top.

PVF slurry holding tanks
