ANALYSIS OF HORSEHEAD CORPORATION MONACA REFINERY FATAL EXPLOSION AND FIRE

JULY 22, 2010

Prepared for the US Chemical Safety Board (CSB)

By William H Hunter MA MIMMM CEng.
Metallurgical Consultant.

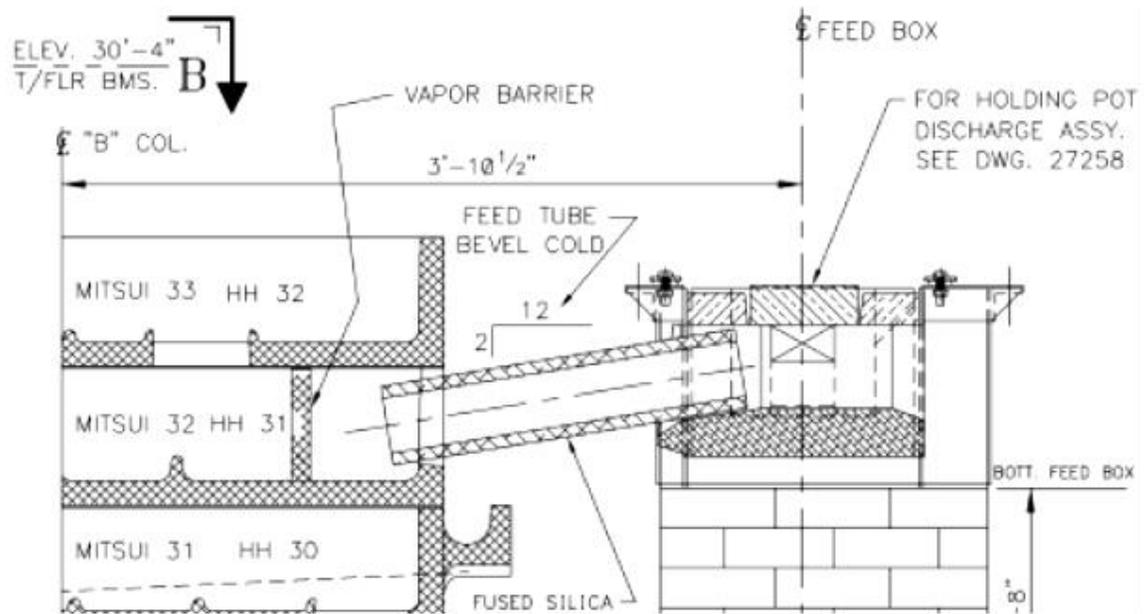
The most problematical seal is at the feedbox, shown below at Horsehead Monaca (from Horsehead drawing #26046-12). It relies on a good seal on the feedbox cover tile. If heating input or feed rate varies the column, until it settles out under the new regime, will undergo internal pressure or suction changes (the former for lower feed/higher heat input and the latter for the reverse). Under suction, which is hard to detect, air may be drawn in if the cover tile seal is not absolutely perfect. Any leakage here renders the liquid metal seal ineffective, and air ingress will be a cause of dross (zinc oxide) formation, and moisture in the air can make the dross sticky; ultimately any dross formed must be able to exit the sump. Steady feed and firing minimises such disturbances.

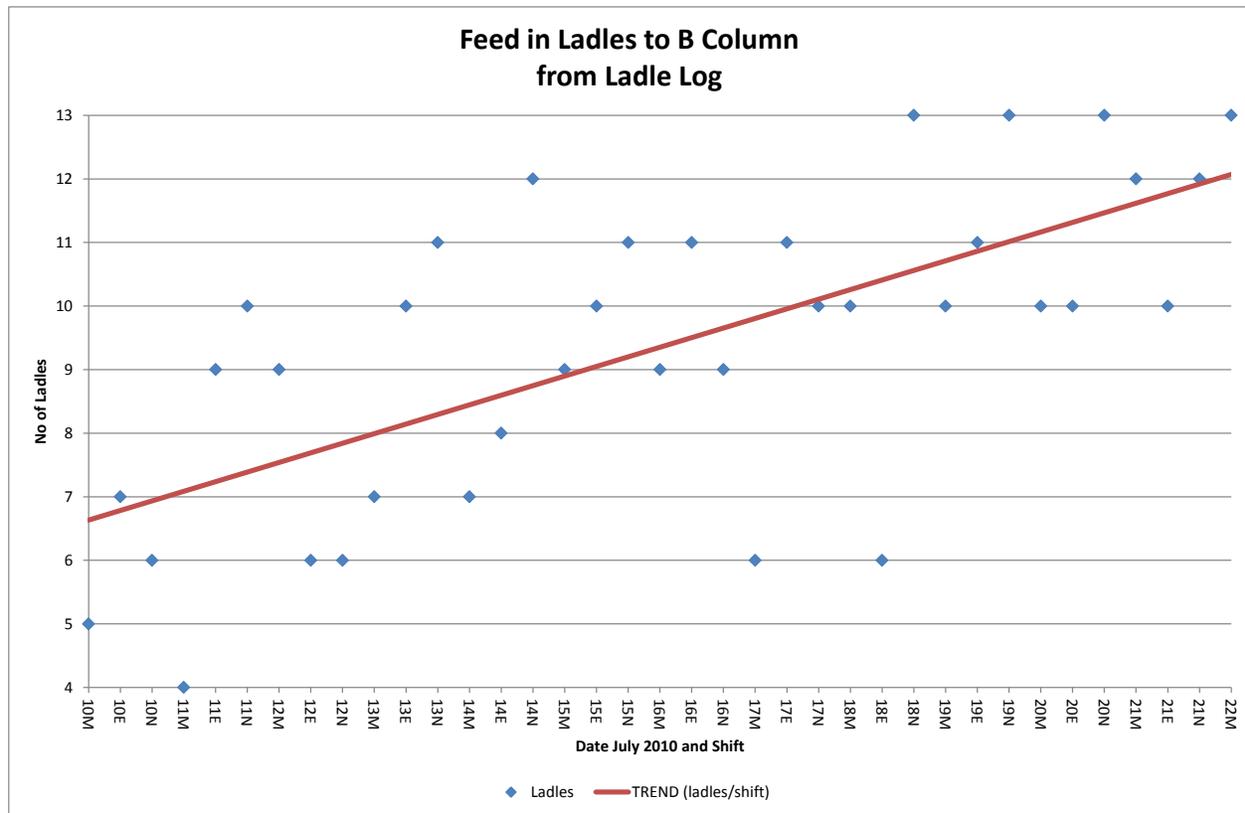
The chart shows large variations in the number of ladles fed from one shift to another. Although the needle valve before the feed box (Section IV.I.III) will smooth the flow to some extent, it may be that feed variations at Monaca were quite significant. Any variation creates an opportunity for air ingress and the subsequent production of zinc oxide dross.

Oxide columns appear to have been operated at approximately 60st/day feed, with 34st/d going to oxide production and the remainder being run-off (26 st/day). This shows the major difference between the two types of column.
