U.S. CHEMICAL SAFETY AND HAZARD INVESTIGATION BOARD

## Pesticide Chemical Runaway Reaction Pressure Vessel Explosion

**BAYER CROPSCIENCE, LP**

Report No. 2008-08-I-WV  
January 2011

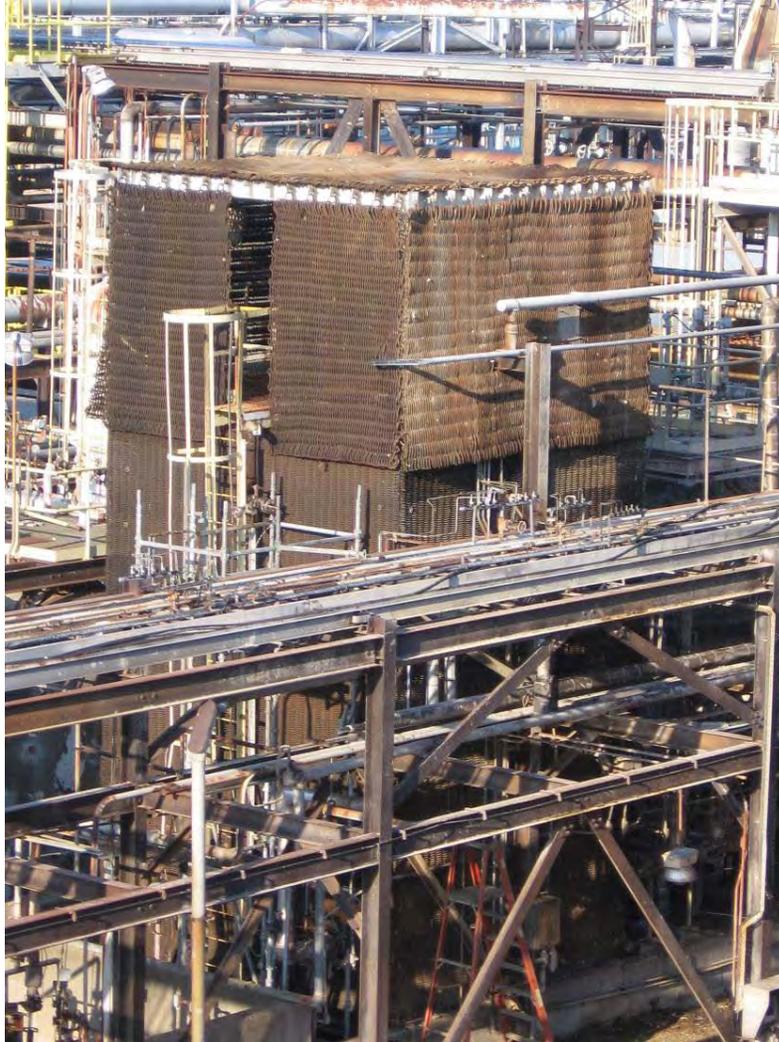
Figure 2. MIC day tank shield blanket structure

The MIC day tank was adjacent to the methomyl-Larvin unit. A steel rope mesh ballistic shield (blast blanket), mounted on the sides of and on top of a structural frame, protected the tank in the event of an explosion in the unit or nearby equipment (see Figure 2). Flying debris from the residue treater explosion struck the blast blanket. The fires radiated intense heat on the blast blankets.

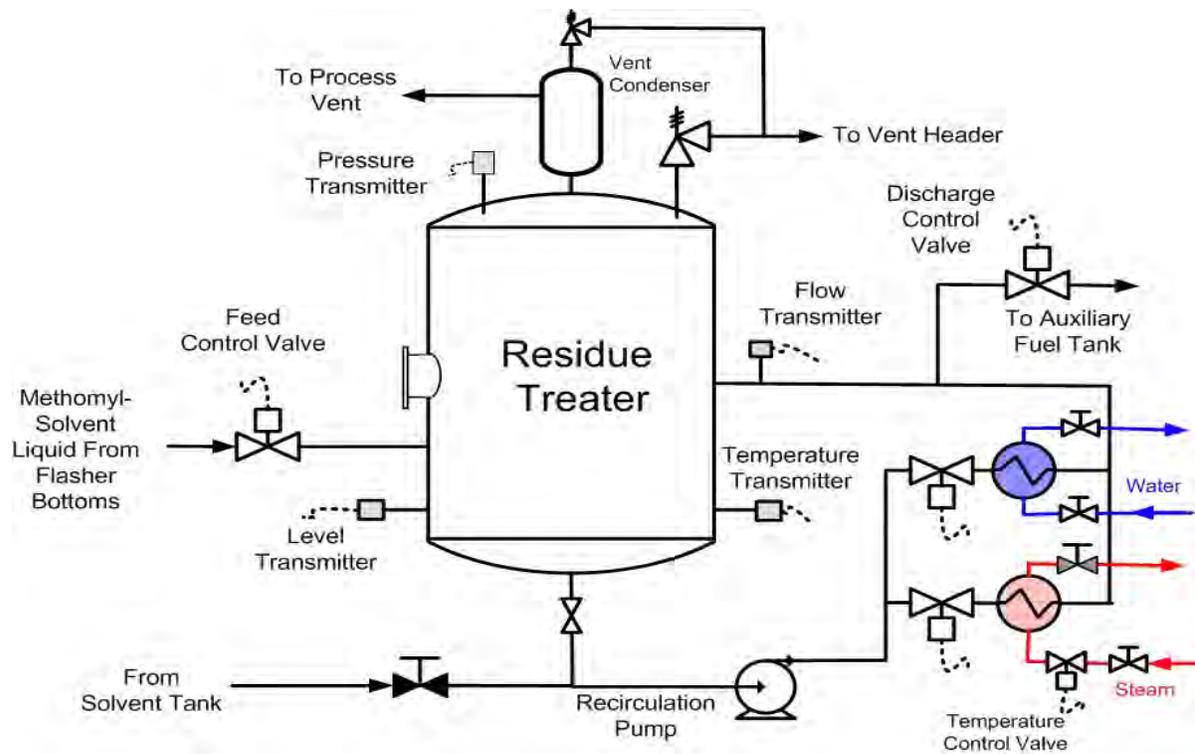
The residue treater (Figure 10) had an automatic level control system to control the liquid level at about 50 percent. The residue treater recirculation system was used to heat the solvent at the beginning of a new production run, mix the incoming flasher bottoms into the partially filled vessel,

Figure 10. Residue treater piping system layout

It was determined that the automatic temperature control system closed both the heater and cooler flow control valves (see Figure 10) at the same time when the recirculation temperature control transitioned from heating to cooling. Bayer examined the temperature controller and its investigation team concluded that

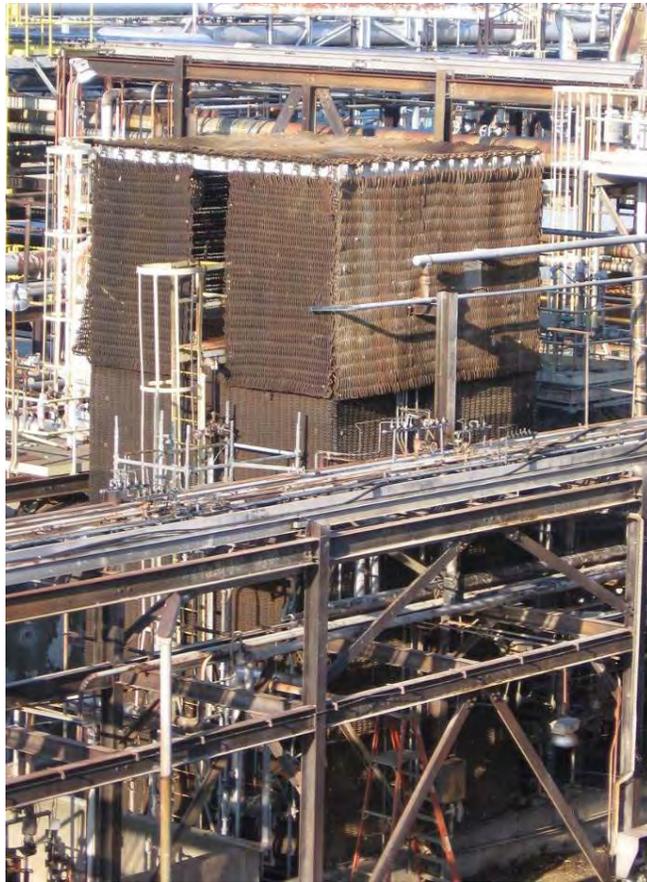
When the day tank was installed in 1983, a wire rope blast blanket system was installed to protect it from flying debris. The blast blankets also provide a radiant heat shield from nearby fires. In 1994, the structure was extended up to completely surround the entire tank and top piping connections (Figure C-2). The original frame design considered static (blast blanket weight) and wind loads only, and did not analyze the structure for dynamic side loading, one of the functional purposes of the assembly.

Figure C-2. MIC day tank shield structure
