U.S. CHEMICAL SAFETY AND HAZARD INVESTIGATION BOARD

INVESTIGATION REPORT

EXPLOSION AND FIRE

FIRST CHEMICAL CORPORATION

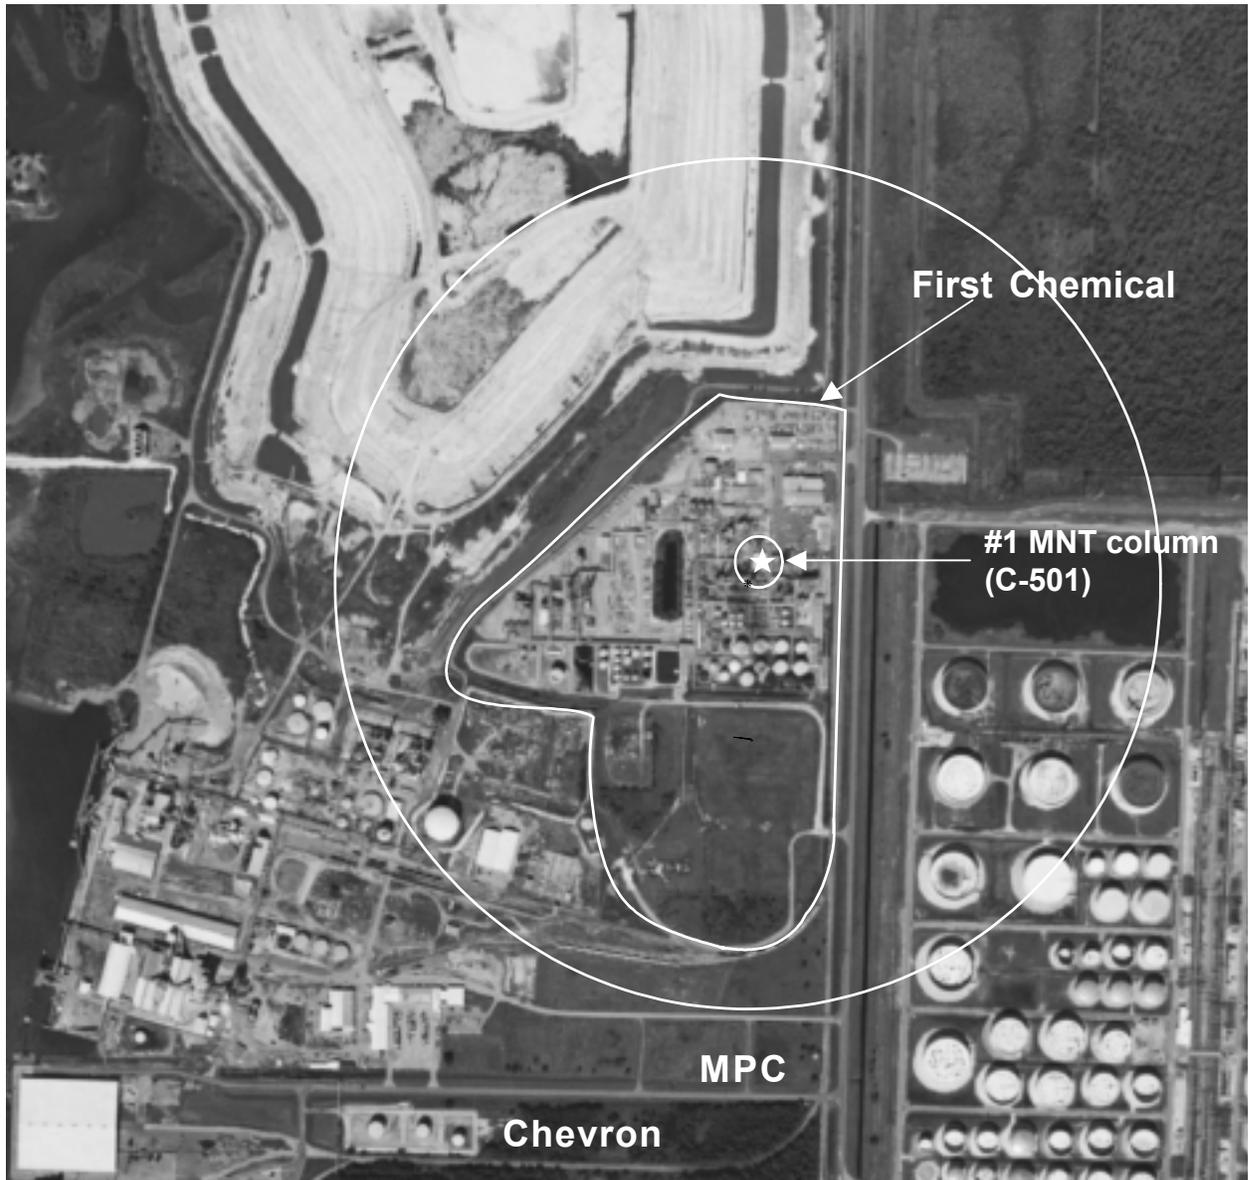
The explosion propelled large fragments from the vicinity of the column. A piece of shrapnel struck a pipe rack directly above a 500,000-pound anhydrous ammonia tank onsite. A 6-ton piece of column sidewall was hurled approximately 1,100 feet onto Chevron property; it landed an estimated 50 feet from a 250,000-barrel crude oil storage tank. A valve and portions of piping were also found on Chevron property as much as 1,700 feet from the column.

Within this radius of potential impact were several pieces of equipment that contained flammable and toxic material, including tanks and piping. As previously discussed, a crude MNT storage tank at FCC (which contained para-MNT) was hit by shrapnel and caught fire. There were a number of other potential receptors, including chlorine cylinders and sulfuric acid tanks. If debris had hit this equipment, it is likely that the incident would have caused significant secondary releases of material. (See Figure 4 for an aerial map of FCC and the surrounding area.)

Figure 4. Aerial map of FCC facility.
(Circle shows an approximate 2,000-foot radius from
the #1 MNT column [C-501], the area of the debris search.)
