## Investigation Report

Published: December 2023

## U.S. Chemical Safety and Hazard Investigation Board

The April 2, 2019, explosion and fire at the KMCO facility in Crosby, Texas, fatally injured James Mangum.

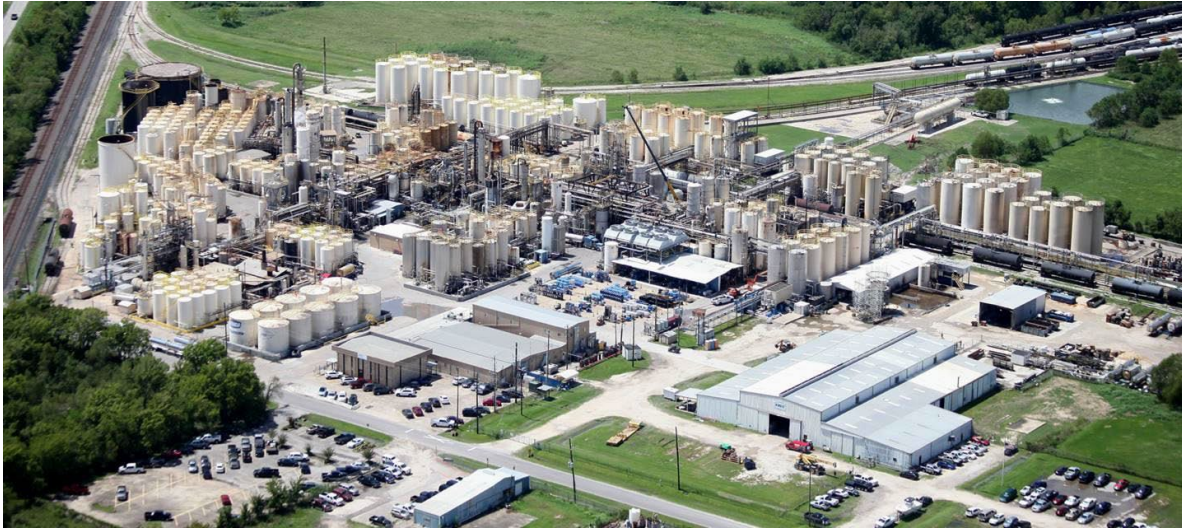
Figure 1. KMCO Facility in Crosby, Texas.<sup>a</sup> (Source: KMCO)

The KMCO, LLC (“KMCO” pronounced “chem-co”) facility in Crosby, Texas, employed 164 people to manufacture specialty chemicals and operate its tolling facilities (**Figure 1**) [1].<sup>a</sup> Tolling is an arrangement in which a company processes raw materials or semifinished goods for another company.”<sup>b</sup> KMCO purchased the Crosby plant on July 1, 2012, and invested over \$50 million in the facility to, among other things, provide new equipment and infrastructure, including:<sup>c</sup>

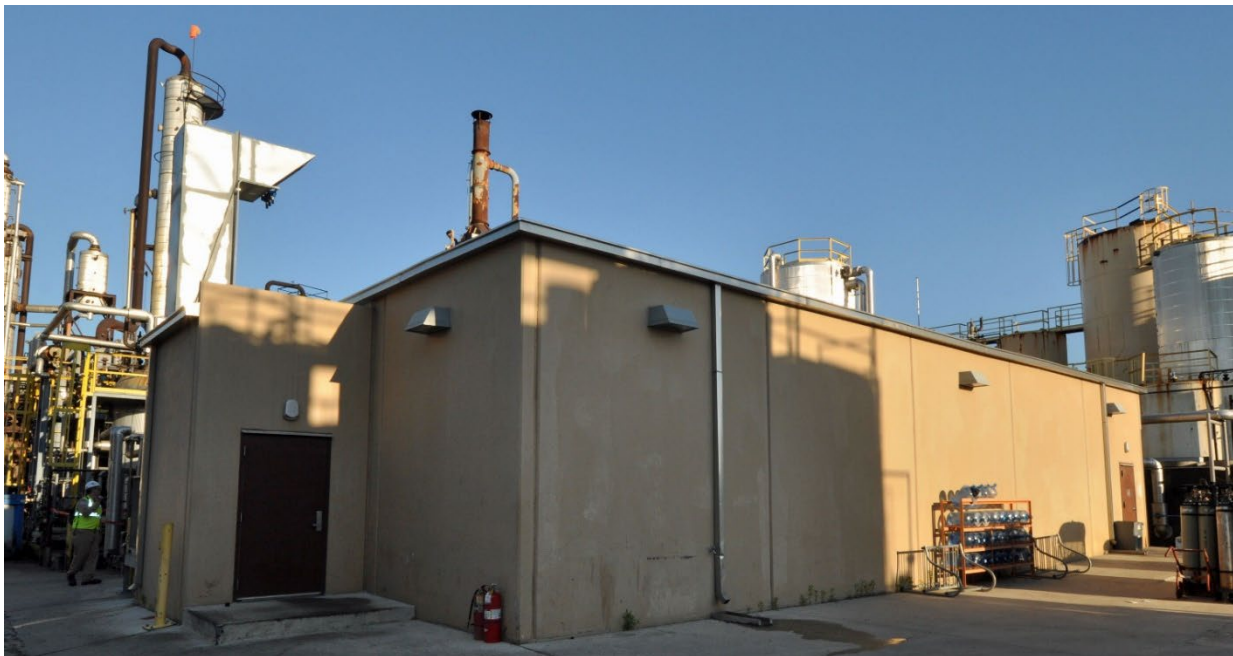
There were three buildings at KMCO that workers commonly referred to as “control rooms,” but at the time of the April 2, 2019, incident, only one was being used as a formal control room (**Figure 5**).

**Figure 5.** Reaction Control Room. KMCO’s blast-resistant control room. (Credit: CSB)

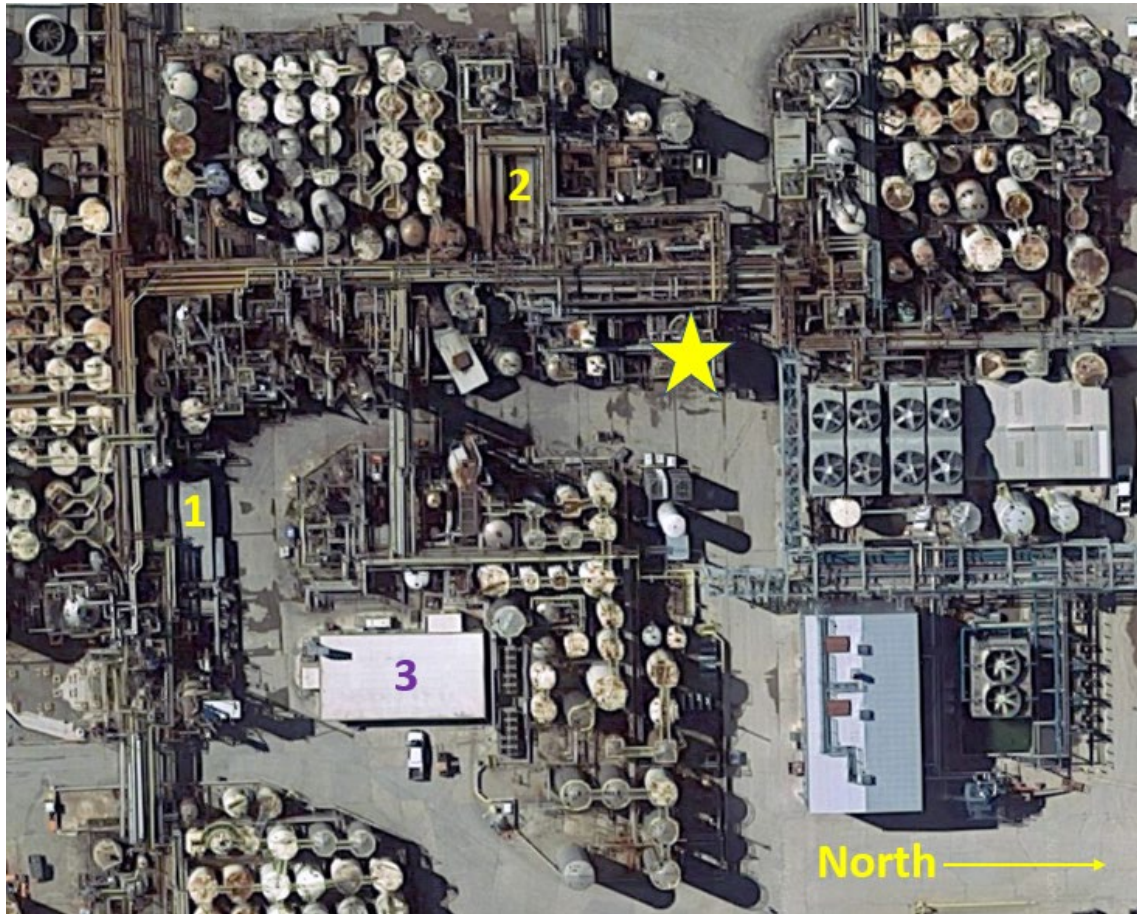
Following a facility siting study, KMCO built a blast-resistant control room in 2013 to improve safety.<sup>a</sup> After its completion, KMCO relocated the shift supervisor and plant operators from the two previous control rooms—the Reaction 1 Control Room and the Reaction 2 Control Room—to the new Reaction Control Room (**Figure 6**).

**Figure 6.** KMCO Control Rooms. This 2019 image of the KMCO facility shows the location of the Reaction 1 Control Room (yellow “1”), the Reaction 2 Control Room (yellow “2”), the new Reaction Control Room (purple “3”), and the location of the isobutylene release (yellow star). (Credit: Google, annotations by CSB)

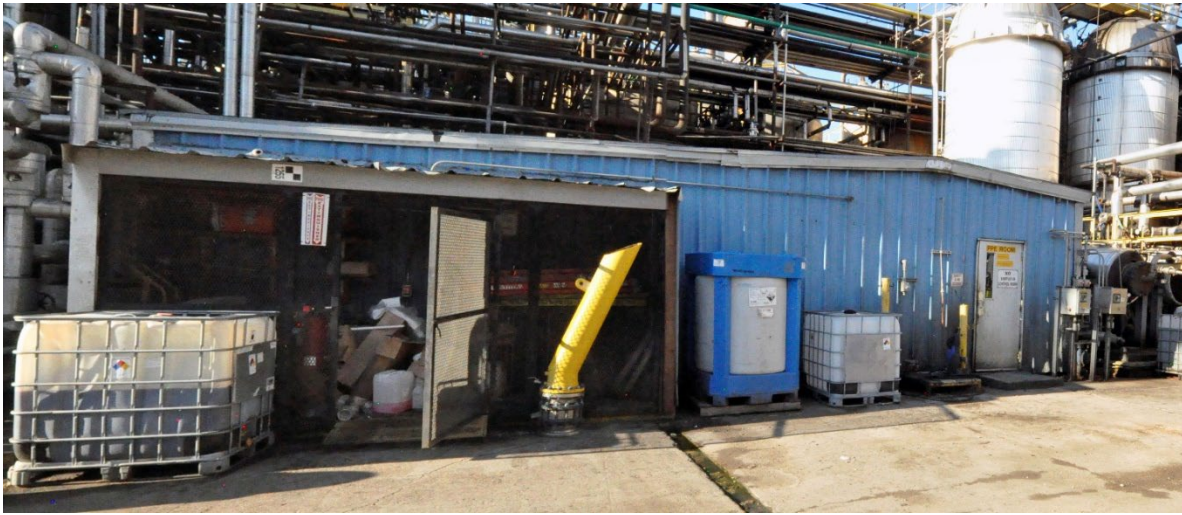
KMCO later converted the Reaction 1 Control Room to store personal protective equipment (PPE) and renamed this plant building the PPE Room (**Figure 7**).

**Figure 7.** PPE Room. This photo shows the former Reaction 1 Control Room that KMCO converted to store PPE. The construction of the former Reaction 2 Control Room was similar to this building. (Credit: CSB)

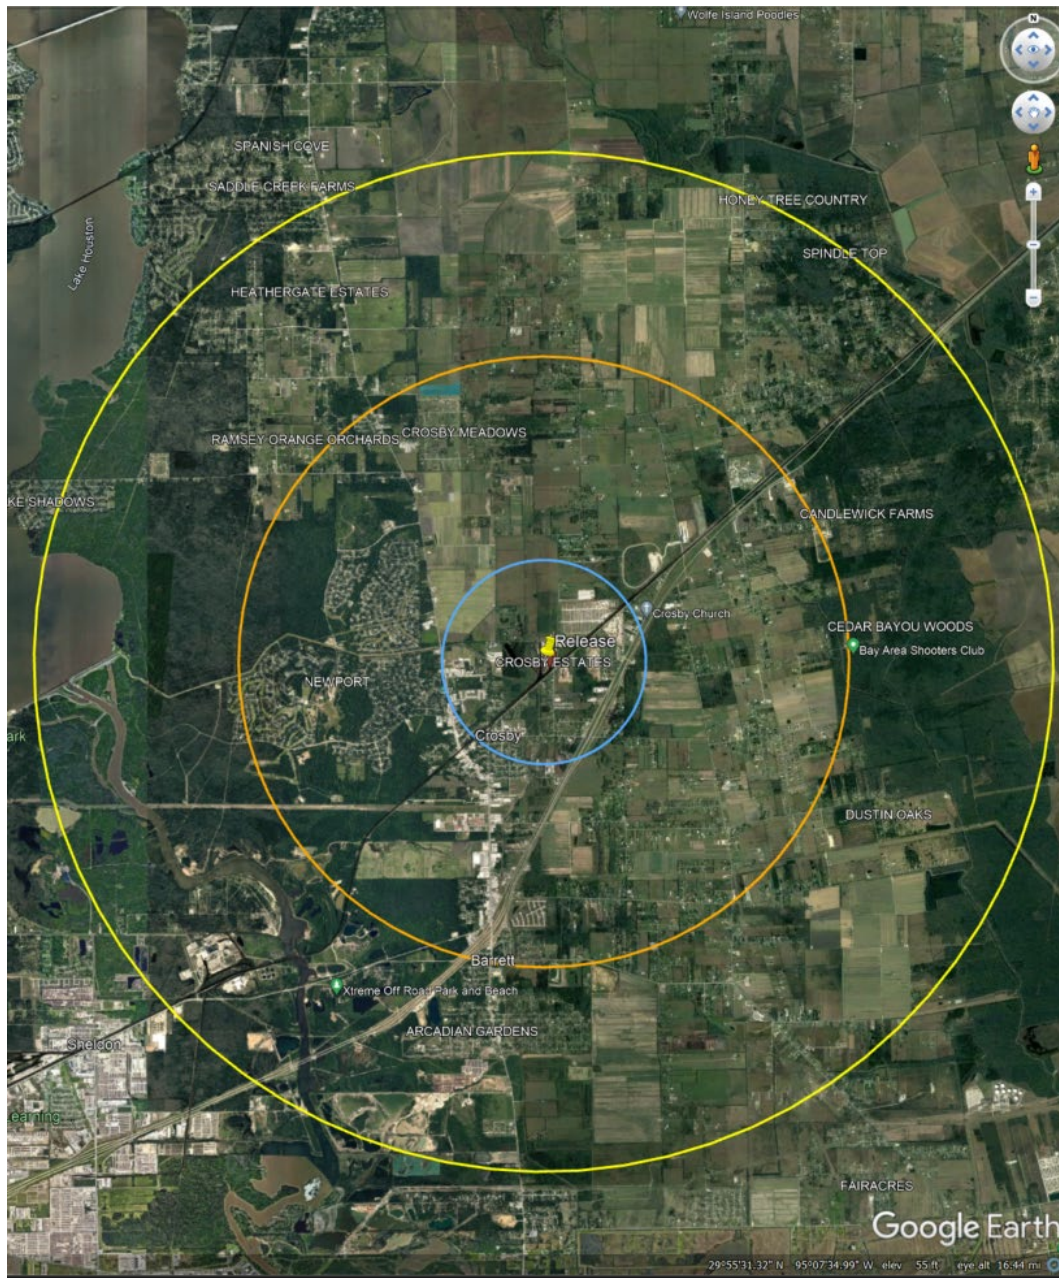
**Figure 8.** Area Surrounding the KMCO Facility. (Credit: Google Earth, annotations by CSB)

**Figure 8** shows the KMCO facility and depicts the surrounding area. The circles are set at one (blue), three (orange), and five (yellow) miles from the location of the isobutylene release. Summarized demographic data for the five census blocks within a 1-mile vicinity of the KMCO facility are shown below in **Table 1**. There are about 24,000 people residing in about 9,184 housing units. In general, the local population is predominantly white, living in single-unit housing, with five percent below the poverty level. Detailed demographic data are included in [Appendix C](#).

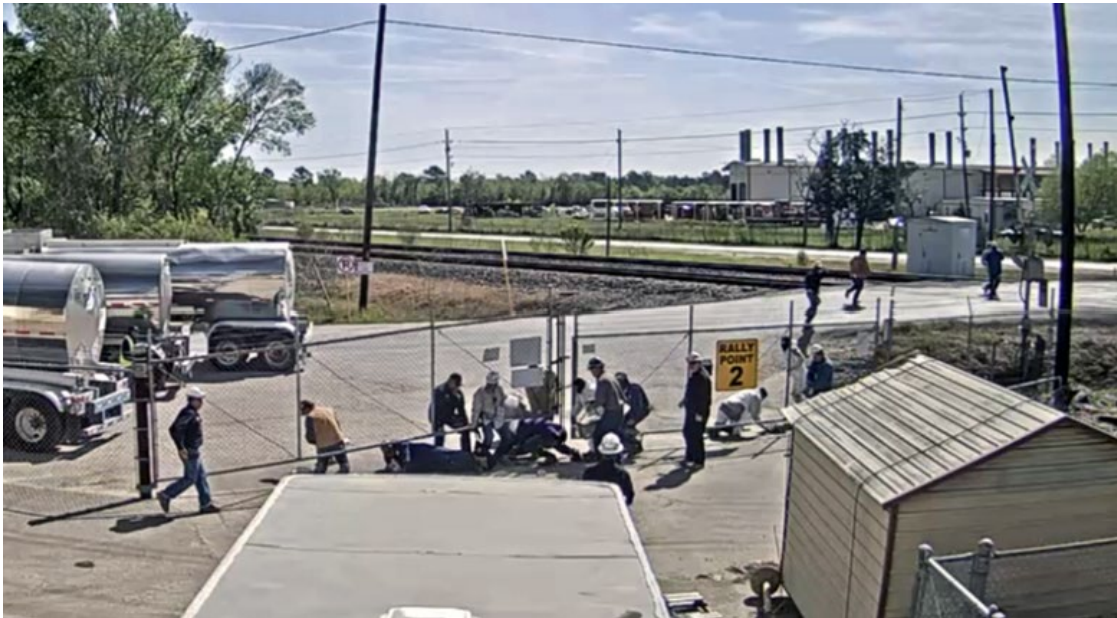
**Figure 10.** Evacuation Under Plant Fencing. This surveillance camera image shows workers helping other workers to exit under plant fencing about 36 seconds after the explosion.<sup>a</sup> (Credit: KMCO)

<sup>a</sup> According to KMCO's evacuation plan, this gate was not intended to be an entrance or exit for workers. KMCO periodically unlocked and opened this gate to allow heavy equipment to enter or exit. At the time of the incident, this gate was in its usual position, closed and locked for site security. Only one of KMCO's four rally points was outside the plant fence line.

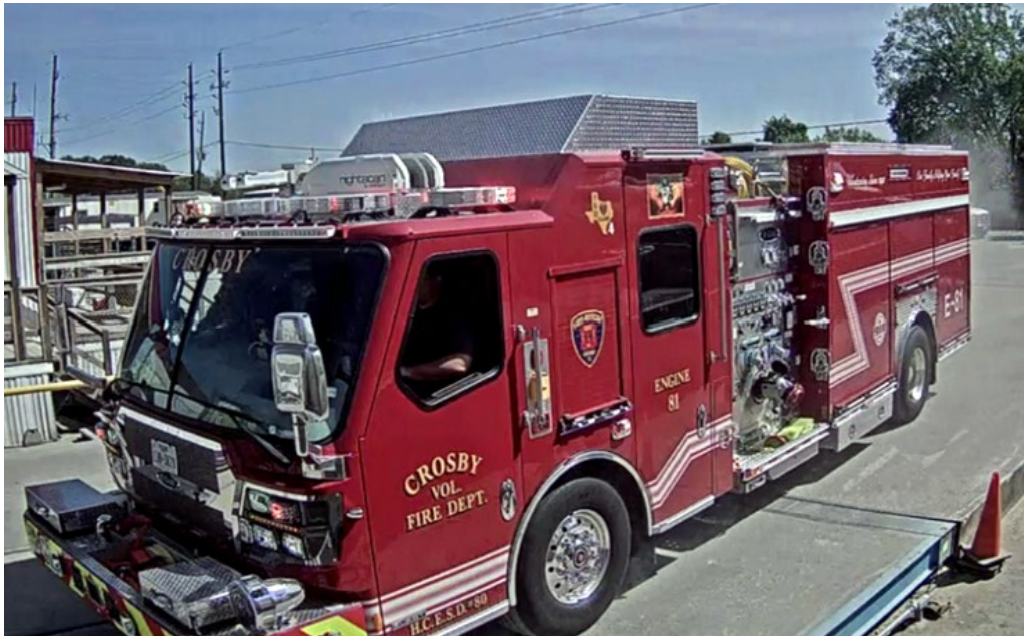
Emergency responders to the incident included KMCO's Emergency Response Team, the Crosby Volunteer Fire Department (**Figure 11**), Mutual Aid Mont Belvieu, and responders from Harris County. Harris County responders included the Sheriff's Office and the Harris County Fire Marshal's Office. KMCO also brought in U.S. Fire Pump to help with the firefighting. The incident triggered a shelter-in-place order for community members within a 1-mile radius [8].<sup>b</sup>

**Figure 11.** Emergency Response. This image from a KMCO surveillance camera shows a fire truck entering the facility at about 11:28 a.m. (Credit: KMCO)

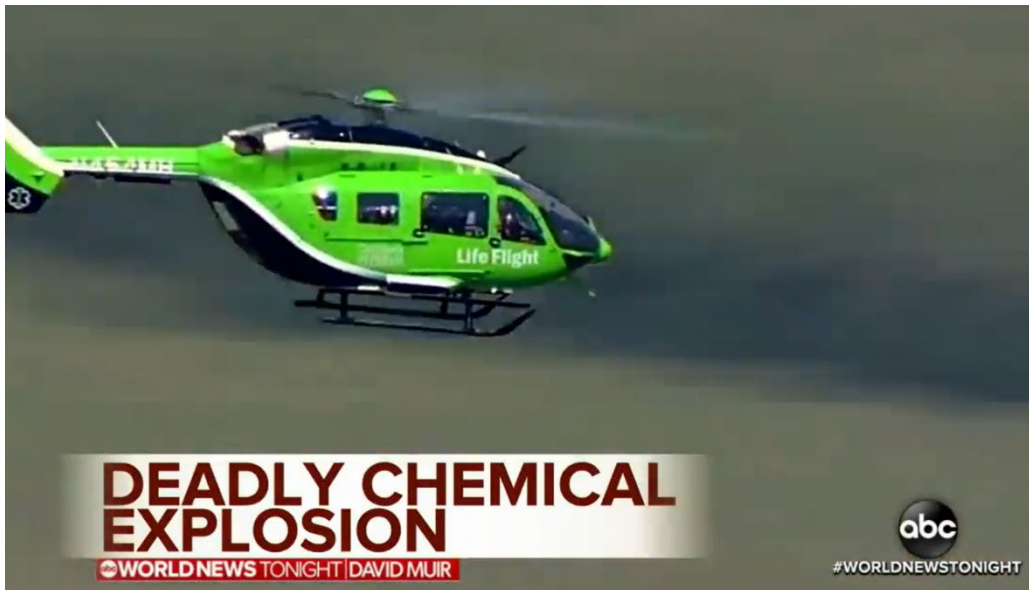
Emergency responders transported Board Operator 1 and the Shift Supervisor by helicopter to a hospital in Houston to get medical treatment for the serious burn injuries they suffered (**Figure 12**).

**Figure 12.** Life Flight Helicopter. One of the two helicopters that responded to the incident to transport injured workers. (Credit: ABC [9])

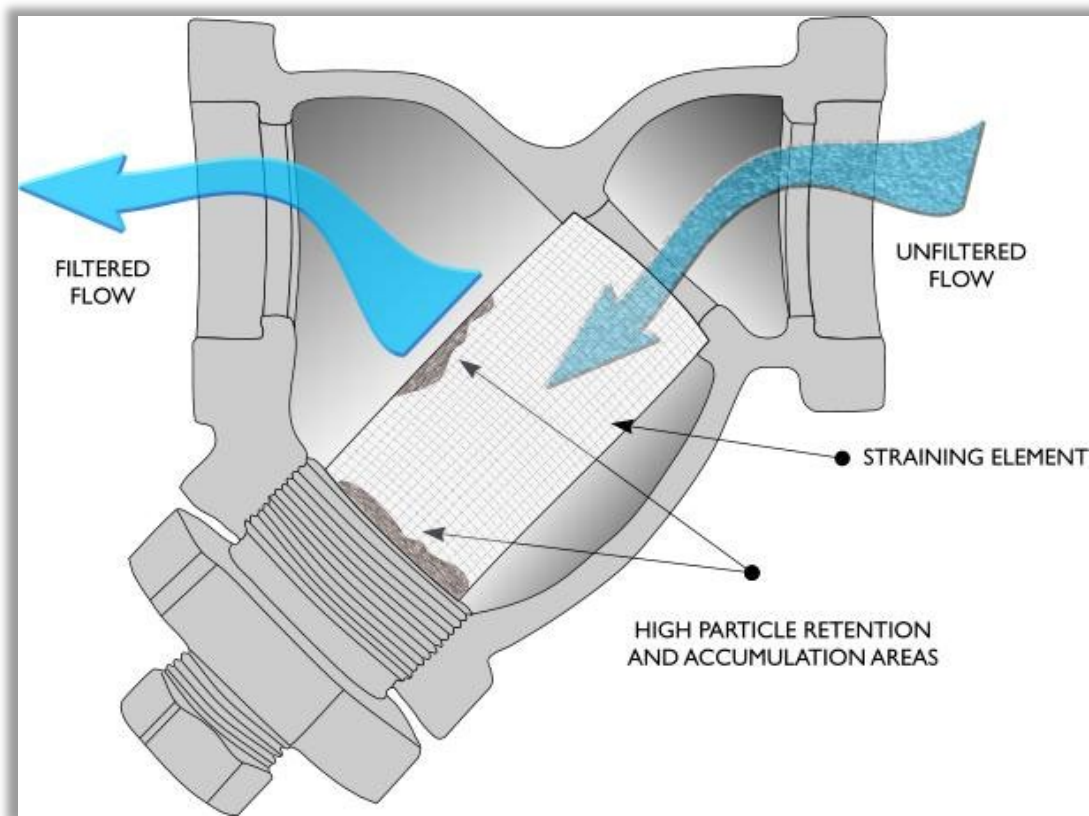
KMCO installed a filtration strainer (y-strainer) on the inlet (suction) piping to the isobutylene charge pump. A typical application for a y-strainer is to remove solid particles from a liquid stream (**Figure 16**). The 3-inch y-strainer had threaded ends, and KMCO added flange-to-threaded connections to allow the y-strainer to connect to the isobutylene piping flanges (**Figure 4**).

**Figure 16.** Generic Y-Strainer. This graphic shows a generic depiction of a typical y-strainer application—used to remove solid particles from a liquid stream. (Credit: Warden [16])

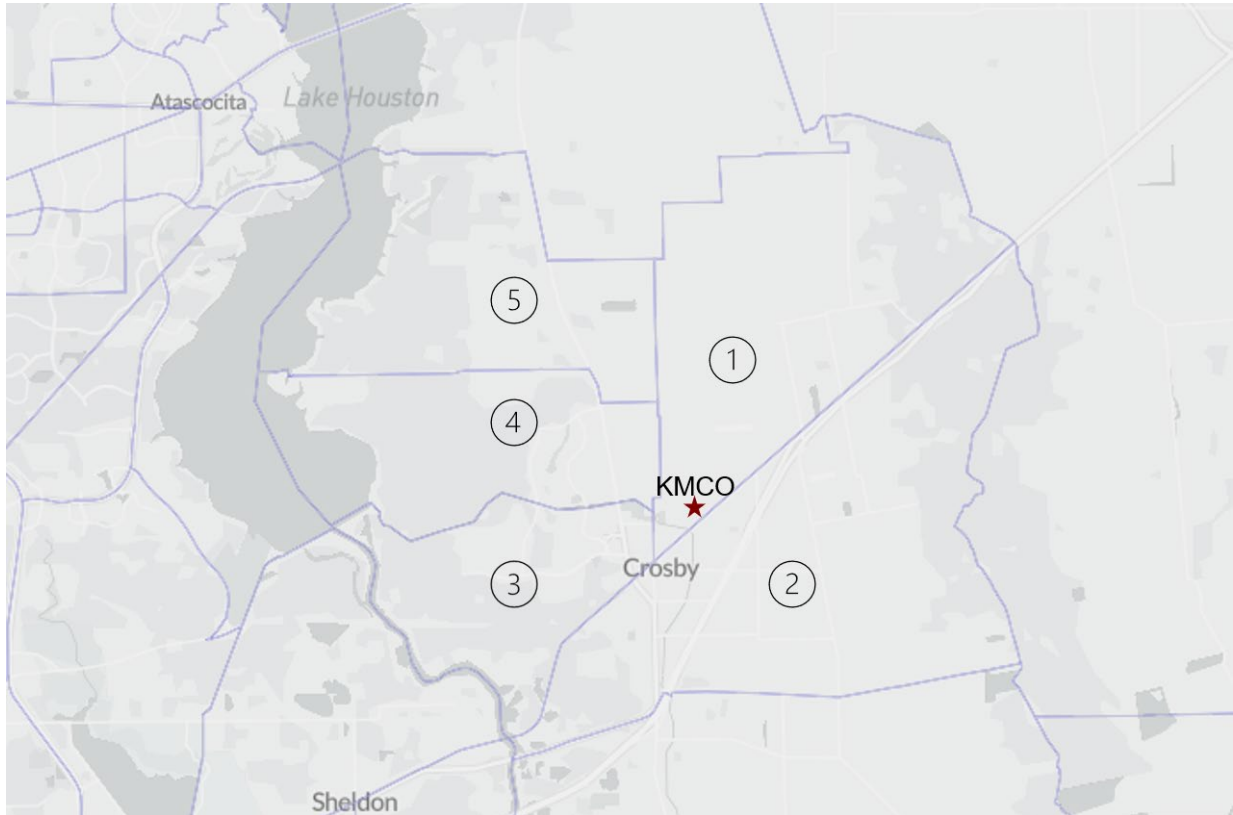
**Figure 24.** Census Blocks Near KMCO Facility. (Credit: Census Reporter, annotations by CSB)

**Figure 24** shows the census blocks within one mile of the KMCO facility. The census information for the blocks shown in **Figure 24** is presented in **Table 2**.
