# E-6600E and E-6600B Heat Exchanger Metallurgical Analysis

April 2, 2010 Tesoro Refinery Incident

Anacortes, Washington

**U.S. CHEMICAL SAFETY AND HAZARD INVESTIGATION BOARD**

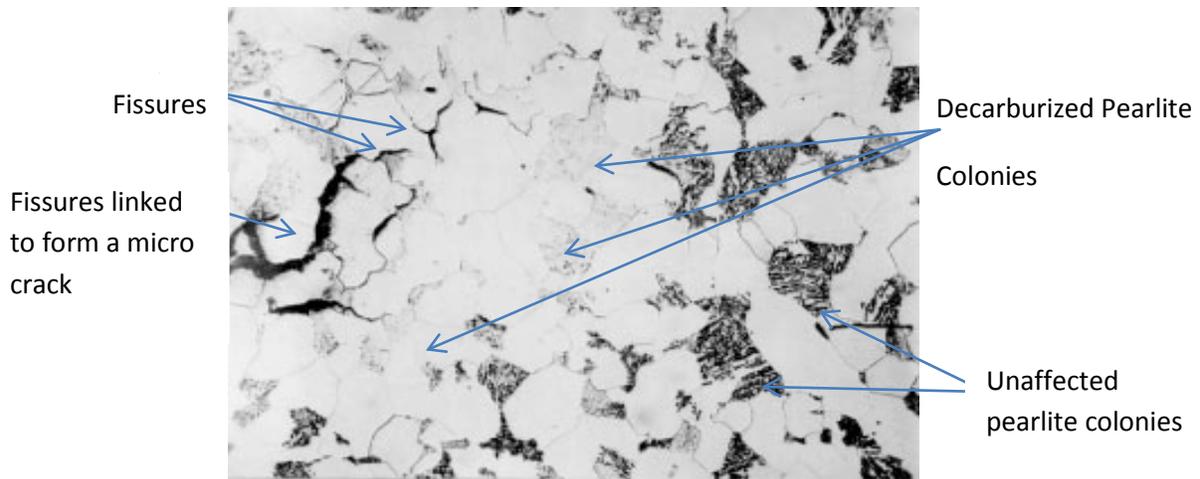
**Figure 3** shows an example of HTHA damage incurred in a C-0.5Mo steel. Note that the HTHA produced fissuring (small cracks) exclusively along the boundaries between different grains of the ferrite phase (ferrite phase is white, and grain boundaries separate the ferrite phase into polygonal shapes (grains)). These fissures then linked together to form a microcrack. Eventually, such damage will result in significant ductility loss and reduced load bearing capacity of a material. The damage typically occurs at grain boundaries or at the interface between the ferrite and pearlite phases as shown in **Figure 4**. The critical point in the initiation of the HTHA hydrogen damage is the formation of a bubble of high-pressure methane gas – a pressure that can be several orders of magnitude higher than the hydrogen partial pressure. This pressure can greatly exceed the yield strength of the steel material. As many

**Figure 3:** An example used in API Recommended Practice 941 (2008) for HTHA in a C-0.5Mo steel (520X, nital). The pearlite colonies, which consist of alternate layers of carbide and ferrite, are in the process of being decarburized, causing the pearlite structure to disappear because the dark carbide phase dissolves – leaving just white ferrite matrix. This dissolved carbon is needed to combine with hydrogen to form methane, which results in fissures (or blisters) in the microstructure.

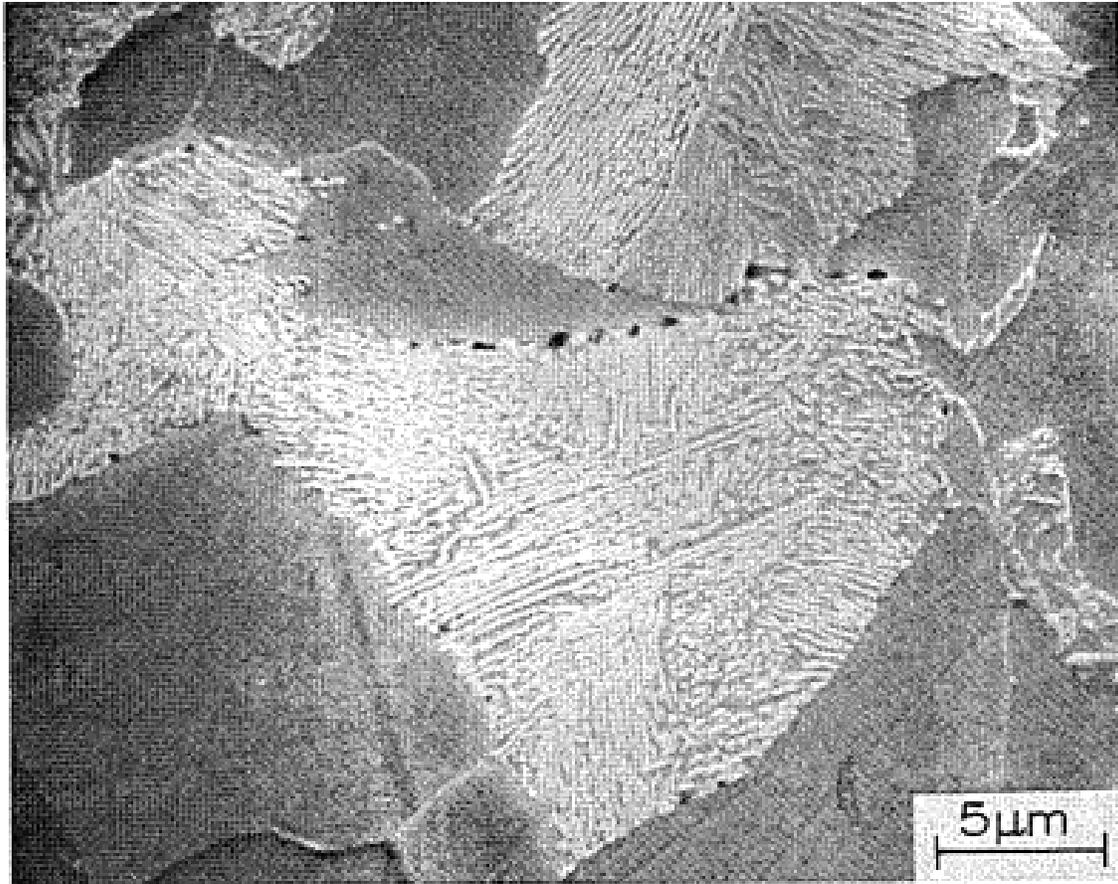
**Figure 4:** Typical methane bubble damage to the HAZ of carbon steel (Fe- 0.3C) after 88 Hr, 450° C,  $P_H = 6.5$  MPa. The bubbles form at the interface between the pearlite phase (whiter region) and the ferrite phase (dark here). Pearlite is a lamellar structure of iron carbides (white) and ferrite (dark). Carbides from the pearlite and isolated carbides at grain boundaries are dissolved to combine with hydrogen to form the bubbles. From R.Pishko, M.G. McKimpson, and P.G. Shewmon, Metall Trans, 1979, 10A, 887-894.

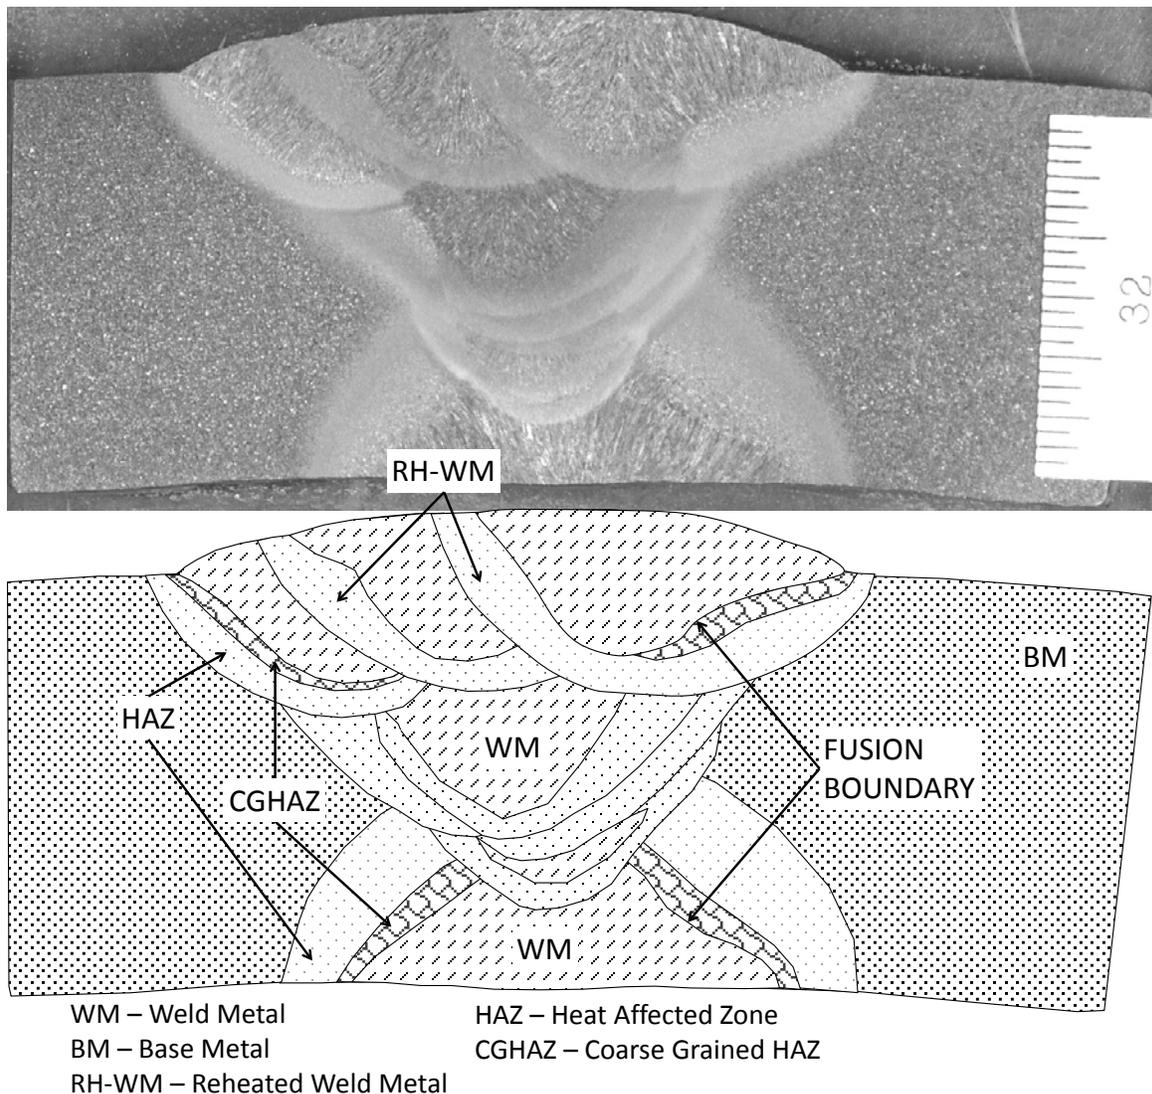
**Figure 5:** A cross section of a multipass weld typical of the Tesoro E-6600 heat exchangers and schematic defining terms associated with the weld.

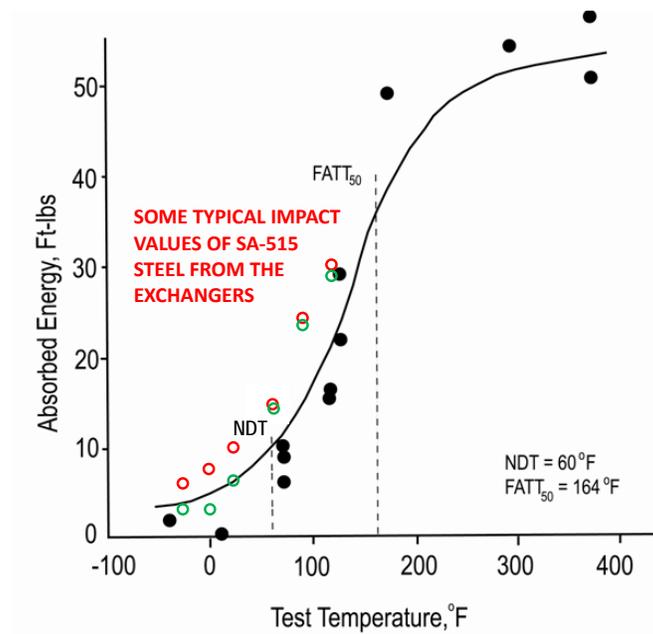
The impact properties of the heat exchangers are shown in **Figure 11**. The ductile-to-brittle-transition of the base material occurs at over 60 °F, likely closer to 100 °F (as indicated by the 50 % fracture appearance shear plot for this data, not shown here). This high transition temperature (above room temperature) at which brittle behavior can occur is expected for this coarse-grained carbon steel, as indicated by the literature data for a SA-515 Grade 70 steel shown in **Figure 12**. **Figure 12** also contains a plot of data points from the heat exchanger materials (approximate median values from **Figure 11**) for comparison. Note that the Charpy impact toughness of the exchanger material is within the typical scatter range shown in **Figure 11**, if not slightly better.

**Figure 12:** Charpy data showing transition example curve for SA-515 Grade 70 steel. The fracture area transition temperature indicated by the 50 % shear (FATT<sub>50</sub>) for this example is 164 °F and the nil ductility temperature is 60 °F. (Re-plotted data from Metallurgical failures in fossil fired boilers, D. N. French , Technology and Eng., John Wiley and Sons 1993 .)

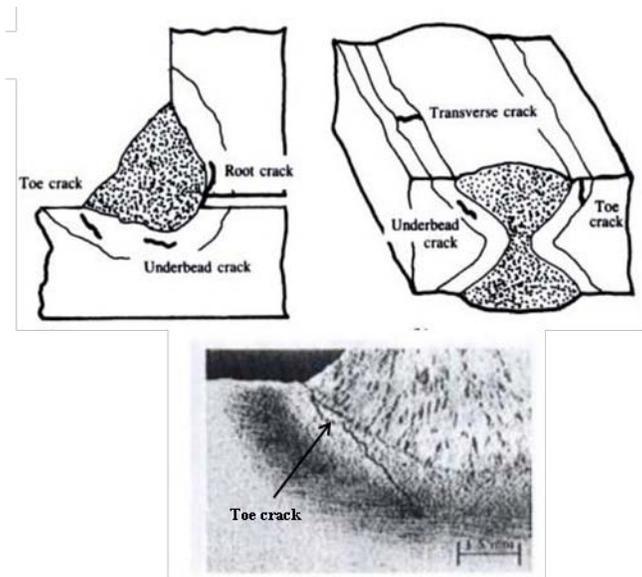
In general, the samples removed for evaluation from the failed E-6600E heat exchanger had cracking in the coarse grain HAZ region of the welds. Crack paths were often very near the fusion lines of the welds. This very selective crack path morphology along fusion lines in welds is not the typical cracking morphology associated with HTHA (although general HAZ cracking is typical). This is a crack morphology that is sometimes associated with hydrogen-induced cold cracking in welds, referred to as “underbead cracking” (“toe crack” morphologies can also be a result of hydrogen cold cracking). **Figure 25** shows the typical morphology of hydrogen-induced cold cracks in fillet and butt welds. Note that the morphology of the cold cracks is comparable to some of the damage observed in the heat exchangers. However, details of the damage along the fusion line and in the coarse grain regions adjacent to the fusion lines of the welds examined here often show that fissures are developed and link to form the underbead macro cracks, and that the fissures are often associated with decarburization. These details are not associated with the hydrogen cold-cracking mechanism in welds; they are associated with HTHA.

Figure 25: Hydrogen induced cracks in weld HAZs from N. Bailey, et. al., *Welding Steels Without Hydrogen Cracking*, Woodhead Publishing, Cambridge, 2004.

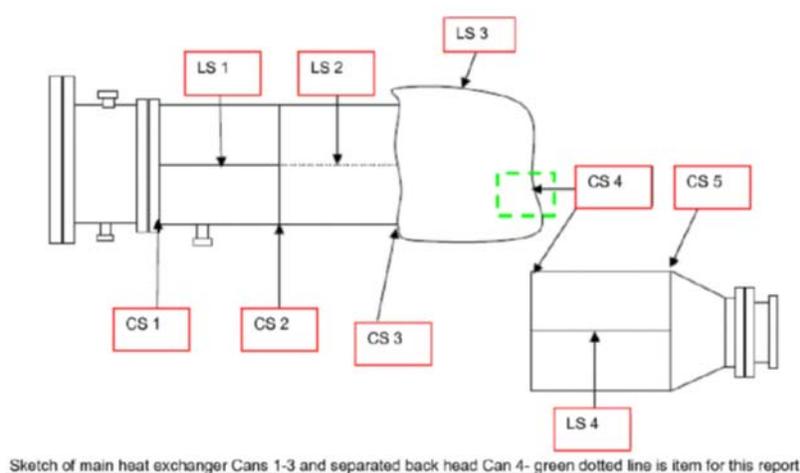
Figure AI.2: Showing sample location in green.

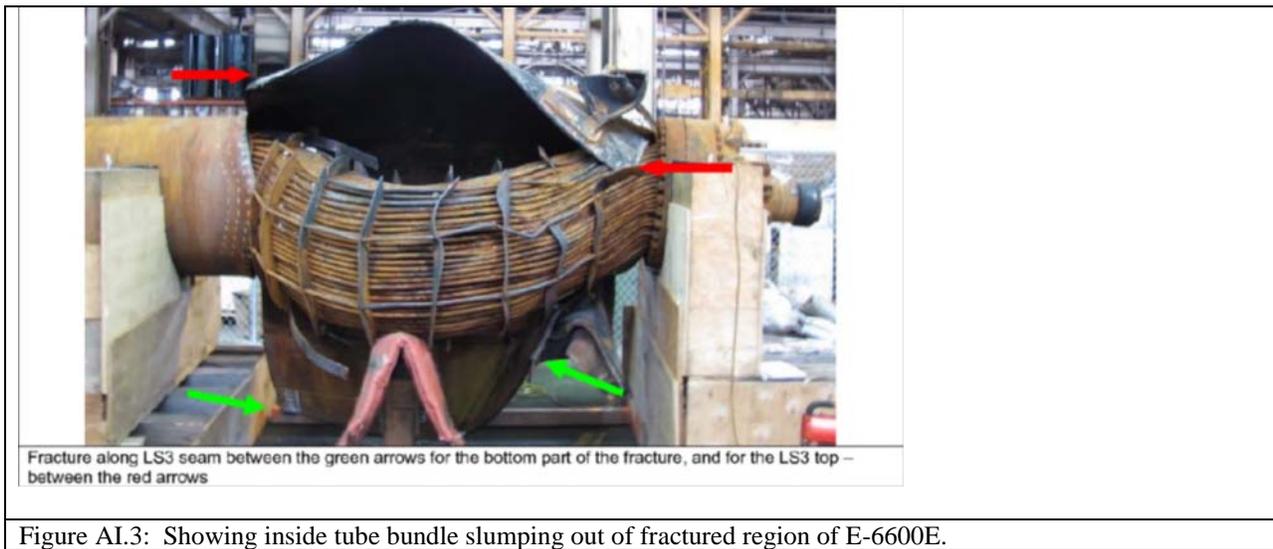
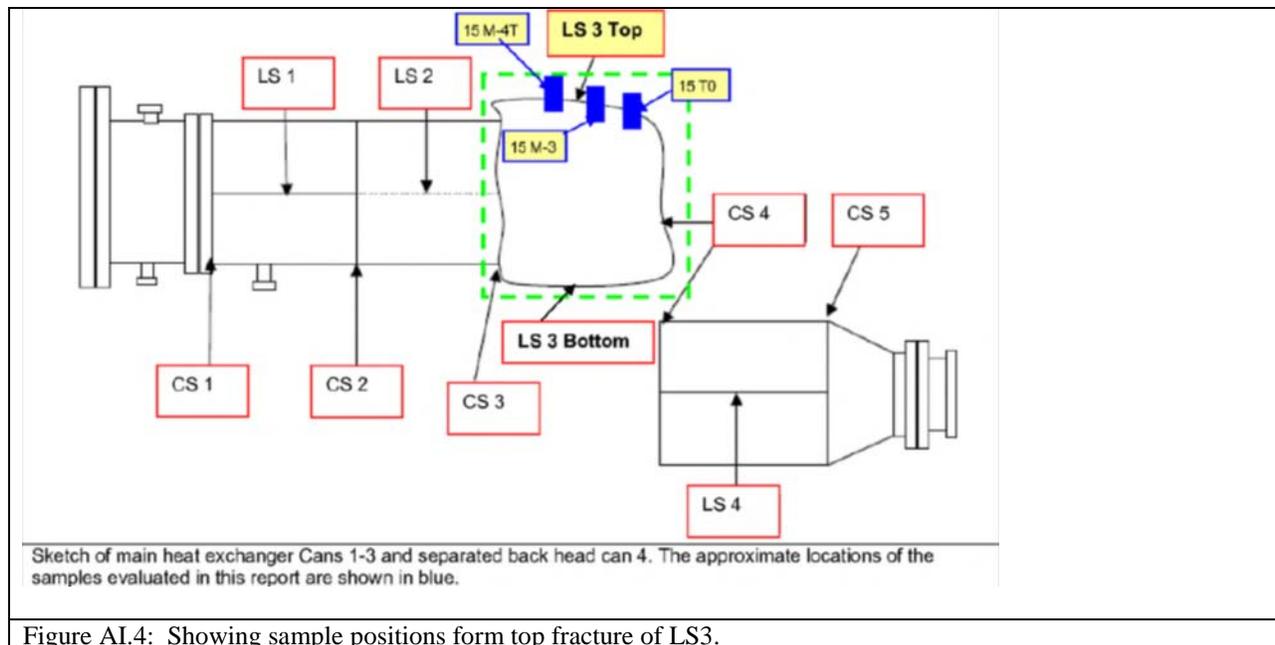
Three mounts from Part 15 (from the top portion of the LS3 fracture) which are matching parts to the mounts from part 14 (bottom fracture of LS3) that were evaluated in a previous report (M10198-LS3 Bottom Findings July30, 2010). Part 15 is a six inch wide section of the top portion of the LS3 fracture between the CS3 and CS4 welds.

Figure AI.4: Showing sample positions form top fracture of LS3.

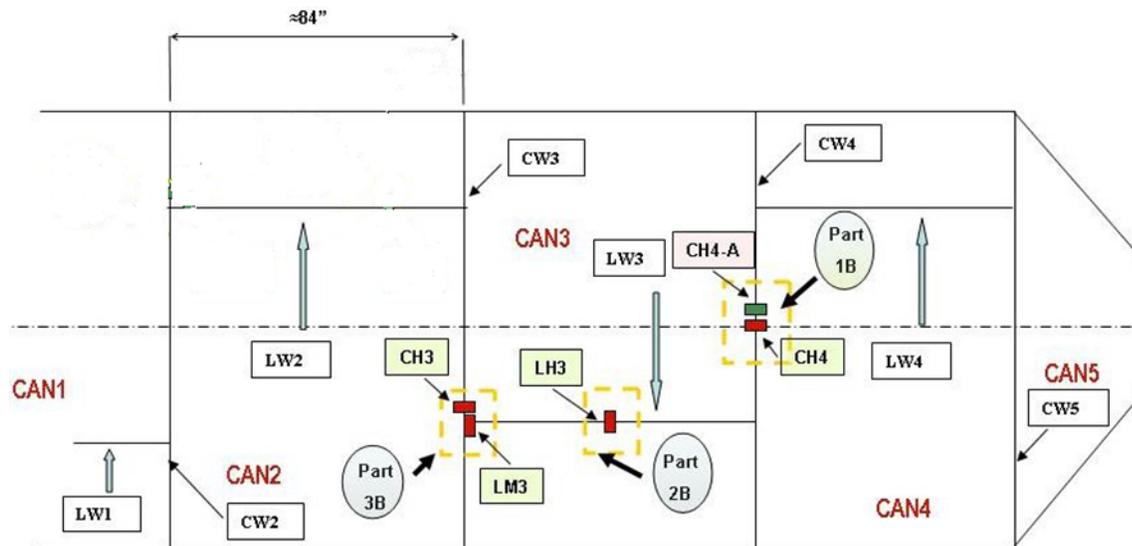
- Part 1B, on CW4 weld
- Part 2B, on LW3 weld
- Part 3B, near the intersection of LW3 and CW3

Figure AI.6: Showing part and sample locations in E-6600B.

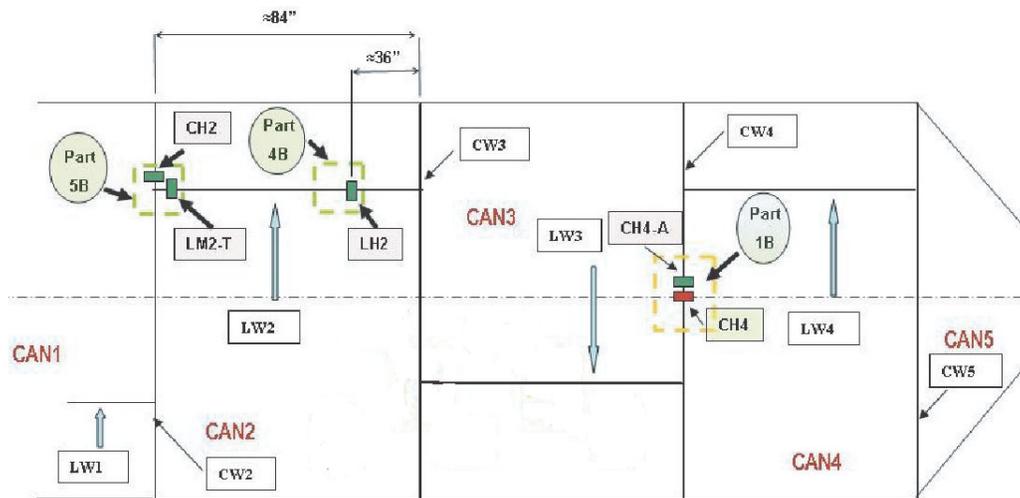
- CW4
- LW2
- CW2

Figure AI.7: From the BETA laboratory report No. M10329-B showing the locations of the specimens examined.
