Investigation Update

March 2025

This document provides a second update^a on the CSB’s investigation of the October 10, 2024, incident at the Deer Park Refining, Limited Partnership’s (“PEMEX Deer Park”) refinery in Deer Park, Texas.

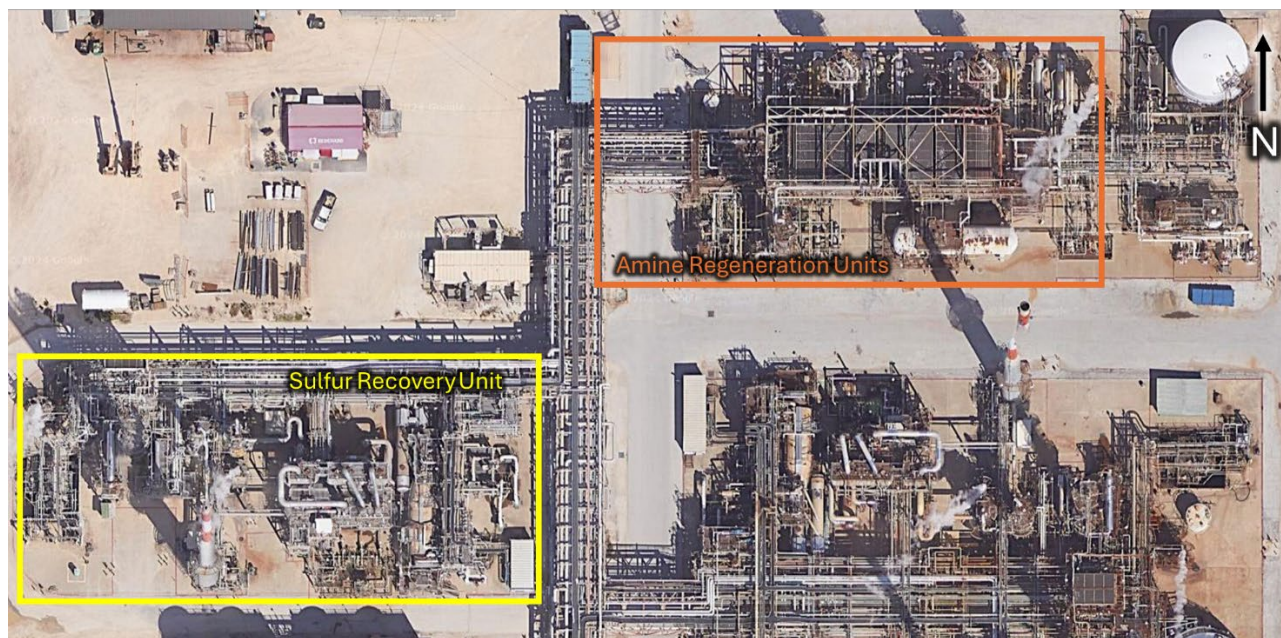
The incident occurred in the PEMEX Deer Park Refinery's Amine Regeneration Units (ARUs), which separate hydrogen sulfide from aqueous amine. The resulting vapor, called acid gas, is a mixture of approximately 90 percent hydrogen sulfide and 10 percent carbon dioxide. The acid gas is transferred through process piping to the downstream Sulfur Recovery Unit (SRU) to convert the hydrogen sulfide into sulfur. The relative locations of the ARUs and the SRU at the refinery are shown in **Figure 2**.

Figure 2. Relative locations of ARUs and SRU. (Credit: Google Earth, with annotations by CSB)

The PEMEX Deer Park Refinery has two ARUs, ARU6 and ARU7, which are identical in function and capacity. The ARU6 and ARU7 equipment and piping are in the same general area, with piping segments for both units sharing the same platforms to access the equipment. ARU6 was shut down for maintenance activities at the time of the incident, and the unit's process piping had been depressurized, purged, and isolated. ARU7 was operating normally after having gone through the same maintenance activity. The nearby SRU (**Figure 2**) was in a scheduled unit shutdown for planned maintenance activities, called a turnaround.

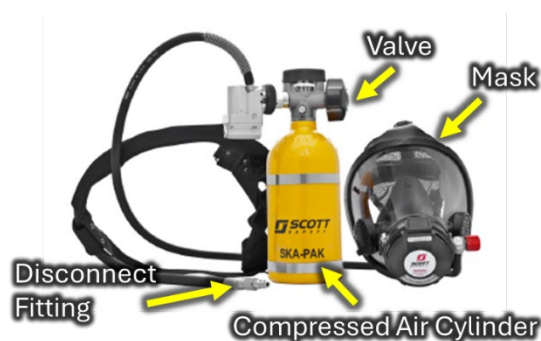
When completing a portion of the ARU6 blind removal work, Repcon workers used a supplied-air respirator system equipped with a compressed air cylinder (**Figure 3**). The system consisted of a mask, a compressed air cylinder,^d a regulator, and hoses connecting the mask to the cylinder and a supplied air quick-disconnect fitting. To properly use the cylinder during an

Figure 3. Supplied air respirator system. (Credit: 3M [11])

Around 3:30 p.m., the Repcon boilermakers had completed the blind removal at the first 13 locations and prepared to remove the final two blinds. The boilermakers obtained supplied-air respirators and emergency escape cylinders from Code Red (**Figure 3**) and donned the equipment. Two of the boilermakers went to the 15th blind location elsewhere in the unit. The remaining two boilermakers climbed to a fixed, elevated platform to begin work at the Blind 407 location. The Repcon foreman located a contractor from another company to serve as the “bottle watch,” who is responsible for monitoring the supplied air tanks connected to the boilermakers’ respirators, among other responsibilities. The boilermakers connected their respirators to supplied-air hoses. They removed their personal
