January 21, 2018

Crew members from the Patterson-UTI Drilling Company had been drilling a gas well for over a week under the direction and supervision of Red Mountain Operating, LLC (or RMO) in Pittsburg County, Oklahoma.

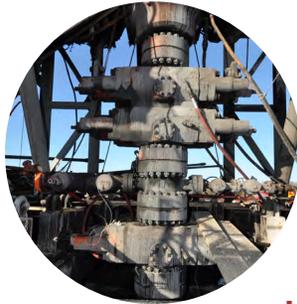
Crew members started to remove the drill pipe from the wellbore. During this operation, called 'tripping,' mud is pumped into the well to replace the volume of drill pipe being removed.
