U.S. Chemical Safety and Hazard Investigation Board

Tesoro Martinez Refinery

Process Safety Culture Case Study

February 12, 2014 and March 10, 2014 Sulfuric Acid Release Incidents

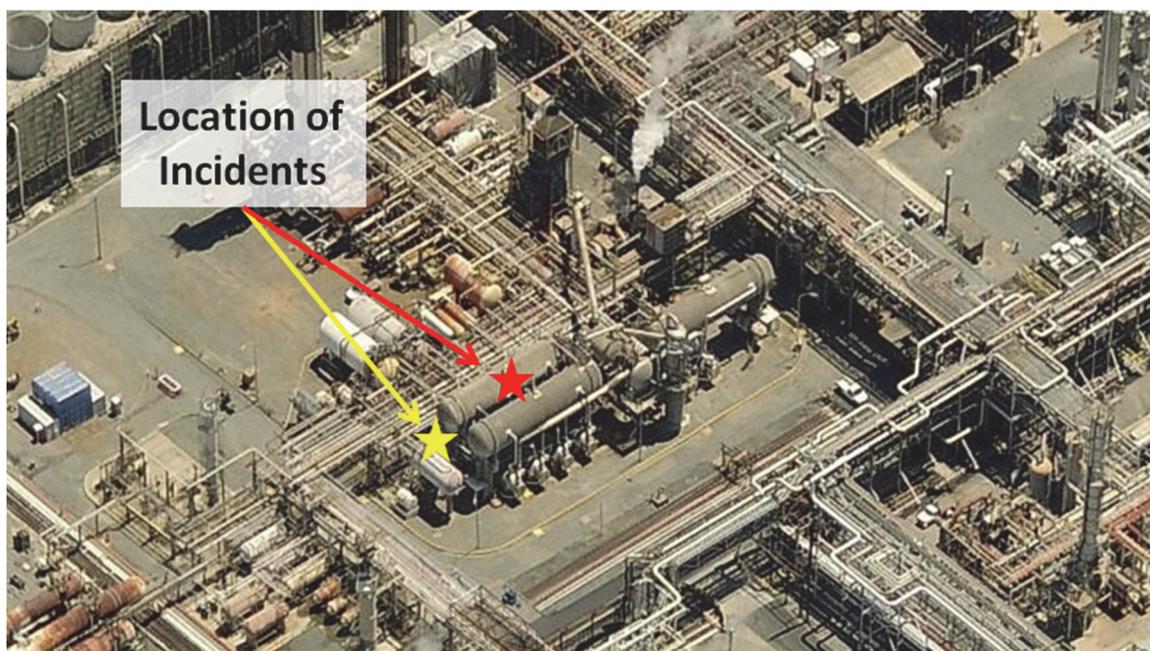
Figure 1. Overhead photo of the Tesoro Martinez refinery Alkylation Unit showing the approximate location of the February 12, 2014 (yellow star) and March 10, 2014 (red star) incidents. Credit Bing Maps.

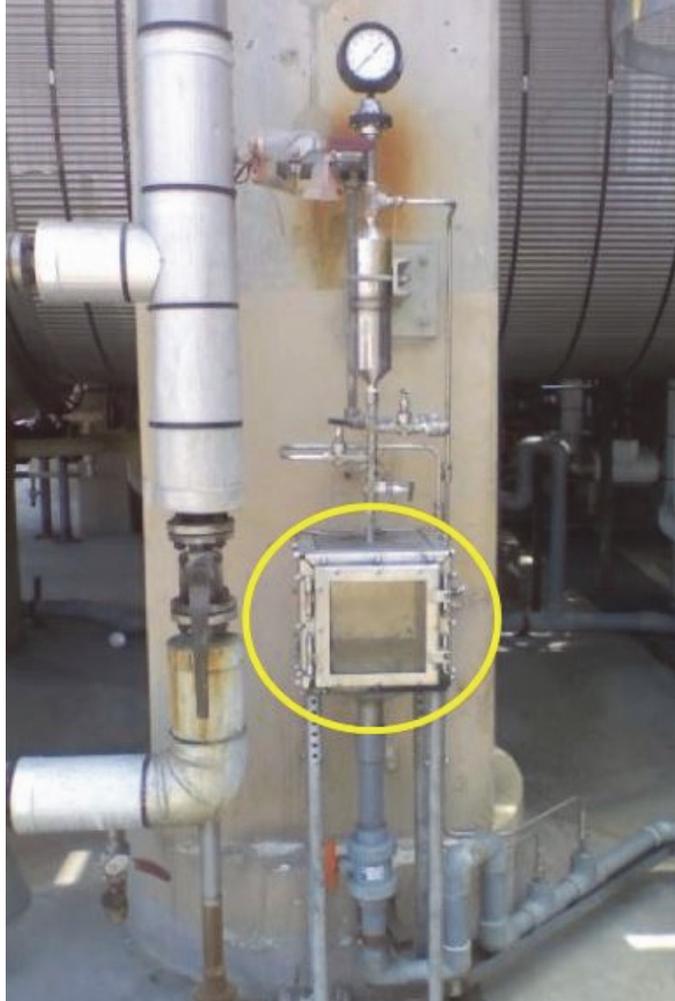
Tesoro records indicate that the Martinez refinery's sulfuric acid alkylation unit acid sampling system has more potential for operator exposure to acid than those in use at the other Tesoro refinery in California, Tesoro's Los Angeles refinery, which uses an enclosure around the sampling system to protect operators from potential acid spray (Figure 9).

Figure 9. Photo of the sulfuric acid sample station at the Tesoro Los Angeles refinery. This sample system includes an enclosure at the sample point to protect operators from potential acid spray.

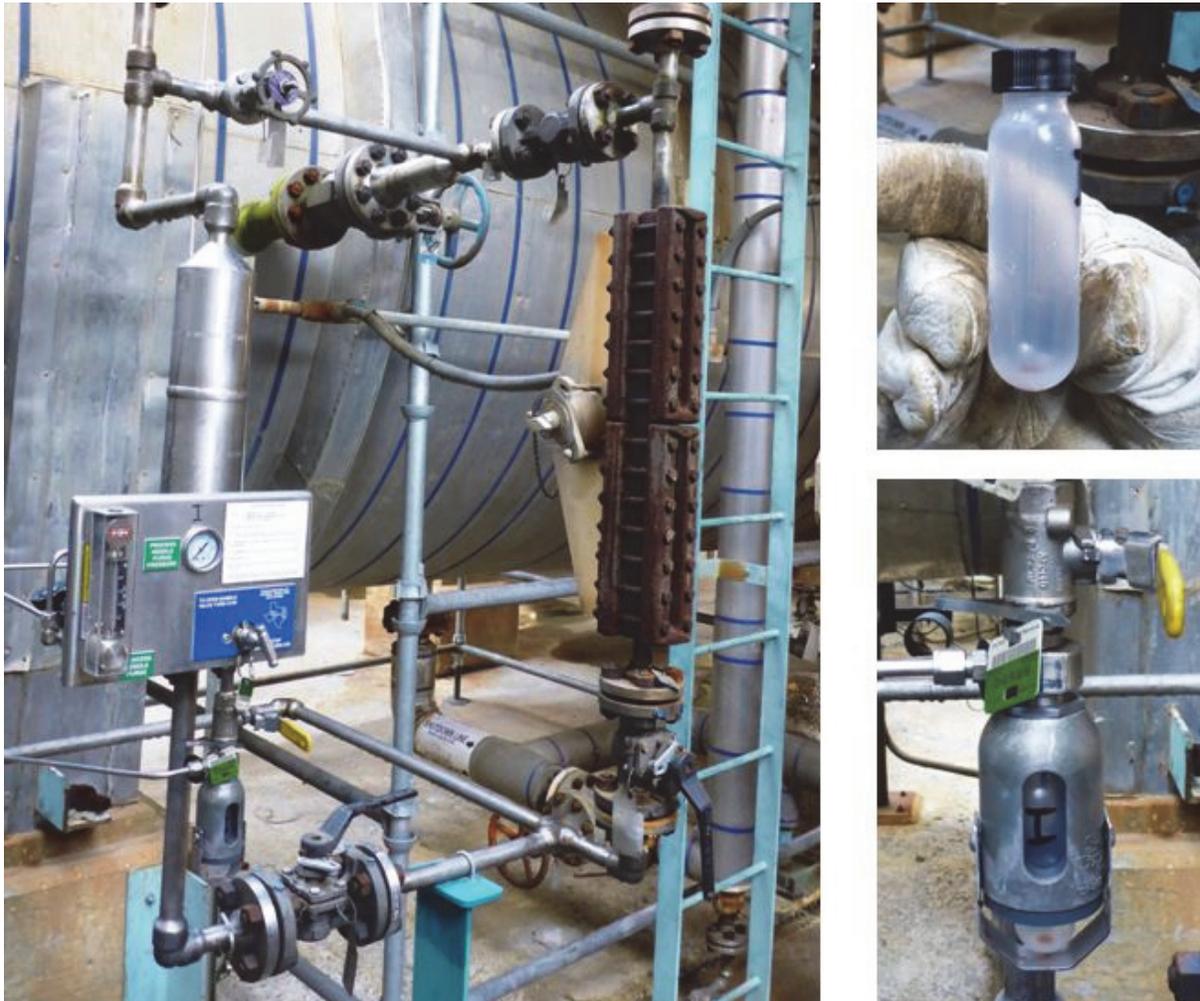
Company X refinery’s sulfuric acid alkylation unit acid sampling equipment (Figure 10) is similar to the inherently safer system that Tesoro installed but took out of service. Company X initiated efforts to upgrade its alkylation unit sample stations in 2012. The design justification for the upgrade includes improved design that would be safer because it would minimize the potential for worker exposure to sulfuric acid. Company X also uses a more robust piping material due to the “extremely high” corrosivity of the sulfuric acid. Company X installed these sample systems in 2013 and the CSB learned that although these systems had some initial reliability problems similar to those Tesoro Martinez experienced, Company X successfully transitioned to its more robust sample systems.

Figure 10. Photo of the sulfuric acid sample station at the Company X refinery. The photo on the left shows a typical sample station used by Company X workers to obtain sulfuric acid samples. The photo on the top right shows a typical sample bottle and the photo on the bottom right shows the sample bottle installed to obtain a sample.

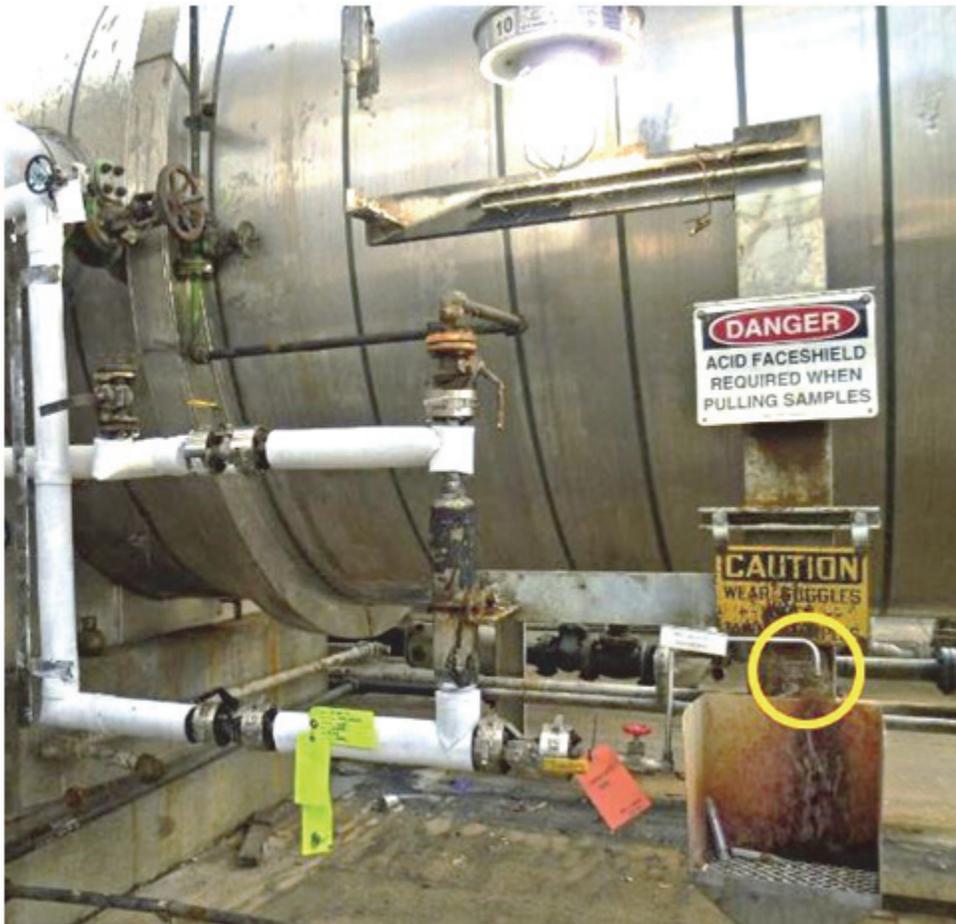
Acid sampling equipment within the sulfuric acid alkylation unit at the Company Y refinery is also more robust than the system at Tesoro Martinez involved in the February 12, 2014 incident.³⁶ Company Y's acid sampling equipment consists primarily of piping with only a short section of tubing used to collect the acid sample (Figure 11). The sampling equipment (piping, valves, and tubing) used by Company Y is better designed and maintained than the equipment at the Tesoro Martinez refinery (left photo in Figure 3).

Figure 11. Photo of the sulfuric acid sample station at the Company Y refinery. The photo shows a typical sulfuric acid sampling station at the refinery. The yellow circle identifies the location where the operator obtains the acid sample.
