## Investigation Update

March 2026

This document provides an update on the CSB's investigation of the October 10, 2025, incident at Accurate Energetic Systems, LLC.

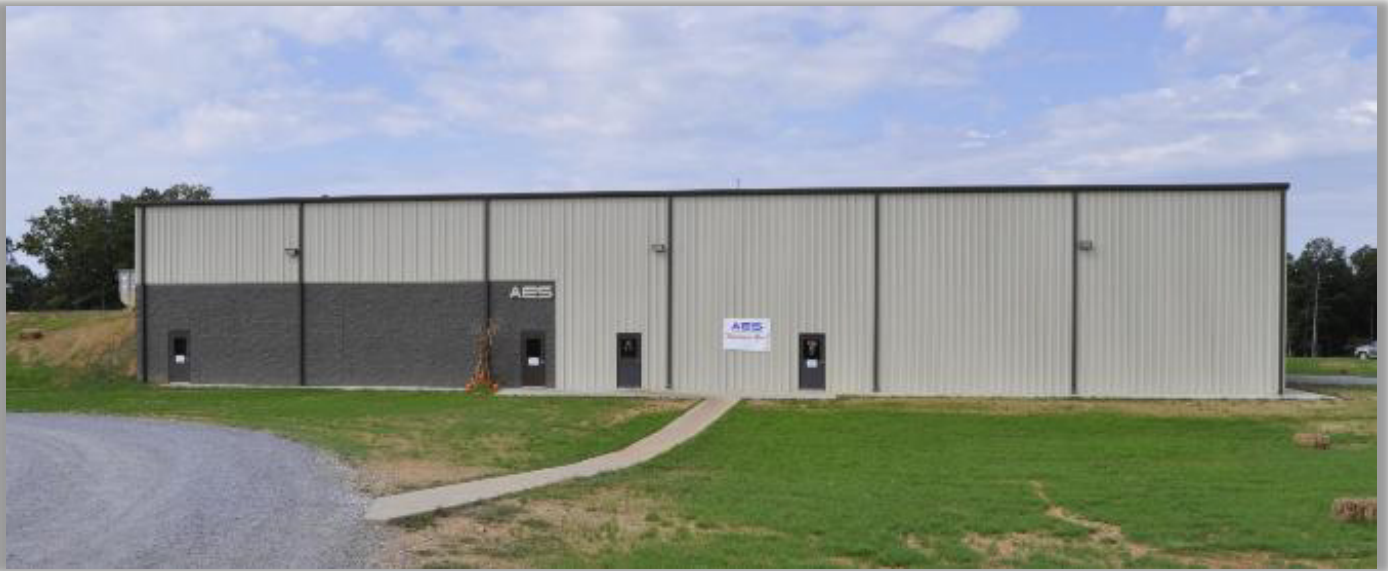
**Figure 2.** Pre-incident photo of Building 602. (Credit: AES)

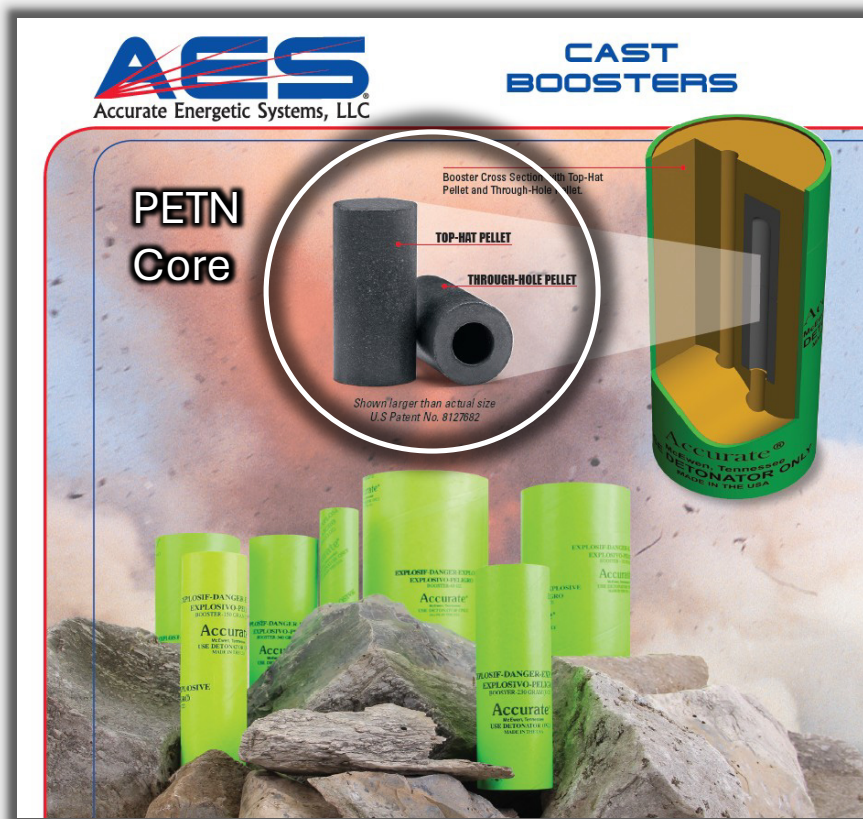
Figure 3. AES depiction of cast boosters (Credit: AES [11])

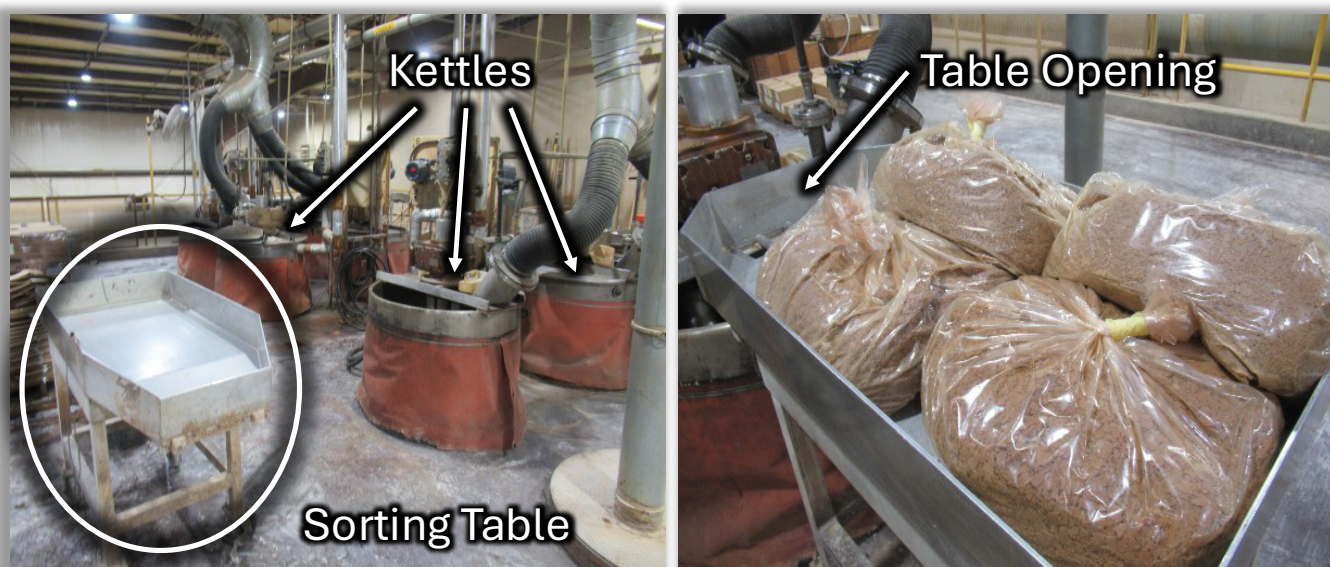
- To prepare for the melt/pour operation, AES workers would obtain solid, flaked TNT-based explosives from storage and deliver these materials to Building 602. A kettle operator would empty these explosive materials onto a wheeled, aluminum sorting table<sup>a</sup> on the mezzanine level and visually inspect for and remove identified debris. The table was equipped with magnets to capture and remove any ferrous metal debris. AES's sorting and inspection process equipment is shown in **Figure 5**.

**Figure 5.** Sorting table (circled on the left) next to the mezzanine-level kettles and TNT-based explosives in bags on sorting table before inspection (right). (Credit: AES, modified by CSB)

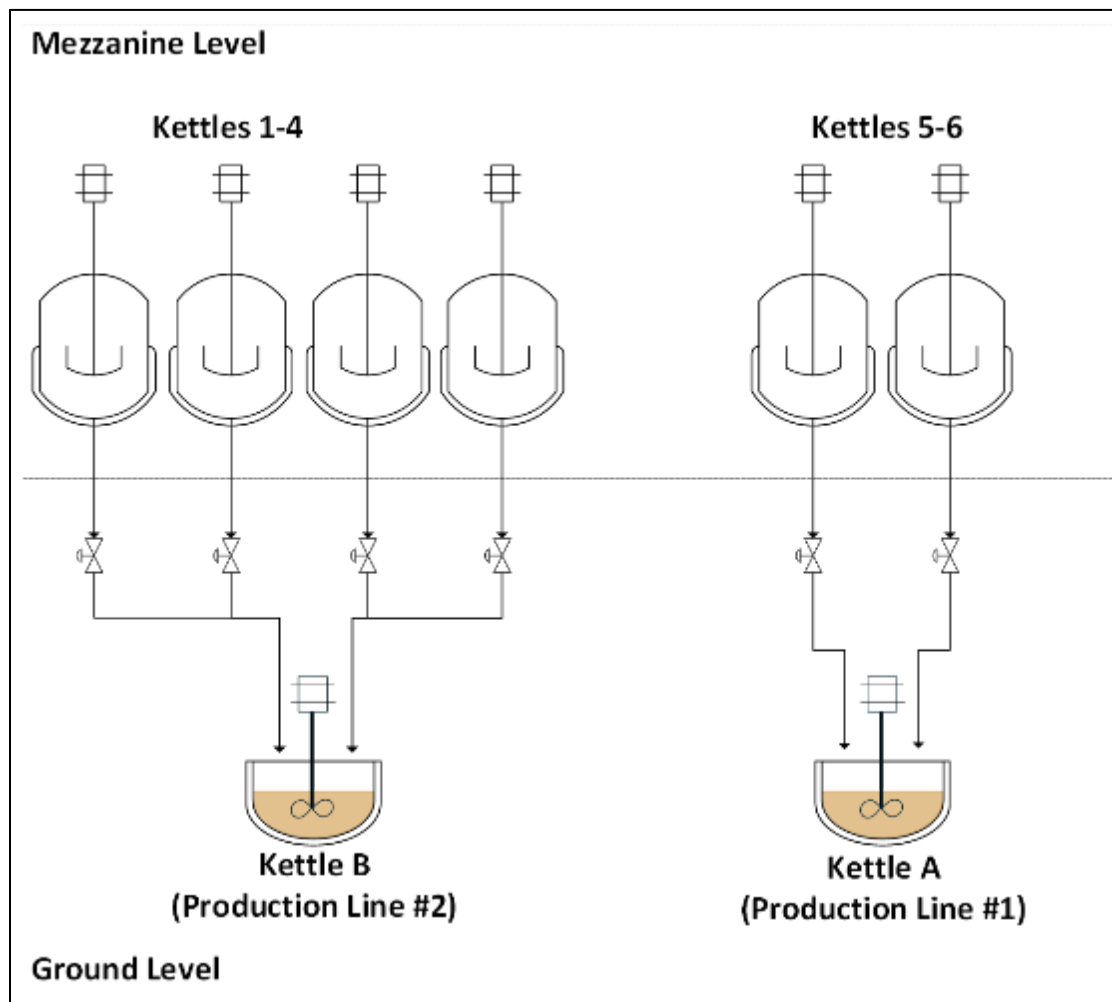
**Figure 6.** Simplified diagram of the melt/pour process (Credit: CSB)

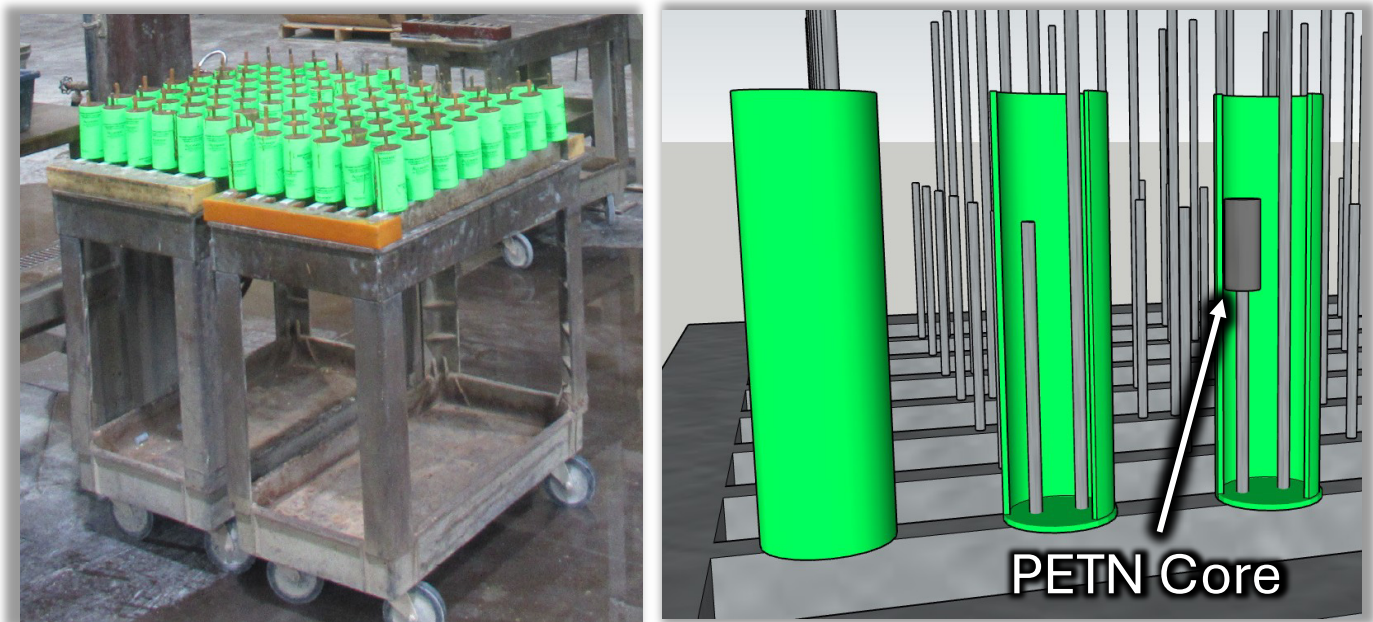
- On the ground floor, operators prepared the booster tubes to receive the molten explosives. Wheeled carts were staged, and metal fixtures, called “pin bars,” were inserted into the carts’ frames. Operators would put the empty tubes onto the pin bars and place a PETN core on one of the pins inside each tube. **Figure 7** shows a photo and depiction of the tubes situated on the pin bars.

**Figure 7.** Carts with staged booster tubes on pin bars (left) and depiction of how a booster tube was oriented on pin bars (right). (Credit: AES (left) and schematic by CSB (right))
