U.S. Chemical Safety and  
Hazard Investigation Board

# Chemical Decomposition, Fires, and Toxic Gas Release at KIK Consumer Products / Bio-Lab Conyers Facility

Conyers, Georgia | Incident Date: September 29, 2024 | No. 2024-04-I-GA

## Investigation Report

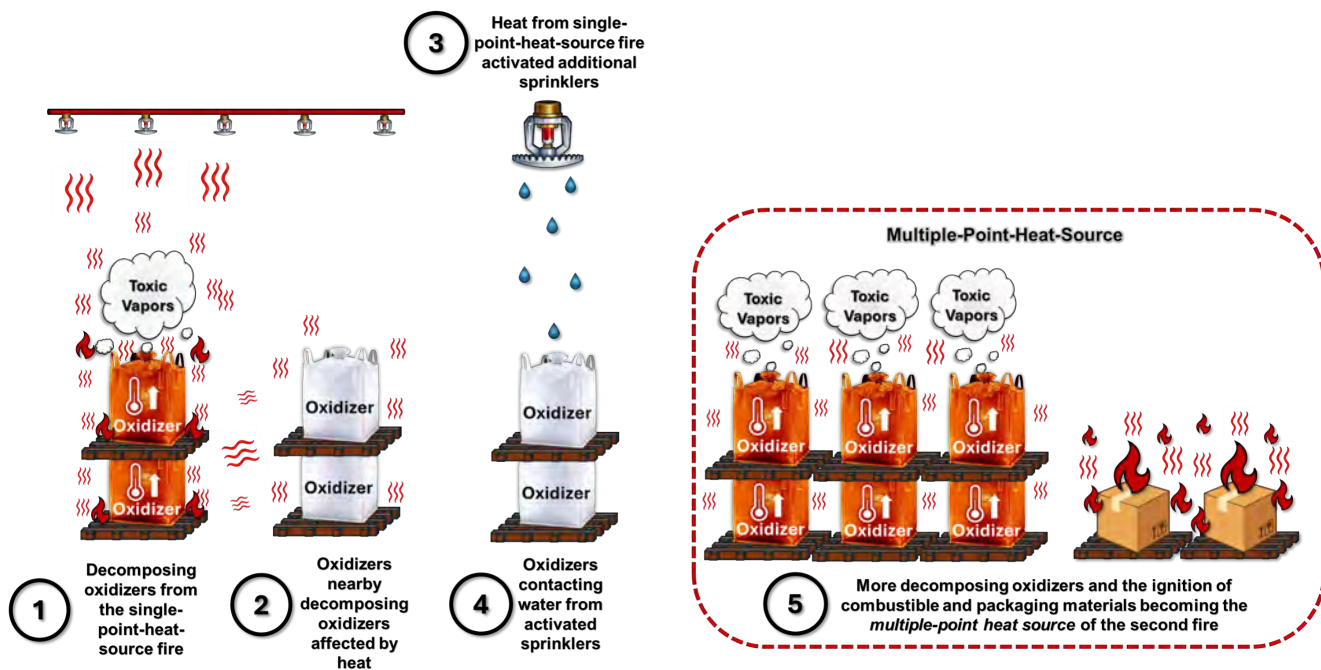
Although the first building fire was extinguished at approximately 8:10 a.m., the elevated temperatures inside the building from additional decomposing super sacks of materials continued to affect other areas of the warehouse. As shown in steps 1 through 3 of **Figure 42**, the heat emitted by decomposing oxidizers also activated the sprinklers in additional zones of the warehouse (see **Section 2.2**).

**Figure 42.** Depiction of the progression of the second fire in Plant 12 Storage Warehouse caused by a multiple-point heat source. (Credit: CSB)
