Investigation Report

SAFETY ISSUES:

The November 12, 2024, explosion at the Givaudan facility in Louisville, Kentucky, fatally injured two people:

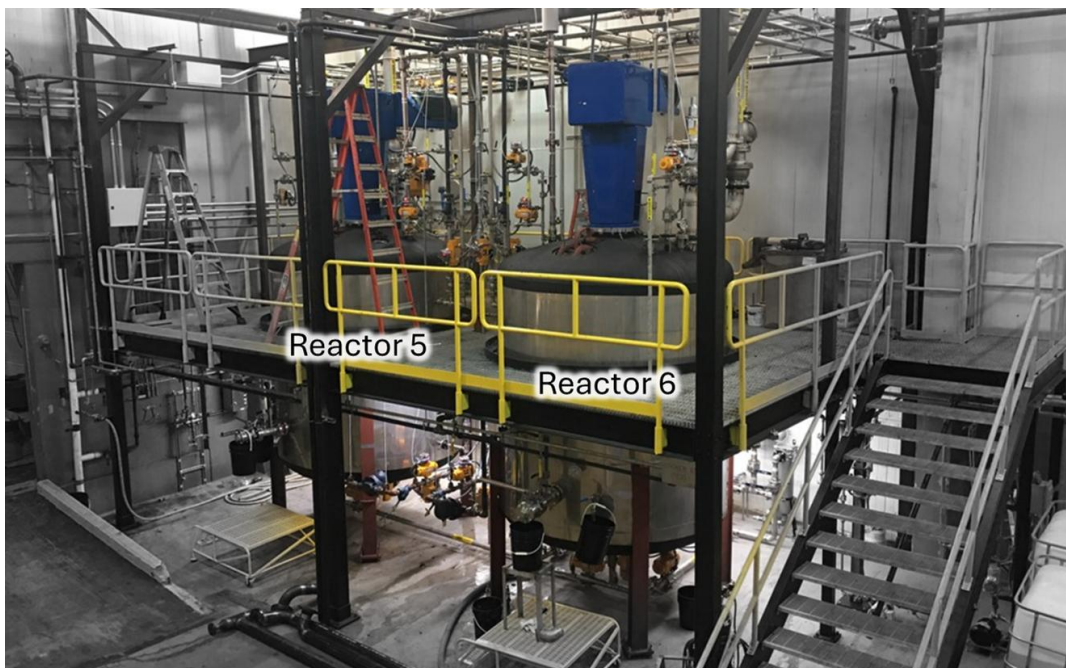
Reactor 6 was installed and began operating at the Louisville facility in 2021. Reactor 6 is shown in **Figure 3**. It was positioned next to Reactor 5, which was also installed in 2021.

Figure 3. Reactor 5 (left) and Reactor 6 (incident reactor, right) after installation in 2021. (Credit: Givaudan)

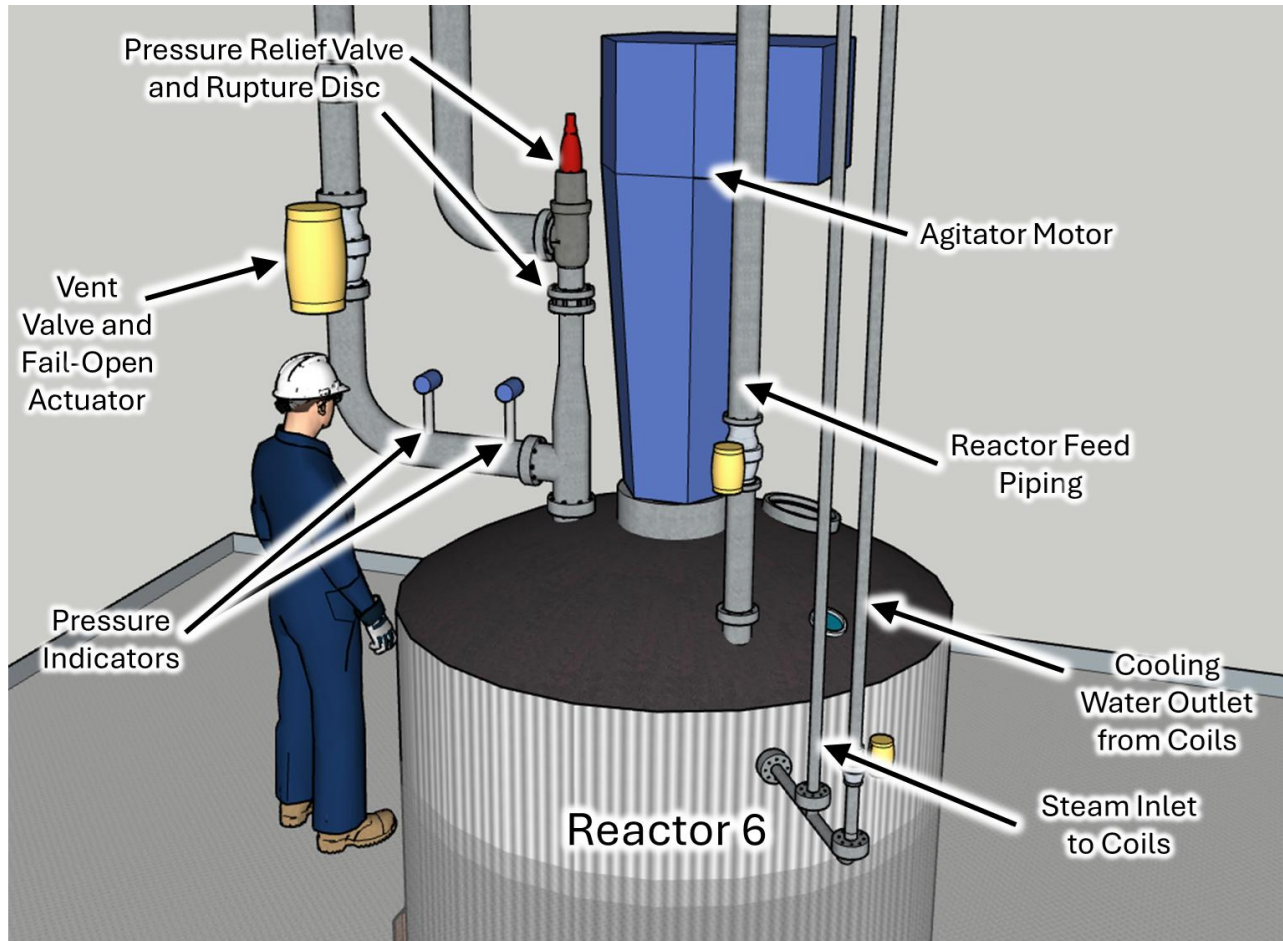
A simplified depiction of the top portion of Reactor 6^a is shown in **Figure 4**. Reactor 6 was a 2,500-gallon vessel constructed of 316 stainless steel with a maximum allowable working pressure (MAWP) of 75 pounds per square inch gauge (psig) at a maximum allowable working temperature (MAWT) of 355 degrees Fahrenheit (°F). The reactor contents were mixed by an agitator.

Figure 4. Simplified depiction of the top portion of Reactor 6. (Credit: CSB)

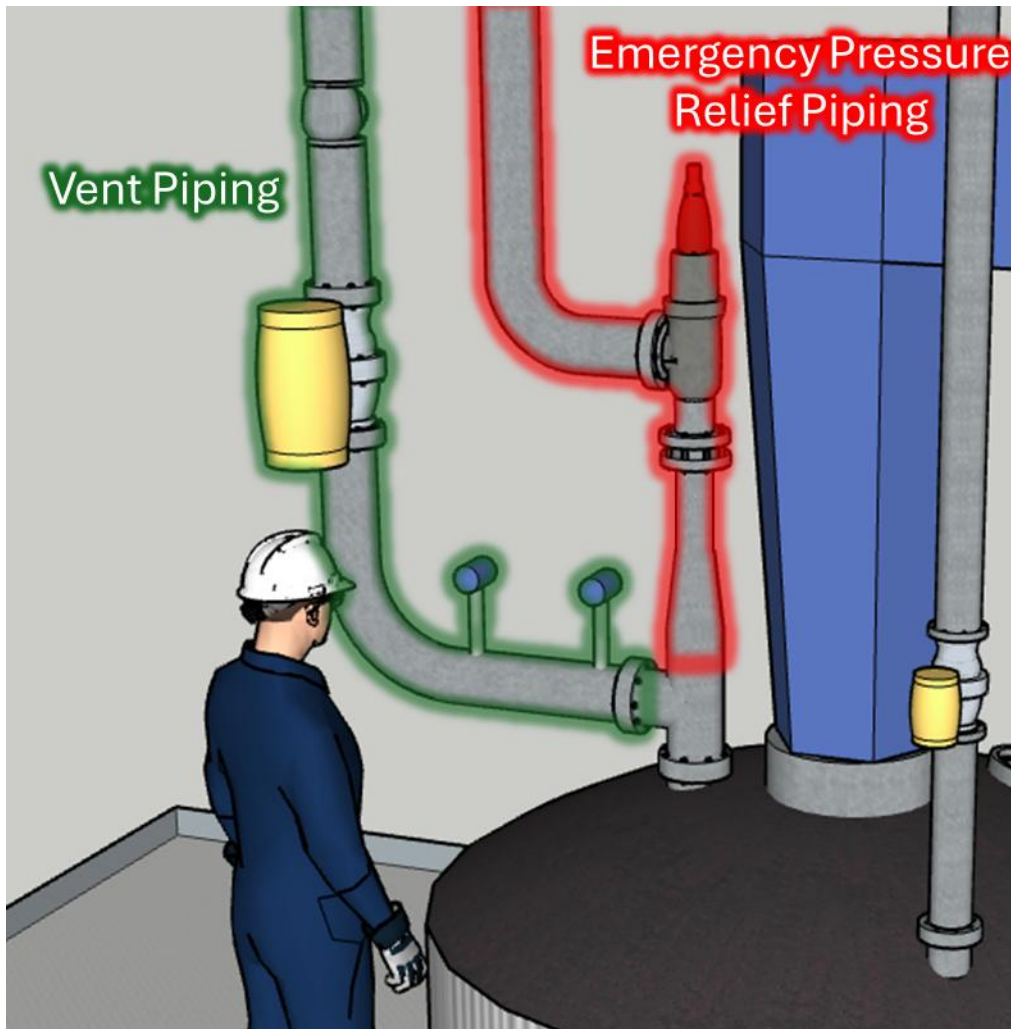
Reactor 6 was equipped with both a vent pipe (used during normal operation) and an emergency pressure relief pipe (used during high-pressure upsets), both of which originated from a single 6-inch nozzle on the head of the reactor (**Figure 5**). The vent pipe, which directed Reactor 6 gases produced during normal operation through a scrubber and to the atmosphere, was equipped with a vent valve (pressure control valve) with a pneumatic actuator that could automatically open and close to control the reactor's pressure. The vent valve position was controlled by a Programmable Logic Controller (PLC), which determined the required vent valve position based on the pressure inside the reactor. When the reactor pressure increased or decreased, the actuator would incrementally open or close the valve to maintain the pressure at the set point. In the event of a loss of actuating

Figure 5. Simplified depiction of vent piping and emergency pressure relief piping. (Credit CSB)

In case of high-pressure events, Reactor 6 was equipped with a rupture disc and pressure relief valve,^a installed in series, on the emergency pressure relief pipe. The rupture disc had a burst pressure of 75 psig at 355°F, and the pressure relief valve had a 75 psig set pressure. The emergency pressure relief pipe discharged to a 4,500-gallon catch tank before being routed through the scrubber and to the atmosphere.

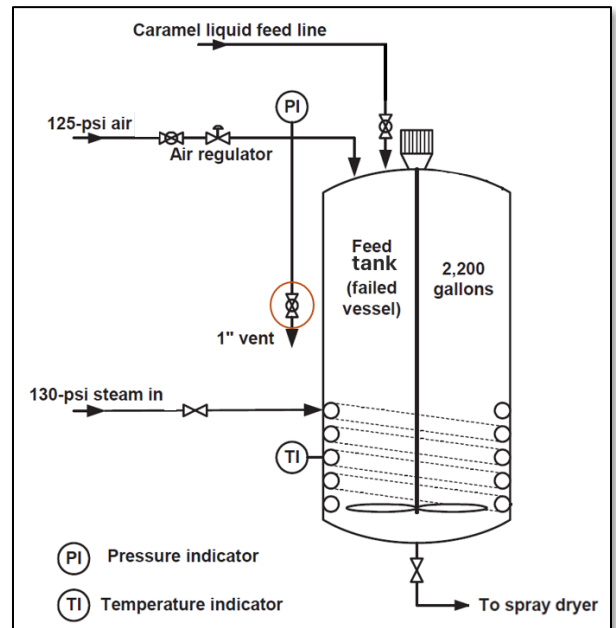
Leading to the incident, operators had been heating caramel coloring inside the vessel^a (**Figure 8**) to a target temperature of 160°F. The vessel was not equipped with a process control or alarm system, and operators monitored the vessel conditions using local temperature and pressure gauges. While heating the vessel, the operators were also conducting other work, and they did not notice when the vessel temperature rose above 160°F. The vessel, which had a MAWP of 40 pounds per square inch (psi), was not equipped with a pressure relief device.^b The air vent valve (**Figure 8**) was also likely closed while the vessel was being heated, blocking all relief capability. The pressure in the vessel increased as the caramel coloring overheated until the vessel overpressured and failed catastrophically (**Figure 9**).

Figure 8. Schematic of vessel involved in 2003 incident. The vessel was not equipped with a pressure relief device. It was equipped with a vent line (1" vent) that was most likely closed as the caramel liquid heated before the incident. (Credit: CSB)

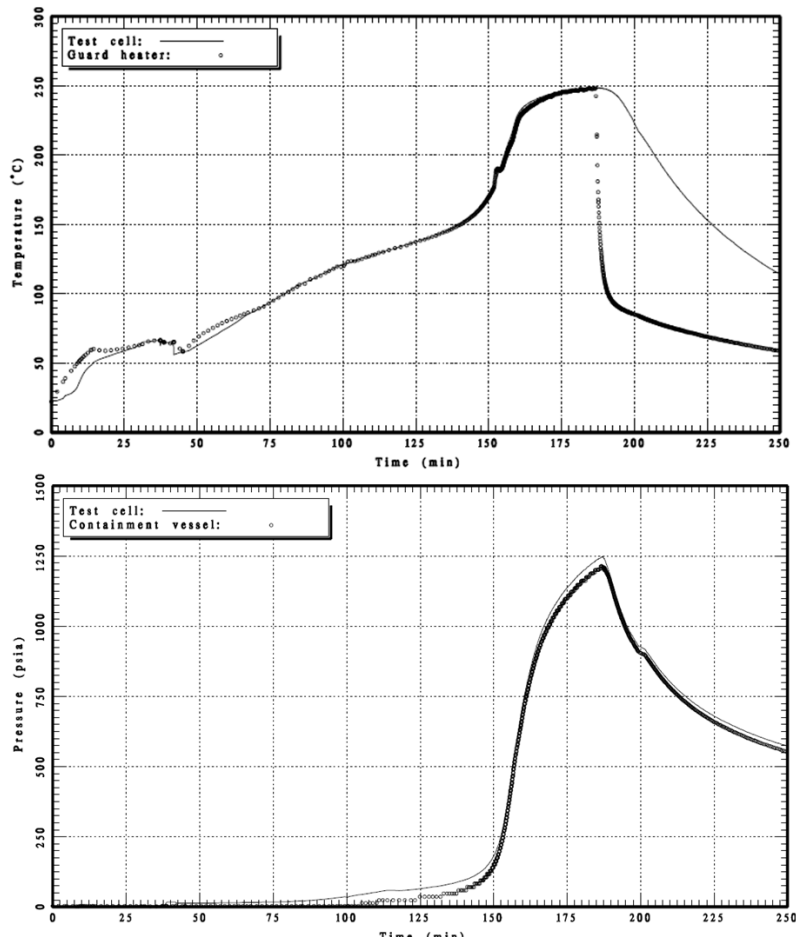
Figure 10 shows the 2012 testing results. When heated in an enclosed container, the Product 034 ingredients experienced a large temperature increase due to an exothermic chemical reaction (exotherm), as well as a significant pressure rise due to the formation of non-condensable gases. D.D. Williamson did not conduct further tests to determine which chemical components reacted (decomposed) to cause this pressure and temperature behavior. As will be described in *Section 3.1*, after the 2024 incident, the CSB conducted similar testing on both the Product 484 ingredients (2024 incident ingredients) and the sugar ingredient alone, and both tests exhibited similar behavior to that observed in the 2012 tests.

Figure 10. Results from D.D. Williamson's 2012 reactivity testing of Product 034 ingredients (corn syrup, phosphoric acid, water, ammonium bisulfite, and ammonia). (Credit: Givaudan)

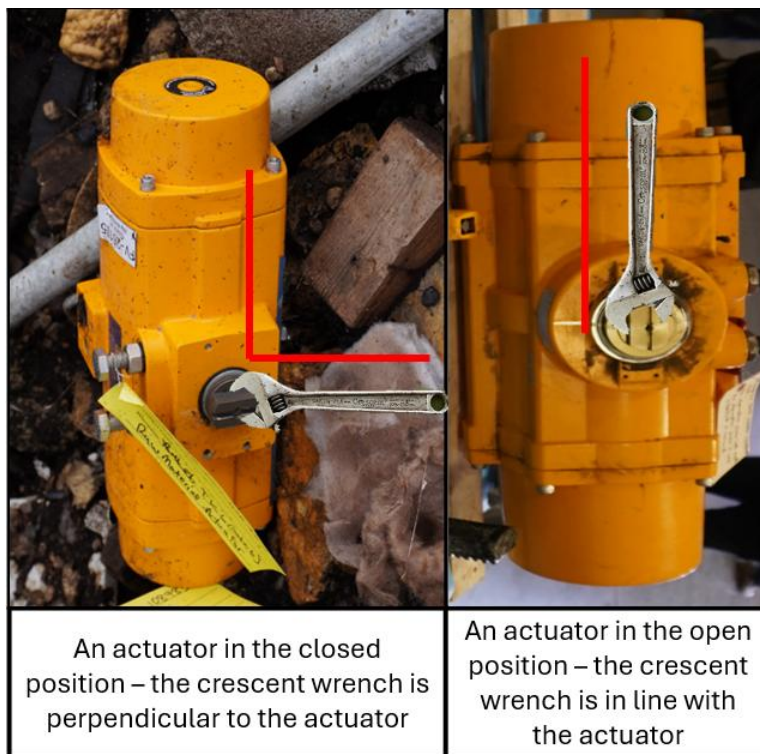
Figure 13. Left photo: example actuator in closed position; Right photo: example actuator in open position. (Wrench placed for illustration) (Credit: CSB)

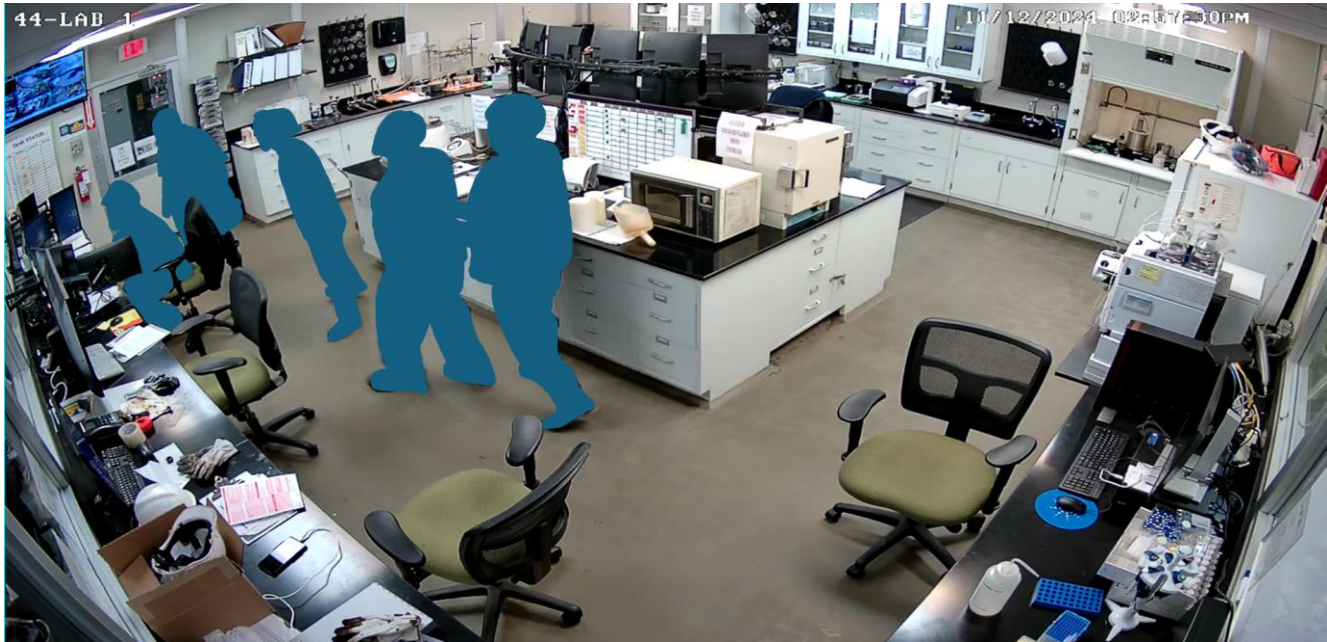
The Reactor 6 pressure and temperature continued to rise, and at 2:54 p.m., the high reactor pressure caused the Reactor 6 emergency pressure relief system to open, which temporarily reduced the Reactor 6 pressure before it again began to rise at a rapid rate (**Figure 11**).^a Operators and other personnel in the control room were monitoring the process data and were attempting to determine why Reactor 6 was experiencing such high temperatures and pressures, as they had not seen this type of temperature and pressure behavior before (**Figure 14**).

Figure 14. Location of personnel inside the control room at the time of the incident. Six employees were in the control room. (One employee, not visible in this photo, was located behind the raised computer monitors.) (Credit: Givaudan, redacted by CSB)

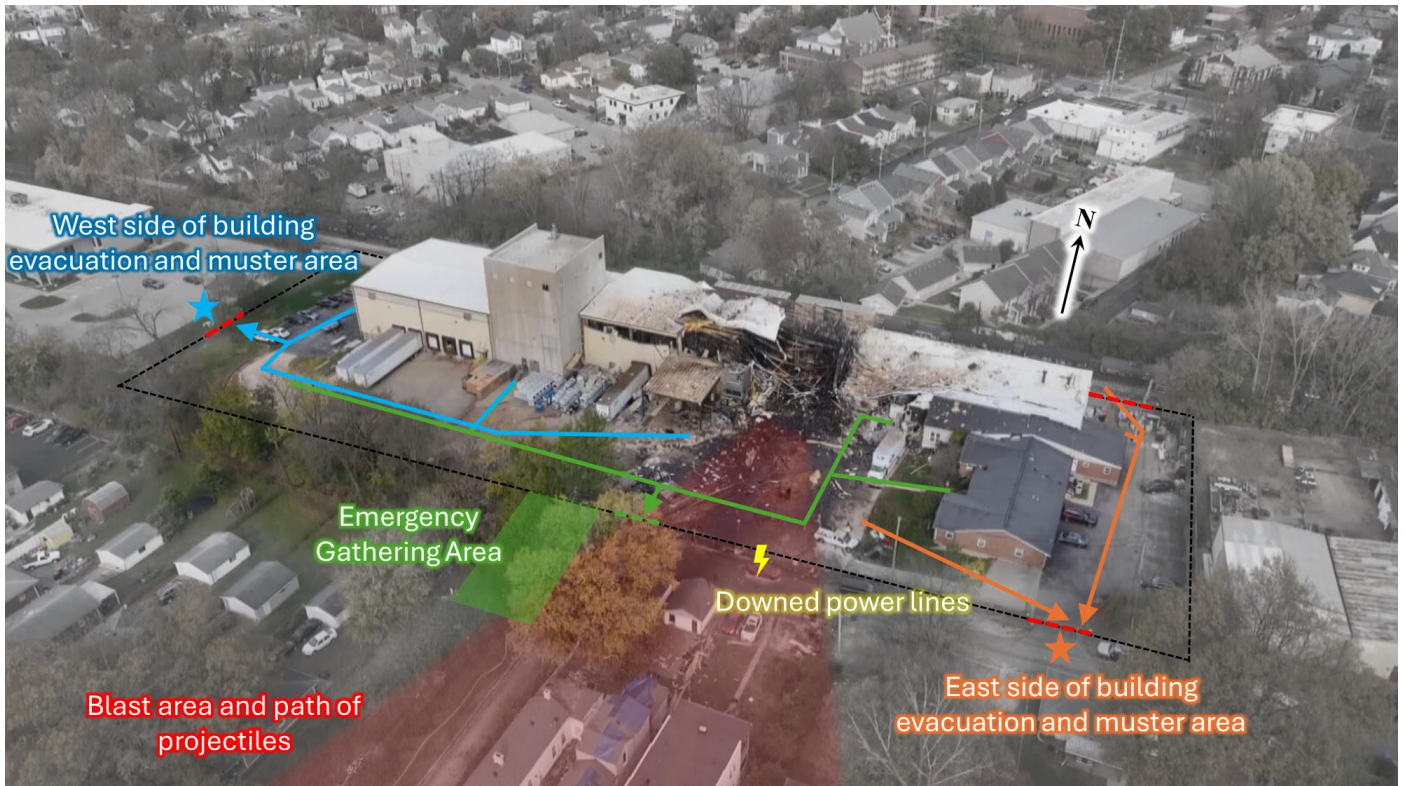
Debris and a downed power line (**Figure 17**) caused by the explosion prevented employees from evacuating to their planned emergency gathering location. Instead, employees who evacuated from the east side of the building remained together in a group to the east, and the employees who evacuated from the west side of the building remained together in a group to the west (**Figure 18**). The groups had no documentation with them detailing who had been inside the facility at the time of the incident, and they therefore relied on memory when conducting head counts to determine whether anyone was remaining in the building.

Figure 18. Depiction of the evacuation plan (green) versus the actual evacuation path taken by individuals at the facility (orange and blue). Personnel could not gather in emergency gathering area due to blast debris and a downed power line. (Credit: WAVE [13], annotated by CSB)

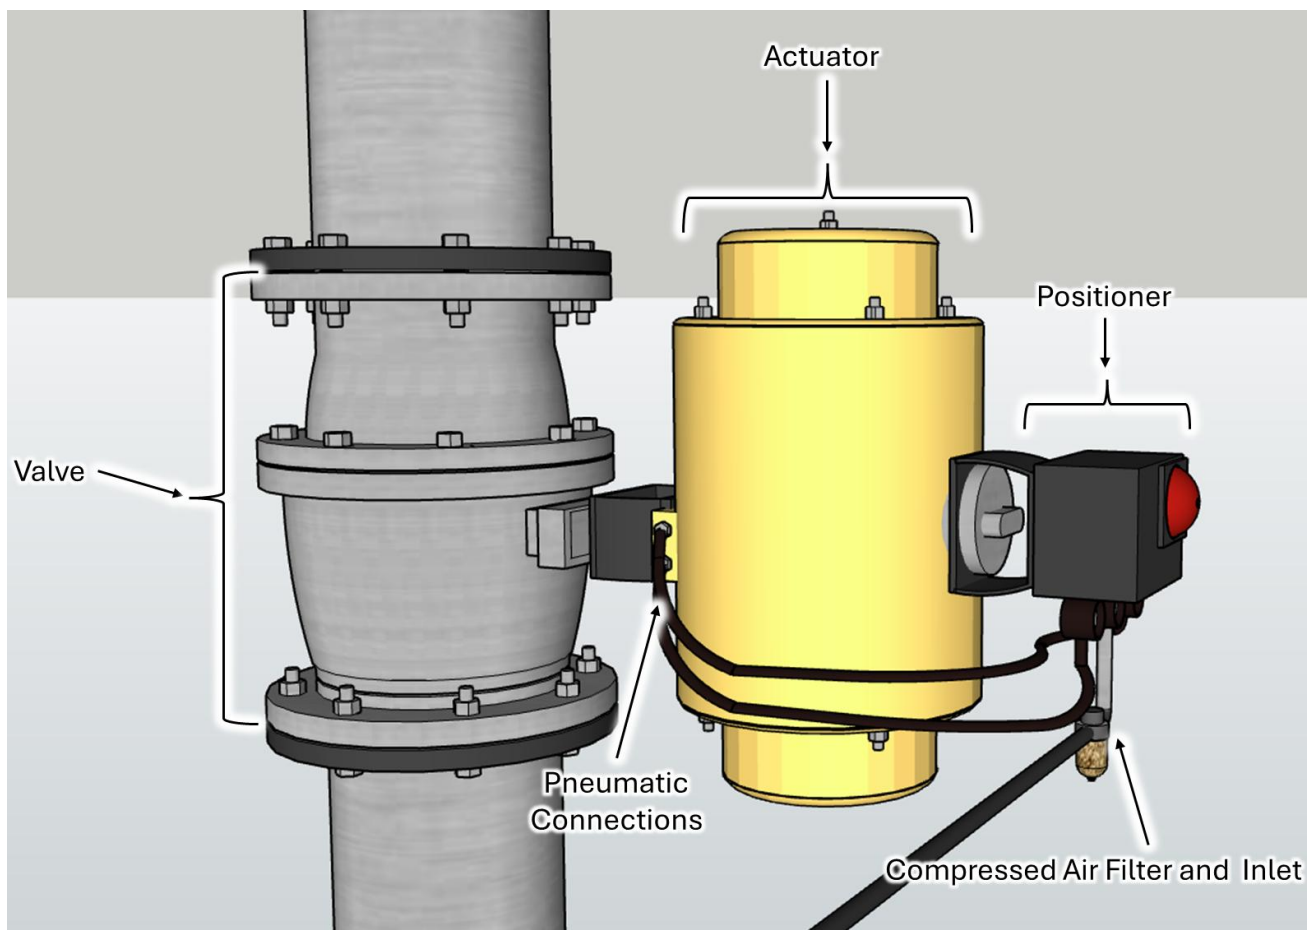
During normal operation, the evaporation and venting of water vapor through Reactor 6's 6-inch vent line aid in controlling the reactor temperature and, consequently, the reaction rate of the typical caramelization reaction described in Appendix D. As discussed in *Section 2*, it was determined that, from 2:39 p.m. until Reactor 6 exploded at 2:57 p.m. —a period of approximately 18 minutes— the vent valve was in the closed position despite being commanded by the PLC to be fully open. This vent valve closure prevented heat from being removed from Reactor 6 by the cooling effect of the evaporation and venting of water vapor.^a As a result, the temperature of Reactor 6 increased at a faster-than-typical rate, accelerating the caramelization reaction in an uncontrolled manner. The closure of the vent valve, therefore, was a key event that triggered the accelerated decomposition reaction that led to the incident.

Reactor 6's vent valve was a 6-inch ball valve (control valve) equipped with a pneumatic^b actuator. A positioner was installed on the actuator to control the actuator's position (**Figure 21**).

Figure 21. Depiction of the Reactor 6 vent valve, actuator, and positioner (Credit: CSB)

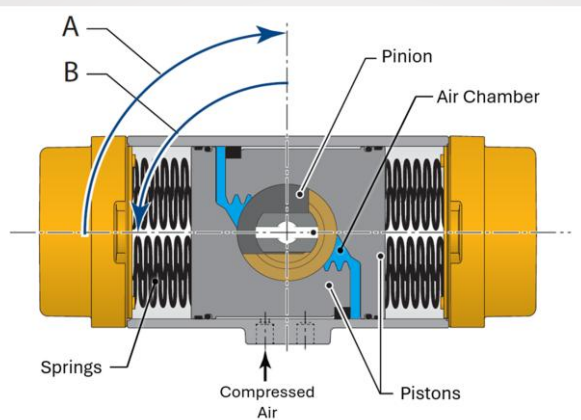
The pneumatic actuator installed on Reactor 6, which was configured to fail open, consists of the following parts within the actuator housing: a pinion, pistons, an air chamber, and springs. As illustrated in **Figure 25**, when air is added to the air chamber, the actuator pistons compress the internal springs and rotate the pinion in the “A” direction. As the air is released from the air chamber, the springs will return the pistons to the de-energized state and rotate the pinion in the “B” direction.

Figure 25. Internal view of a fail-open pneumatic actuator in the de-energized state (valve open) with parts labeled (Credit: Elomatic, annotated by CSB)

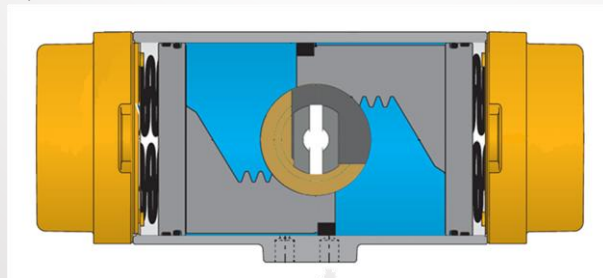
For an actuator configured to fail open, the “A” direction (air chamber is pressurized) closes the valve (**Figure 26**), and the “B” direction (air chamber is not pressurized) opens the valve (**Figure 25**).

Figure 26. Internal view of a fail-open pneumatic actuator in the energized state (valve closed). (Credit: Elomatic, modified by CSB)

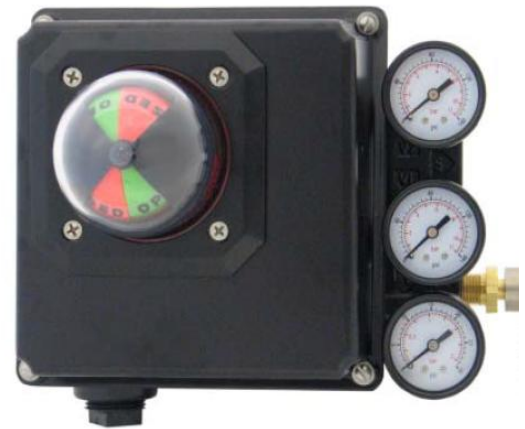
The positioner installed on the Reactor 6 vent valve actuator was not recovered after the incident. The positioner installed on the Reactor 5 vent valve actuator was also not recovered after the incident. As a result, the CSB was unable to test potential positioner scenarios that might have contributed to the Reactor 6 vent valve remaining closed when it was commanded to open, such as communication failures to/from the positioner or a mechanical failure that could prevent air from being released from the actuator chamber, thereby holding the valve in the closed position.

Figure 27. Example of a valve positioner.

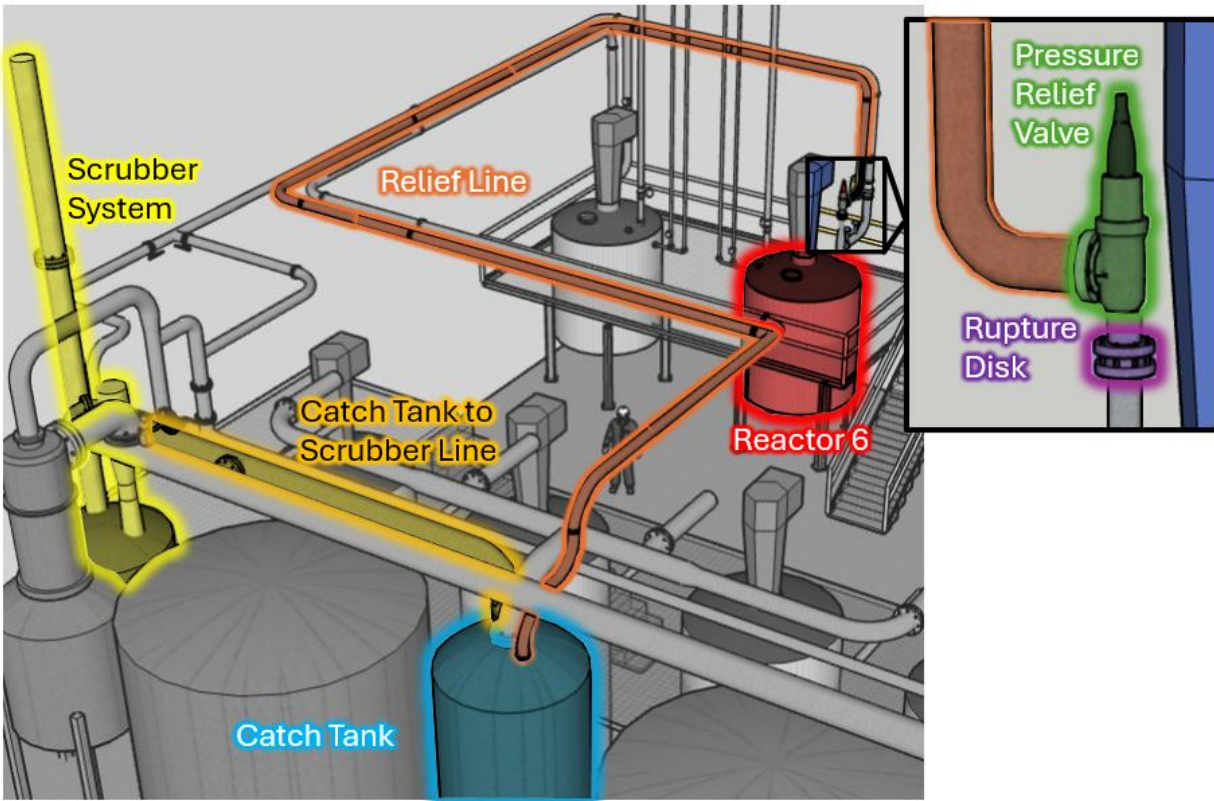
Figure 29. Reactor 6 emergency pressure relief equipment and piping (Credit: CSB)

The pressure relief system installed on Reactor 6 consisted of a rupture disc and a pressure relief valve installed in series. The rupture disc was a 4-inch disc (12.56 square inch area), constructed of 316 stainless steel with a burst rating of 75 psig at 355°F. The pressure relief valve, set to relieve pressure at 75 psig, had a 4-inch inlet and a 6-inch outlet, with a 4.186-square-inch orifice size (API designation 4M6).^c The pressure relief valve's outlet was connected to a 6-inch stainless steel pipe with an equivalent length^d of 184 feet. This relief piping was routed to a 4,500-gallon catch tank, which vented to the atmosphere through the plant scrubber system, as shown in **Figure 29**.

Recorded process data indicates that the rupture disc and pressure relief valve activated at 2:54 p.m., and the pressure inside Reactor 6 temporarily decreased before rising again. The pressure continued to rise until Reactor 6 ruptured with a final recorded pressure of 237 psig, more than three times the MAWP of 75 psig. Evidence indicates that the relief system (rupture disc and pressure relief valve) functioned as designed (see process data in **Figure 11** and the relief system component testing information in *Section 3.4.1* below). The relief system, however, was undersized for the sugar decomposition reaction that occurred on the day of the incident, as evidenced by the Reactor 6 rupture, and was unable to adequately relieve the gas and pressure generated.

The CSB concludes that the Reactor 6 emergency pressure relief system functioned as designed but was undersized for the accelerated sugar decomposition reaction that occurred on the day of the incident. As a result of the emergency pressure relief system's inadequate size, the gases and pressure generated by the accelerated decomposition reaction could not be adequately relieved from the reactor, and the reactor's internal pressure continued to rise from the formation and heating of the gases until Reactor 6 ruptured from the runaway reaction. To prevent the Reactor 6 rupture, the existing emergency pressure relief system (pressure relief valve with rupture disc) would have needed to be four times larger. Alternatively, calculations and modeling software show that a 4-inch rupture disc alone should have provided the necessary relief capacity to prevent the rupture of Reactor 6.

pressure relief valve. With a relief capacity over four times that of the 4M6 pressure relief valve installed on Reactor 6, a 6R10 pressure relief valve has a 6-inch-diameter inlet, a 10-inch-diameter outlet, and an 18.6-square-inch orifice. Installation of the larger pressure relief valve would also require a 6-inch rupture disc and increasing the relief line diameter from 6 inches to 10 inches.

The relief study determined that, alternatively, the 4M6 pressure relief valve could have been removed, and that the 4-inch rupture disc alone would have provided the necessary relief capacity to prevent the rupture of Reactor 6.

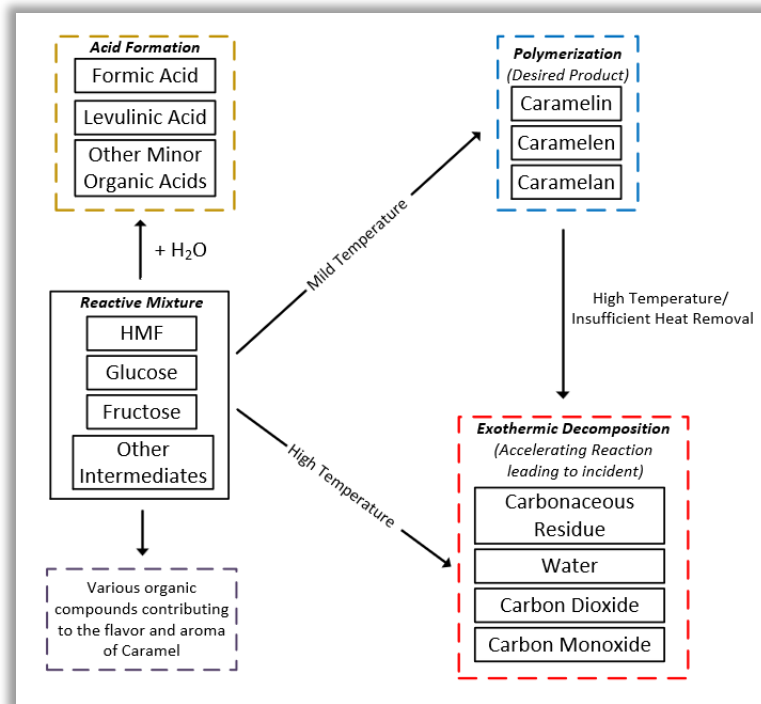
Figure 38. Simplified illustration of the possible reaction pathways.
(Credit: CSB)

Once HMF has been formed, several subsequent reactions can take place (**Figure 38**) depending upon the reaction conditions, such as temperature and pH. Each of these subsequent reactions is discussed below.
