DATE: JULY 22, 2025

INCIDENT REPORTS

EVENTS REPORTED TO THE CSB UNDER THE ACCIDENTAL RELEASE REPORTING RULE

U.S. Chemical Safety and
Hazard Investigation Board

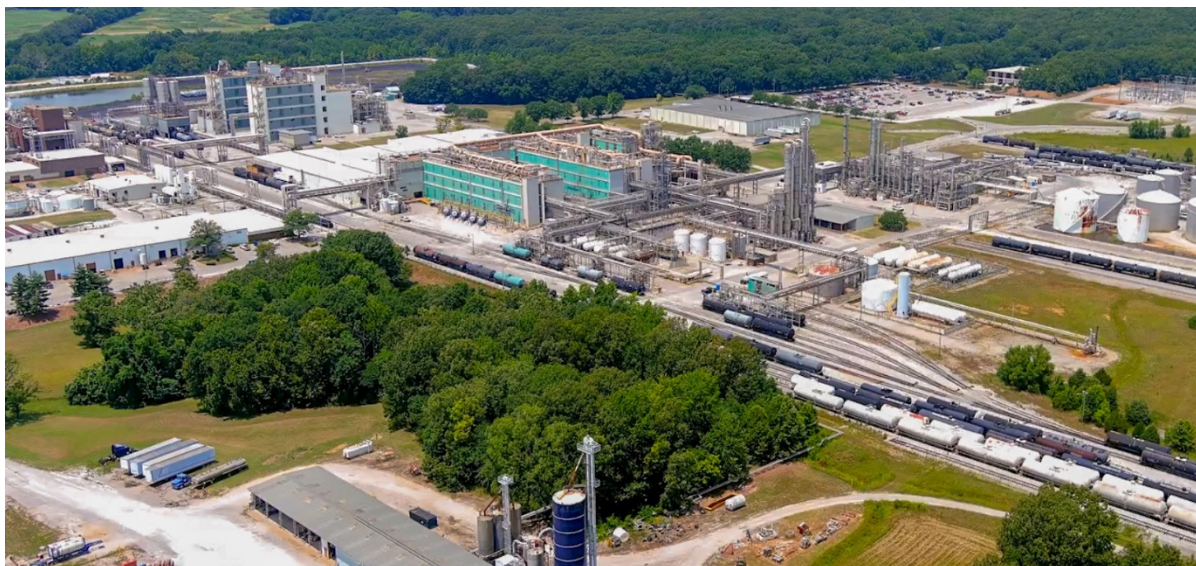
Figure 1. FutureFuel facility in Batesville, Arkansas. (Credit: FutureFuel)

At the time of the incident, an operator was transferring oleum from a railroad tank car to a production building vessel connected by a flexible polymer hose to permanent metal piping. The operator was on an unloading platform above the tank car and was wearing a hard hat, safety glasses, fire-resistant clothing, steel-toed boots, and gloves.

The operator opened a valve to begin the transfer. Immediately after opening the valve, the flexible hose ruptured (**Figure 2**), spraying the operator and the surroundings with liquid oleum. The operator's personal protective equipment (PPE) did not protect him from being sprayed with corrosive oleum. For example, the fire-resistant clothing fibers absorbed the acid, allowing it to contact his skin. The release blocked the operator's path to the tank car's ladder. The operator jumped from the tank car to the ground and ran to a nearby building, where emergency responders initially treated him. The operator was then transported by helicopter to a regional burn center, where he was admitted for treatment of chemical burns. There was no remotely operated isolation valve capable of stopping the release, and the oleum continued to release from the hose for 73 minutes. At 8:35 a.m., FutureFuel emergency responders manually closed the valve, stopping the release.

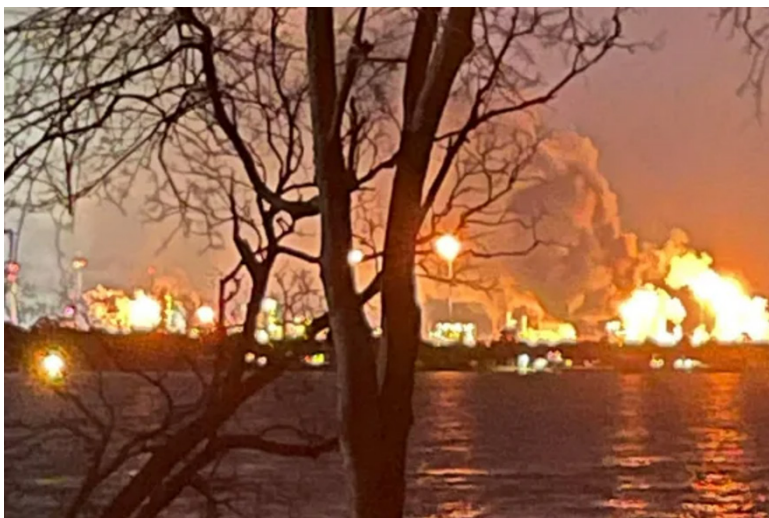
On December 23, 2021, at approximately 12:51 a.m., an explosion occurred at the ExxonMobil refinery in Baytown, Texas, when piping catastrophically ruptured, releasing hot flammable naphtha vapor that ignited (autoignition), creating a large fire within a hydrodesulfurization unit at the refinery (**Figure 1**). The incident seriously injured four contractors and caused approximately \$107 million in property damage.

Figure 1. Fire and flaring at the ExxonMobil refinery. (Credit: Michael Ryleigh Felts)

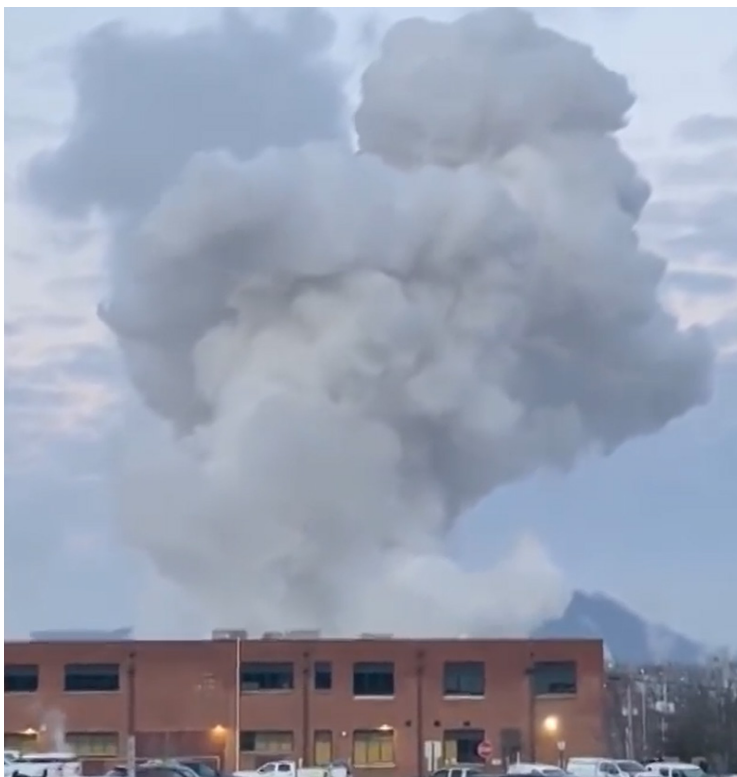
Figure 1. Steam Release at Eastman. (Credit: WJHL)

On the day of the incident, an elbow in a section of carbon steel piping that contained steam at 600 psig and 750°F ruptured. The elbow was forcefully ejected, releasing steam from both ends of the pipe. The incident caused extensive damage to the surrounding equipment (**Figure 2**). The area of the facility where the incident occurred was shut down from the loss of steam, and other areas were impacted by the loss of other utility systems, including electrical power, river water, plant air, and instrument air. Additionally, because the steam piping was insulated with asbestos, asbestos fibers were released into the neighboring community as a result of the explosion.

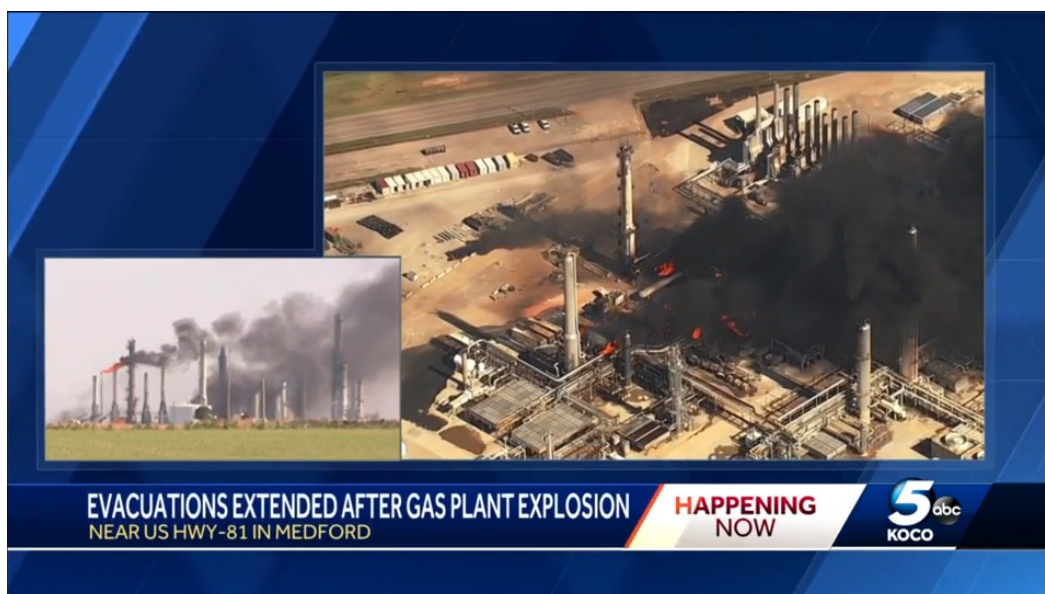
On July 9, 2022, at approximately 2:13 p.m., approximately 450 barrels of an ethane and propane mixture were released at the ONEOK Hydrocarbon, L.P. (“ONEOK”) facility in Medford, Oklahoma. The flammable liquid vaporized, forming a vapor cloud that soon ignited. The explosion damaged equipment, released other materials, and caused fires. The incident caused approximately \$930 million in property damage (**Figure 1**).

Figure 1. News images of the fire. (Credit: KOCO)

ONEOK’s investigation found that the ethane and propane mixture was released from a ruptured section of 12-inch carbon steel piping. This piping was part of the overhead condenser and reflux drum equipment for a distillation column. The failure occurred at the bottom of the piping, specifically at an elbow where the pipe turned vertically upward toward the reflux drum (**Figure 2**).

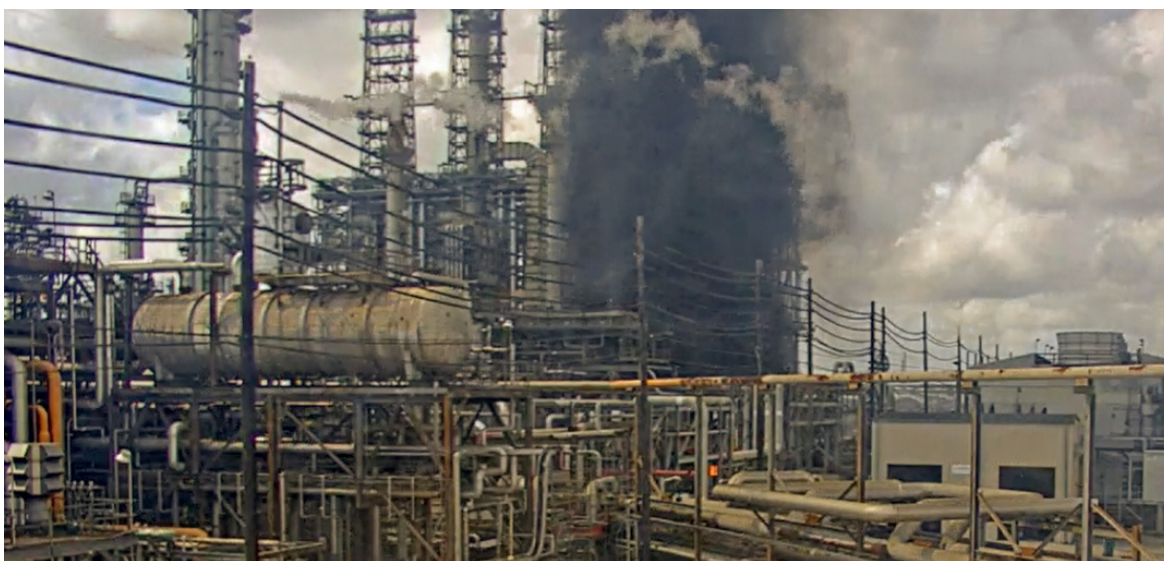
On April 19, 2023, at approximately 11:00 a.m., a hose ruptured at the Valero Port Arthur Refinery (“Valero”) in Port Arthur, Texas (**Figure 1**), releasing a flammable mixture containing hydrogen and hydrocarbons that ignited, resulting in a large fire at the refinery. The Premcor Refining Group Inc., a subsidiary of Valero, owns the facility. Valero estimated that the incident resulted in \$2.3 million in property damage.

Figure 1. Fire at the Valero refinery in Port Arthur, Texas (Credit: Valero)

Based on Valero's investigation, the CSB determined that the probable cause of the incident was the overpressure of a temporary hose. Contributing to the incident was not recognizing the potential to overpressure the hose, resulting from misunderstandings during the management of change process and an ineffective pre-startup safety review. An effective hazard analysis or pre-startup evaluation would have identified the need for equipment with an increased pressure rating, which could have prevented this incident.

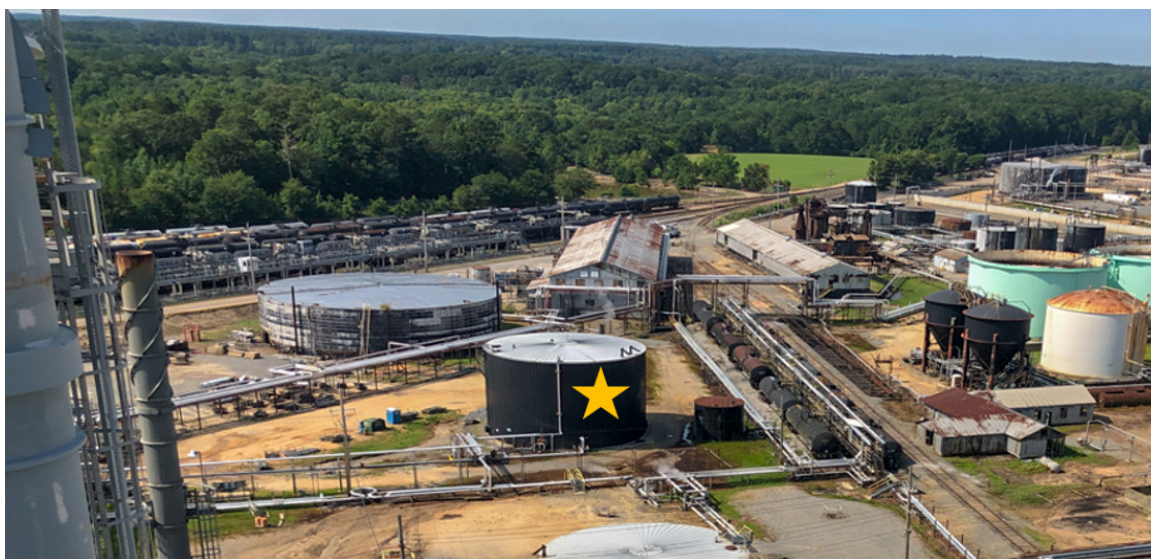
On May 8, 2023, at 6:01 p.m., an 850,000-gallon storage tank exploded, and a large fire erupted at the Delek US Holdings Inc.'s ("Delek") Lion Oil refinery in El Dorado, Arkansas (**Figure 1**). Delek Logistics, a subsidiary of Delek, owned this storage tank. Delek estimated that the property damage from the incident was \$1.27 million.

Figure 1. The 850,000-gallon storage tank (yellow star) at the Delek refinery in El Dorado, Arkansas. (Credit: Delek, modified by CSB)

Based on Delek's investigation, the CSB determined that the probable cause of the incident was splash filling—allowing the hydrocarbon liquid to free fall about 30 feet from the top of the tank to the surface of the liquid. As a result of splash filling, a flammable aerosol likely formed, which was ignited when lightning struck the tank. The incident could have been prevented by filling the tank from the bottom to prevent the presence of a flammable atmosphere inside the tank.

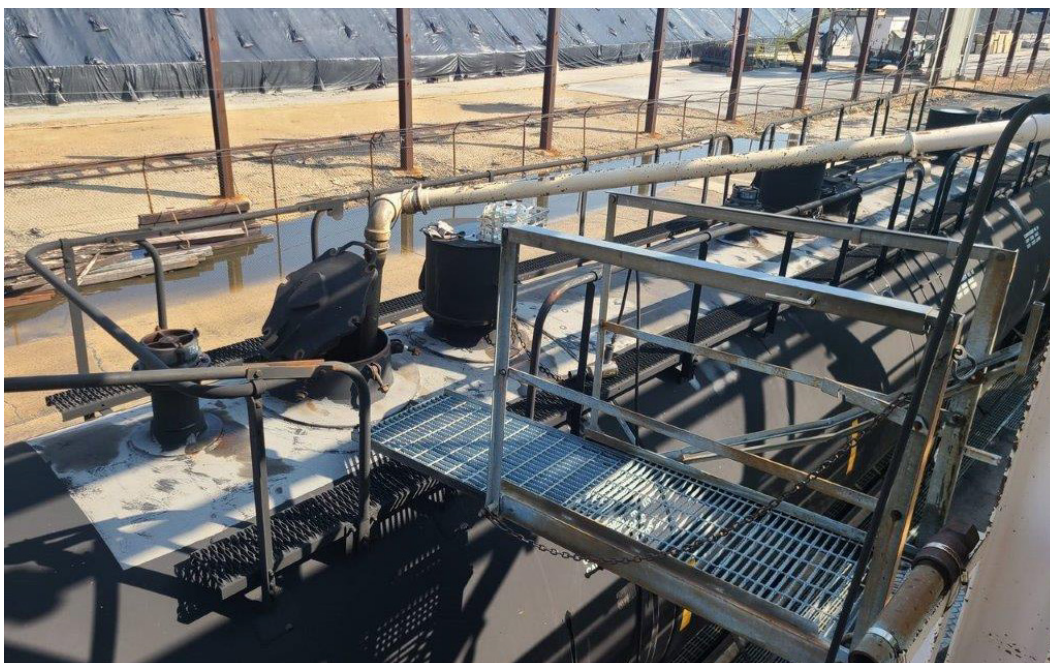
On the day of the incident, an employee was loading an open railcar compartment with mineral spirits, a mixture of C9-C15 hydrocarbons (**Figure 1**). Before beginning the loading operation, the employee inspected the compartment and saw some residual liquid at the bottom. The compartment previously held heptane. The employee drained the heptane (estimated to be about a pint) before transferring the mineral spirits into the railcar.

Figure 1. Loading arm and railcar hatch opening. (Credit: CITGO)

CITGO’s investigation confirmed that loading mineral spirits into the compartment that previously held heptane was switch loading. Static discharge likely ignited the fire as the sample device approached the liquid surface. The company had not previously identified the risks of switch loading and sampling. CITGO also found that its training program did not reliably ensure workers knew of the fire and static electricity hazards associated with sampling.

Based on CITGO’s investigation, the CSB determined that the probable cause of the incident was switch loading —loading a low vapor pressure material (mineral spirits) into a railcar compartment that contained a high vapor pressure material (heptane). A static discharge likely ignited the flammable vapor in the compartment as a metal sampling device was lowered to the liquid surface. The incident could have been prevented by prohibiting switch loading, and cleaning and purging the compartment to avoid this scenario.

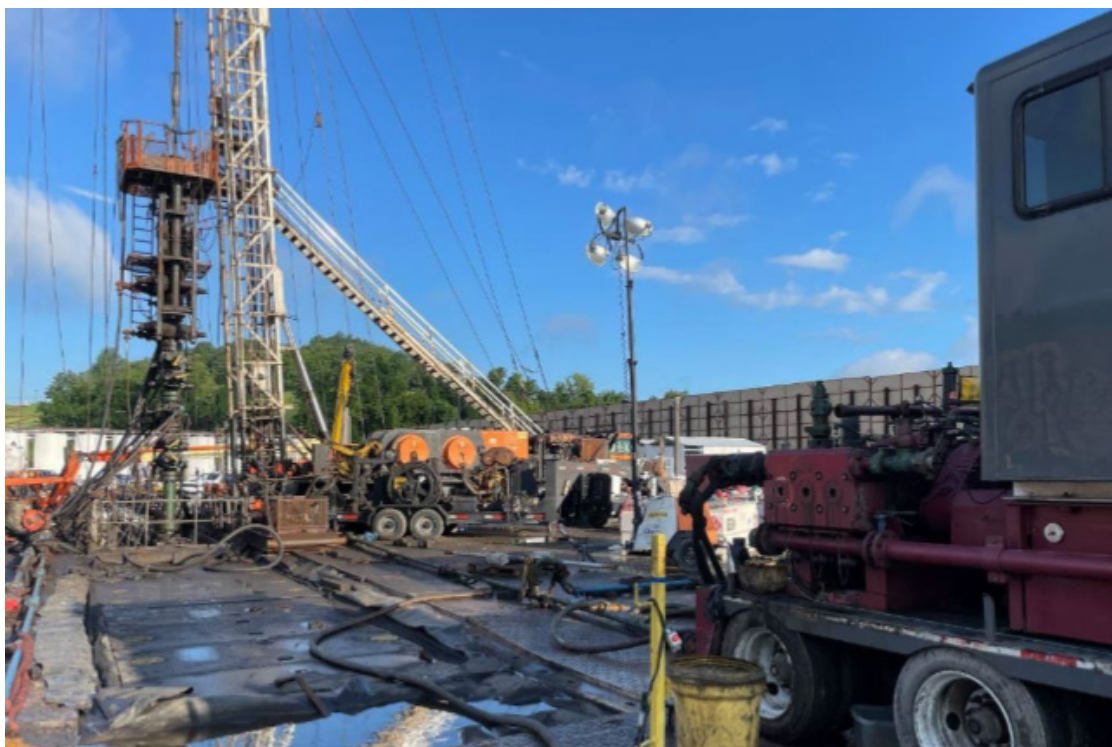
On August 23, 2023, at approximately 10:50 p.m., a fire seriously injured two people at the Southwestern Energy oil and gas well site (**Figure 1**) in Ohio County, West Virginia.

Figure 1. The Southwestern Energy site in West Virginia. (Credit: Southwestern Energy)

Based on Southwestern Energy's investigation, the CSB determined that the probable cause of the incident was the uncontrolled release of natural gas during a drill-out operation. An operating electric generator ignited the flammable vapor. The lack of a fixed flammable gas detection and warning system contributed to the severity of the incident. An effective flammable gas detection and warning system could have alerted the workers to stop circulating the well and evacuate the area.

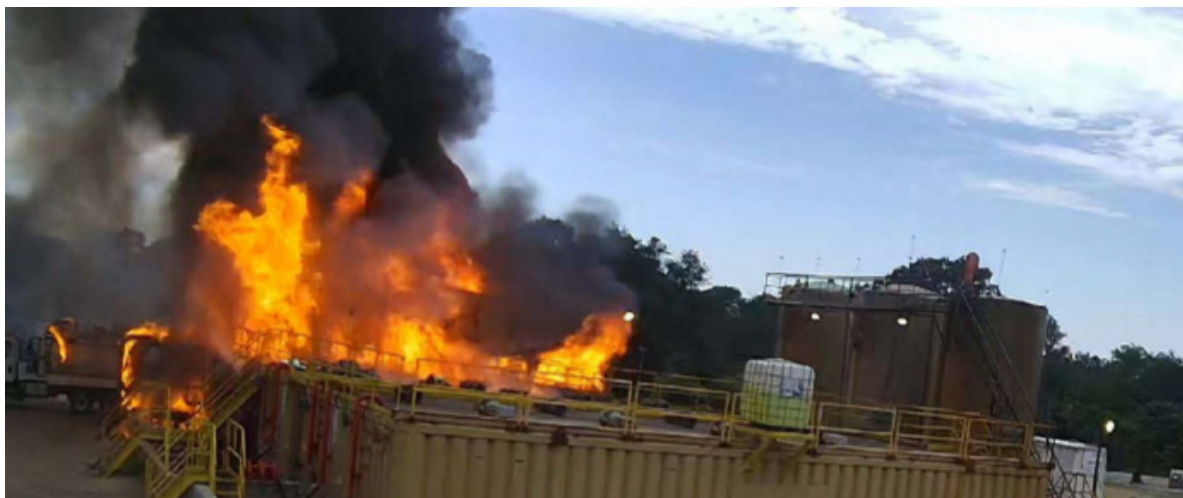
On May 17, 2024, an explosion and fire occurred at the Advantek Eagleford LLC (“Advantek”) oil and gas waste disposal facility in Westhoff, Texas (**Figure 1**). The explosion and fire fatally injured one Advantek employee and caused an estimated \$6.94 million in property damage.

Figure 1. The fire at the Advantek facility in Westhoff, Texas (Credit: Advantek)

Based on Advantek's investigation, the CSB determined that the probable cause of the incident was unloading a truck of flammable hydrocarbons onto equipment designed to process non-flammable drilling fluids. When the hydrocarbon was processed through the shakers, flammable vapor was released into the air and ignited by a running truck engine.

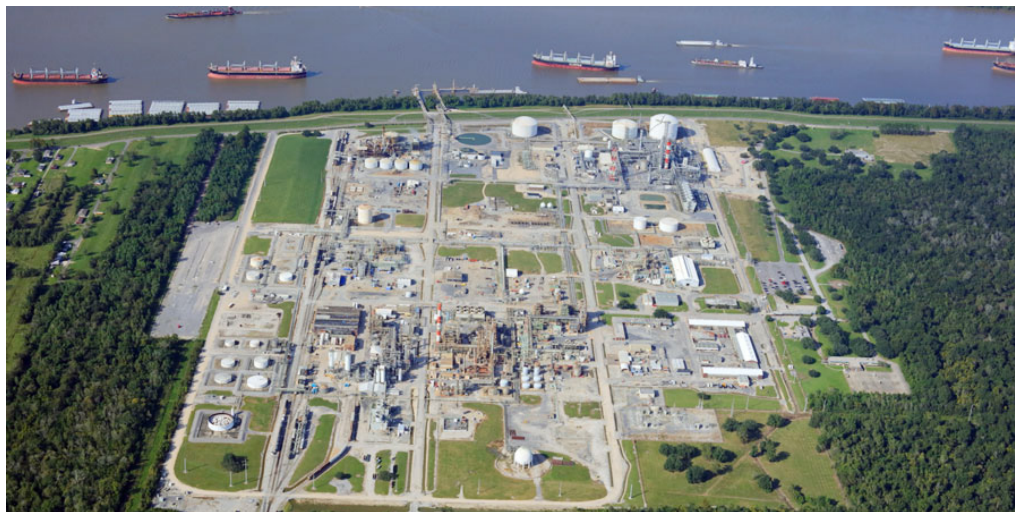
On June 11, 2024, at about 6:30 a.m., a storage tank exploded, releasing approximately 5,300 pounds of hot urea at the Cornerstone Chemical Company (“Cornerstone”) facility in Waggaman, Louisiana (**Figure 1**). The explosion and urea release seriously injured one Cornerstone employee and caused approximately \$2.5 million in property damage.

Figure 1. The Cornerstone Chemical Company facility (Credit: Cornerstone)

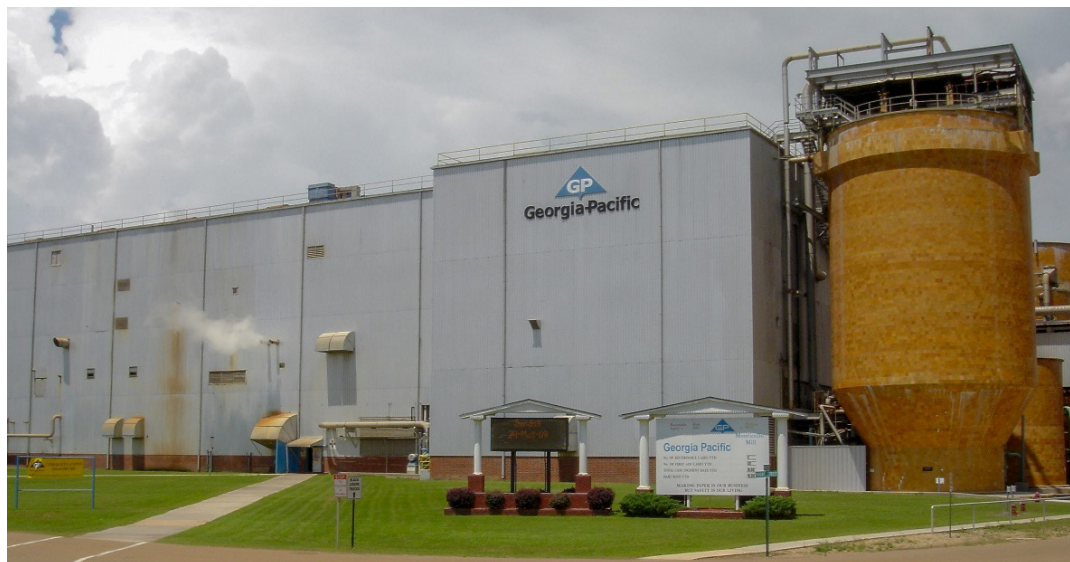
On January 16, 2025, at approximately 5:00 p.m., an employee was seriously injured after being sprayed with very hot water at the Georgia Pacific Monticello, LLC (“Georgia Pacific”) paper mill in Monticello, Mississippi (**Figure 1**).

Figure 1. The Georgia Pacific facility in Monticello, Mississippi. (Credit: DieselDucy)
