VOLUME: 4

INCIDENT REPORTS

EVENTS REPORTED TO THE CSB UNDER THE ACCIDENTAL RELEASE REPORTING RULE

U.S. Chemical Safety and Hazard Investigation Board

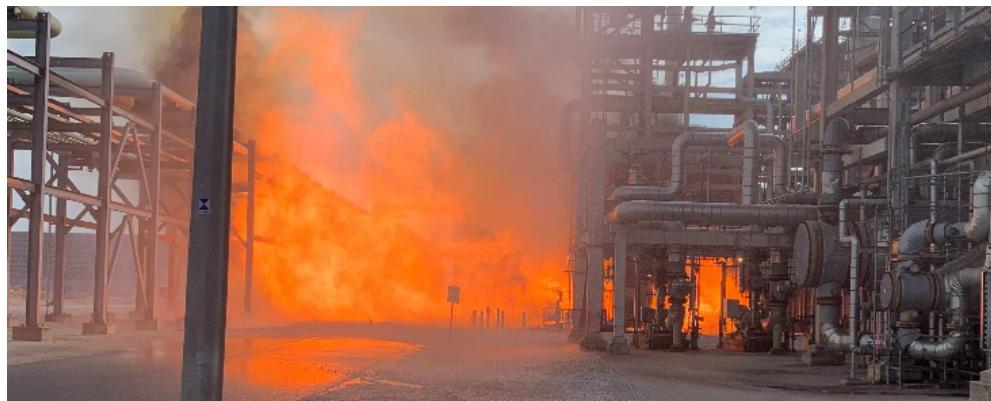
On February 21, 2022, at 9:22 a.m., a large jet fire occurred at the Marathon Petroleum Company LP (“Marathon”) Refinery in Garyville, Louisiana, after a vacuum ejector ruptured within a hydrocracker unit at the refinery (Figure 1). Marathon estimated that the fire caused approximately \$54 million in property damage.

Figure 1. Fire at the Marathon Refinery in Garyville, Louisiana. (Credit: Marathon)

After the operators completed the air removal step, the hydrogen and hydrocarbon flows were initiated, which increased the pressure inside the unit's equipment. At 9:22 a.m., the vacuum ejector ruptured, releasing a flammable gas mixture mainly composed of methane and hydrogen that ignited, resulting in a large fire. Emergency responders closed Valve A (**Figure 2**) to stop the release of flammable gas and successfully extinguished the fire at 12:27 p.m., roughly three hours after it began. Marathon estimated that approximately 7,000 pounds of flammable gas were released.

Marathon's investigation determined that after the air removal step was completed, an operator closed Valve C, but Valve A remained open. During the startup, this valve alignment allowed process gas to enter and pressurize the vacuum ejector to approximately 1,465 pounds per square inch (psi). The pressure ruptured the vacuum ejector, which had a design pressure of 360 psi. Marathon concluded that the flammable gas was ignited by a spark created when the vacuum ejector ruptured or from static electricity.

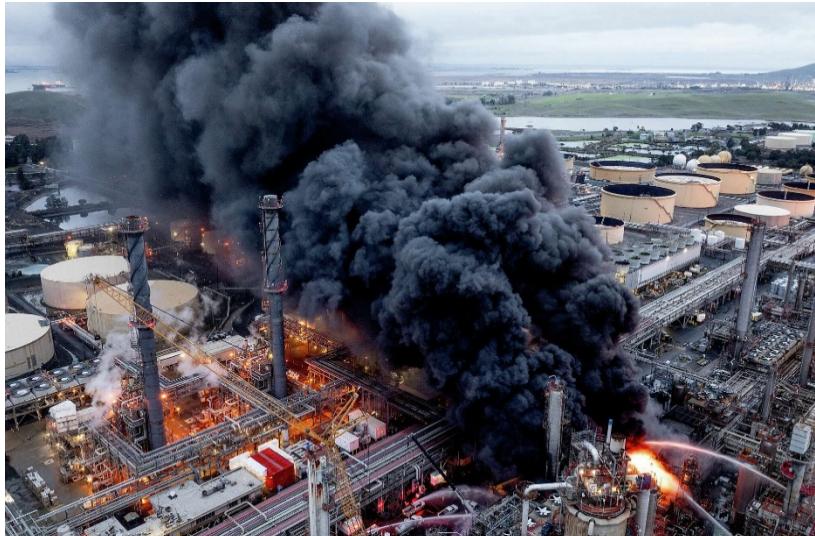
On February 1, 2025, around 1:36 p.m., an explosion and fire occurred at the Martinez Refining Company refinery in Martinez, California (**Figure 1**), a subsidiary of PBF Holding Company LLC (“PBF Energy”). PBF Energy estimated that the incident caused approximately \$924 million in property damage.

Figure 1. Fire at the Martinez Refining Company refinery in Martinez, California. (Credit: San Francisco Chronicle)

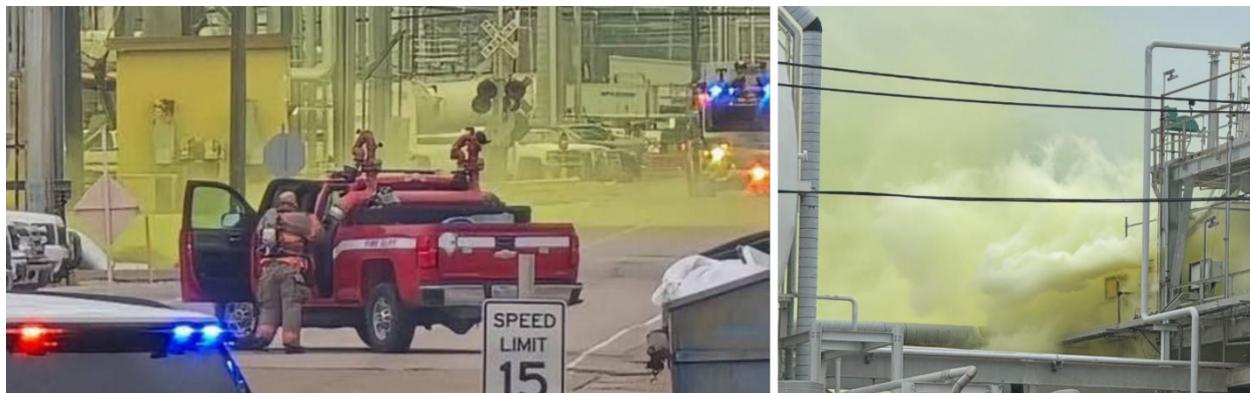
On May 20, 2025, at approximately 8:15 a.m., approximately 8,000 pounds of toxic chlorine were released, seriously injuring one employee at the Olin Corporation (“Olin”) facility in Freeport, Texas (Figure 1), operated by Blue Cube LLC, an Olin subsidiary. The community was ordered to shelter in place, and Olin estimated that the incident resulted in approximately \$23 million in property damage.

Figure 1. Images of the Chlorine release at the Olin facility in Freeport, Texas. (Credit: KHOU)
