## Investigation Update

August 2026

This document provides an update on the CSB's investigation of the May 26, 2026, incident at the Nippon Dynawave Packaging Company, LLC ("NDP") Pulp and Paper Mill in Longview, Washington.

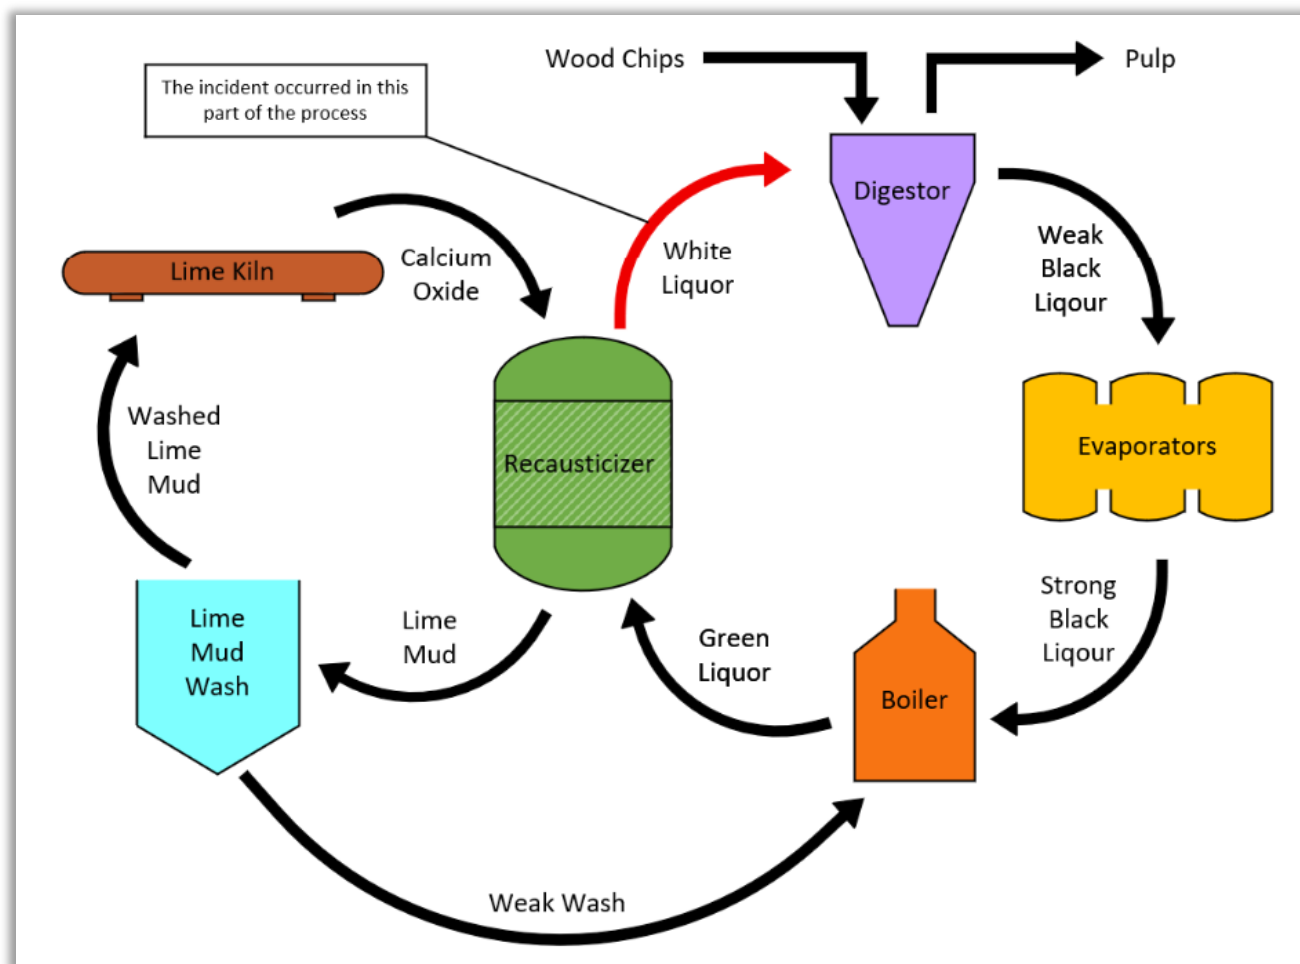
**Figure 1.** A simplified flow diagram of the Kraft process for producing pulp. (Credit: CSB)

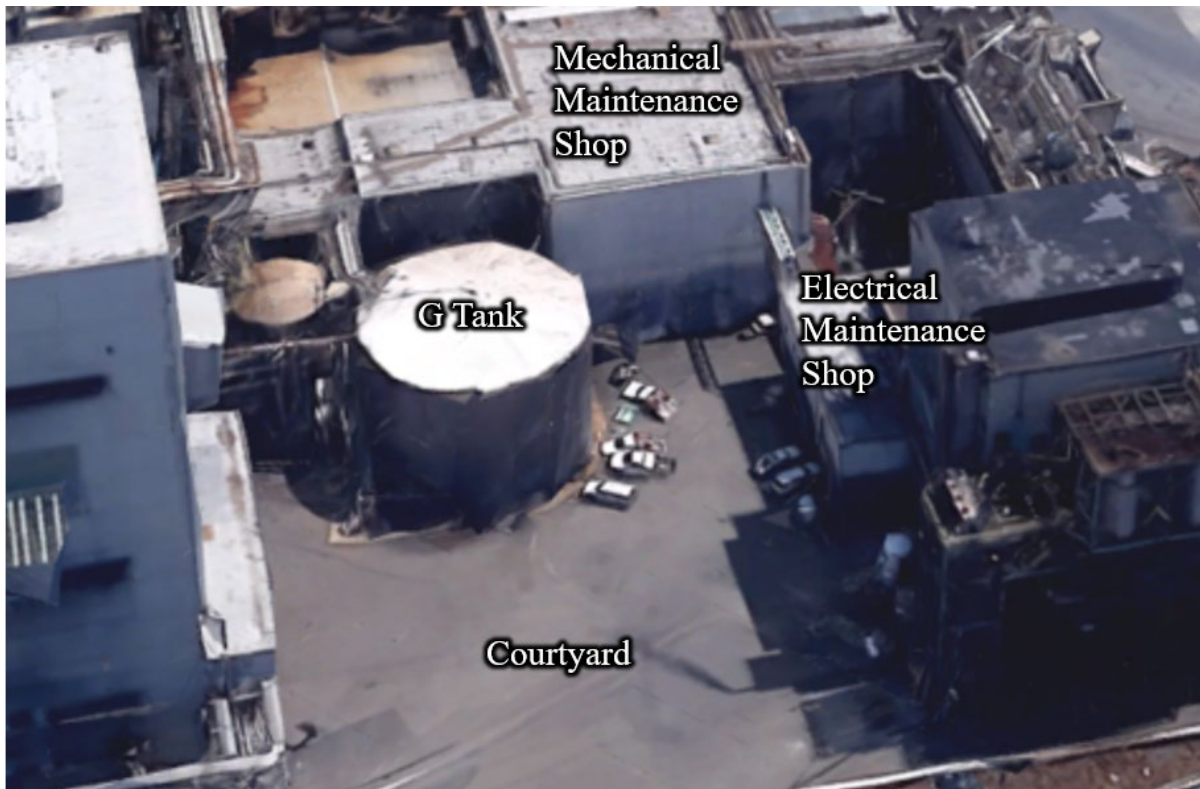
worked on the tank when it was first installed, told the CSB that Weyerhaeuser placed the tank in the courtyard because “that was the available area.”

**Figure 3.** A pre-incident satellite image of the courtyard where G tank was built. (Credit: Google Earth, annotated by CSB)
