U.S. Chemical Safety and
Hazard Investigation Board

Fatal Hydrogen Sulfide Release at PEMEX Deer Park Refinery

Deer Park, Texas | Incident Date: October 10, 2024 | No. 2024-05-I-TX

Investigation Report

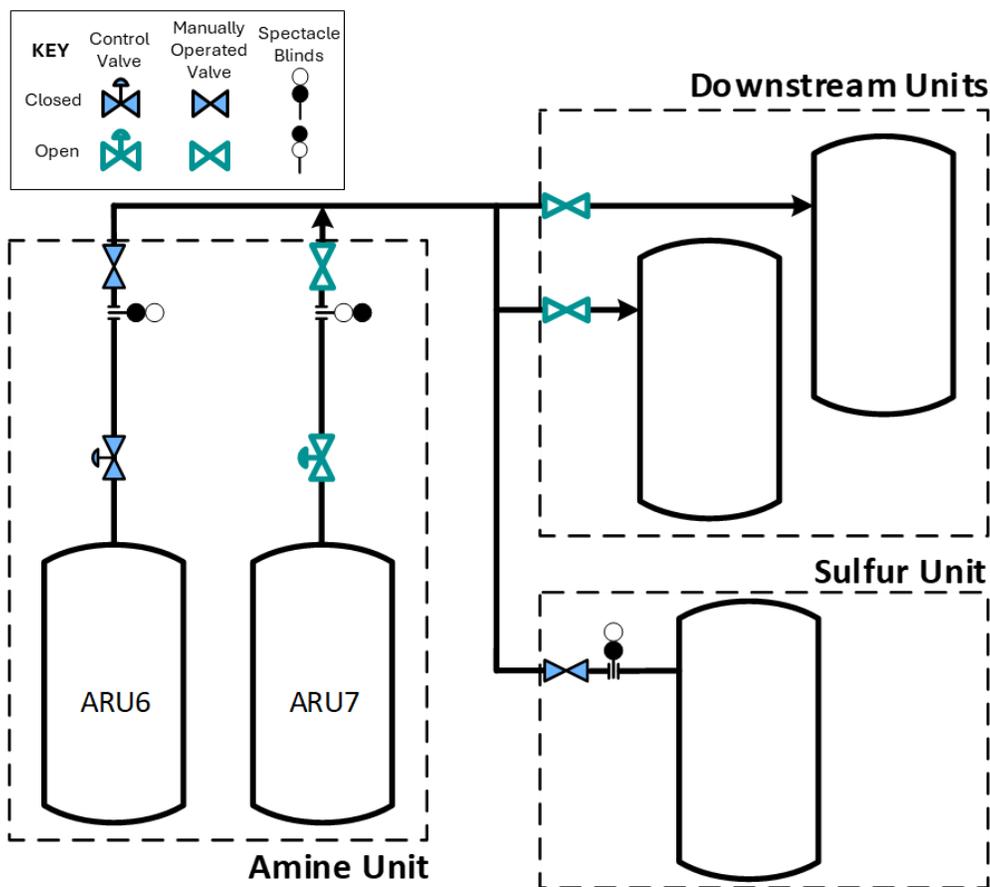
Figure 2. Acid gas process flow from the Amine Unit to the Sulfur Unit and other downstream processes, with valve configuration at the time of the incident. Valves next to the dotted lines represent process battery limits.^c (Credit: CSB)

The incident occurred in the PEMEX Deer Park Refinery's Amine Regeneration Unit ("Amine Unit"), which separates hydrogen sulfide from aqueous amine. The resulting vapor, known as acid gas, is a mixture comprising approximately 90 percent hydrogen sulfide and 10 percent carbon dioxide. The acid gas is transferred through process piping to downstream units and the Sulfur Recovery Unit ("Sulfur Unit") to convert the hydrogen sulfide into sulfur, as shown in **Figure 2**. Each refinery unit has a defined perimeter (battery limit) with manual isolation valves at the perimeter capable of isolating the unit from the rest of the refinery process (**Figure 2**).

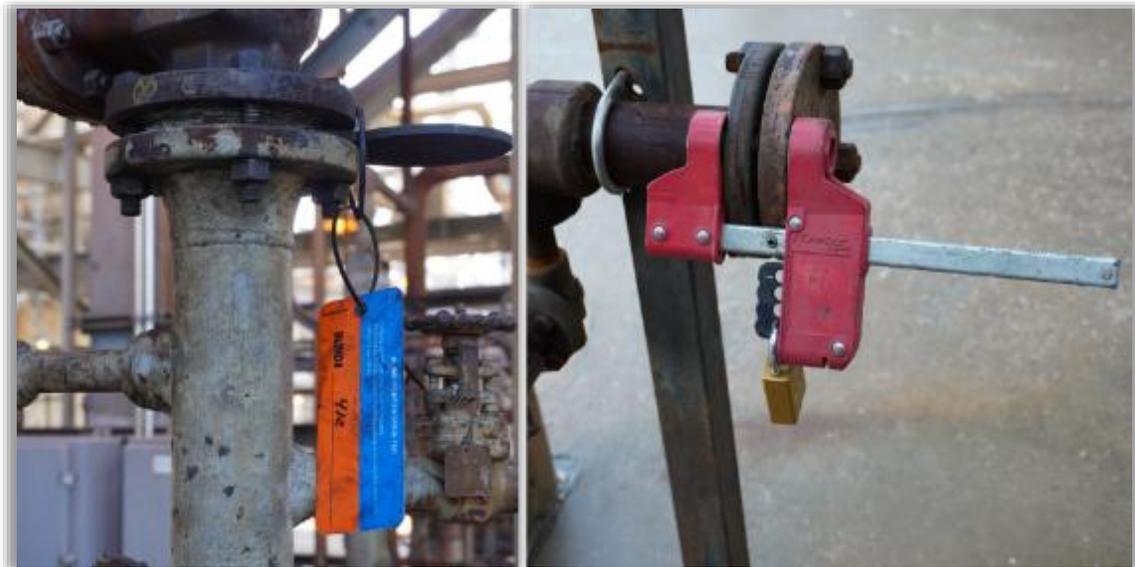
Figure 7. Blind tag (left) and flange-locking device (right). (Credit: CSB)

After the boilermakers finished installing a blind, they typically placed an unlocked flange-locking device (Figure 7) on each flange, which was the required practice in the Sulfur Unit turnaround, where they had been working in the days prior. The boilermakers consequently placed unlocked flange-locking devices on the ARU6 equipment. PEMEX Deer Park's procedures did not require the use of flange-locking devices for the ARU6 blind installation activities, however. The Repcon night shift foreman stated to the U.S. Chemical Safety and Hazard Investigation Board (CSB) that they did not witness PEMEX Deer Park operators lock the flange-locking devices after they were placed on ARU6 equipment. The PEMEX Deer Park operator also stated to the CSB that he was not aware that the flange-locking devices had been placed on ARU6 equipment because they were not normally used outside of turnaround activities.

Over the next several hours, the four Repcon boilermakers worked in two pairs, opening flanges and removing blinds from the ARU6 piping. The boilermakers told the CSB that they looked for either the orange-and-blue blind tags or unlocked red flange-locking devices to locate the 15 blinds (**Figure 7**), rather than referencing the blind list or drawing. As will be described in Section 3.1.1, the blind list and drawing did not clearly indicate where each flange to be opened was located.

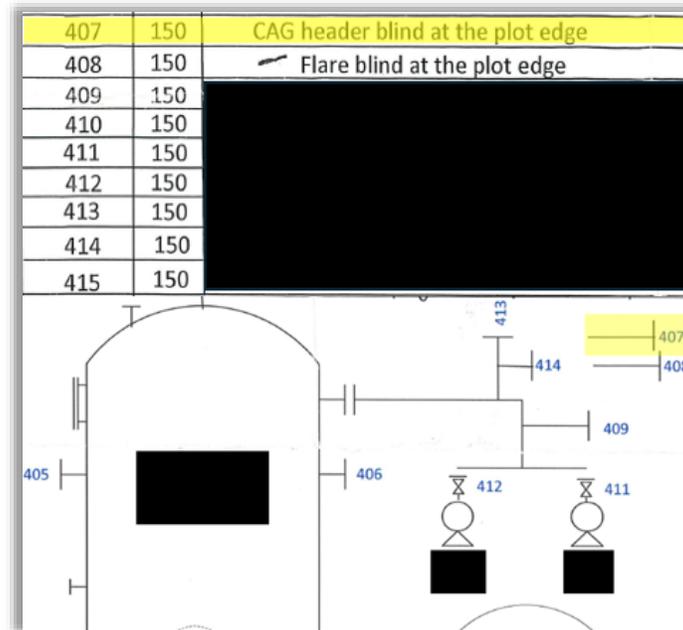
Figure 13. ARU6 blind list and drawing with Blind 407 highlighted. (Credit: PEMEX Deer Park, modified by CSB)

As highlighted in yellow in **Figure 13**, the location of Blind 407 is shown to be on piping not connected to any other portion of the process, rendering it ineffective for identification. Further, the sketch inaccurately depicts Blind 407 as adjacent to Blind 408. This arrangement implies that these two blinds could be spatially adjacent, similar to the parallel and adjacent ARU6 and ARU7 piping segments (**Figure 9**). However, Blind 408 was actually located several yards away on a different piping segment, accessed by a different platform.

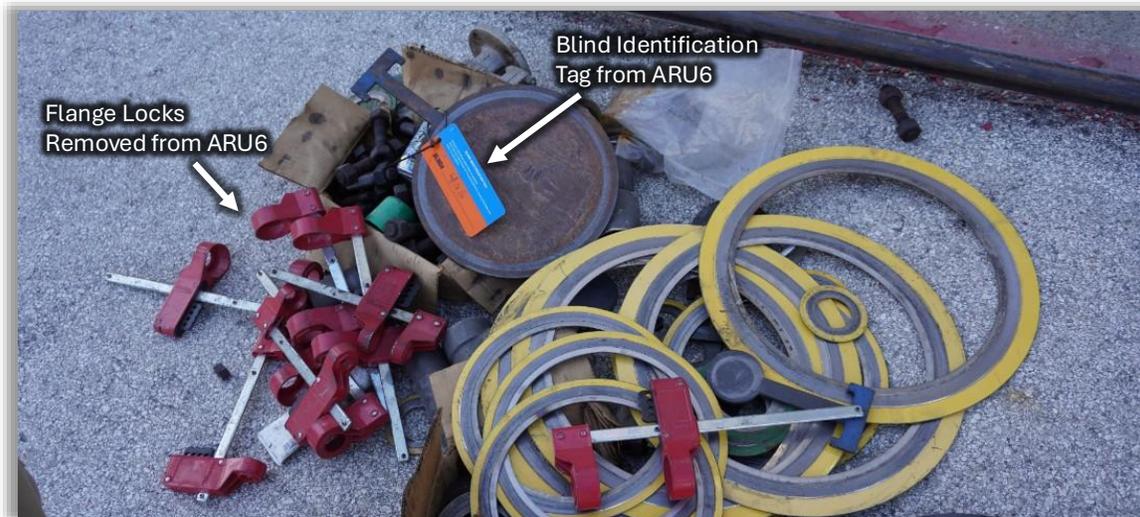
Figure 15. Flange-locking devices and blind tag from the ARU6 maintenance activity. (Credit CSB)

Flange-locking devices (**Figure 14**) were commonly placed on flanges during the Sulfur Unit turnaround to secure a blind installation. PEMEX Deer Park did not instruct Repcon to install these flange-locking devices for the Amine Unit maintenance task, however. Nevertheless, the surviving Repcon boilermakers told the CSB they located the isolation blinds in the Amine Unit primarily by looking for unlocked flange-locking devices because the flange-locking devices were used in the Sulfur Unit. As the Repcon boilermakers removed the blinds, they collected the flange-locking devices, as shown in **Figure 15**. As detailed in Section 2.2, when the boilermakers attempted to locate Blind 407, they found an unlocked flange-locking device on the ARU7 piping, which informed their decision to open the piping, believing it was the location of Blind 407. After the incident, the CSB found the flange-locking device under the ARU7 piping, as shown in **Figure 16**.

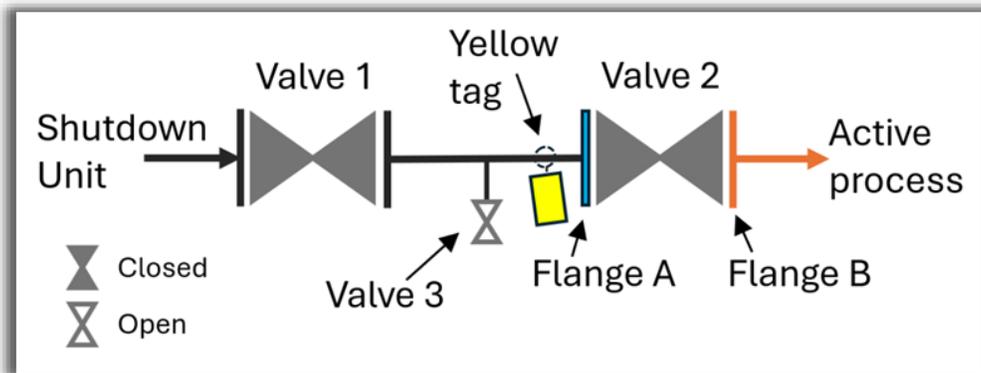
Figure 24. Existing isolation before blind installation. (Credit: CSB)

On February 1, 2025, contractors installing blinds disassembled an incorrect flange, resulting in a fire and a release of more than 50,000 gallons of hydrocarbon material. PBF Energy tasked contract workers with installing an isolation blind at Flange A (**Figure 24**) to prepare a unit for turnaround maintenance. PBF Energy operations placed a yellow tag between Valve 2 and Valve 3 to indicate the location of the blind installation. However, the contract workers had not received training on the refinery's equipment opening policies and procedures and were unfamiliar with PBF Energy's tagging practices. After completing a field walkthrough to verify that the piping segment between Valve 1 and Valve 2 was empty, an operator issued a permit to the contractor work crew supervisor at 11:30 a.m. on February 1.

At approximately 1:25 p.m., two contract workers began unbolting Flange B, which was not isolated from the active process, believing it was the intended location to install the blind. At this time, neither the workers' supervisor nor the operator who issued the permit were present. Minutes later, flammable material escaped from the opened Flange B. A standby worker activated an air horn to stop the work, and the two contract workers safely evacuated from the area.

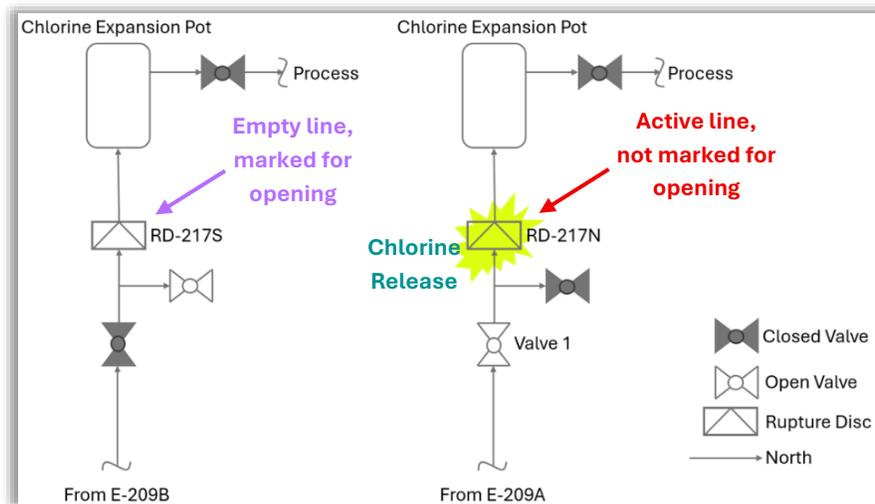
Figure 25. Simplified equipment drawing showing the relevant equipment and valve positions before the rupture disc replacement work began. (Credit: CSB)

On May 20, 2025, around 8:15 a.m., approximately 8,000 pounds of toxic chlorine gas were released at the Olin Corporation facility in Freeport, Texas. The release seriously injured one employee and resulted in approximately \$23 million in property damage. On the day of the incident, an Olin operator issued a work permit to two contract maintenance workers to replace rupture disc RD-217N (Figure 25). Prior to the incident, Olin's operations team mistakenly tagged a different rupture disc (identified as RD-217S) (Figure 25) for replacement after isolating and emptying the surrounding piping. The permitted rupture disc, RD-217N, was located on active piping containing liquid chlorine. The unit operator and the maintenance workers did not perform a field walkthrough of the job to confirm the location of the work, nor did the contract workers review or sign the equipment isolation plan or the tag that identified the rupture disc holder to be opened.

At approximately 8:10 a.m., one of the maintenance workers began disassembling the RD-217N rupture disc holder. At 8:15 a.m., liquid chlorine at a pressure of 100 pounds per square inch began releasing from the partially disassembled rupture disc holder. The maintenance workers evacuated from the area. Alarm horns in the unit were activated after chlorine gas detectors identified the release. Local officials issued a shelter-in-place order for the cities of Clute and Lake Jackson. At 9:03 a.m., emergency responders closed an upstream valve to stop the release.

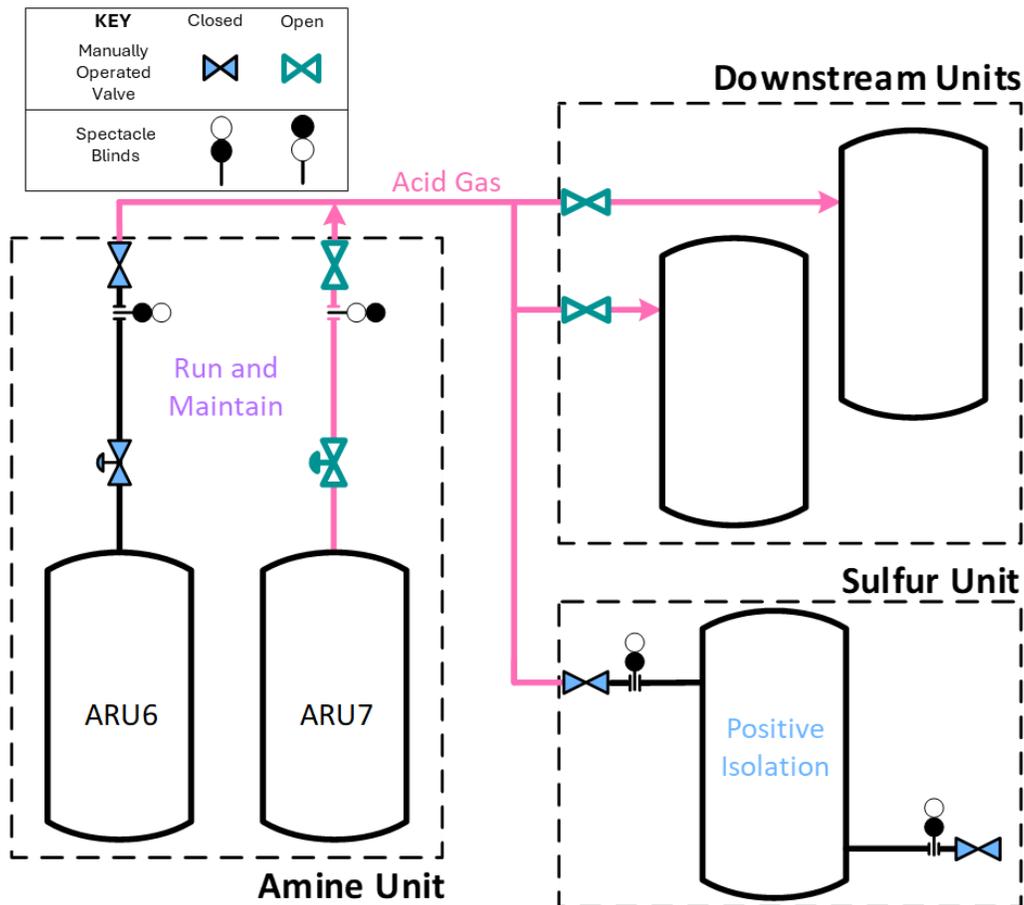
Figure 30. Amine Unit under Run-and-Maintain and the turnaround Sulfur Unit under Positive Isolation with adjacent operating units.^a (Credit: CSB)

isolated from outside hazardous process energy. As shown in **Figure 30**, on the day of the incident, the Amine Unit was operating in Run-and-Maintain, while the Sulfur Unit was in Positive Isolation

PEMEX Deer Park's procedures had defined, more stringent requirements for Run-and-Maintain operations to control the hazards of working around live equipment. In contrast, the Positive Isolation rules during turnaround were less stringent because workers were assumed to be working around depressurized and empty equipment. The difference between the Run-and-Maintain and Positive Isolation requirements left the Repcon boilermakers with a misperception of the hazards in their work area, as illustrated in **Figure 31**.

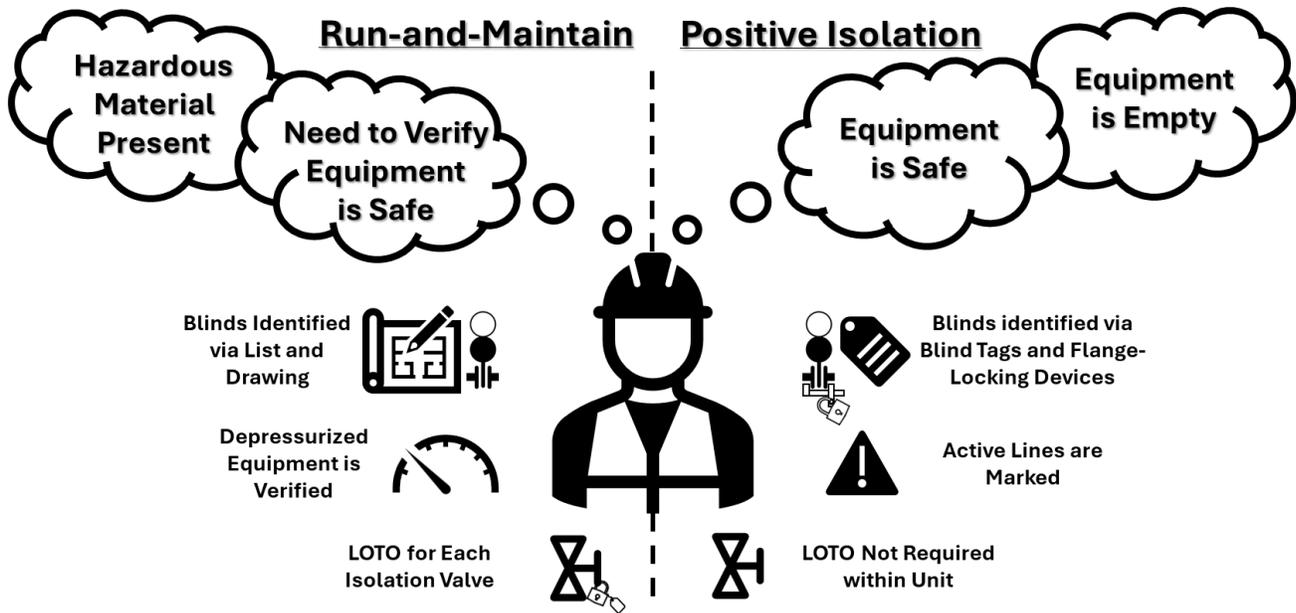
Figure 31. The applicable requirements within Run-and-Maintain (left) and Positive Isolation (right). (Credit: CSB)

At the start of the turnaround, PEMEX Deer Park provided an onboarding briefing to the Repcon boilermakers with information specific to the Sulfur Unit turnaround. The turnaround onboarding did not include information on the Amine Unit or a description of Run-and-Maintain operations. The Repcon boilermakers who were tasked with removing Blind 407 had been working on the turnaround for at least 10 consecutive days before the incident. Four days before the incident, when the Sulfur Unit achieved Positive Isolation, the Repcon boilermakers started working in a shutdown, depressurized, deinventoried, and isolated unit (right side of **Figure 31**).

On October 10, PEMEX Deer Park reassigned the boilermakers from the Sulfur Unit in Positive Isolation to the Amine Unit in Run-and-Maintain. The reassigned boilermakers had not been involved in the Amine Unit blind installation and had not previously worked outside the Sulfur Unit turnaround in the days prior to the incident. Further, PEMEX Deer Park did not brief the boilermakers on Run-and-Maintain expectations (left side of **Figure 31**) comparable to the turnaround onboarding for the Sulfur Unit. Although the boilermakers had been trained in and previously worked in Run-and-Maintain operations, they were not aware that their reassignment to the Amine Unit was outside the turnaround. As a result, the boilermakers were unaware of the hazards involved in removing the Amine Unit blinds near active equipment, which required Run-and-Maintain procedures for mitigation, as depicted in **Figure 31**.

Because the boilermakers believed that they were working under the established safeguards of the turnaround environment (**Figure 31**), they had a misperception of the unit hazards and overlooked practices and safeguards necessary to ensure the equipment was safe. The boilermakers perceived that verifying the equipment status was inconsequential, as they expected the Amine Unit also to be shut down, depressurized, decontaminated, and isolated, like the rest of the turnaround equipment.
