# Fatal Coke Oven Gas Explosion at U.S. Steel Clairton Coke Works

Clairton, Pennsylvania | Incident Date: August 11, 2025 | No. 2025-03-I-PA

## Investigation Report

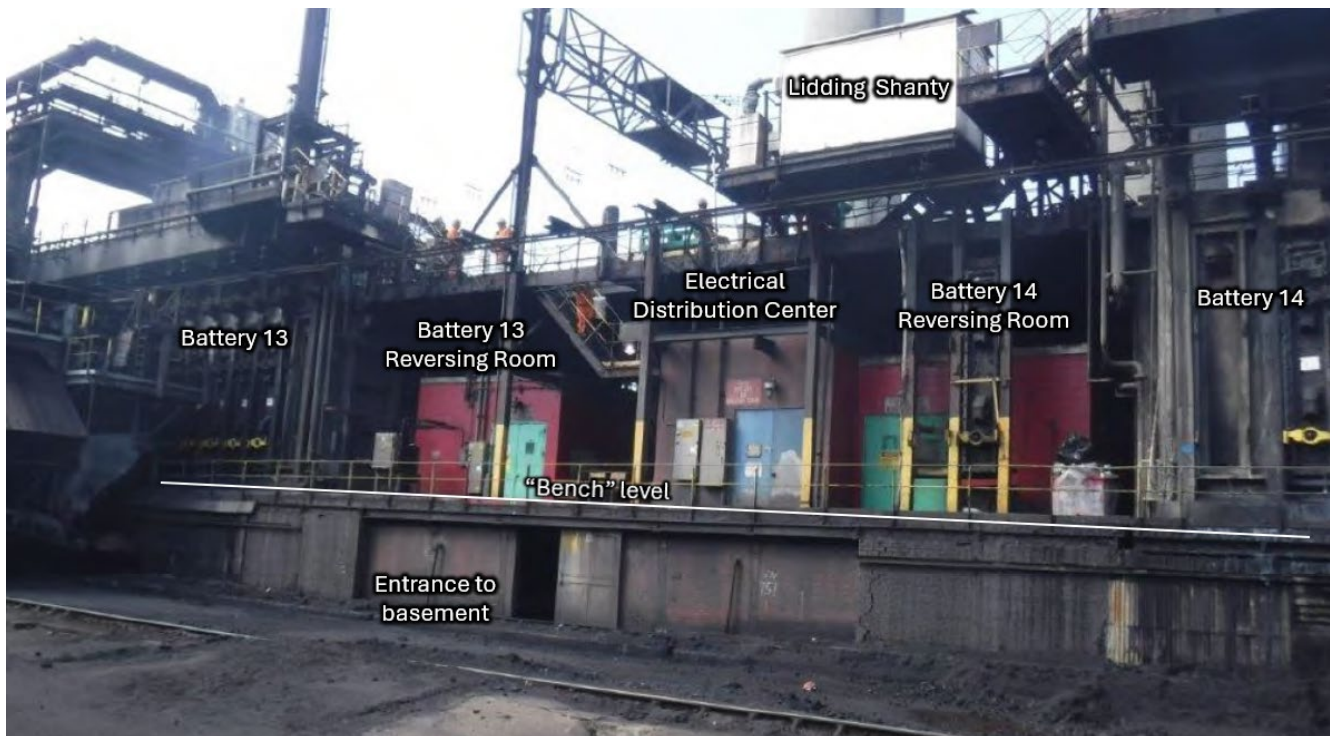
Below the bench level is the basement level, where the processed coke oven gas supply piping is located. The transfer area also has staircases leading to the top level of the battery, where a “lidding shanty”<sup>a</sup> is located. None of the rooms or shanties in the Battery 13/14 transfer area were designed or constructed to withstand an explosion.<sup>b</sup> The buildings in the transfer area were routinely occupied by workers.

**Figure 5.** Pre-incident photo of the Battery 13/14 Transfer Area, showing the reversing rooms and other buildings. The break room is not pictured because it was located on the bench level behind the buildings shown here. (Credit: U.S. Steel, annotated by CSB)

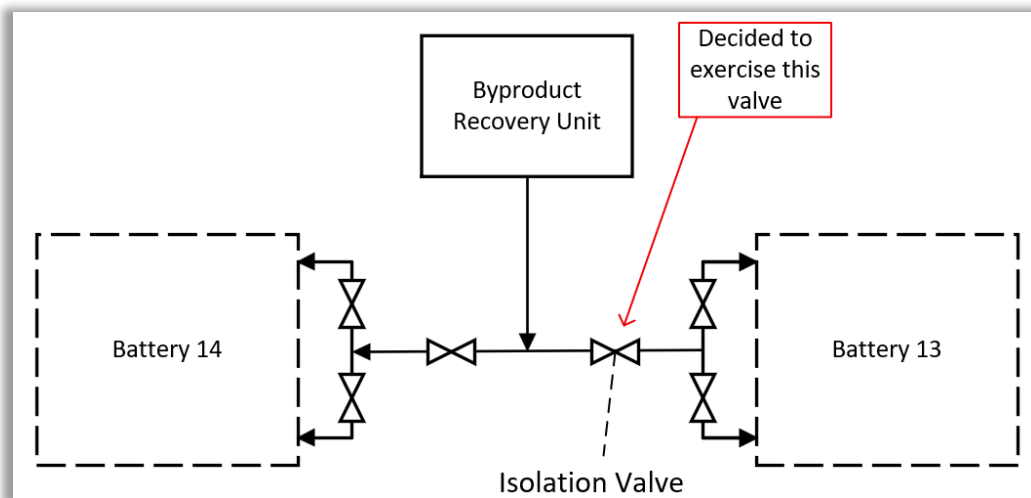
**Figure 10.** Simplified process flow diagram of the Battery 13 and 14 coke oven gas supply systems. (Credit: CSB)

The MPW pump truck arrived at the Battery 13/14 transfer area, and by approximately 8:00 a.m., two MPW employees had connected water from a nearby hydrant to the pump truck. At 10:35 a.m., a U.S. Steel employee and an MPW employee connected a hose from the pump truck to a cleanout port on the bottom of the isolation valve. At 10:39 a.m., U.S. Steel personnel shut off the flow of coke oven gas to the individual Battery 13 ovens.

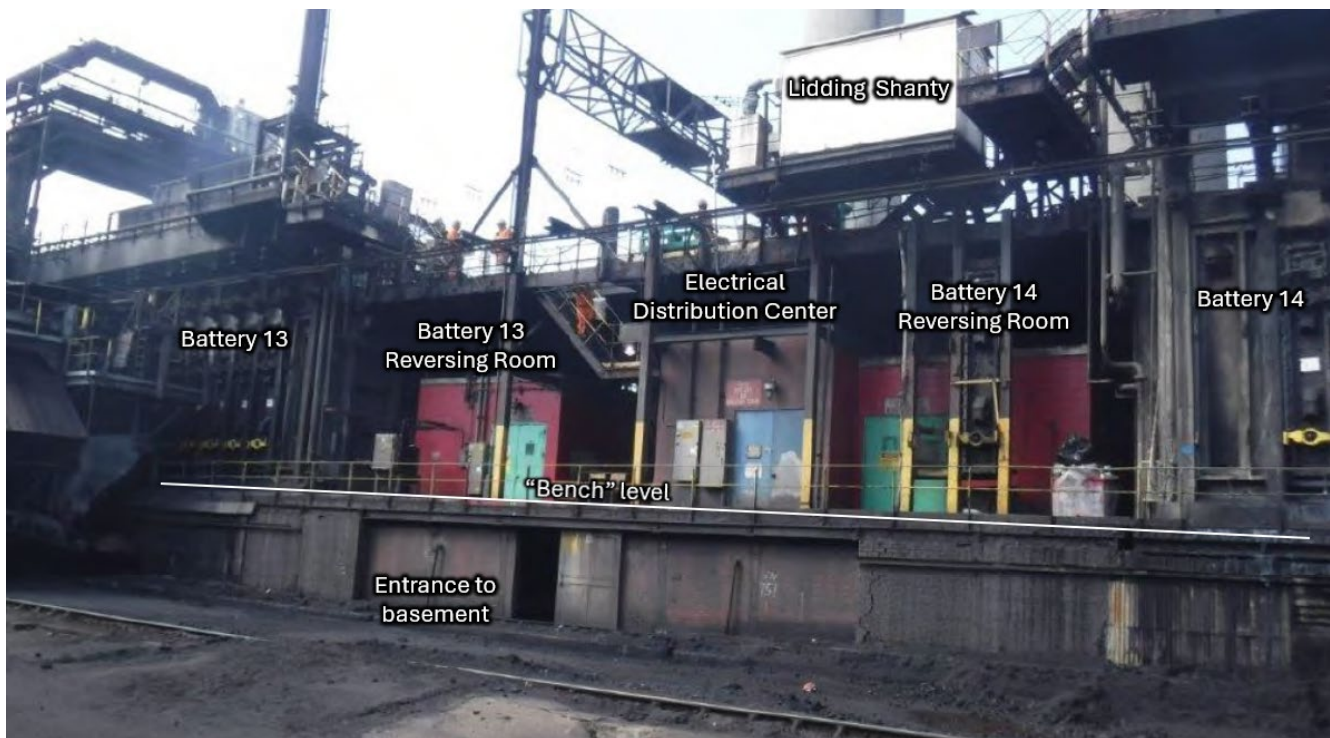
Within the Battery 13/14 transfer area, there were at least five buildings: two reversing rooms (one for each battery),<sup>a</sup> a break room, a lidding shanty,<sup>b</sup> and a room that housed electrical and motor control equipment, which U.S. Steel called the “Electrical Distribution Center” (EDC). A photo of the 13/14 transfer area prior to the incident is shown in **Figure 20**, and a post-incident photo is shown in **Figure 21**:

**Figure 20.** Pre-incident photo, date unknown, of the 13/14 transfer area. The break room is not pictured, as it was located behind the EDC and the Battery 14 reversing room. (Credit: U.S. Steel, annotated by CSB)

area were located roughly less than 20 feet directly above the coke oven gas supply piping, and the release point for this incident (**Figure 20**).

Conduct a siting evaluation for all occupied and potentially occupied buildings at the Clairton Coke Works facility. Utilize the guidance contained in the Center for Chemical Process Safety's *Guidelines for Evaluating Process Plant Buildings for External Explosions, Fires, and Toxic Releases*, the American Petroleum Institute's Recommended Practices 752, 753, and 756, and other industry good practice guidance documents.

Using the results from the evaluation performed in **2025-03-I-PA-R1**, ensure that all documented facility siting hazards are mitigated in accordance with the guiding principles contained in the American Petroleum Institute's Recommended Practices 752, 753, and 756.

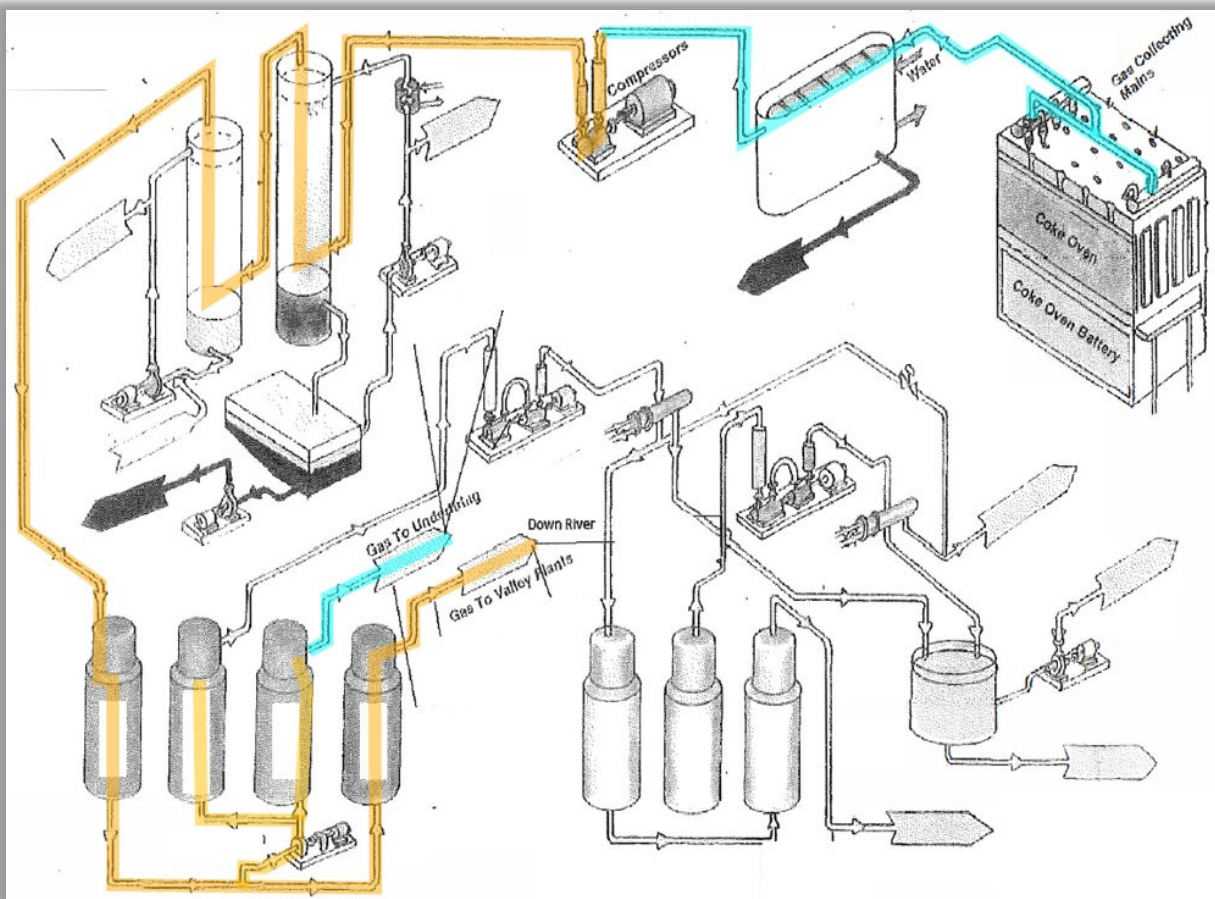
The CSB requested that U.S. Steel provide documentation supporting the company's statement. In response, U.S. Steel submitted calculations from 2010 that included only the parts of the coke oven gas process outside the bounds of the byproduct recovery unit. The company estimated the inventory of these parts of the process to be roughly 7,000 pounds. Along with the calculations, U.S. Steel noted that, since 2010, the company had decommissioned four coke batteries and had commissioned just a single new one. The company reasoned that as a result, the Clairton coke oven gas system contained less inventory in 2025 than it did in 2010. However, the 2010 calculations were incomplete and excluded the entire coke oven gas byproduct recovery unit,<sup>a</sup> as illustrated below in **Figure 23**:

<sup>a</sup> It is not clear to the CSB why U.S. Steel has excluded the byproduct recovery unit from these calculations. The OSHA PSM standard states that "any group of vessels which are interconnected and separate vessels which are located such that a highly hazardous chemical could be involved in a potential release shall be considered a single process." 29 C.F.R. § 191.119(b). Given that all of U.S. Steel's coke oven gas piping and process vessels are interconnected from the point at which the raw coke oven gas is generated at the coke batteries, to the point at which the processed coke oven gas is eventually burned as fuel, the CSB believes that U.S. Steel's calculations should include the inventory of the process both inside and outside the byproduct recovery unit together.

**Figure 23.** Illustrative diagram of the Clairton coke oven gas process. Portions highlighted in blue were included in the 2010 calculations; orange-highlighted portions were excluded. Only one coke oven battery is shown rather than six. (Credit: U.S. Steel, redacted and annotated by CSB)

When the CSB requested calculations for the excluded byproduct recovery unit, U.S. Steel responded that it had no documents indicating the quantity of coke oven gas in those portions. The company also stated that it had no calculations that were more recent than the 15-year old calculations from 2010 and that the company was “assessing the feasibility of updating the [...] 2010 calculations.”
