Report No. 5005.3434 C

November 6, 2018

**LABORATORY EVALUATION OF SAMPLES FROM THE  
BRAZED ALUMINUM PLATE-FIN HEAT EXCHANGER H-3059 INVOLVED IN  
THE JULY 27, 2016 FIRE AT ENTERPRISE PRODUCTS OPERATIONS,  
MOSS POINT, MS**

Customer Authorization: CSB-16-0030

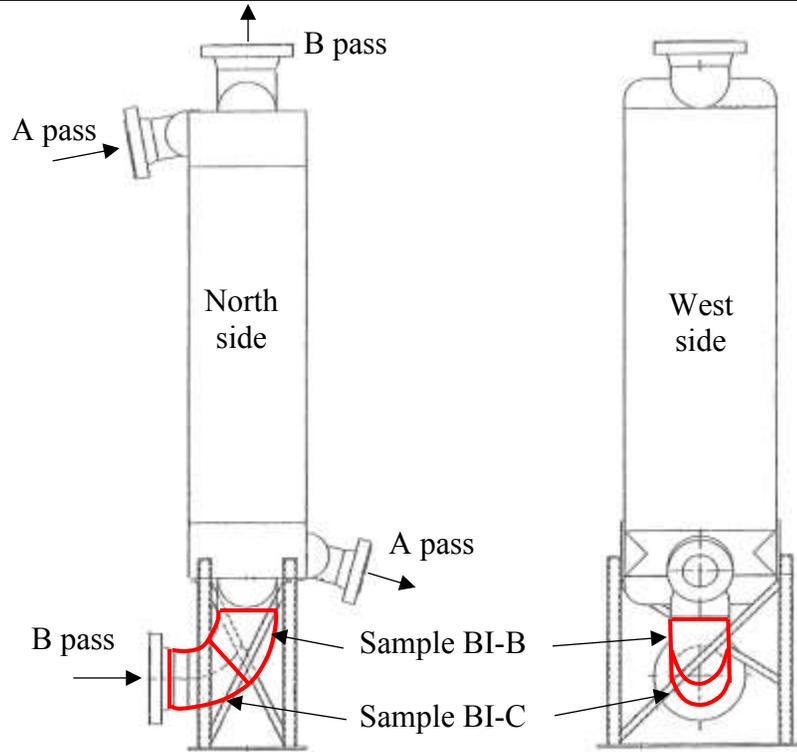
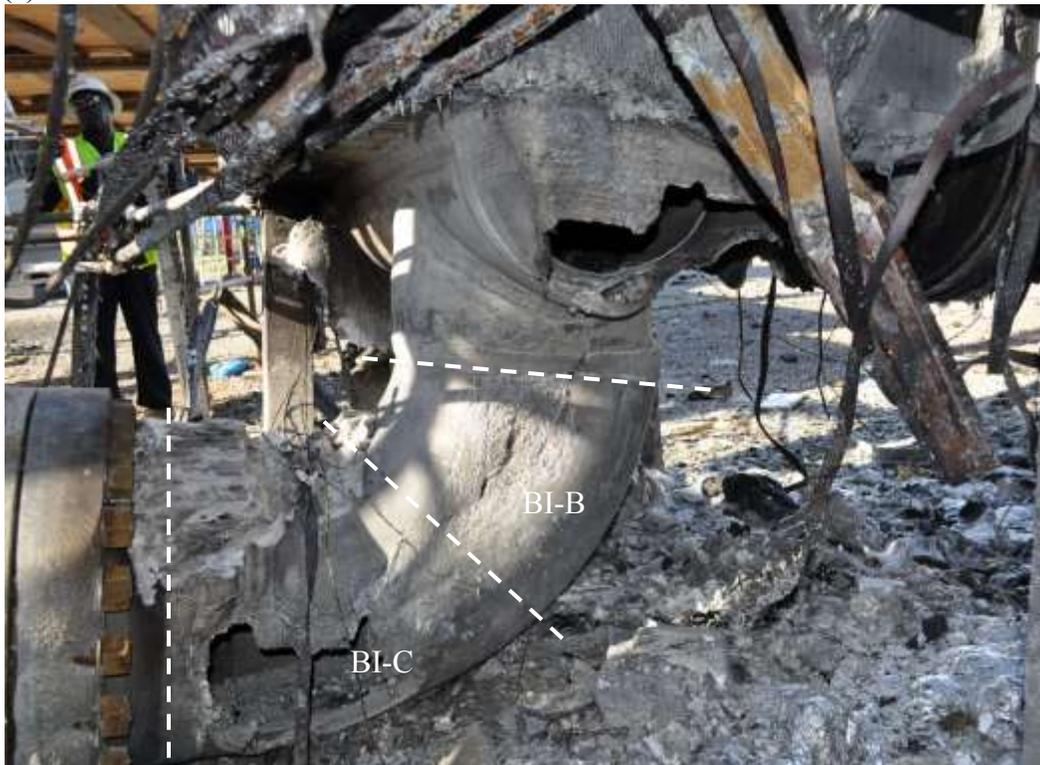
A photograph of the B stream inlet nozzle and header taken after the fire with the ACSR in place is shown in Figure 4. After removal from site, the nozzle and header were cut along the dashed lines shown in the figure. The resulting header and nozzle samples were labeled H-3059 BI-A, BI-B, and BI-C, as indicated. Laboratory evaluation of the header sample BI-A is described in the next section.

Figure 4 Simplified ACSR drawing with header samples indicated and photograph of the north side of the B stream inlet nozzle and header. Dashed lines indicate where were saw cuts made for samples BI-B and BI-C.

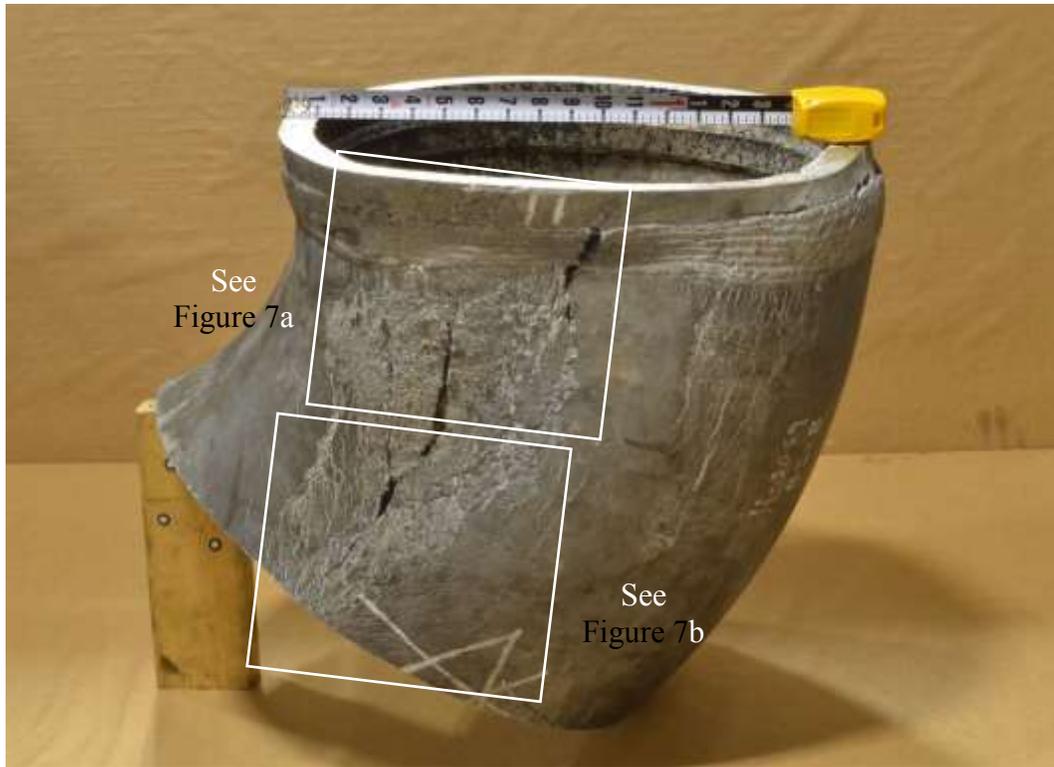
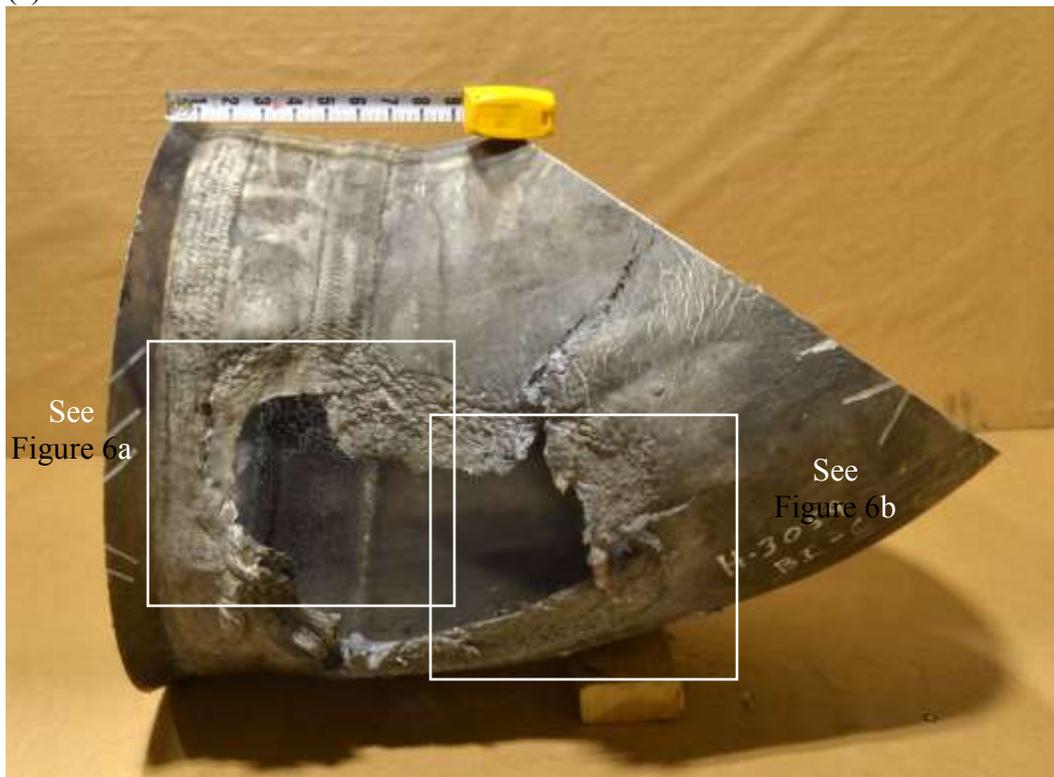
The north sides of nozzle samples BI-B and BI-C are shown in Figure 5. A large hole was present in section BI-C. Evidence of melting and partial melting during the fire included out-of-round sections, solidified drips, sag lines in the nozzle wall and weld, and dull grey oxide on the edges of the hole. Similar evidence of partial melting was present on the north side of sample BI-B. Cracks along the girth weld toe, cracks between weld passes, and transverse weld bead cracks also indicated partial melting of the nozzle. Examples of these features are shown in Figure 6 and Figure 7. If a pressure boundary breach had formed in this region of the nozzle prior to the fire, evidence of that breach was destroyed by melting, partial melting, and oxidation. The south side of the nozzle, shown in Figure 8, appeared to be in good condition.

Figure 5 Photographs of the north side of nozzle samples BI-B and B-I-C.

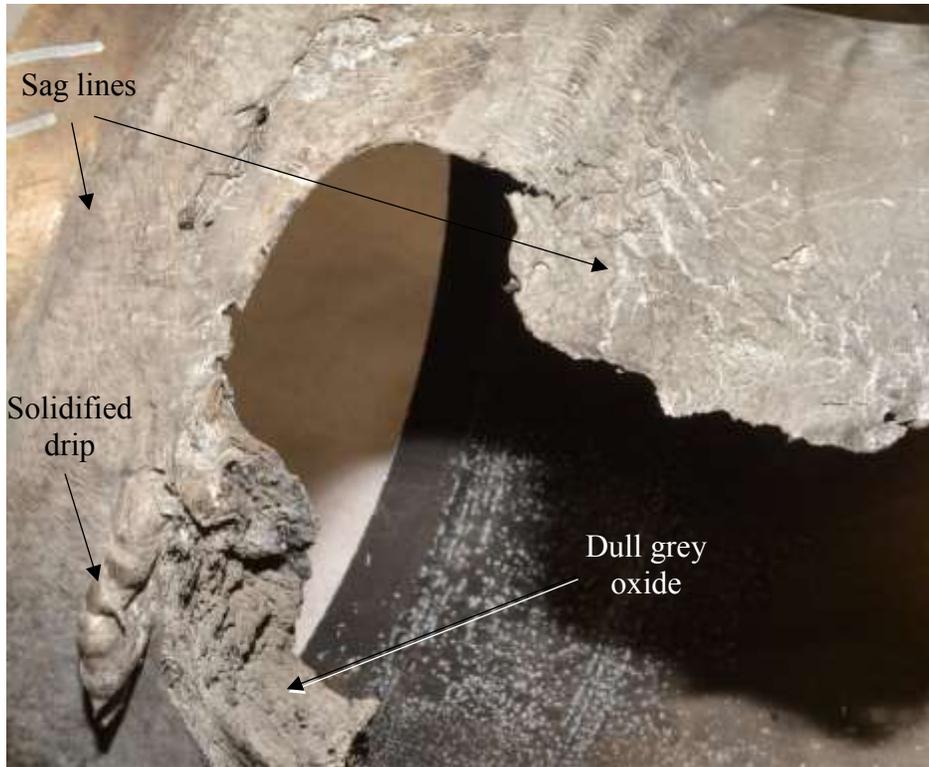
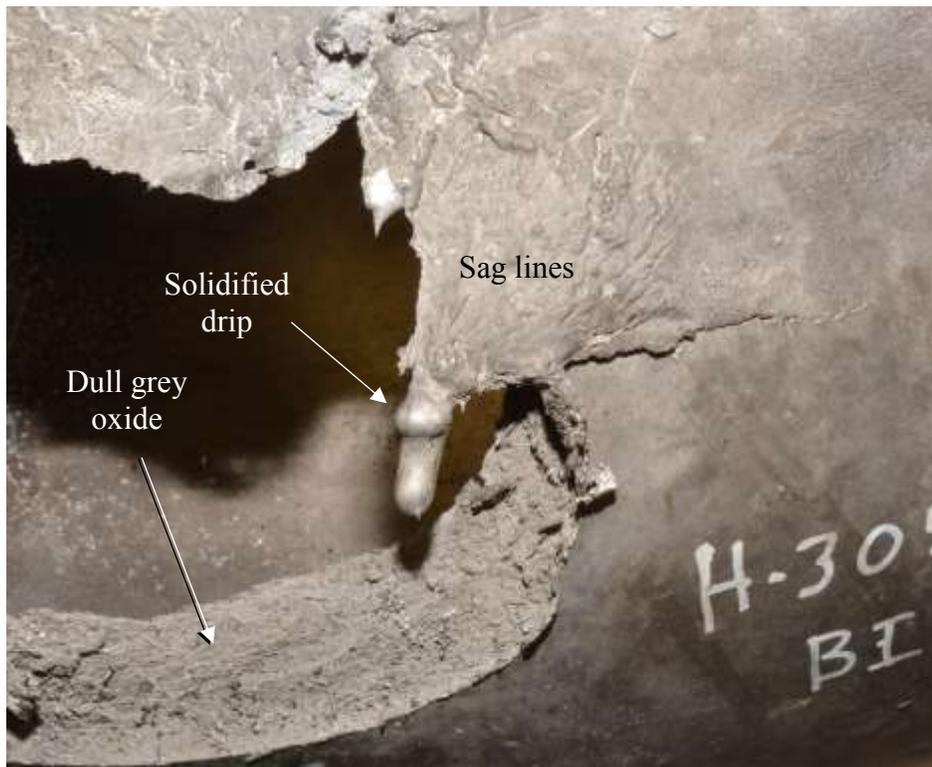
Figure 6 Photographs of the outside surface of sample BI-C, boxed regions in Figure 5b.

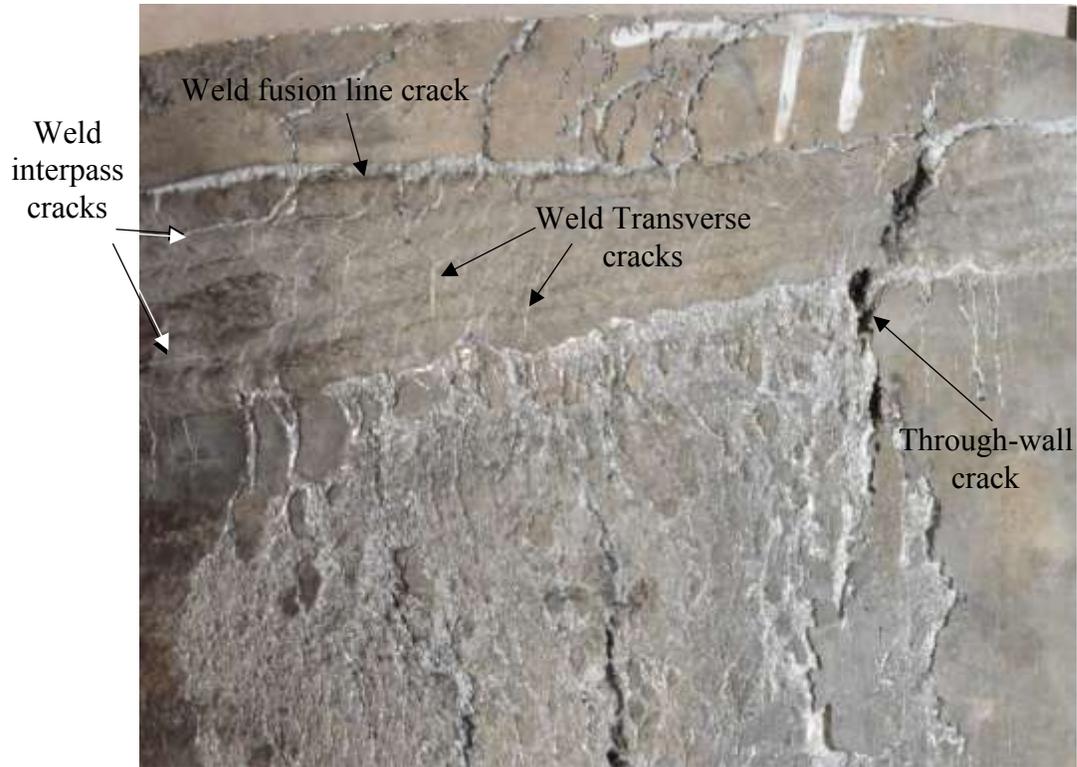
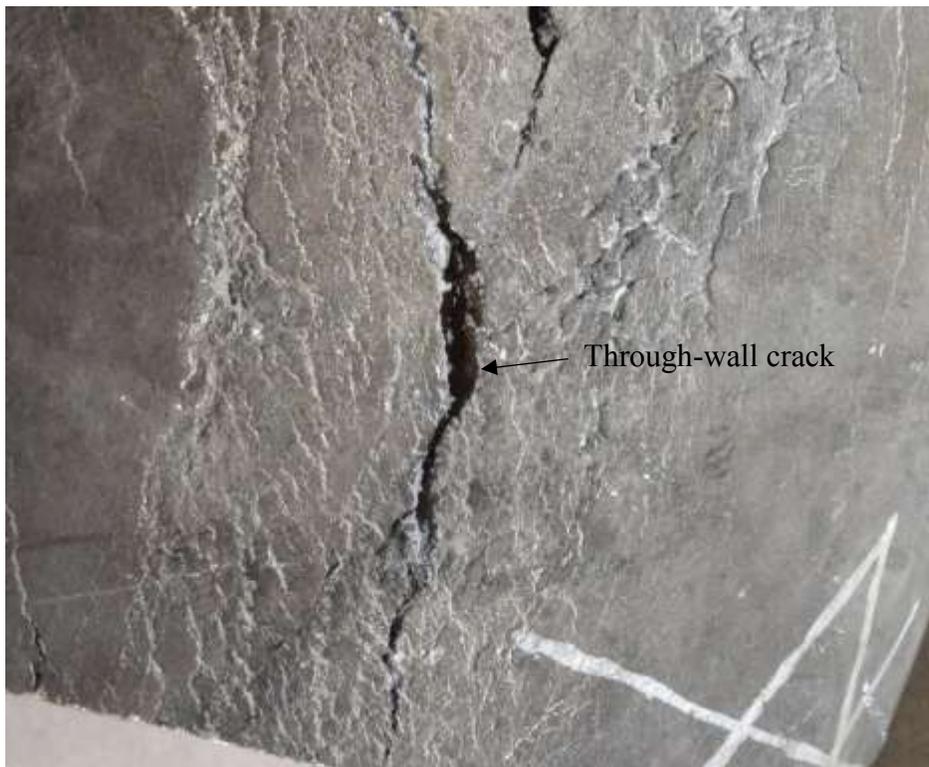
Figure 7 Photographs of the outside surface of sample BI-B, boxed regions in Figure 5a.

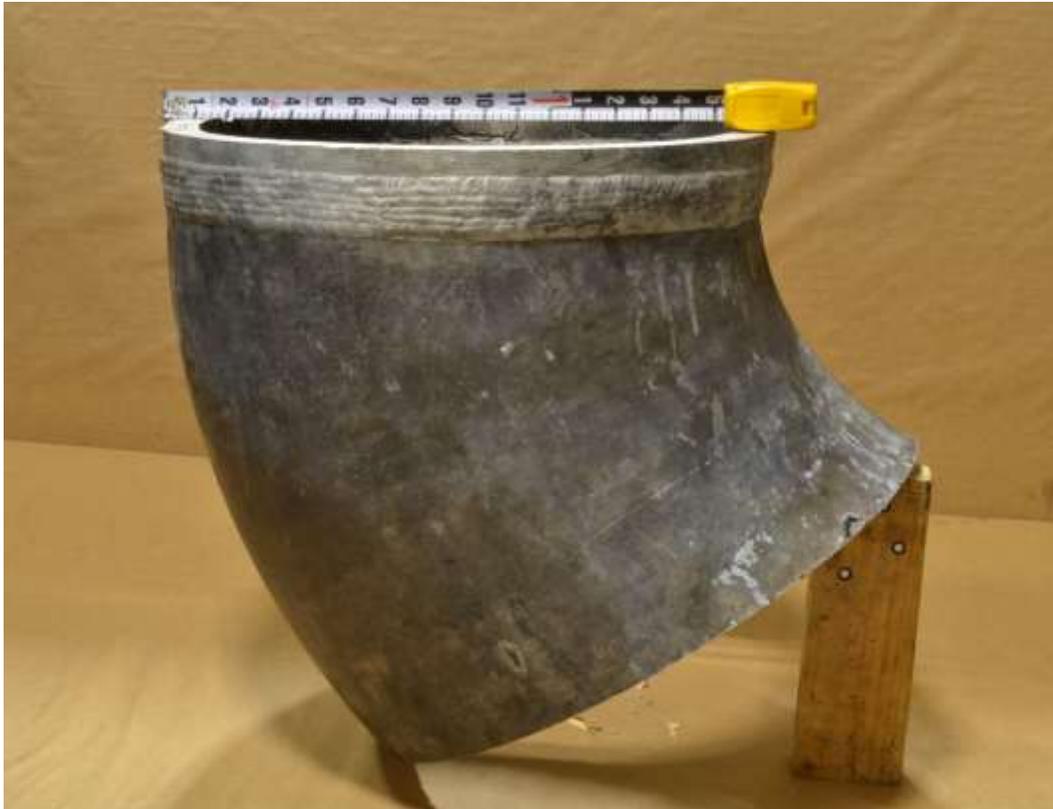
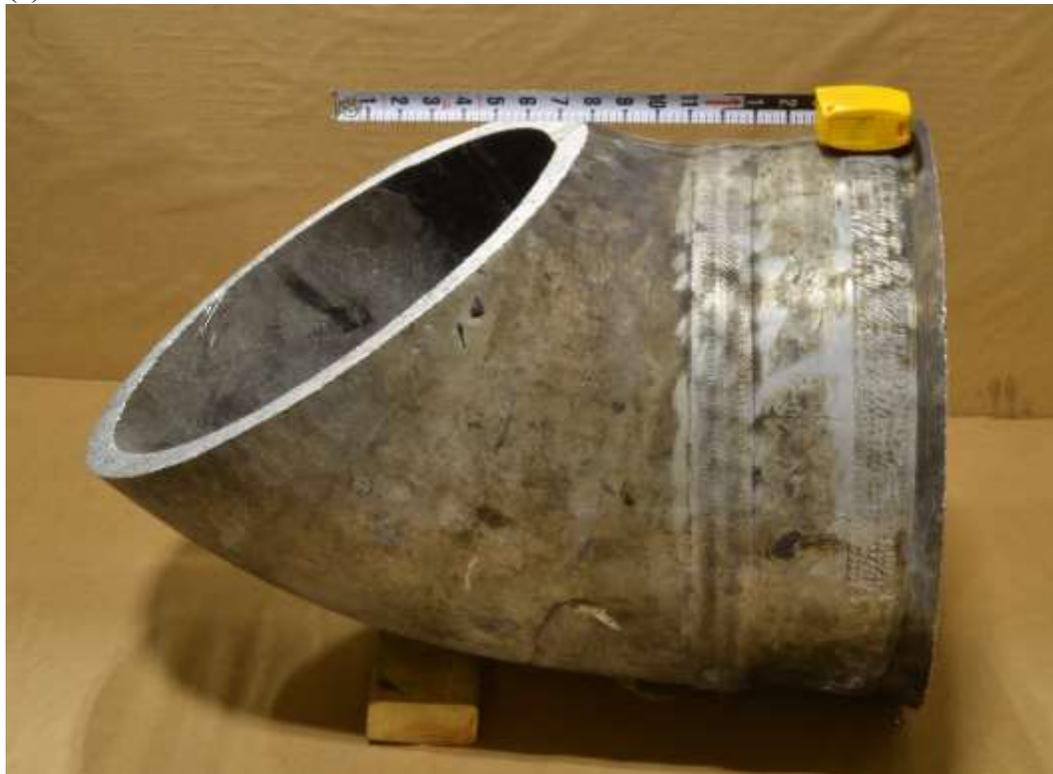
Figure 8 Photographs of the south side of nozzle samples BI-B and BI-C, indicated in Figure 4.

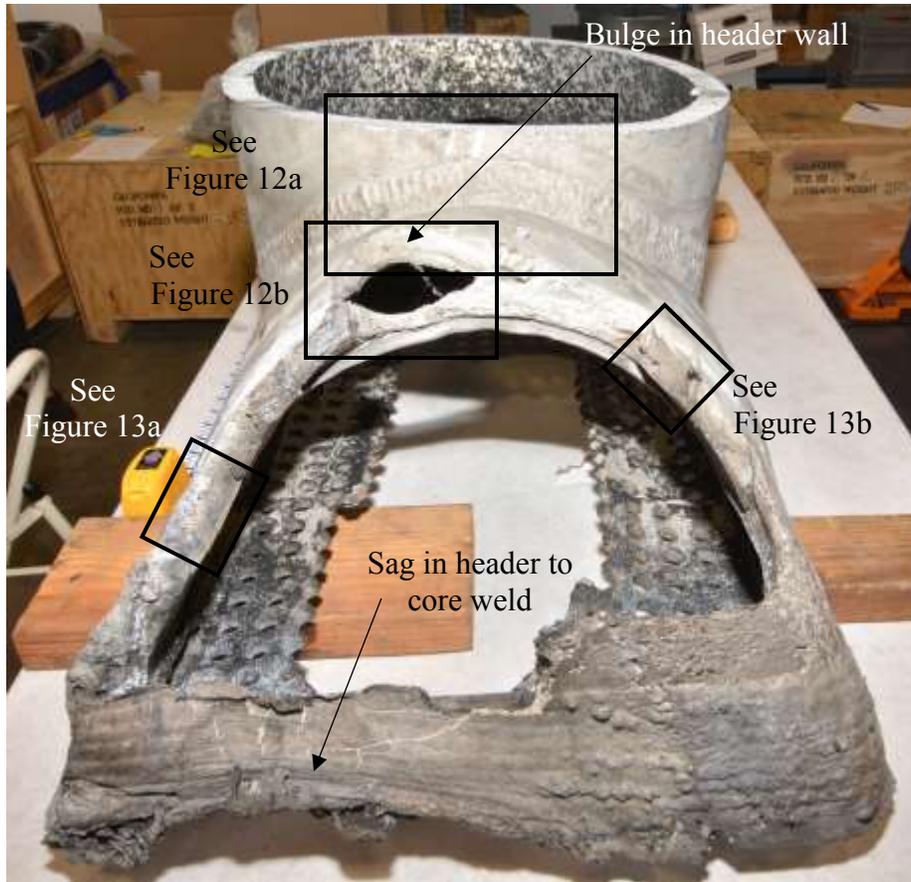
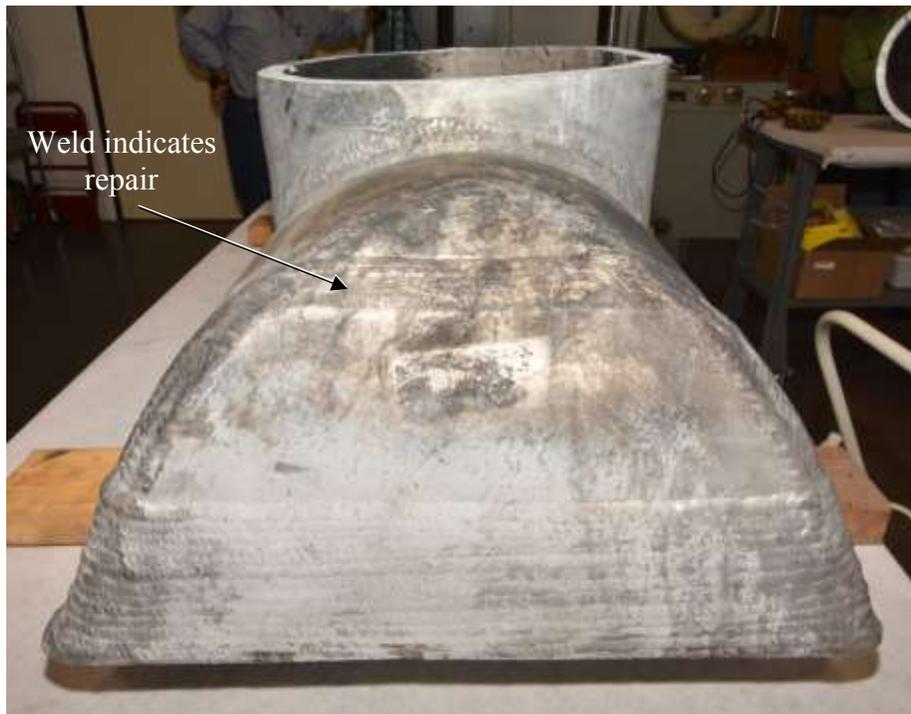
Figure 11 Photographs of the B stream inlet header BI-A cut from the ACSR.

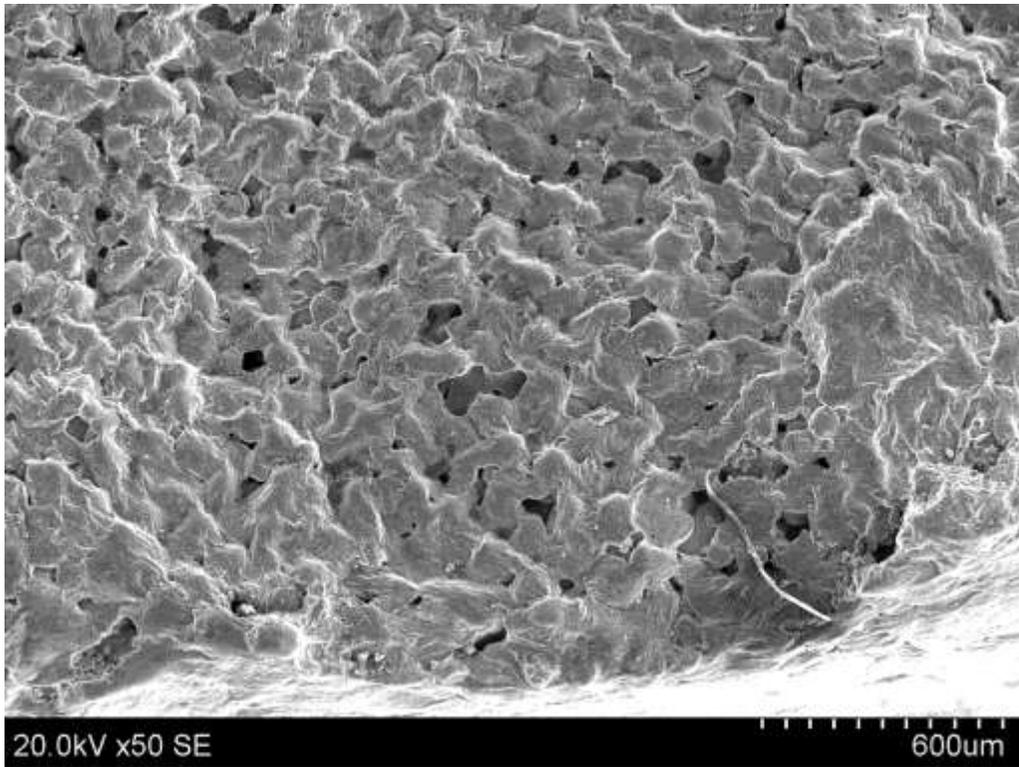
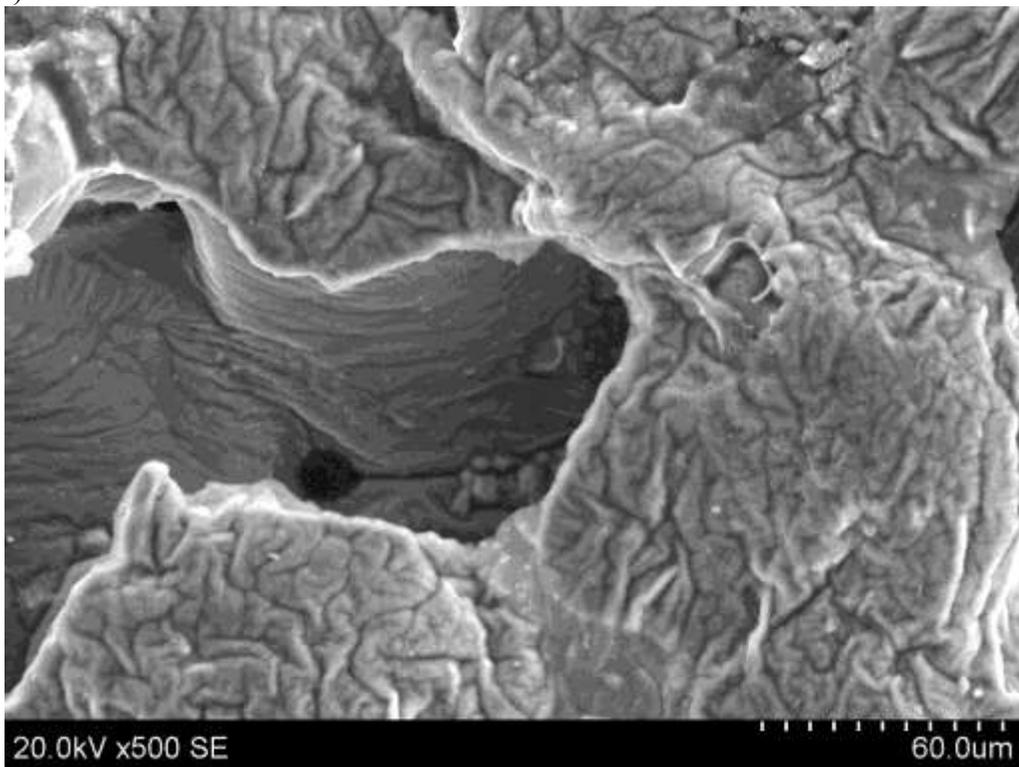
Figure 14 SEM micrographs of the boxed location indicated in Figure 13a.

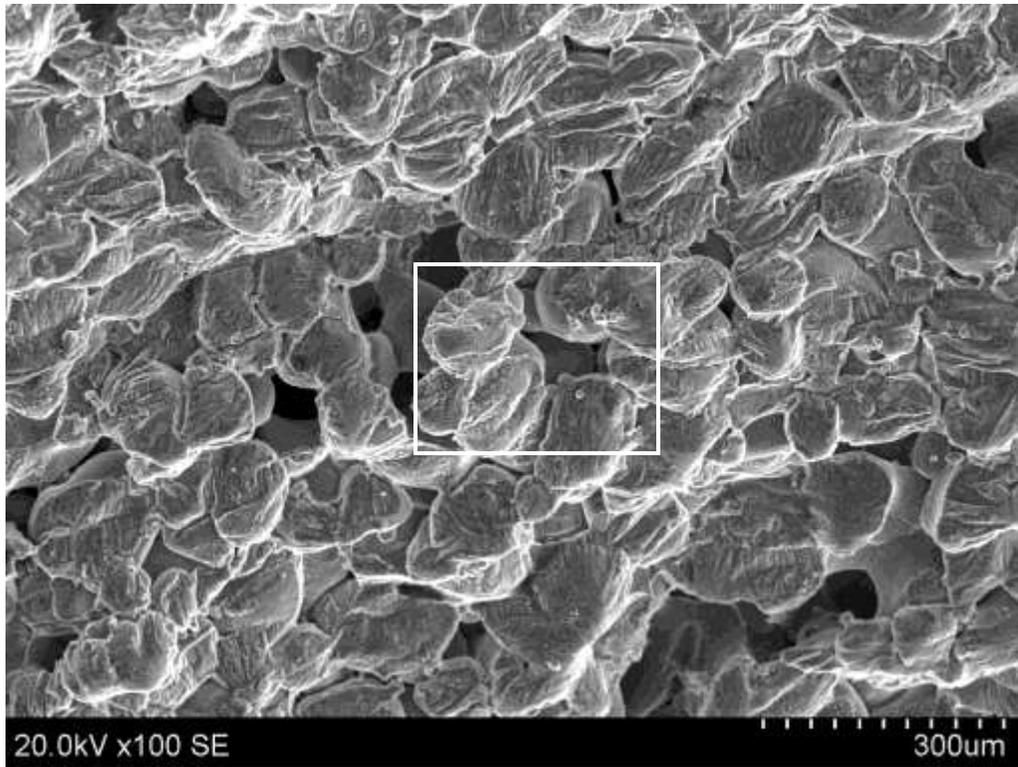
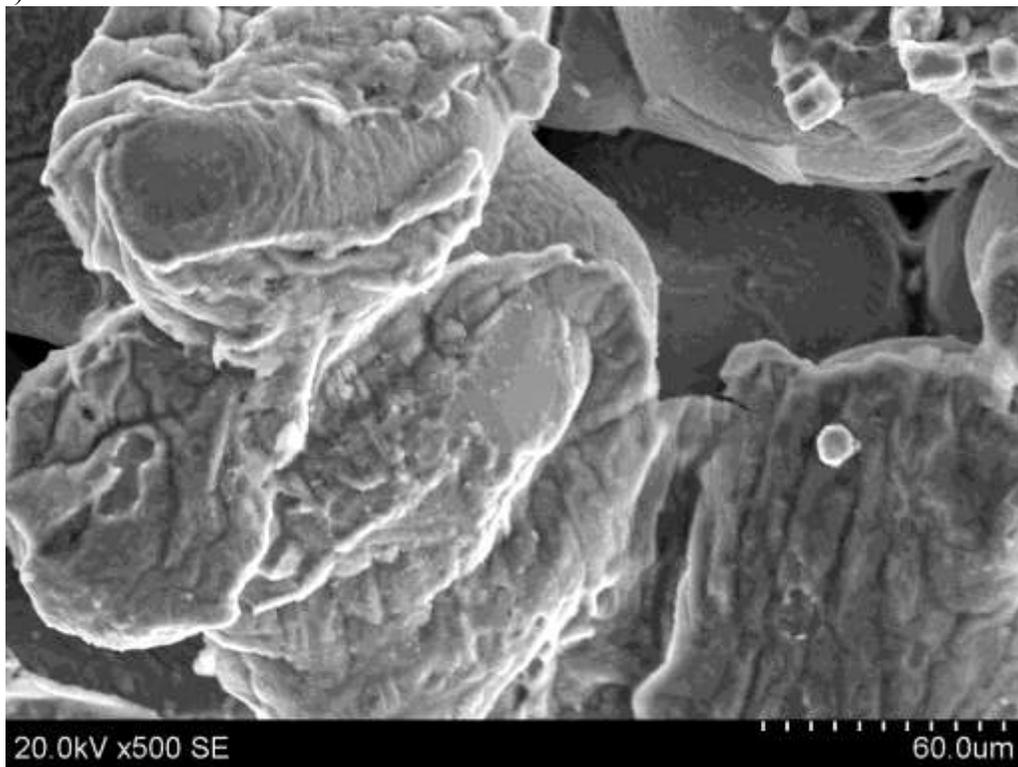
Figure 15 SEM micrographs of the boxed location indicated in Figure 13b.

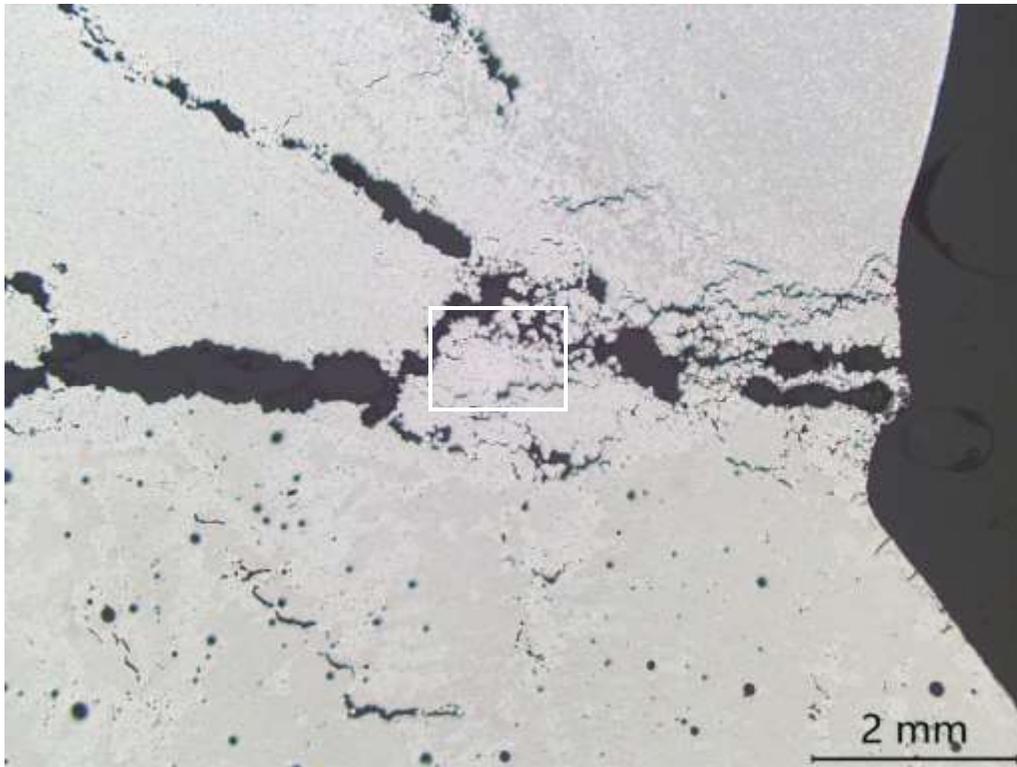
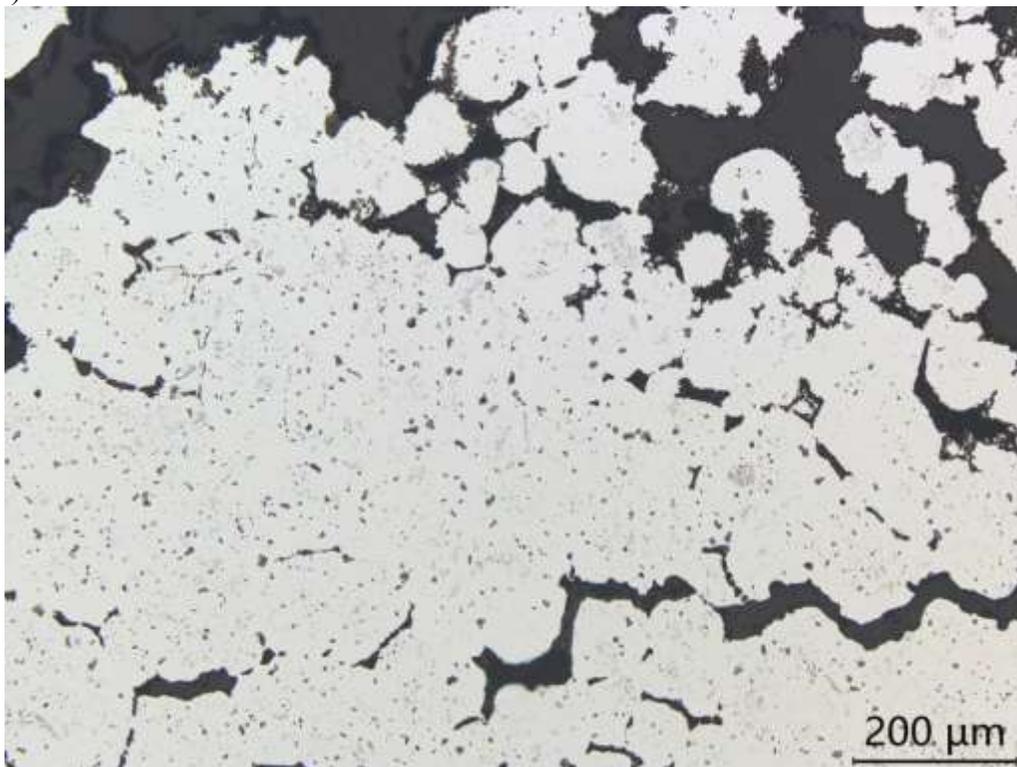
Representative optical micrographs of the section BI-A-1C-1 are shown in Figure 18. Rounded features indicative of localized melting corresponded to the rounded surface features revealed by SEM on the header hole edges. Elemental segregation that occurs during weld solidification

Figure 18 Micrographs of section BI-A-1C-1 from the boxed region in Figure 17b.

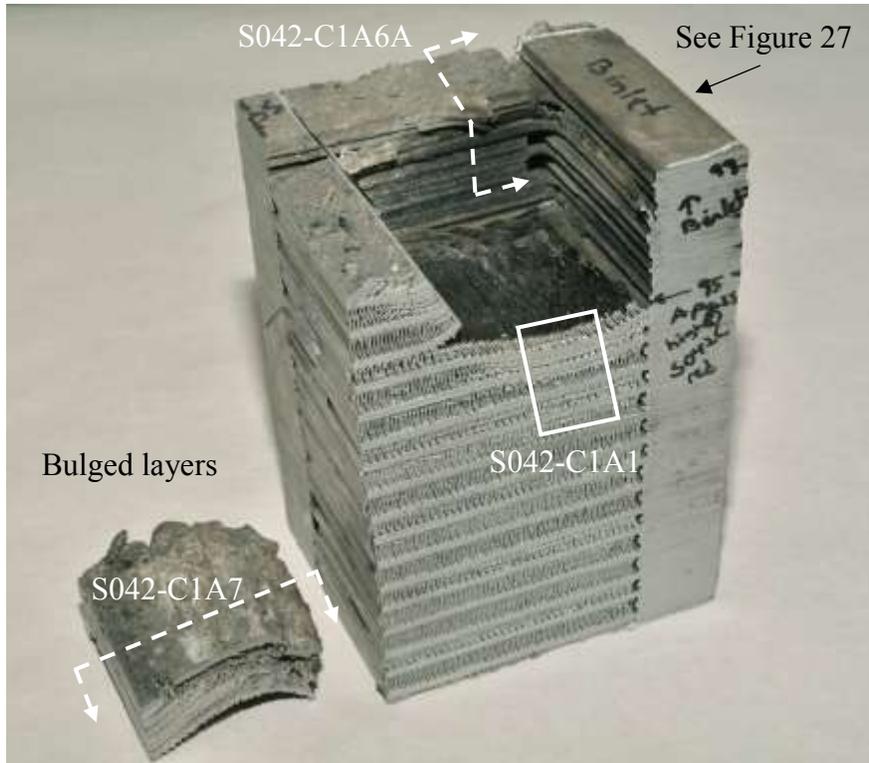
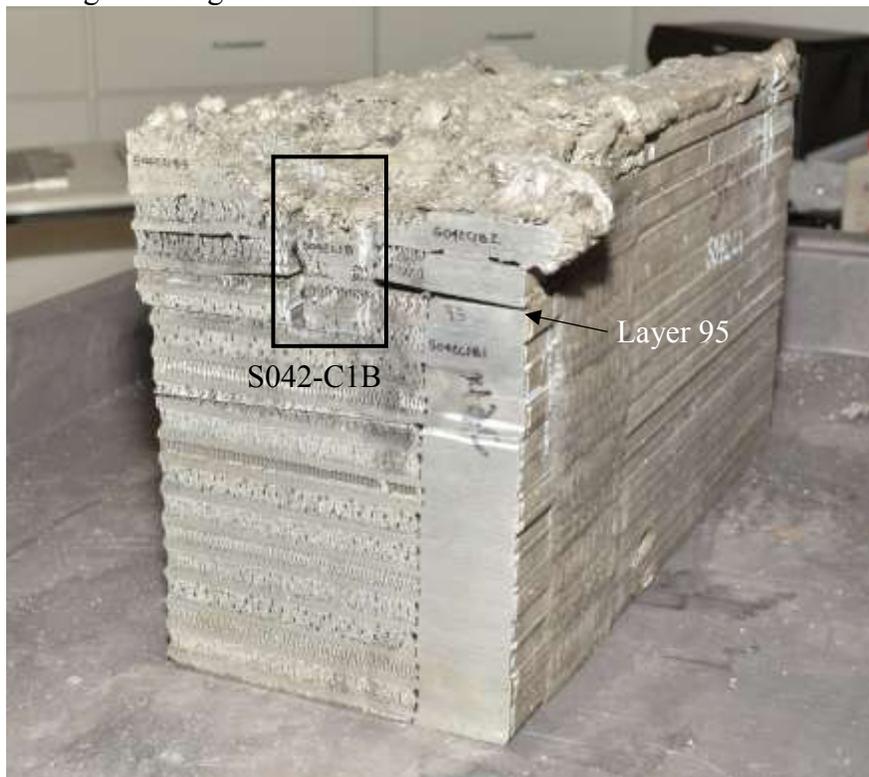
To expose the inside of the void, the bulged layers were cut from the sample as indicated in Figure 26. Parting sheet fracture along the edges of the side and end bars had occurred from layer 95 through 99. Separation of layer 95 fins from the parting sheet was visible on the cut face of the sample approximately 3-feet from the B pass inlet, shown in Figure 25b. Partial separation of the parting sheet to side bar braze was also visible in this location.

Figure 26 Boxed regions in Figure 25.

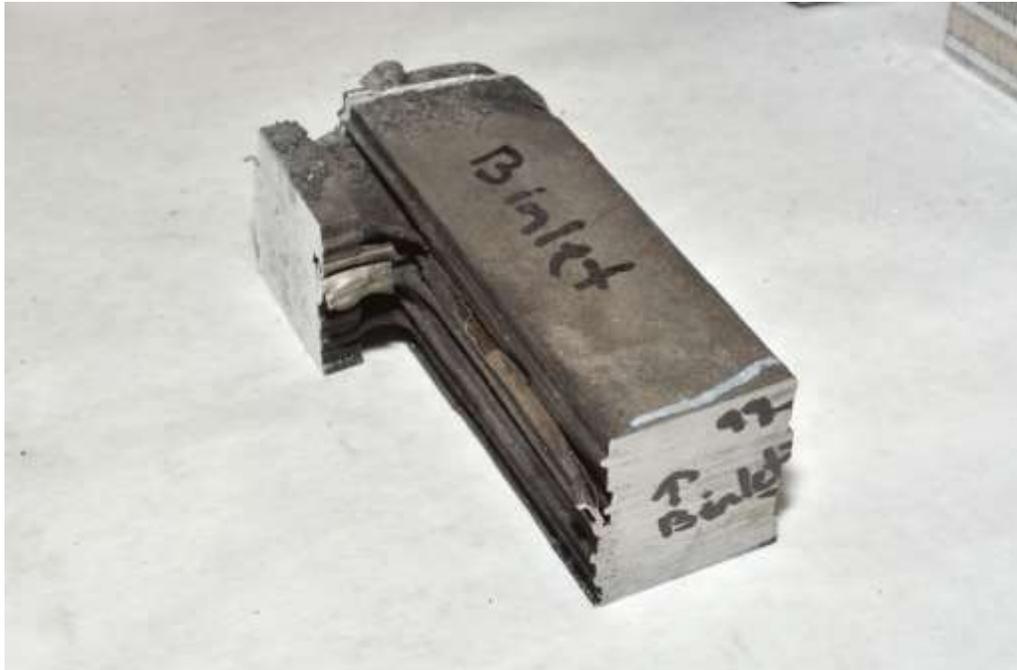
The side bars and end bars around the bulge were cut from the sample, shown in Figure 27. Thick oxide was present on the fractured parting sheet edges. The image in Figure 27b was taken after cleaning with acetone, followed by scrubbing with a soft bristle brush and soapy water.

Figure 27 Images of side bar and side bar section from sample S042-C, indicated in Figure 26. Thick oxide covered fractured parting sheets and side bars.

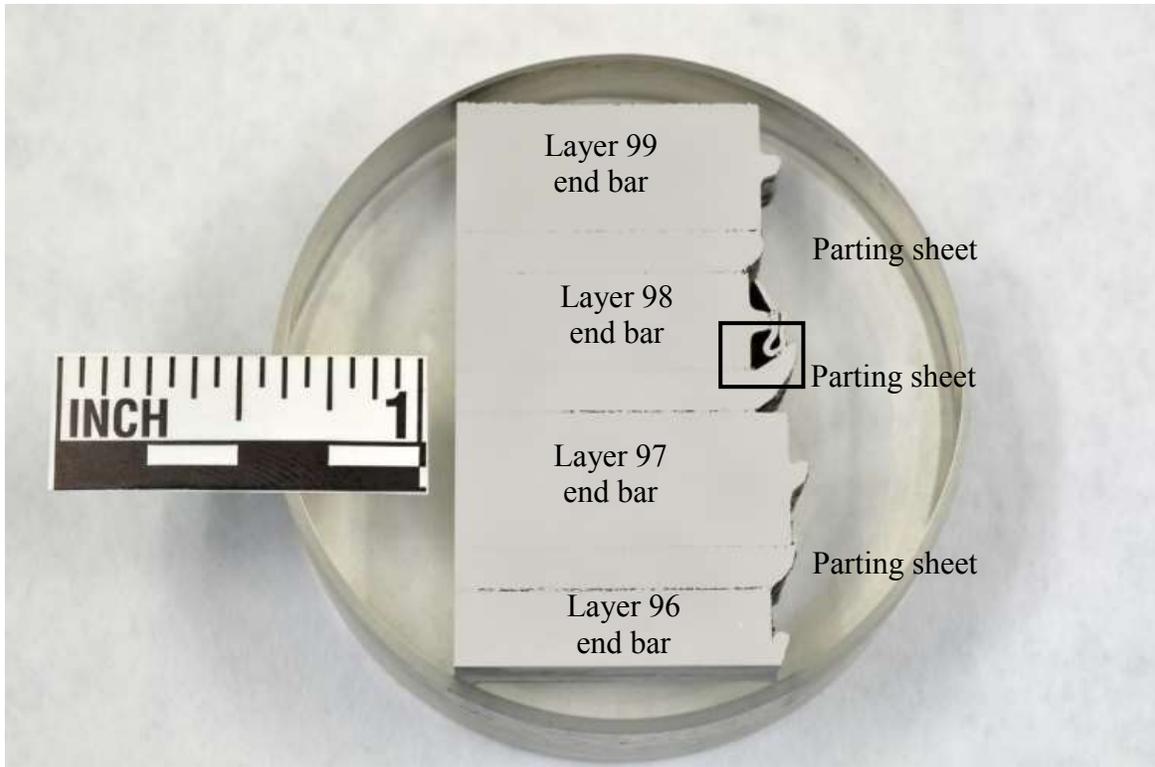
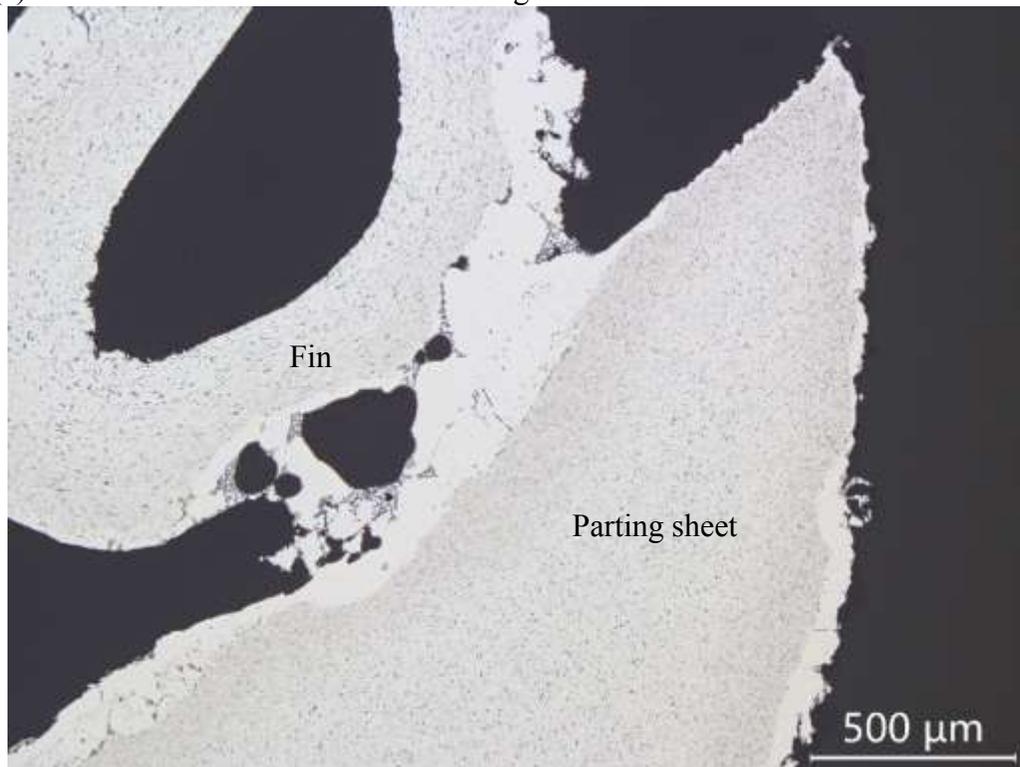
Figure 28 Photograph and micrograph of section S042-C1A6A, indicated in Figure 26a, prepared for metallography.

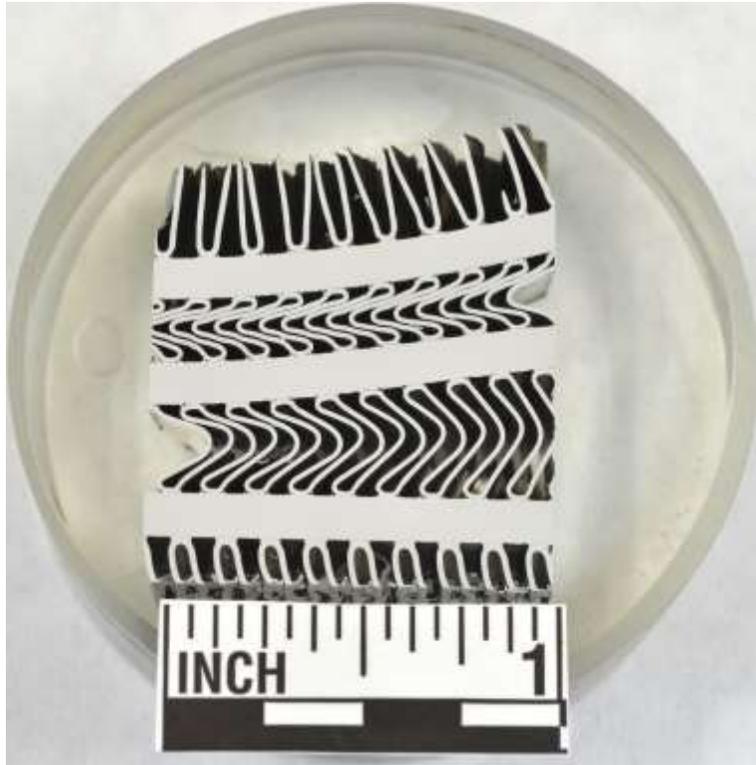
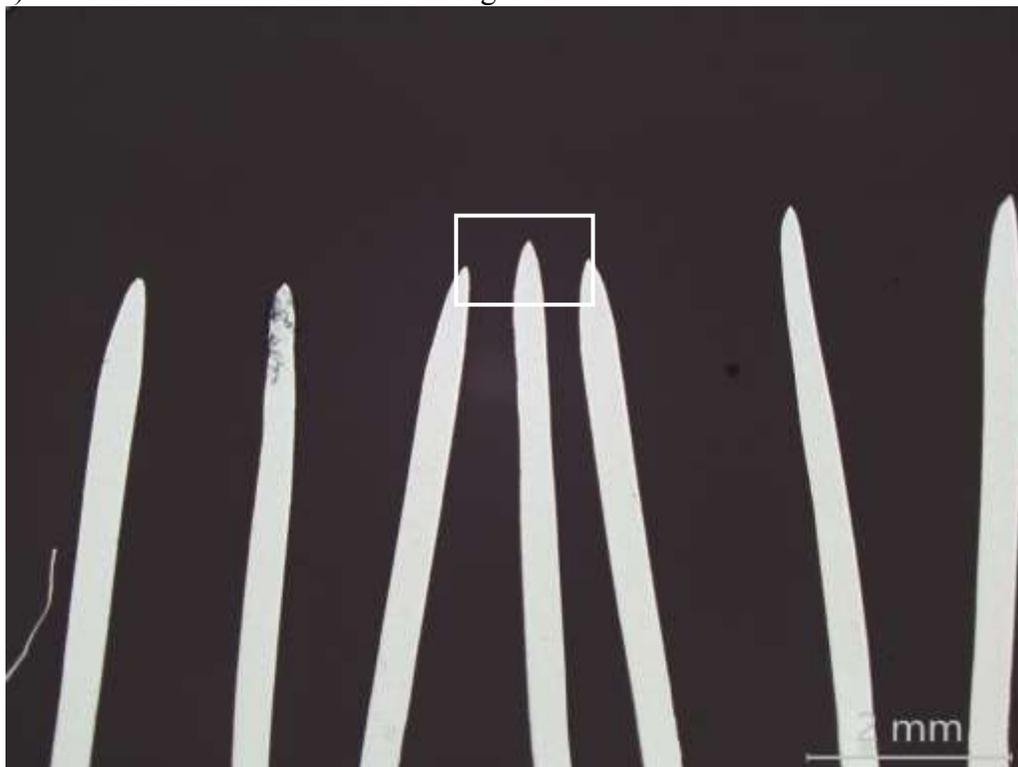
Figure 29 Images of section S042-C1A1, indicated in Figure 26a, prepared for metallography.

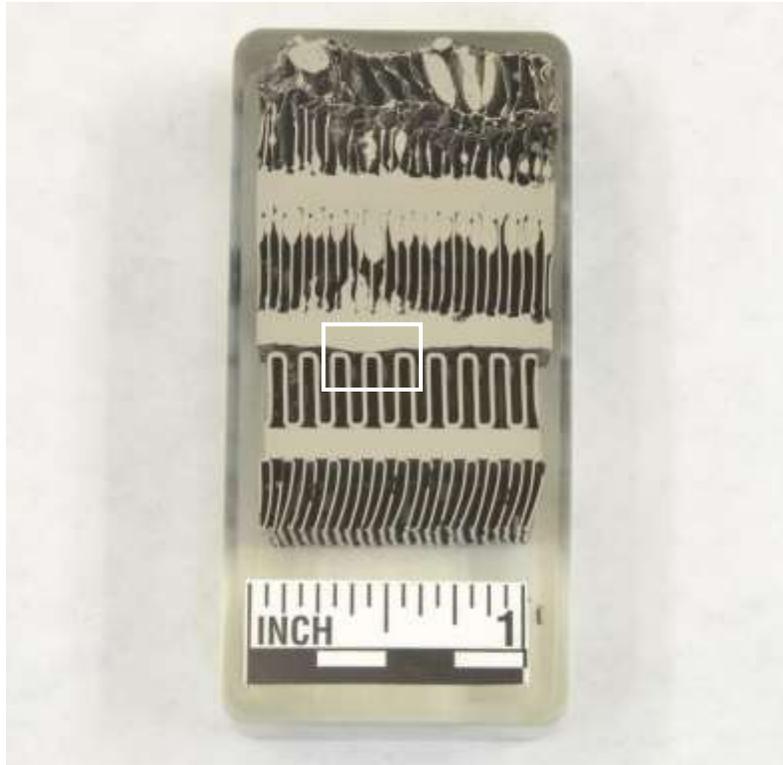
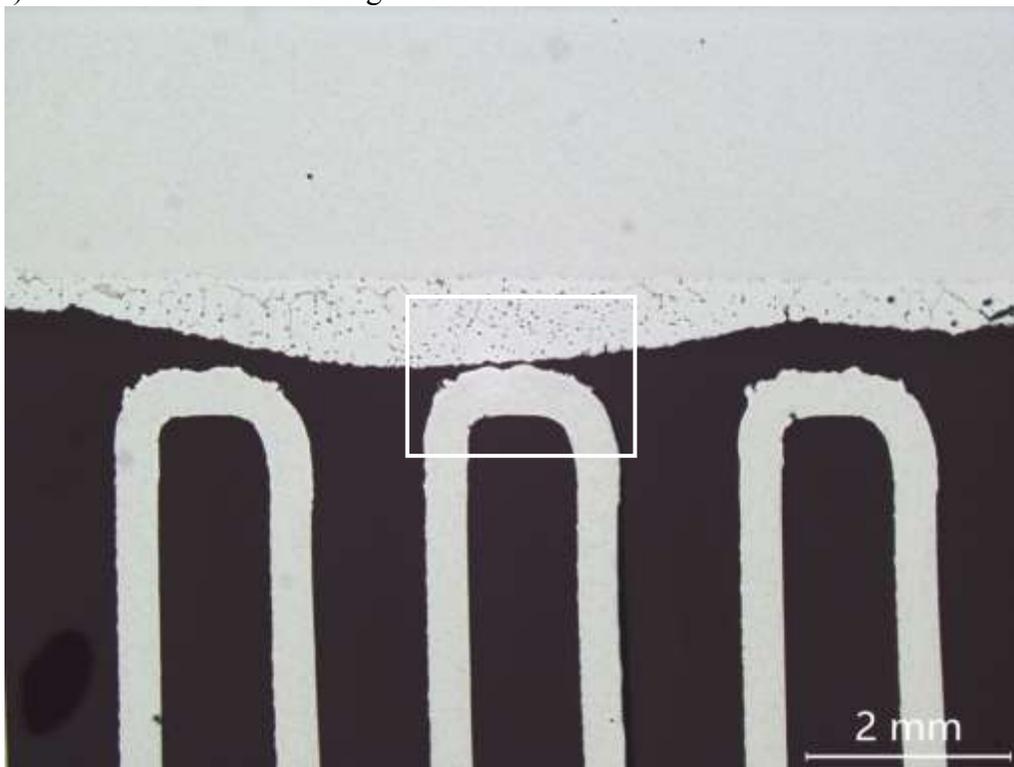
Figure 33 Images of section S042-C1B indicated in Figure 26b.

(a) S042-C1B indicated in Figure 26b.

(b) Boxed region in (a)

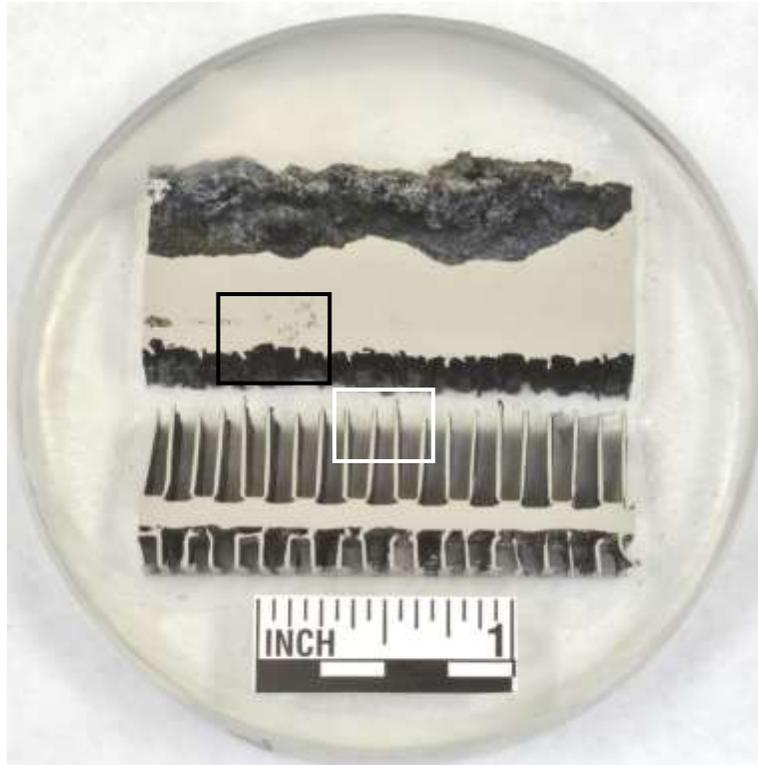
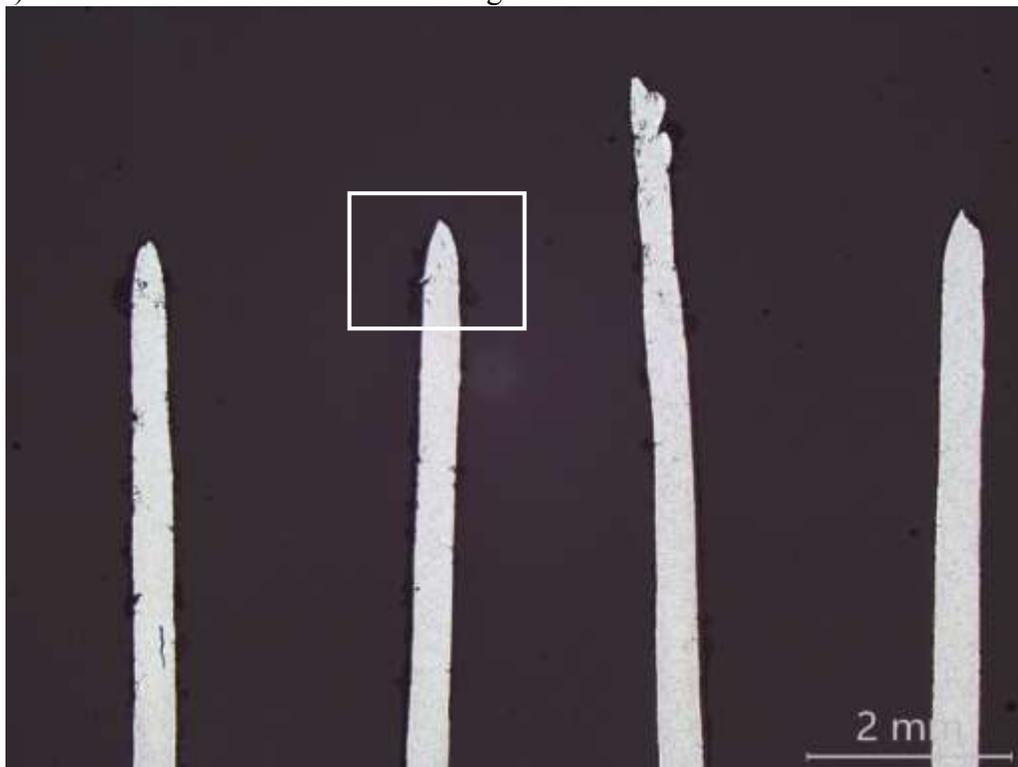
Figure 35 Images of section S042-C3B1 prepared for metallography.

(a) Section S042-C3B1 indicated in Figure 25a
