Report No. 5005.3434 C

November 6, 2018

**LABORATORY EVALUATION OF SAMPLES FROM THE  
BRAZED ALUMINUM PLATE-FIN HEAT EXCHANGER H-3059 INVOLVED IN  
THE JULY 27, 2016 FIRE AT ENTERPRISE PRODUCTS OPERATIONS,  
MOSS POINT, MS**

Customer Authorization: CSB-16-0030

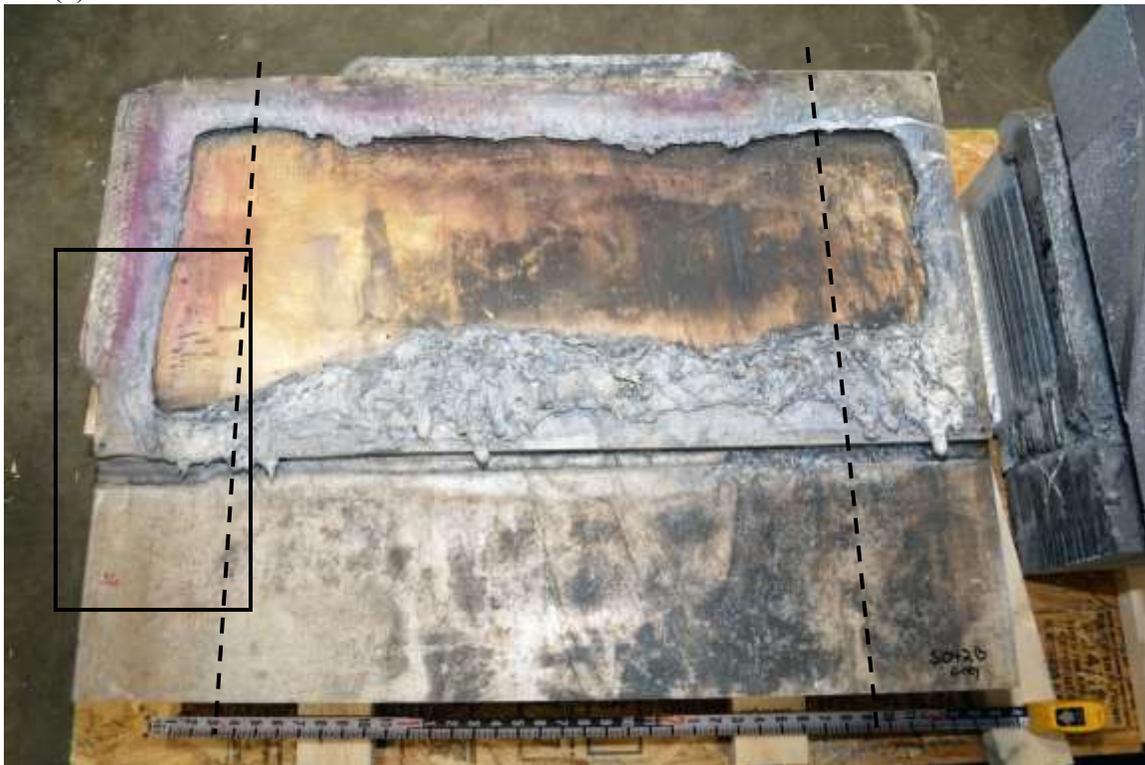
Sample S042-B was sectioned from the upper north side of the ACSR. A drawing with the sample location indicated, and a photograph of the sample are shown in Figure 37. The majority of the attachment plate had melted off the section during the fire. Remnants of the attachment plate were removed from the sample by cutting approximately 0.5-inch inside the attachment plate edge with a carbide tipped circular saw, and the entire sample was cut with a large horizontal band saw along the dashed lines indicated in Figure 37b. A wide through-cap sheet crack parallel to the inner edge of the side bar was present under the remnants of attachment plate. At the ends of the crack, depressions in the cap sheet were present, consistent with large scale plastic deformation. The crack and depressions are shown in Figure 38.

Figure 37 Simplified drawing of the ACSR with the location of sample S042-B indicated, and a photograph of the sample. Most of the attachment plate had been melted. Dashed lines indicate cuts made with a horizontal band saw. Boxed region is shown in Figure 38.

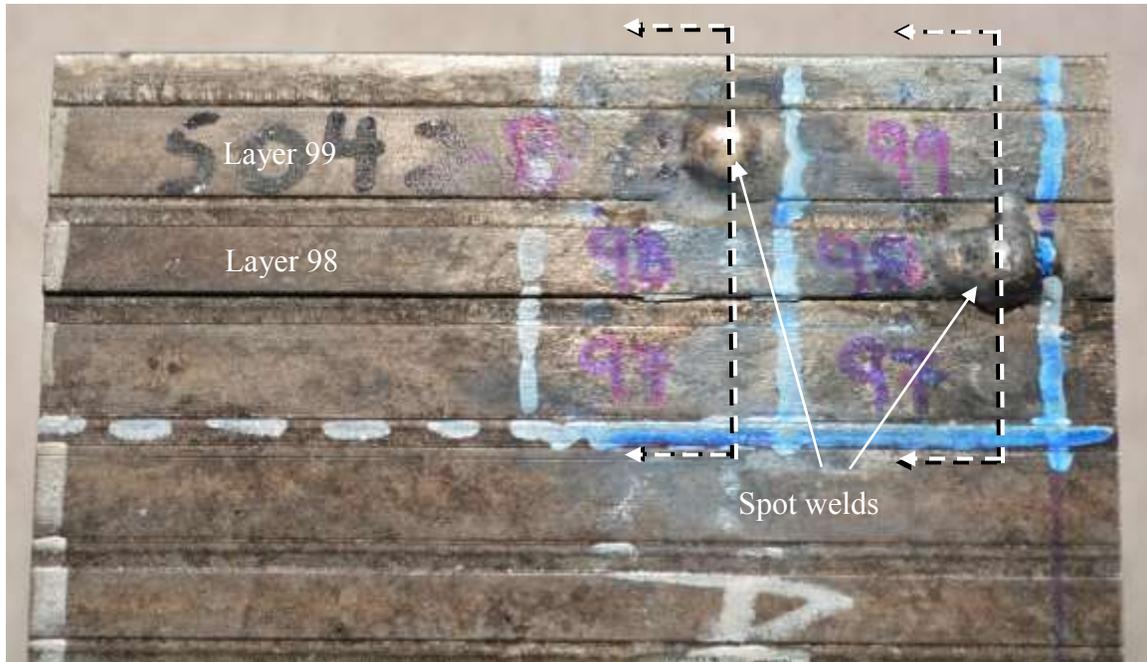
Figure 47 Photographs of the S042-B spot welds and sections through the spot welds. Boxed region in (b) was prepared for metallography.

Figure 46 Photograph of the west side of sample S042-B. Arrows point to two spot welds located on side bars of layers 98 and 97.

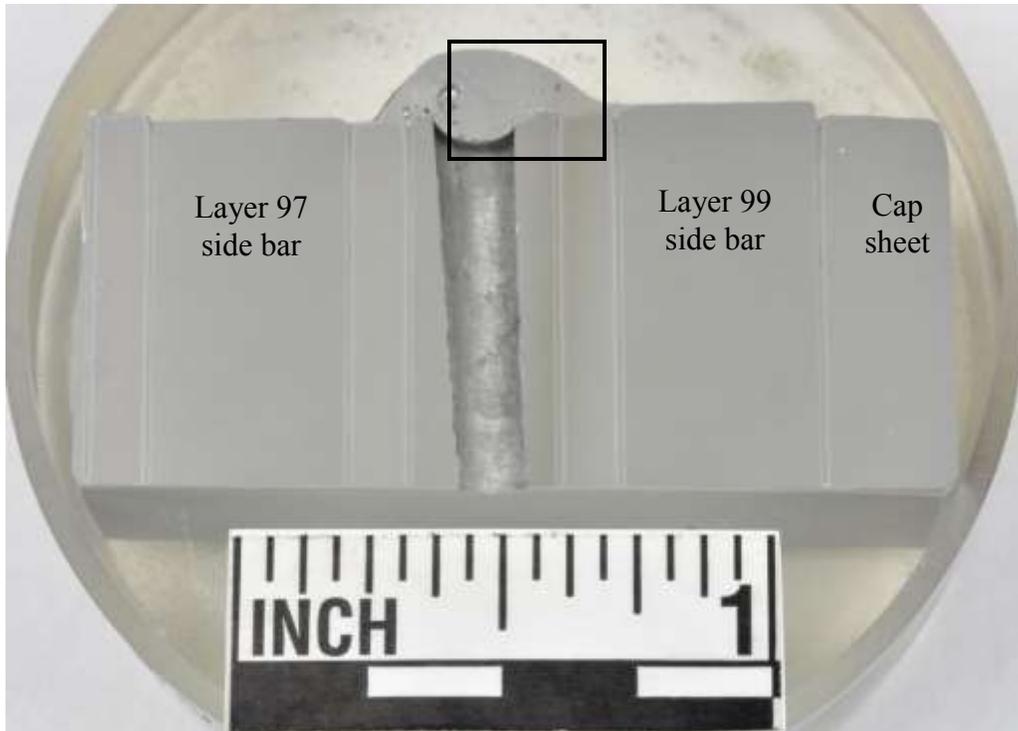
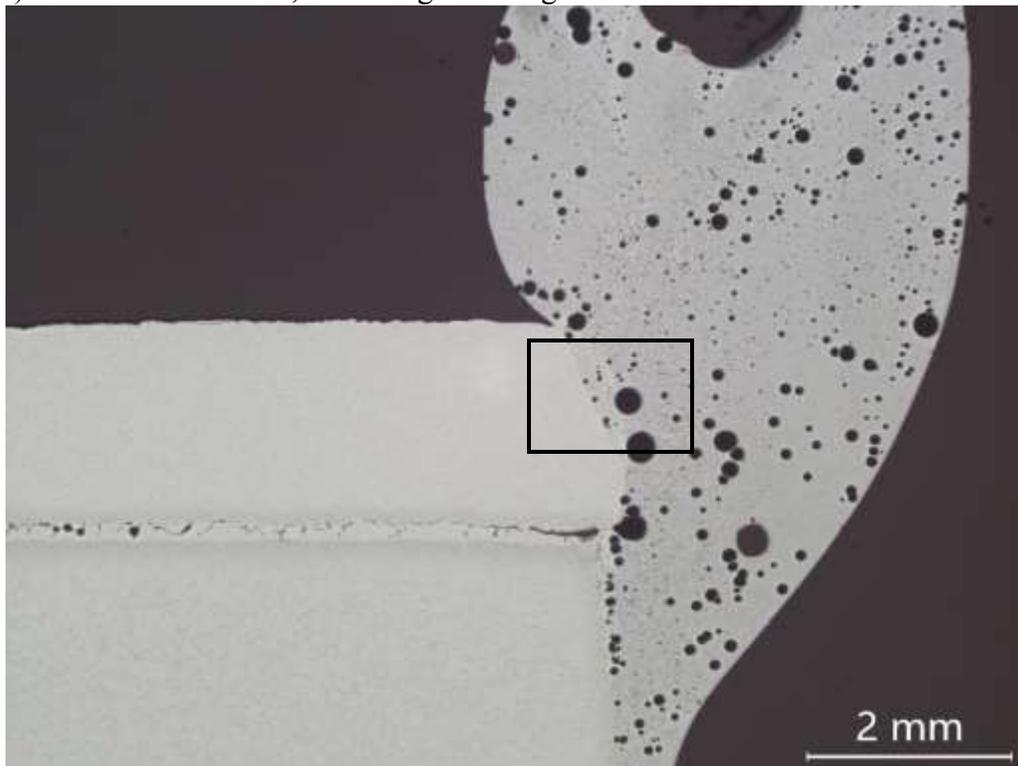
Figure 48 Photograph and micrograph of spot weld section S042-B-1A prepared for metallography. Boxed region in (b) shown in Figure 49.

(a) Section S042-B-1A, boxed region in Figure 47b

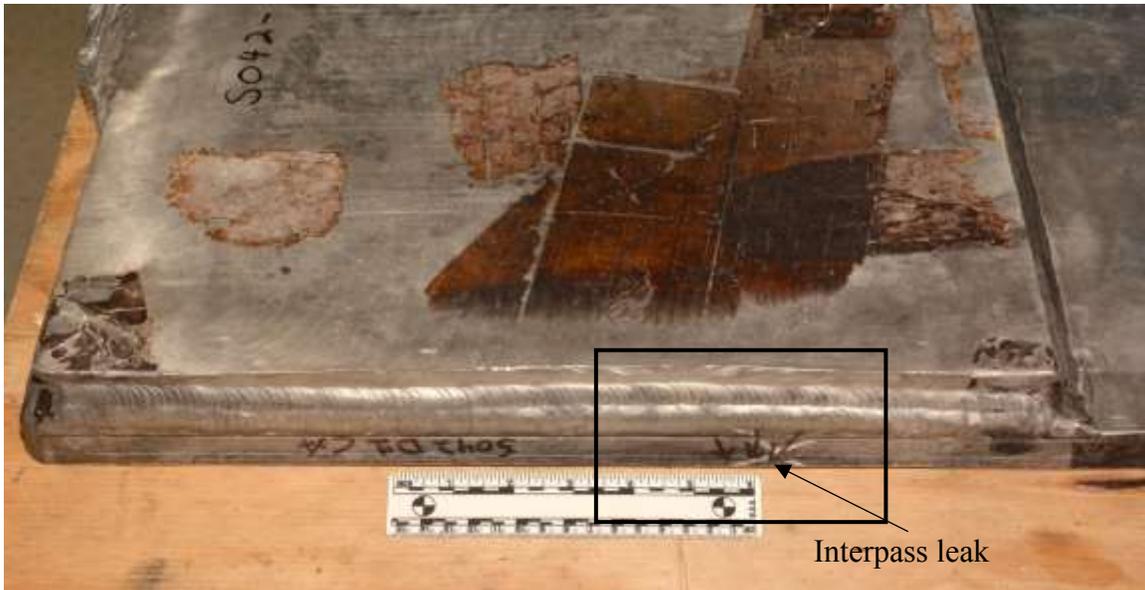
Sample S042-D1 was cut from the top, south side of the ACSR. The sample included the full width of the reboiler, extended from the B pass outlet header weld to approximately 6-inches below the attachment plate, and contained the layer 1/2 parting sheet, cap sheet, and attachment plate. A simplified drawing with the location of sample S042-D1 indicated, and a photograph of the sample are shown in Figure 50. The sample was in good condition visually. The CSB reported that during leak testing before the reboiler was cut into samples, an interpass leak had been detected between layers 1 and 2. The leak location was marked on the outside of the sample, shown in Figure 51, although the leak itself was internal.

Figure 51 Photograph of Boxed region in Figure 50a. Layer 1 to 2 internal leak location, indicated by arrows, was reported by the CSB to have been detected during leak testing prior to cutting the ACSR. Dashed lines in (b) indicate where the section shown in Figure 54 was cut.

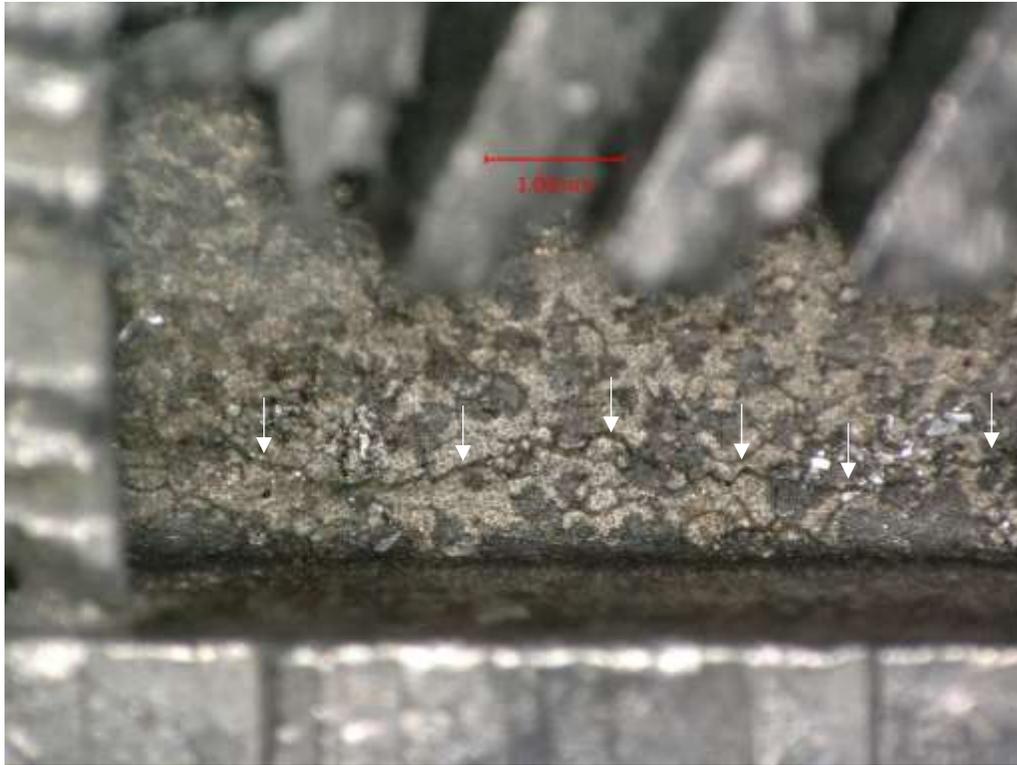
Figure 53 Images of the interpass crack between layers 1 and 2, viewed from the layer 2 side. Arrows point to the crack.

The attachment plate was removed from sample S042-D1 by milling a continuous slot approximately 0.5-inch inside of the edge of the attachment plate. With the attachment plate removed, visual examination and visible dye penetrant testing (PT) was performed on the cap sheet. No crack indications were detected. Both sides of the sample were cut approximately 4-inches inboard of the outer edges with a band saw. Visual examination of the layer 2 side of the parting sheet was performed where gaps in the fin sheets exposed the parting sheet. A crack in the corner formed by the west side was found that corresponded to the interpass leak location, indicated in Figure 52. The visible crack path tended to follow interdendritic regions of the parting sheet braze alloy. Low-power optical images of the crack are shown in Figure 53.

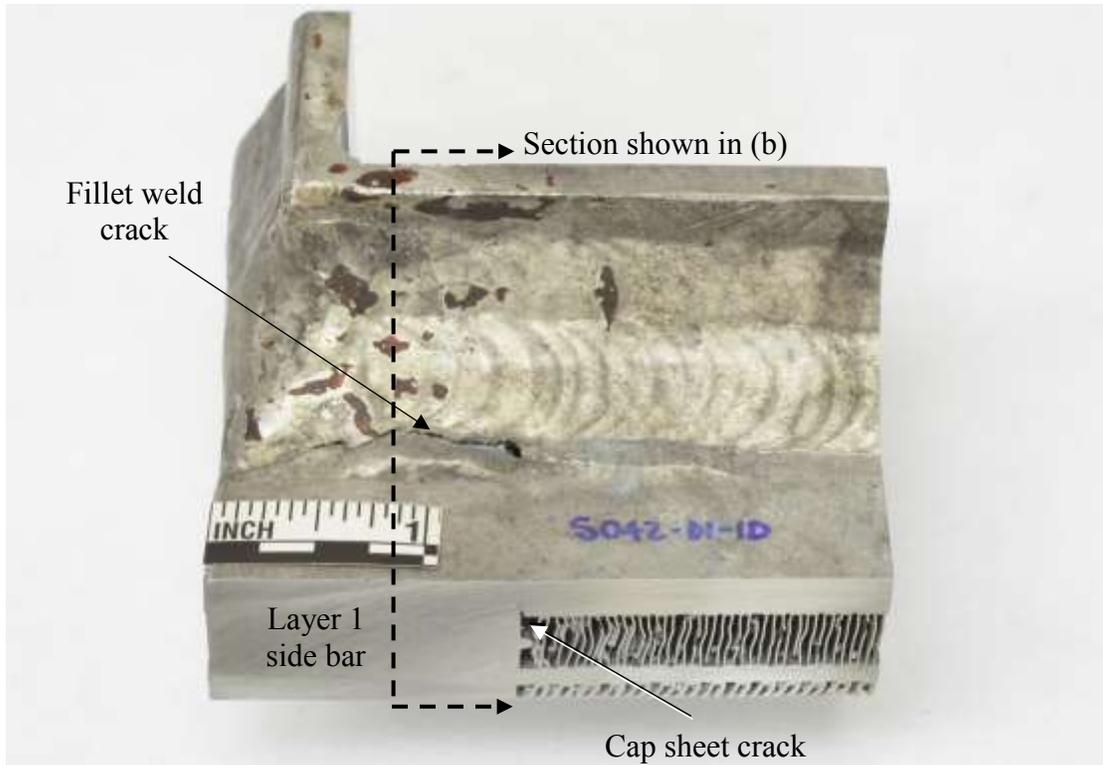
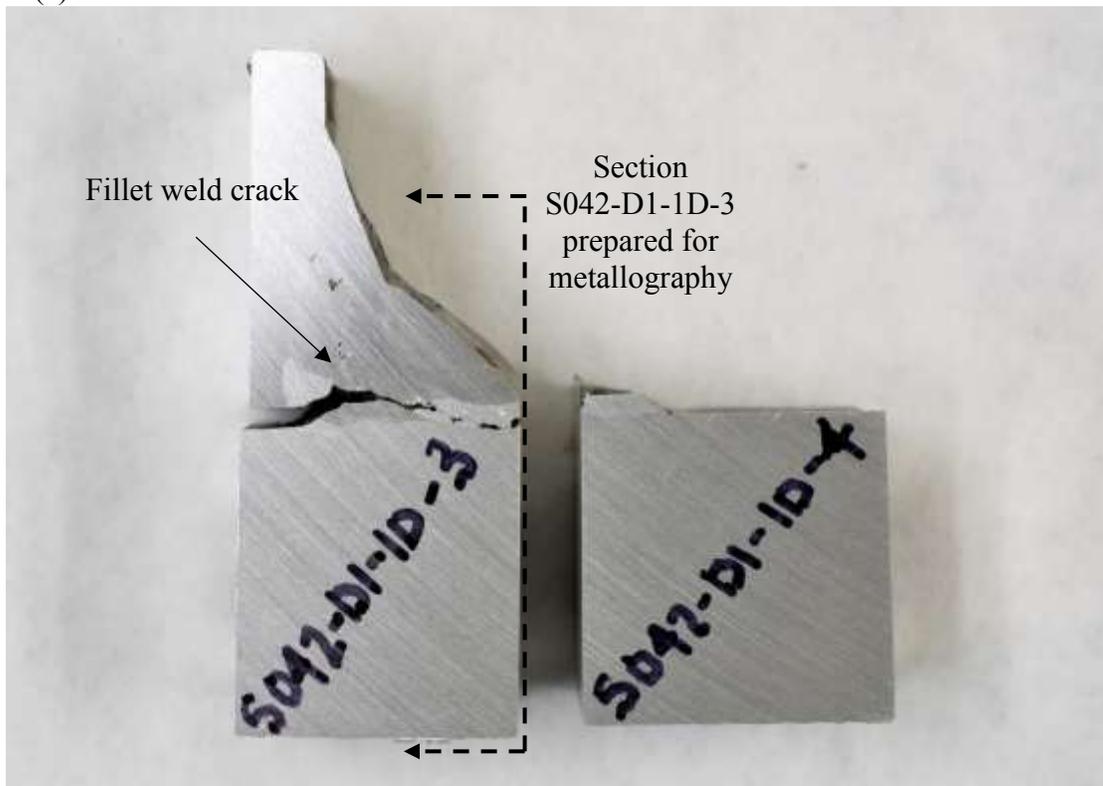
Figure 58 Photographs of sections through the sample S042-D1 attachment plate corner. The location of section S042-D1-1D-3 is indicated in Figure 52a.

A crack was visible in the west corner of the attachment plate lower edge fillet weld. A leak test performed during this evaluation indicated the crack extended through the fillet weld. As shown in Figure 58, the crack path closely followed the plane of the cap sheet and extended from the toe of the fillet weld through the root of the weld. Examination of the fillet weld crack indicated that it intersected an extension of the cap sheet crack in section S042-D1-1D-1.

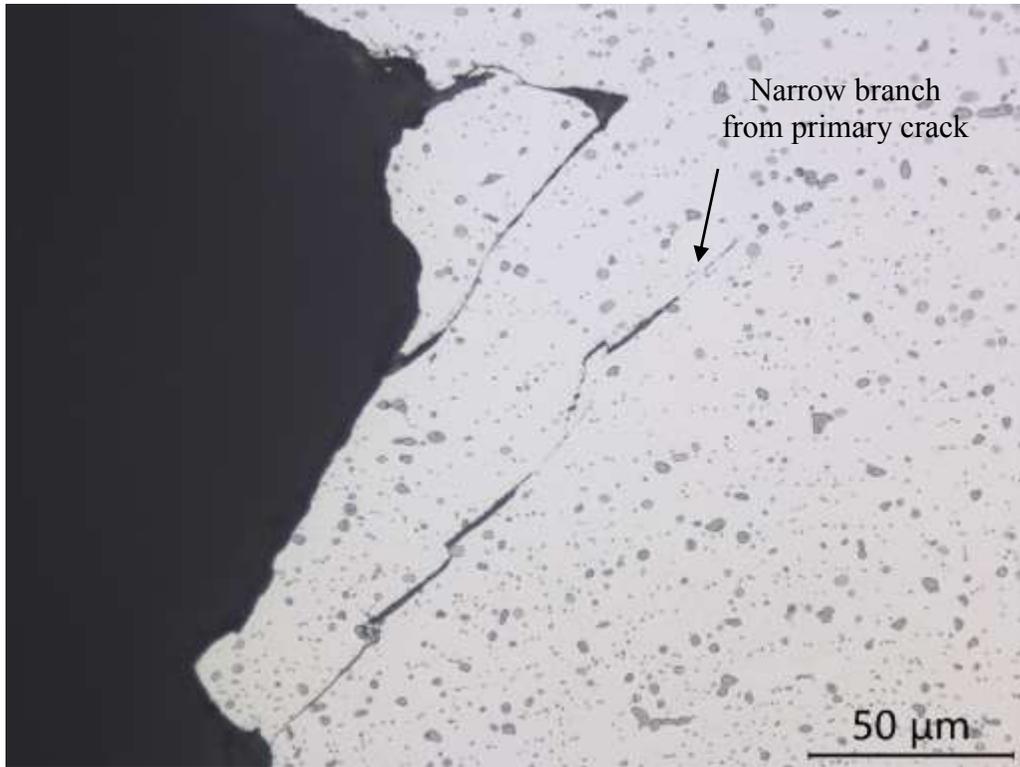
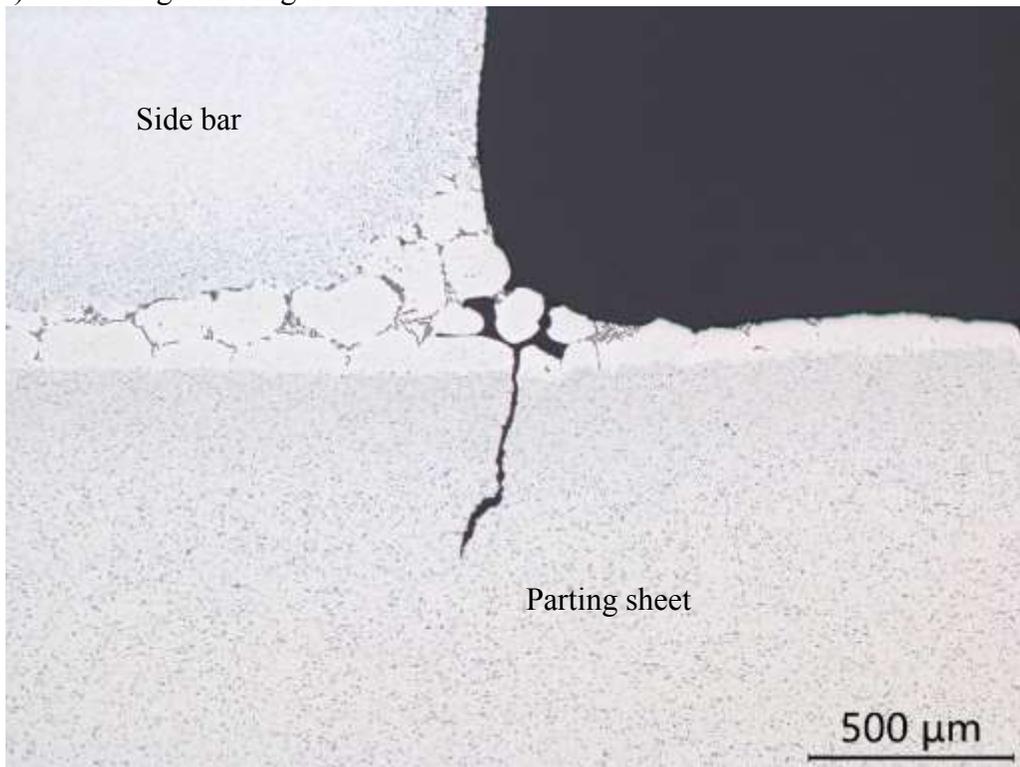
Figure 65 Micrographs of the section shown in Figure 64a.

Photographs and micrographs of the sections are shown in Figure 62 through Figure 65. All of the main cracks in these sections had been widened (blunted) by plastic strain. The predominantly uniform width of the individual cracks, indicated that a single strain event was responsible for the widening. Crack branches and cracks that were outgrown by neighboring cracks were narrow, consistent with high cycle fatigue cracks. These narrow cracks represent the character of the wide cracks before the plastic strain event, most likely the fire, caused larger than normal stresses and strains in the ACSR.

Figure 64 Photograph and micrograph section S042-D1-1C2 indicated in Figure 52a. The cap sheet crack initiated on the inside of the cap sheet and the parting sheet crack initiated on the layer 1 side of the parting sheet.

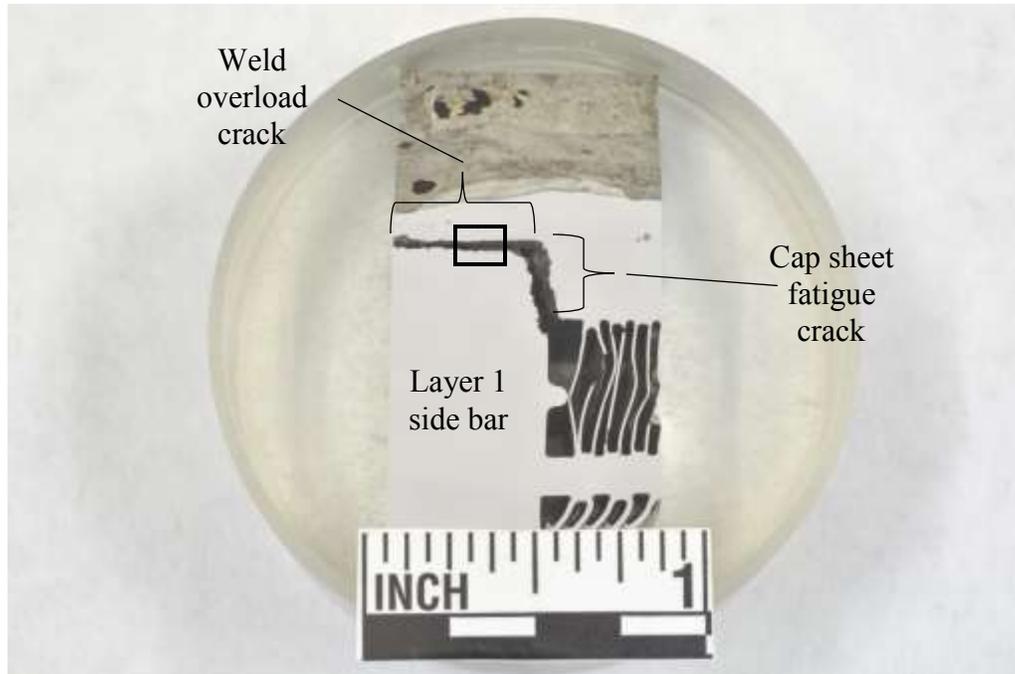
Figure 66 Photograph and micrograph section S042-D1-1D-3, cap sheet crack and attachment plate fillet weld crack. Section indicated in Figure 52a and Figure 58b.

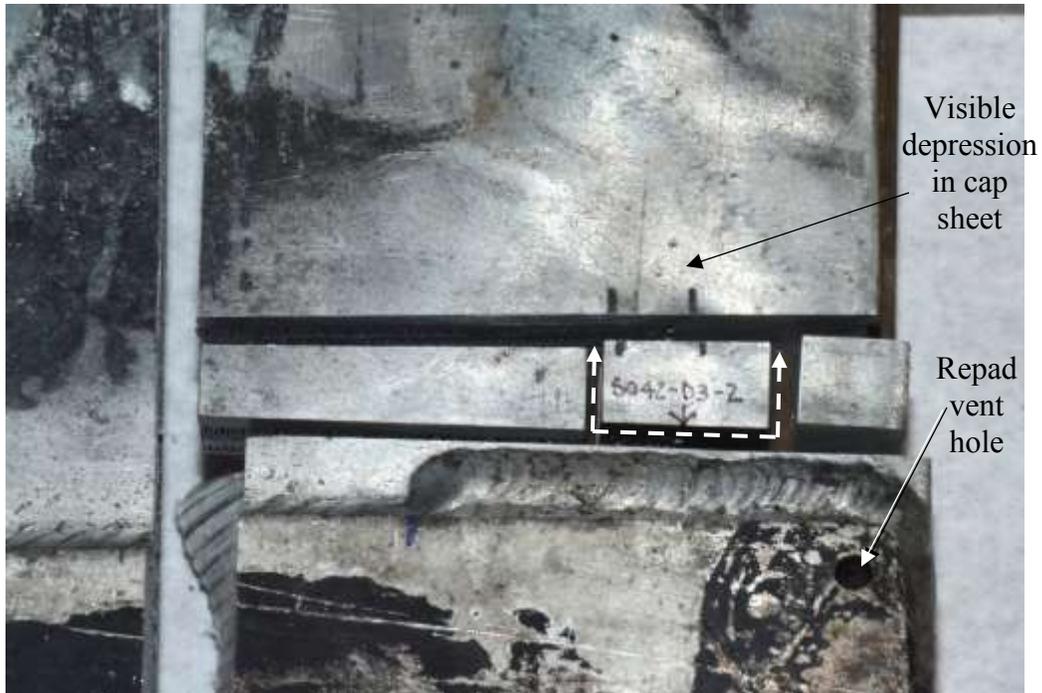
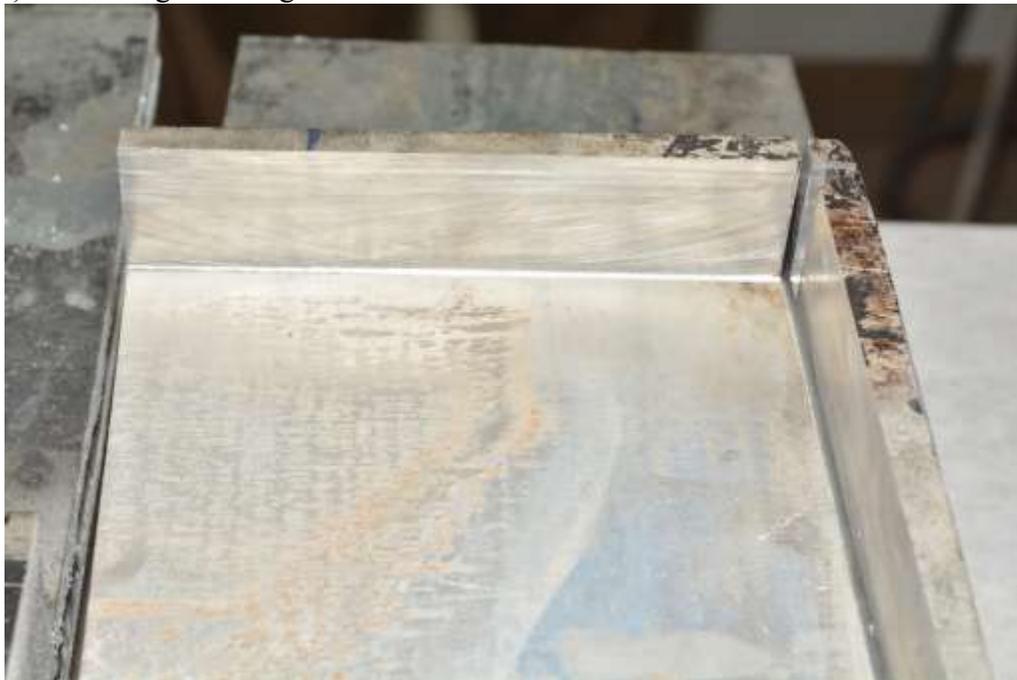
Figure 68 Photographs of the sectioned corner of sample S042-D3.

A depression was visible in the cap sheet at the upper east corner of the attachment plate. In the other samples, similar depressions were found to be associated with cap sheet fatigue cracks that initiated on the inside surface in the corner formed by the side bar. The sample was cut through the depression, resulting in section S042-D3-2 indicated in Figure 68a. The attachment plate was removed from this region by cutting near the edge with a circular saw. No cracks in the cap sheet under the attachment plate or in the depression above the attachment plate were detected.

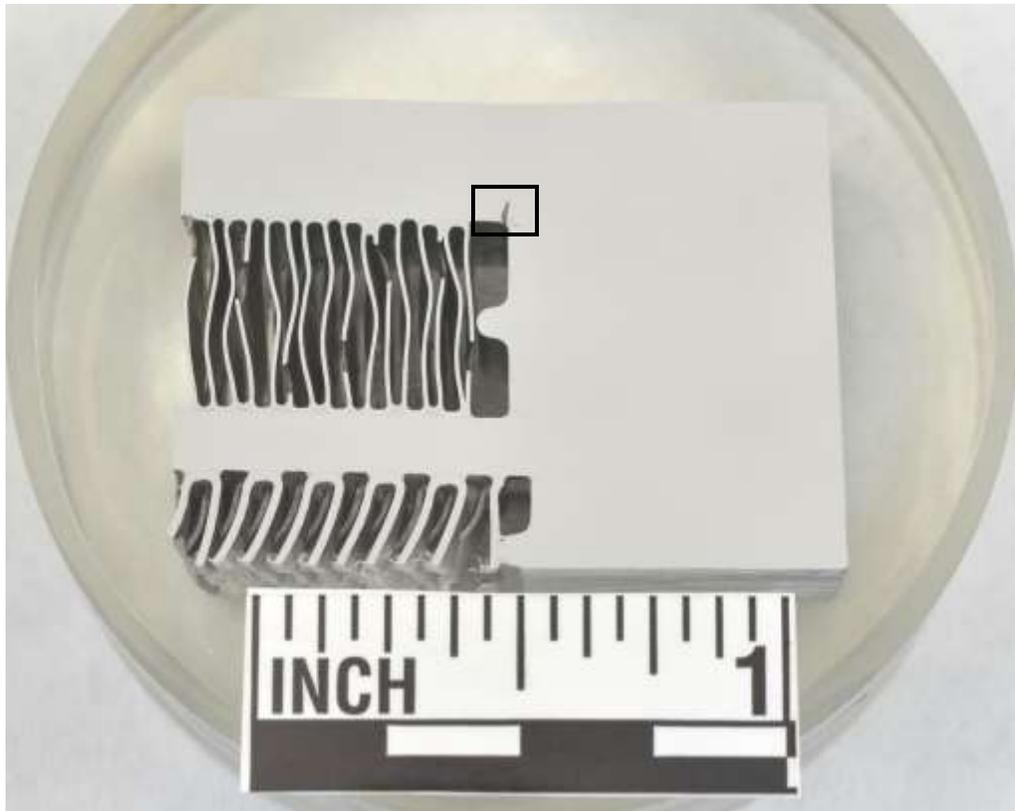
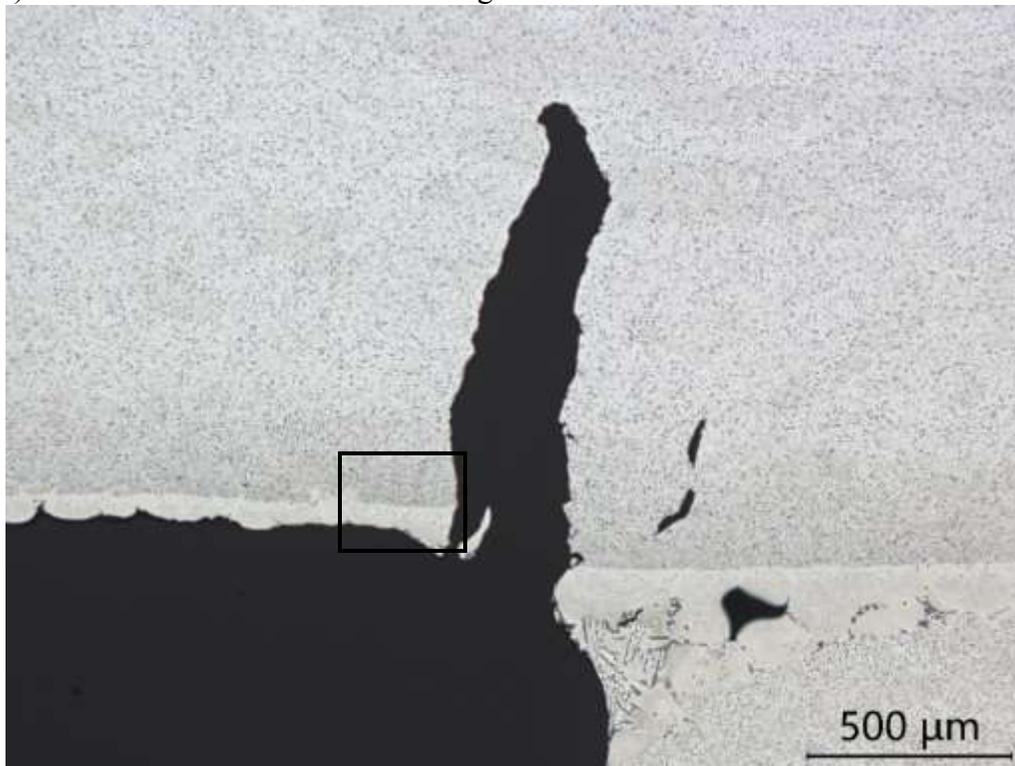
Section S042-D3-2, indicated in Figure 68a, was prepared for metallography using the same techniques as described in previous sections of this report. A photograph and micrographs of the section are shown in Figure 69 and Figure 70. A short, wide crack that had initiated on the inside surface of the cap sheet was present under the depression visible on the outside surface. A shorter, narrow crack was present next to the larger wide crack. Based on the examination of other similar crack faces, the two cracks initiated and grew by fatigue. The narrow crack indicates the two cracks initiated at the same general time, but the larger crack grew faster, eventually shielding the smaller crack from cyclic stresses. When a large strain/stress event occurred, likely caused by the fire, the longer crack blunted, but because the smaller crack was shielded by the larger crack, it remained narrow. Therefore, the smaller crack represents the typical width of fatigue cracks that grew in the ACSR during normal service conditions.
