Structural Performance and Collapse Sequence

Didion Corn Mill Facility – Cambria, Wisconsin
Grain Dust Explosions – Event of May 31, 2017
CSB Investigation 2017-07-I-WI

Prepared by **Atlas Engineering, Inc.**
551A Pylon Drive, Raleigh, NC 27606
Report date: May 12, 2023

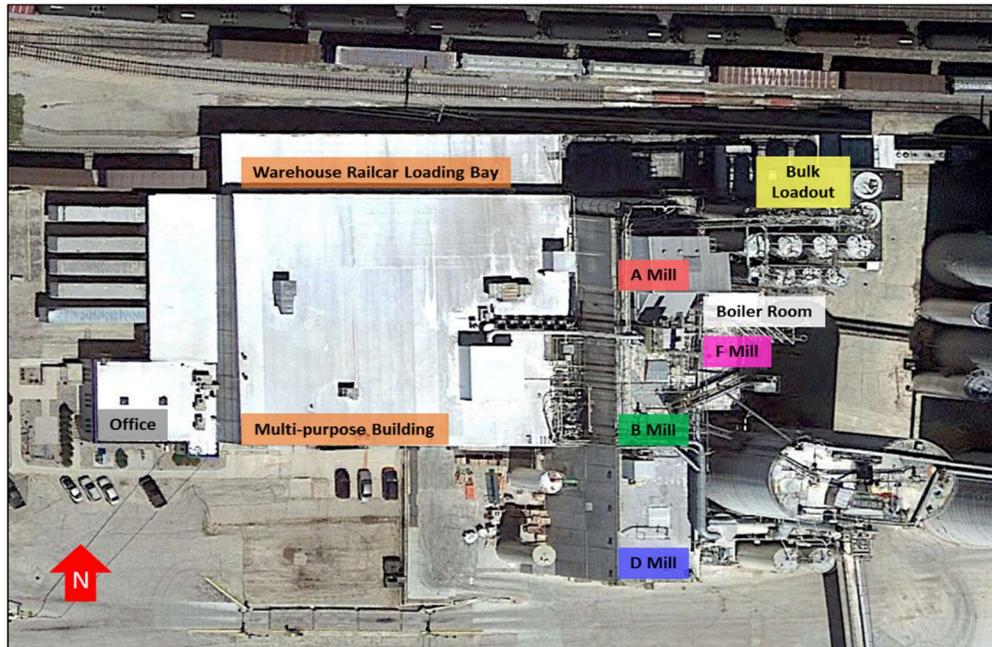
Pre-blast layout of mill buildings.
 (photo/diagram by CSB)

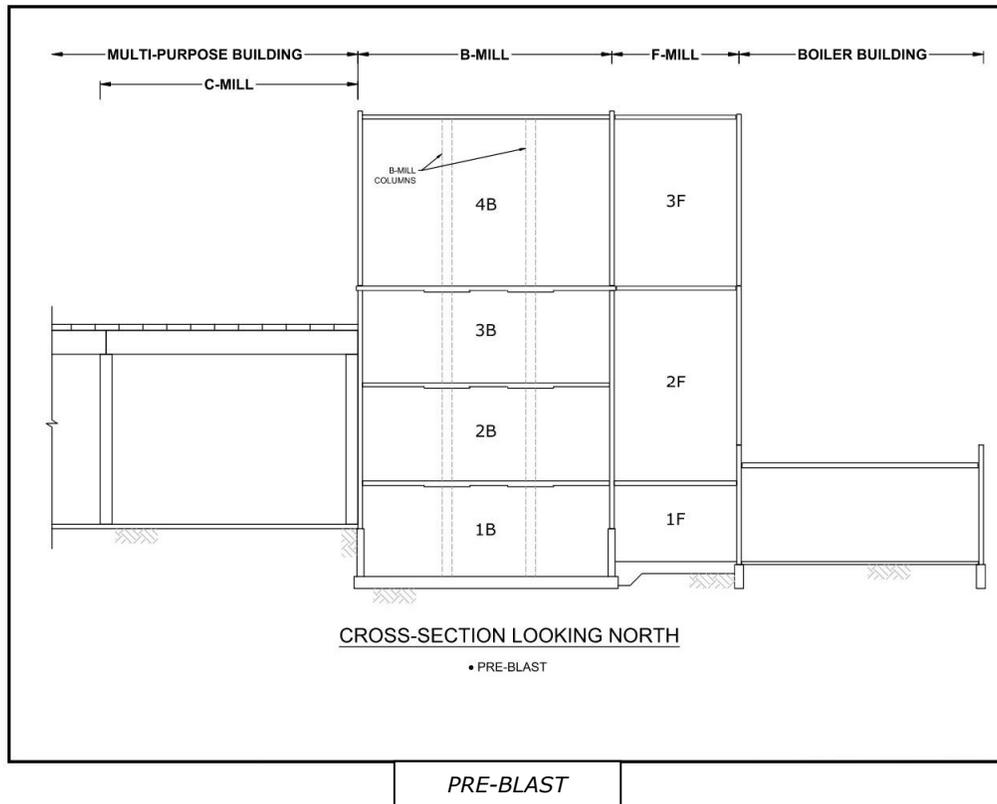
The following diagram is a cross-section view, looking north, across a portion of the facility that includes C-Mill, B-Mill, F-Mill, the Boiler Building, and a part of the Multi-Purpose Building. This view shows how these buildings were structurally interconnected.

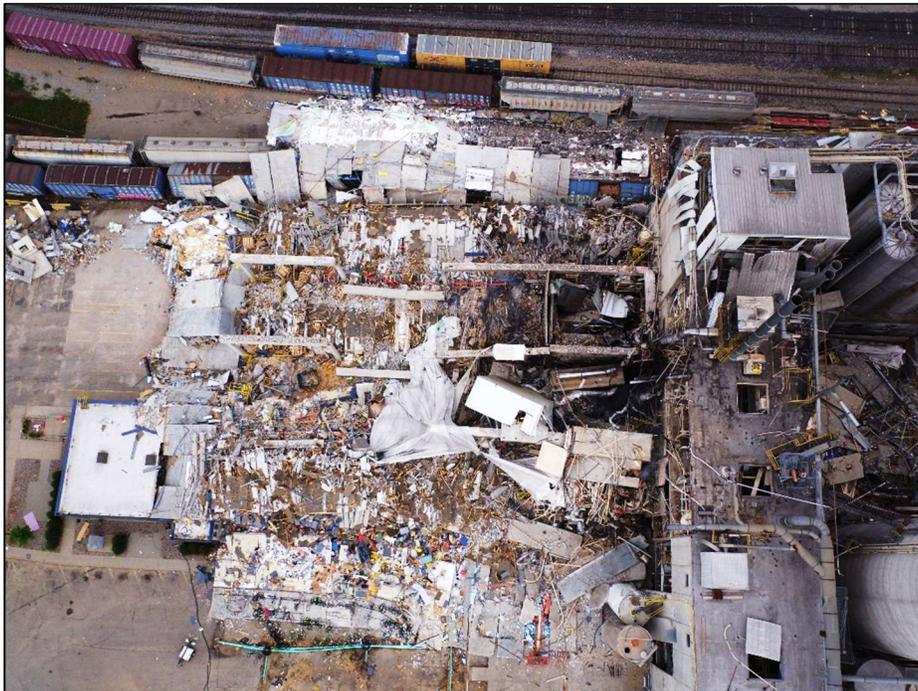
B-Mill and D-Mill were of **hybrid construction**, with cast-in-place columns and floor slabs, and tilt-up concrete panels for exterior walls. At these two buildings, the cast-in-place components survived relatively intact, while most of the tilt-up wall panels were either heavily damaged or had blown off the buildings entirely.

The construction of C-Mill, F-Mill, the Boiler Building, and the Multi-Purpose Building included load-bearing **pre-cast and tilt-up** wall panels, and **pre-cast** floor and roof panels. These buildings collapsed completely. Blast loads broke apart weak structural connections and the heavy, destabilized components drove progressive, total collapse. This is a typical destruction sequence for pre-cast and tilt up structures, where damage is often disproportionate to the triggering event.

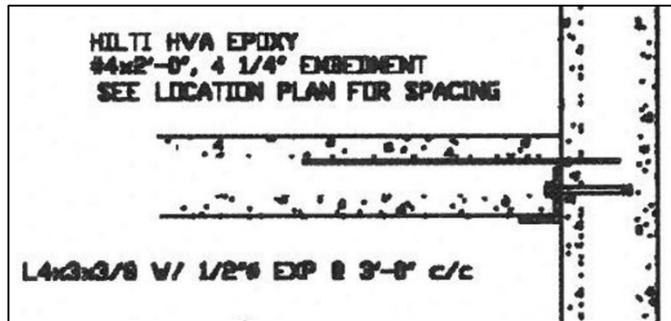
Wall panel connections at B-Mill: Where the panels were mounted outboard of the slab, 24" long, 1/2" diameter steel reinforcing bar dowels were set into 4-1/4" holes drilled into the panels.

The dowels were adhered in the drill holes with an epoxy product made by the Hilti company. The long end of each bar was embedded into the outer edge of the cast-in-place concrete floor and roof slabs. The spacing of the bars varied from 12" to 36".

*B-Mill floor slab/ /wall panel connection
(detail, B-Mill plans)*

Specifications from Hilti show that the epoxy connections at B-Mill, if properly made, would carry over 12,000 lbs of tension before failing. At this load the 1/2" bars would yield (permanently stretch), and the concrete around the hole would spall and show substantial damage. To stress the dowels to this level at a typical B-Mill panel would require an internal blast pressure of 2 to 3 psi.

Where panels separated from the buildings, post-blast photos show the dowels still embedded in the floor and roof slabs. This means the connections failed at the epoxy connections at the wall panels.
