U.S. Chemical Safety and
Hazard Investigation Board

Explosions, Fires, and Toxic Ethylene Oxide Release at Dow Louisiana Operations

Plaquemine, Louisiana | Incident Date: July 14, 2023 | No. 2023-03-I-LA

Investigation Report

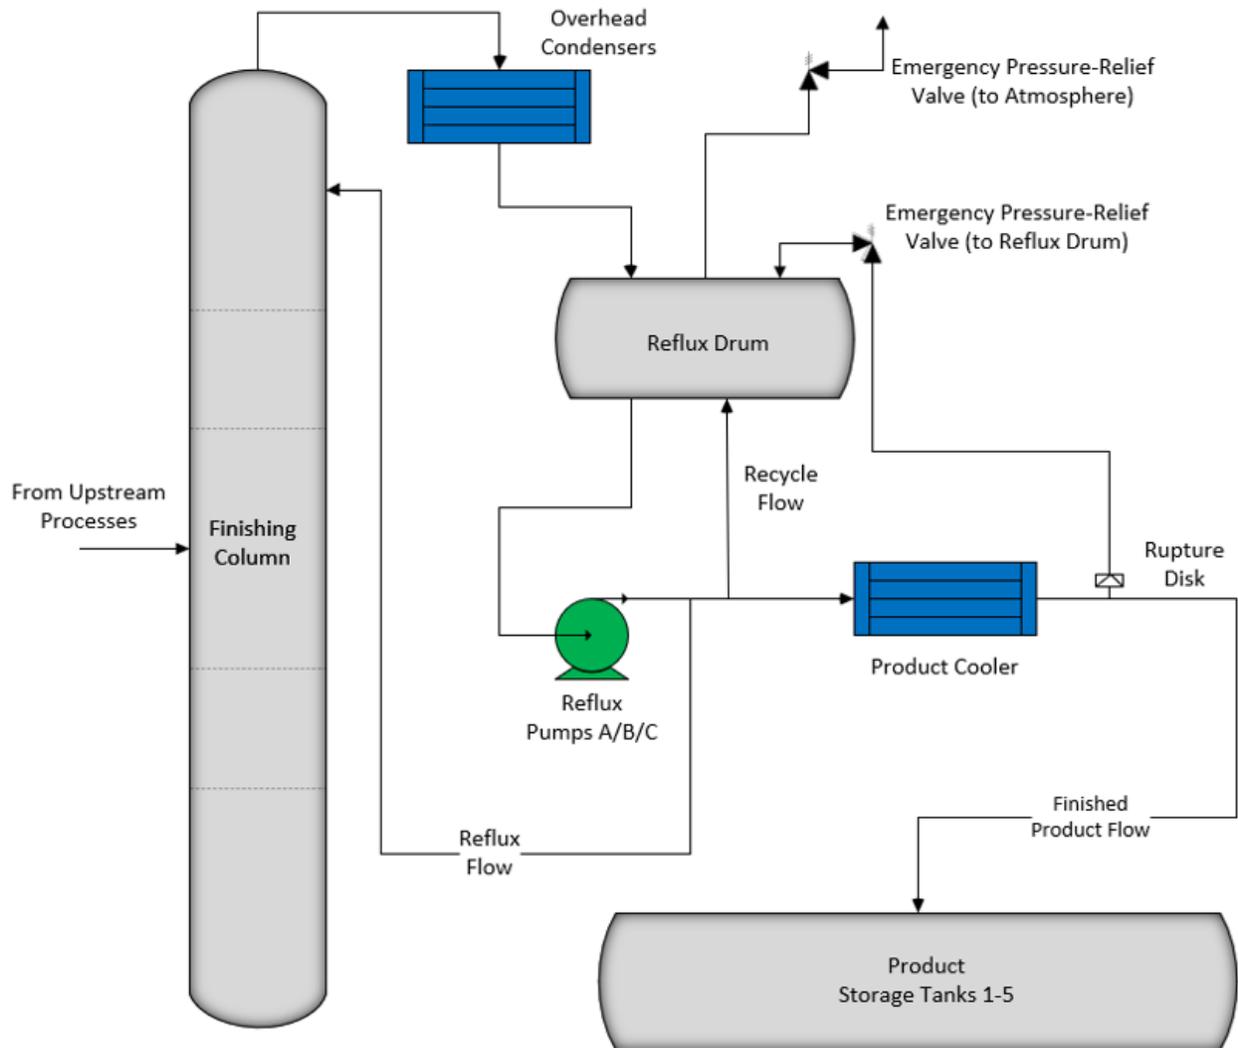
Figure 1. Simplified process flow diagram of the ethylene oxide Finishing Process. (Credit: CSB)

During normal production operations, the majority of the liquid ethylene oxide leaving the reflux drum was pumped back into the finishing column as reflux flow, with a smaller fraction of the liquid routed through a product cooler to one of five finished product storage tanks as finished product flow. The remainder of the reflux drum's outgoing liquid was returned to the reflux drum as recycle flow.

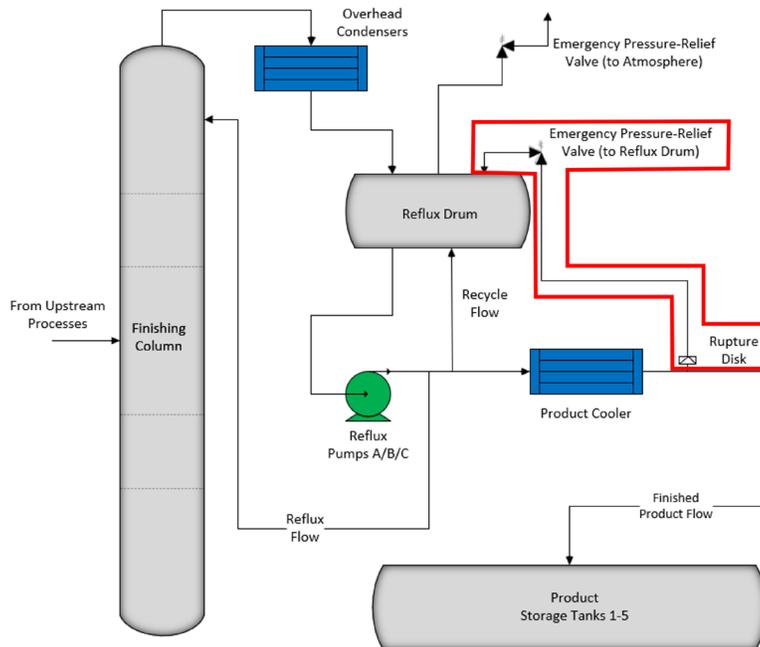
Figure 2. Simplified process flow diagram of the ethylene oxide Finishing Process, with highlighted Product Cooler's Emergency Pressure-Relief System. (Credit: CSB)

At the time of the incident, the product cooler was protected from a thermal overpressure event by a rupture disc and an emergency pressure-relief valve (PRV) in series^b installed downstream of the product cooler (see **Figure 2**). The rupture disc and pressure relief were intended to provide relief in the event of the product cooler being blocked in and heated at a faster rate than the ethylene oxide could safely handle.

The rupture disc and the PRV were separated by approximately 50 feet of four-inch diameter pressure relief piping. Dow installed a pressure-indicating transmitter on this piping segment that included an alarm set at 80 psig to detect a disc rupture or leak.^a Both the rupture disc and the PRV were set to relieve at 265 psig. Once the overpressured liquid or vapor was discharged from the PRV, it was routed back to the reflux drum, as shown in **Figure 3.**^b

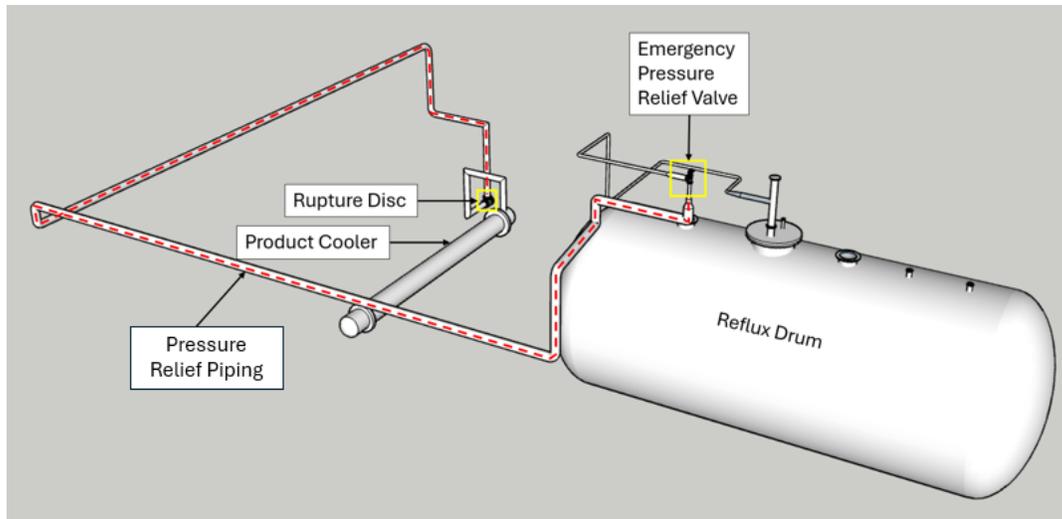
Figure 3. Schematic of product cooler and its emergency pressure-relief system components in relation to the reflux drum. (Credit: CSB)

^b The reflux drum had its own emergency pressure-relief system that was to open at 75 psig, and to release its' effluent into the atmosphere.

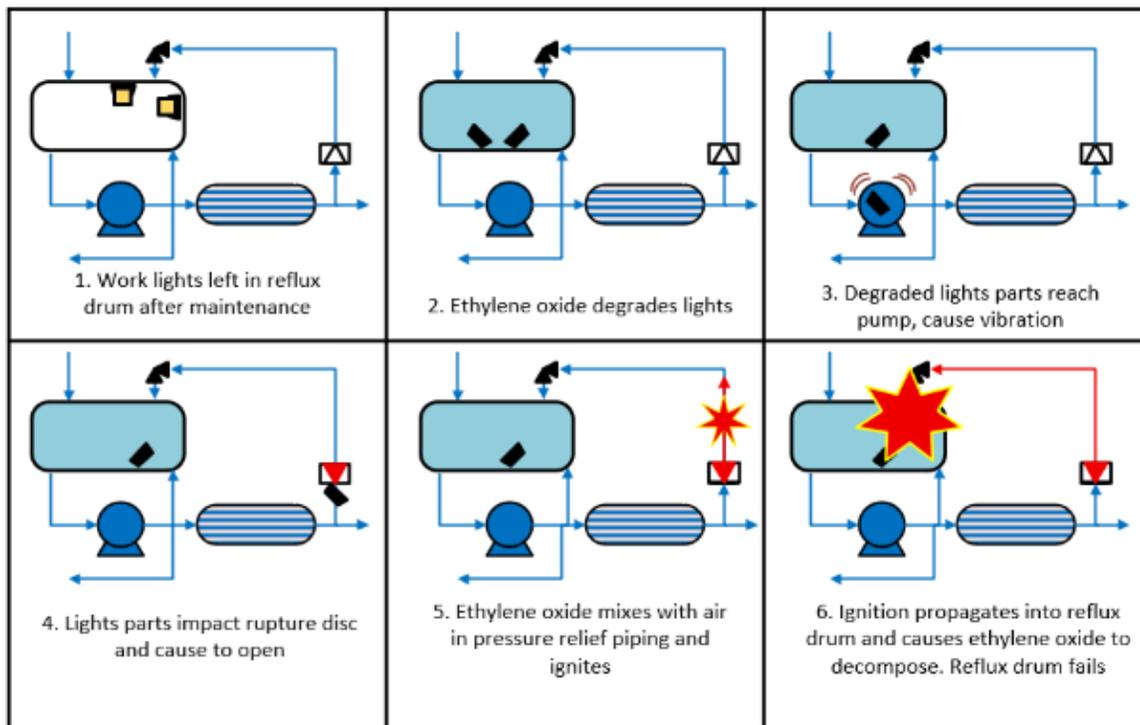
Figure 7. Chain of events of the incident (Source: CSB)

The explosion occurred when a reflux drum containing liquid and vapor ethylene oxide failed catastrophically. The chain of events began when metal debris from portable work lights that had been left in the drum impacted a rupture disc, causing it to partially open, allowing ethylene oxide to flow into pressure relief piping, which contained air. The ethylene oxide ignited and propagated through the pressure relief piping into the reflux drum. The heat from the flame front caused the liquid ethylene oxide within the drum to decompose, and the subsequent pressure rise caused the drum to fail.

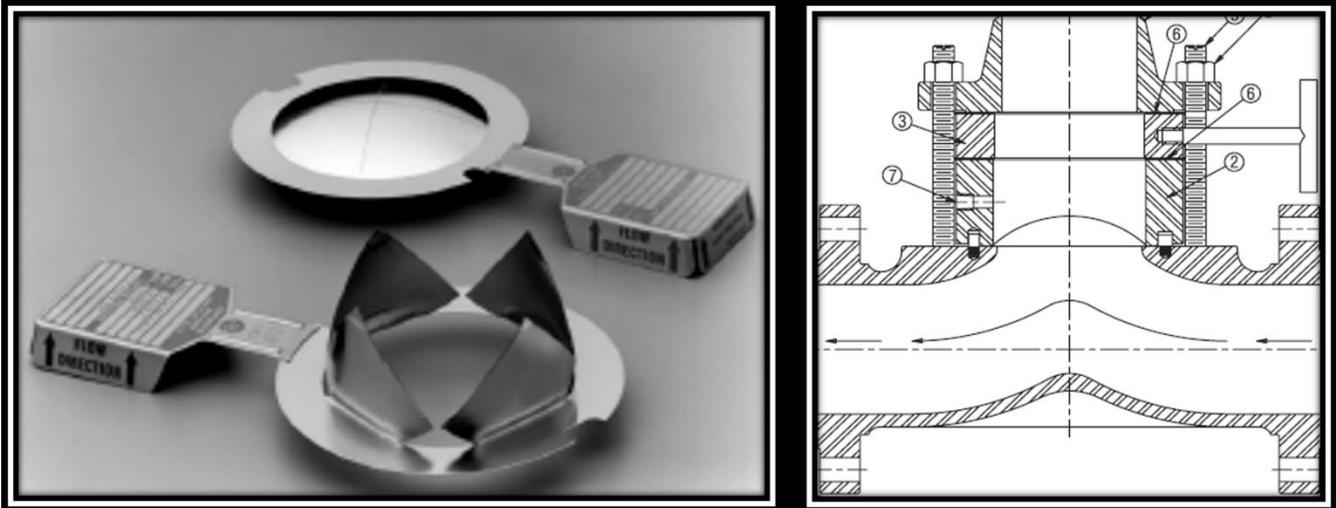
Figure 11. Rupture disc of the type used in the product cooler pressure relief line (left) before (above) and then after (lower) a full rupture [11] and a cross-section schematic of the rupture disc holder (right) [12]. (Credit: Continental Disc Corporation)

Metallurgical testing and post-incident analysis determined that the rupture disc did not fail in the designed and intended manner as it would in a regular overpressure event. Rupture discs are designed to open in the event of a pressure event in a symmetrical fashion and with minor deformation (**Figure 11**). A “normal” rupture disc opening would have all four portions of the rupture disc open in a symmetrical pattern. The asymmetry of the rupture disc involved in this incident indicates that it likely did not burst from a consistent pressure increase inside the product cooler, but opened through a different mechanism.

Post-incident metallurgical testing of the rupture disc identified small pieces of corroded carbon steel embedded in the rupture disc body. The presence of these small pieces of debris, together with the manner in which the rupture disc opened, indicates that a small hard piece of metal debris likely impacted the rupture disc, causing a hole in the surface of the rupture disc, which resulted in the partial opening of the disc. As the rupture disc was designed for liquid ethylene oxide service and was not intended to withstand metal debris, it most likely failed below the design burst pressure.
