VOLUME: 2 DATE: MARCH 12, 2025

INCIDENT REPORTS

EVENTS REPORTED TO THE CSB UNDER THE ACCIDENTAL RELEASE REPORTING RULE

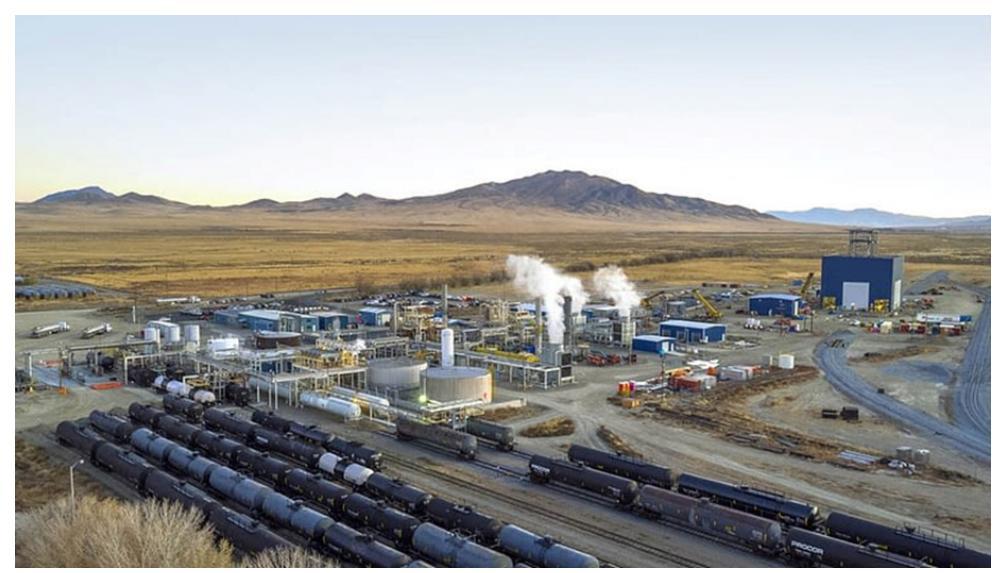
Figure 1. Cyanco Facility in Winnemucca, Nevada (Credit: Cyanco)

At the time of the incident, an operator who was preparing to wash equipment in a process building within the solid sodium cyanide plant felt vapors on their face as they walked over a floor drain and noticed a strong "almond" odor characteristic of hydrogen cyanide, a highly toxic substance used in the production of sodium cyanide. The operator's gas detector sounded its alarm and briefly displayed a high concentration of hydrogen cyanide. The operator was not wearing respiratory protection. Shortly thereafter, the operator began to experience shortness of breath. After taking a short break, the operator's symptoms worsened, including headache, nausea, and fatigue, which along with shortness of breath, are symptoms of cyanide poisoning that can occur rapidly following exposure to hydrogen cyanide. Emergency responders transported the operator to a hospital, where medical professionals admitted the operator and diagnosed cyanide exposure. The operator was successfully treated with cyanide antidote therapy.

Cyanco's investigation did not identify a specific source for the accidental release of hydrogen cyanide. The company examined the floor drain and the equipment near the exposure location but did not identify a release point or develop a plausible scenario for how the release of hydrogen cyanide occurred. In addition, the investigation revealed that although Cyanco workers had assessed the potential hazards related to the planned equipment washing operation before commencing work, they had concluded that the operators did not need respiratory protection because the risk of hydrogen cyanide exposure was low. This led to the operator not wearing protective respiratory equipment at the time of the incident.

Based on Cyanco's investigation, the CSB determined that the probable cause of the incident was exposure to hydrogen cyanide vapors from an unknown source. Contributing to the severity of this incident was that the operator's personal protective equipment (PPE) did not include respiratory equipment that could have protected the operator from hydrogen cyanide exposure. Had the operator been wearing appropriate protective respiratory equipment, the operator likely would have not been exposed to highly toxic hydrogen cyanide.

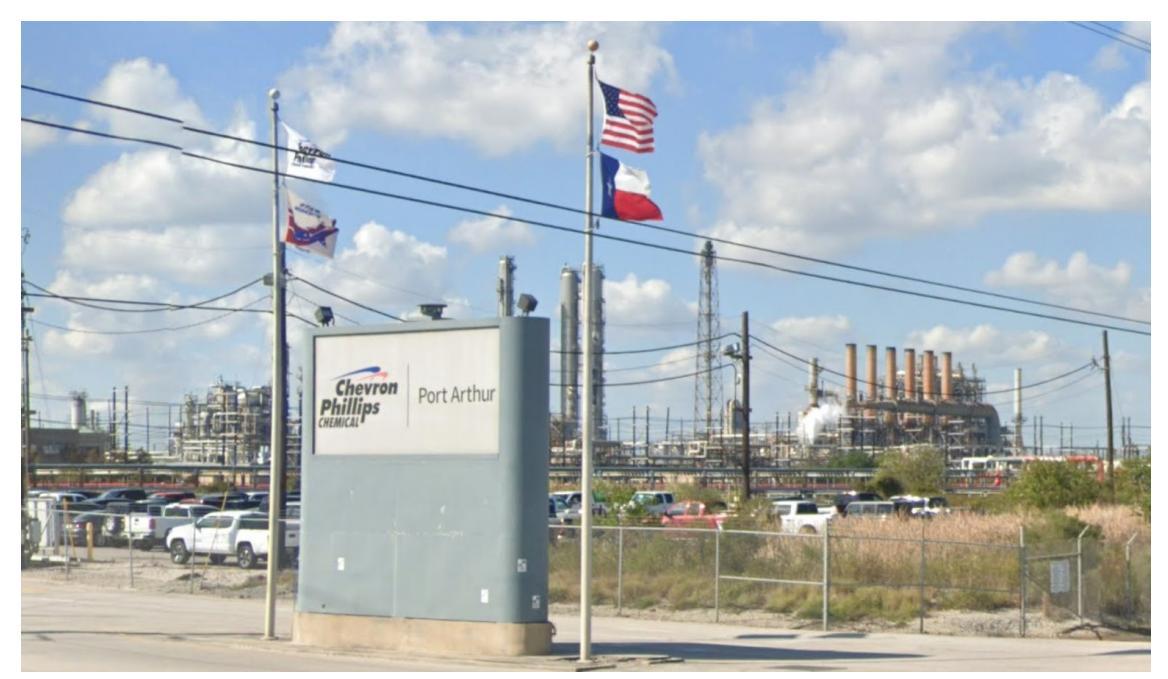
Figure 1. The Chevron Phillips facility in Port Arthur, Texas. (Credit: Google Maps)

Chevron Phillips' investigation determined that freeze-related operational issues due to extreme cold weather from Winter Storm Uri caused the facility's boiler units to shut down. This shutdown decreased the supply of steam and water to an ethylene unit at the facility. A safety system automatically shut the fired heater down due to insufficient steam and water flow. Although the automatic valves closed to prevent feed from entering the tubes, the fired heater's fuel gas isolation valve failed to close as intended. This failure allowed the burners to continue operating. Without any flow through the tubes to remove heat from their walls, the tubes in the fired heater reached excessively high temperatures. Some tubes ruptured, likely due to short-term overheating, but a metallurgical analysis was not performed to confirm the cause of the tube failures (**Figure 2**). When the tubes ruptured, hydrocarbons downstream from the fired heater were released through the broken tubes and ignited by the burner flames inside the firebox, causing a fire.

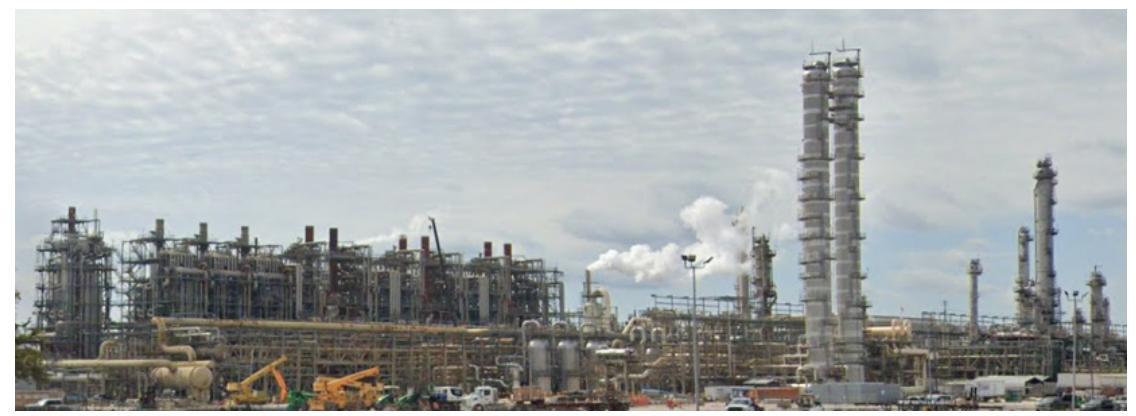
Figure 1. The Chevron Phillips facility in Sweeny, Texas. (Credit: Google Maps)

Chevron Phillips' investigation found that the facility shut down multiple fired heaters when extreme cold weather from Winter Storm Uri caused several freeze-related operational issues. Due to emergency conditions that included utility losses and supplier-driven gas shortages, Chevron Phillips shut down its fired heaters without removing the solidified carbon deposits on the interior walls of the heater tubes (decoking).

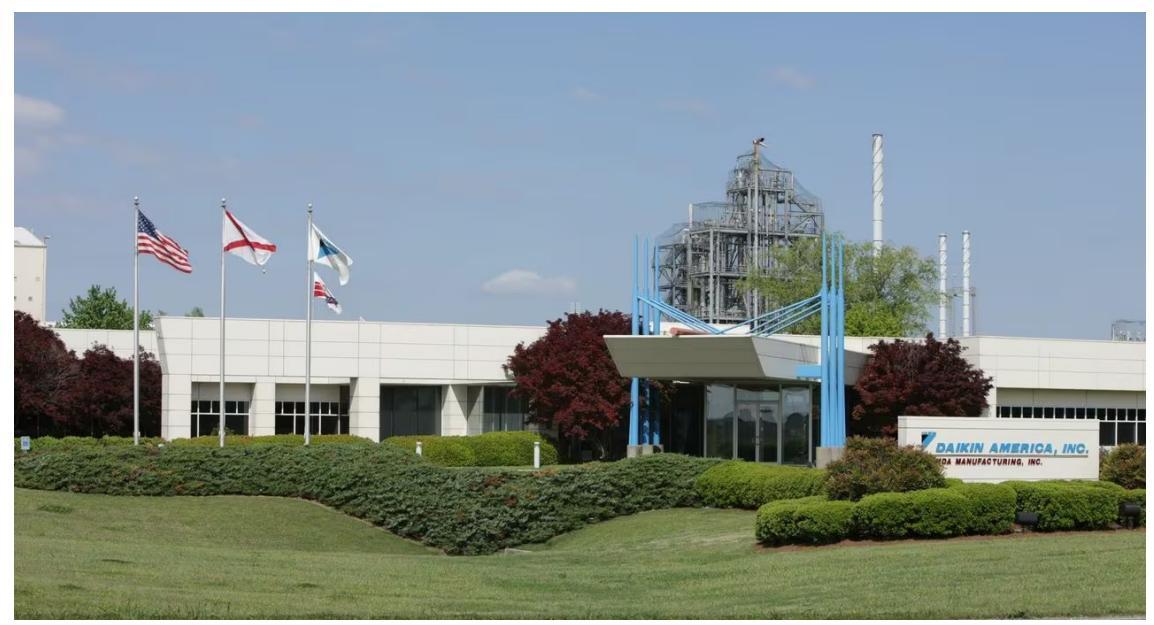
Figure 1. Daikin Facility. (Credit: al.com)

Daikin was returning a drying tower to service after it had been offline for maintenance. After the maintenance activity, this equipment contained air, and Daikin's procedure included steps to remove this air and replace it with R22. To accomplish this, the company used a two-step purge process. First, nitrogen was added to sweep out the air, and second, R22 was added to sweep out the nitrogen. The displaced vapors were released into the ambient air from an open valve about six feet above the ground for each step. The valve was aimed vertically downward, resulting in the vapors being released in a downward direction toward the area where the operators were working.

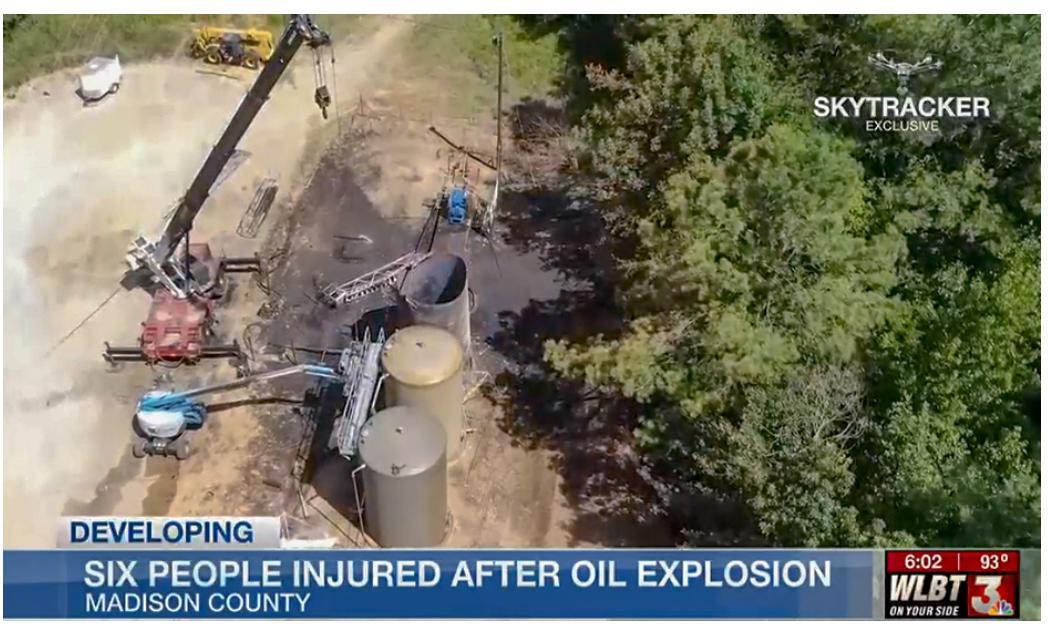
On July 29, 2022, at 7:45 a.m., an explosion and fire occurred at the W.S. Red Hancock ("Red Hancock") facility in Canton, Mississippi. The explosion and subsequent fire fatally injured one employee and seriously injured five other employees (**Figure 1**).

Figure 1. News report image after the explosion at Red Hancock. (Credit: WLBT News)

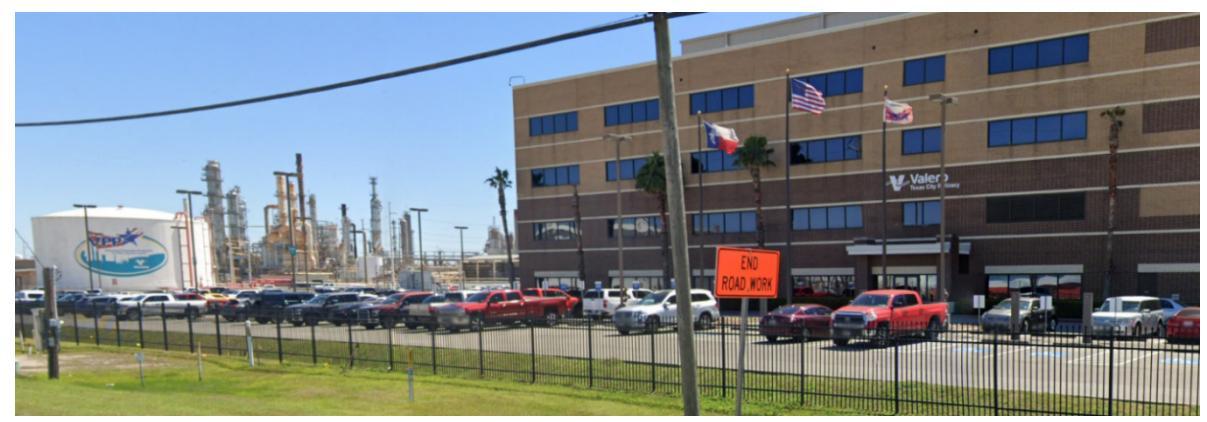
On August 19, 2022, at approximately 3:45 a.m., about 4,000 pounds of a hydrogen and hydrocarbon mixture was accidentally released into the firebox of a fired heater, where it ignited, creating a large fire at Valero Refining-Texas, L.P.'s ("Valero") refinery in Texas City, Texas (**Figure 1**). Valero estimated that the property damage from the incident was \$10 million.

Figure 1. The Valero refinery in Texas City, Texas. (Credit: Google Maps)

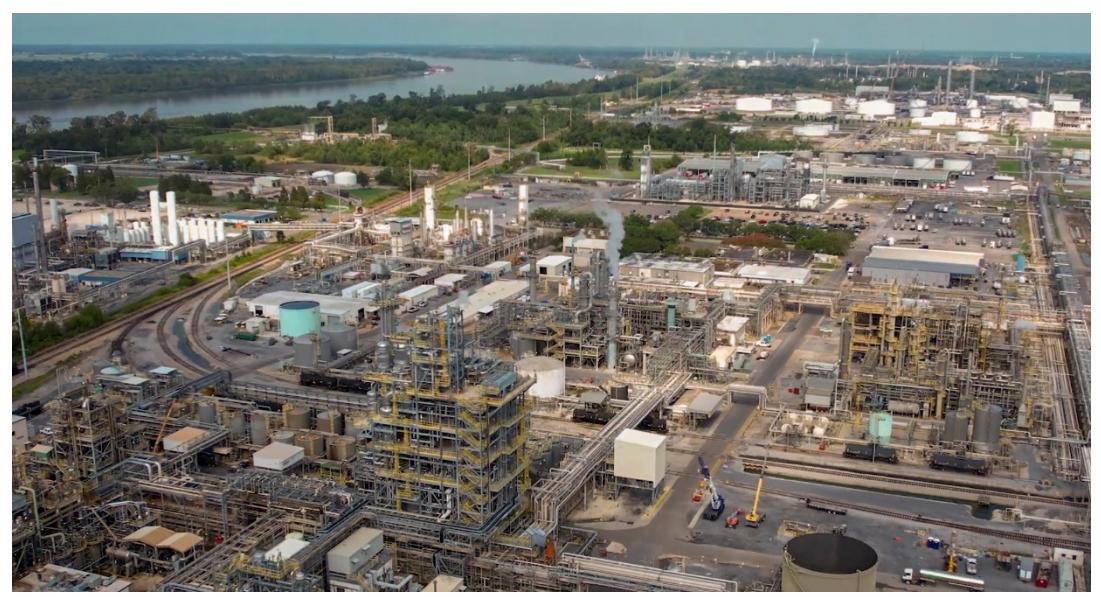
On September 22, 2022, at approximately 9:00 a.m., a liquid mixture comprised of aniline, formalin, and hydrochloric acid was accidentally released, seriously injuring one contractor at the Rubicon chemical manufacturing facility ("Rubicon") in Geismar, Louisiana (**Figure 1**). Rubicon is a joint venture between Huntsman and Lanxess.

Figure 1. Rubicon chemical manufacturing facility in Geismar, Louisiana. (Credit: Rubicon)

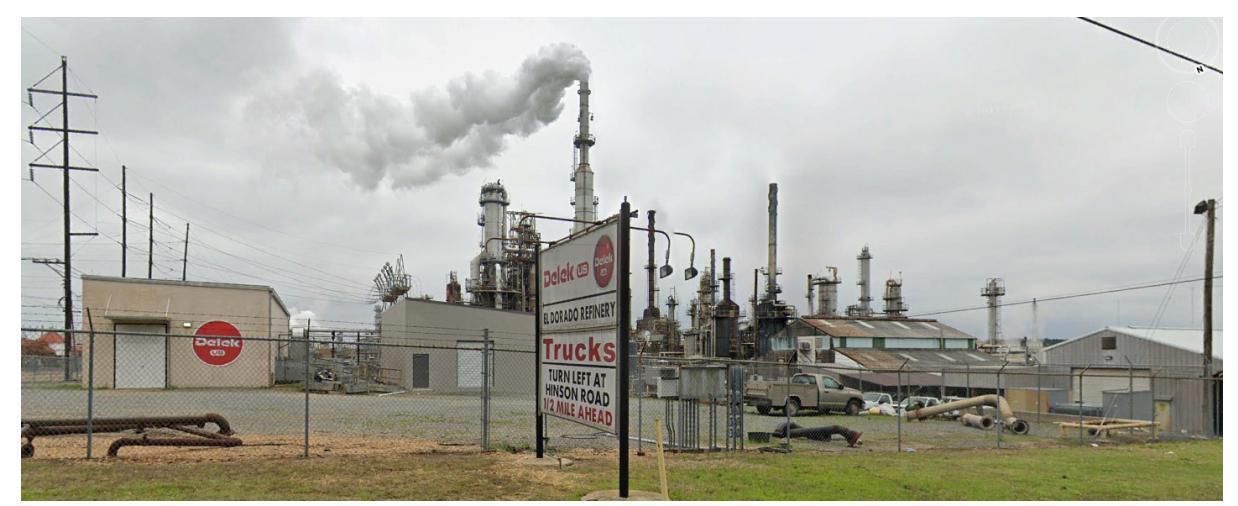
On December 23, 2022, at about 4:08 a.m., approximately 1,800 gallons of naphtha were accidentally released into the firebox of a fired heater, where it ignited, resulting in a serious fire at the Delek US Holdings, Inc.'s ("Delek") Lion Oil Refinery in El Dorado, Arkansas (**Figure 1**). Delek estimated that the property damage from the incident was \$36 million.

Figure 1. The Delek refinery in El Dorado, Arkansas. (Credit: Google Earth)

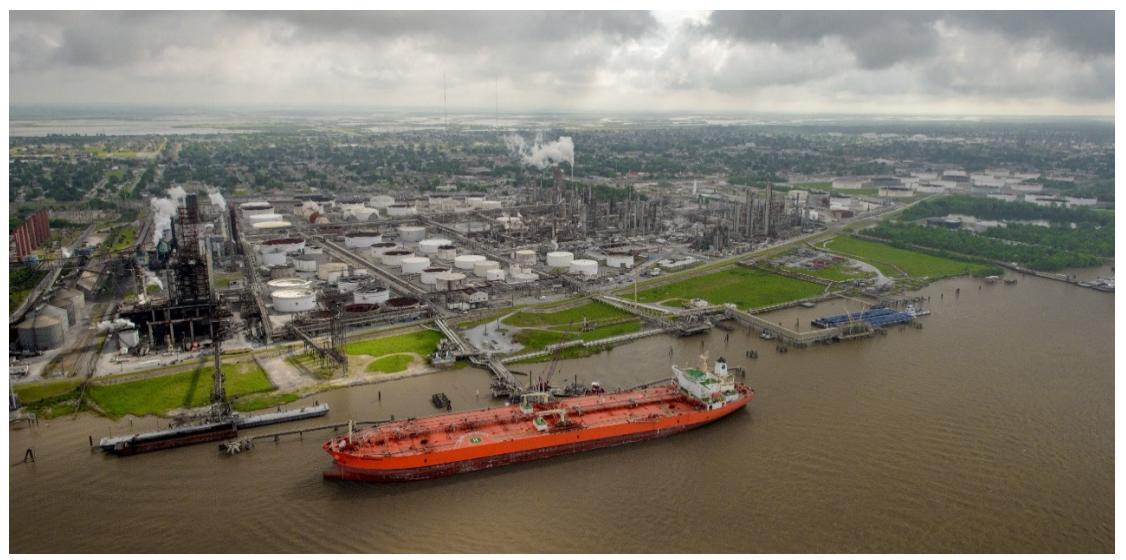
On January 21, 2023, at 1:58 p.m., a mixture of hydrogen and hydrocarbons was accidentally released into the firebox of a fired heater, where it ignited, resulting in a large fire at the Chalmette Refining, L.L.C.'s refinery in Chalmette, Louisiana, a subsidiary of the PBF Holding Company LLC ("PBF Energy") (**Figure 1**). PBF Energy estimated the property damage from the incident to be approximately \$34.1 million.

Figure 1. The PBF Energy refinery in Chalmette, Louisiana. (Credit: PBF Energy)

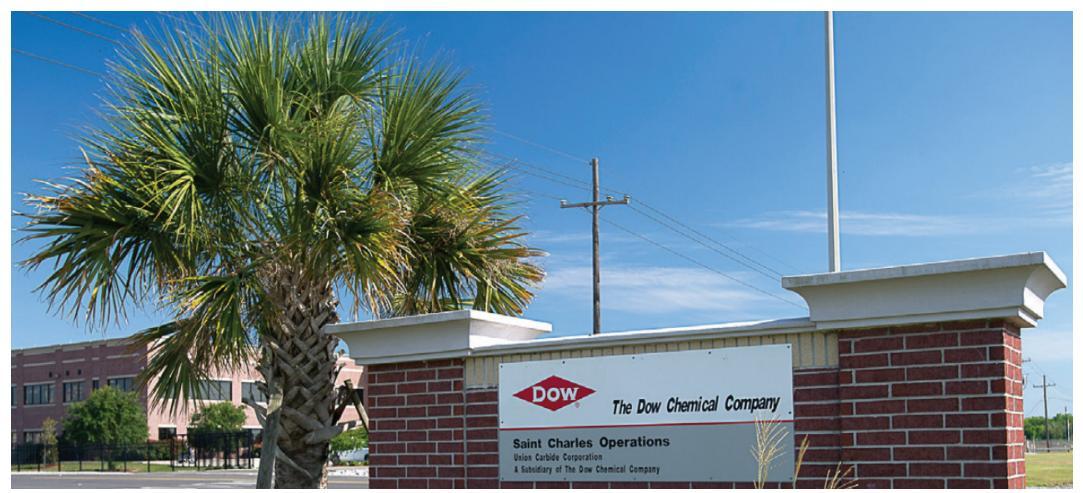
On Friday, February 3, 2023, at approximately 10:46 p.m., a flash fire was accidentally released from a product purge vessel ("vessel") flange during planned maintenance activities at a facility operated by Union Carbide Corporation ("Union Carbide") in Hahnville, Louisiana (**Figure 1**). Union Carbide is a subsidiary of The Dow Chemical Company ("Dow"). The fire seriously injured four contract workers.

Figure 1. Saint Charles Operations in Hahnville, Louisiana. (Credit: Dow)

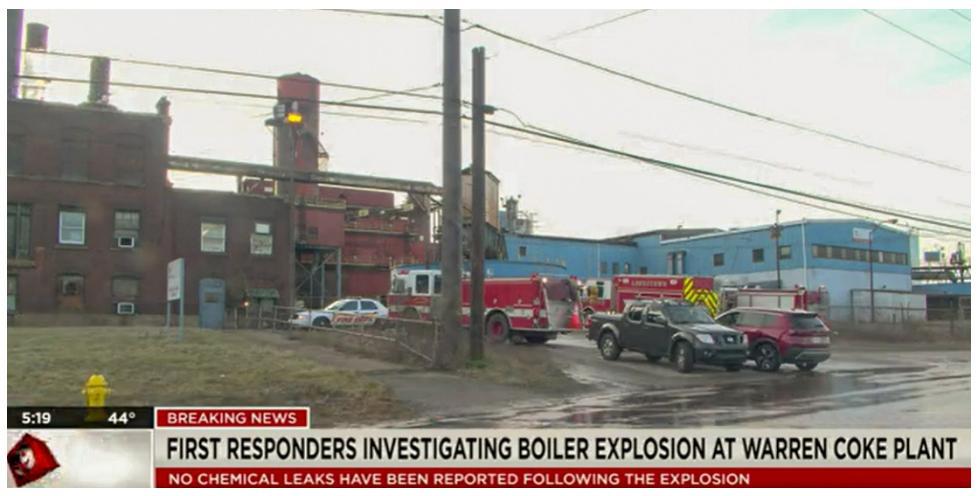
On February 18, 2023, at 2:50 p.m., flammable fuel gas ignited, resulting in an explosion of a boiler at the Cleveland-Cliffs Cleveland Works LLC Warren Coke Plant ("Cleveland-Cliffs") in Warren, Ohio (**Figure 1**). Cleveland-Cliffs estimated that the property damage was approximately \$1 million.

Figure 1. Emergency response after the explosion. (Credit: Cleveland 19 News)

On the day of the incident, tubes inside the boiler were carrying water, and a burner inside the structure heated the water to produce steam. The boiler's burner was combusting fuel gas (composed of natural gas and coke oven gas) to heat the water to produce steam. The forced draft fan that introduced air to the burner unexpectedly shut down, and without air being fed to the burner, the burner flame went out. Flammable fuel gas continued to enter and accumulate in the boiler, however, and about ten minutes later, the accumulated flammable gas ignited, resulting in an explosion. The company determined that the oxygen analyzer installed in the boiler was the source of ignition. The explosion caused extensive damage to the boiler and ductwork.

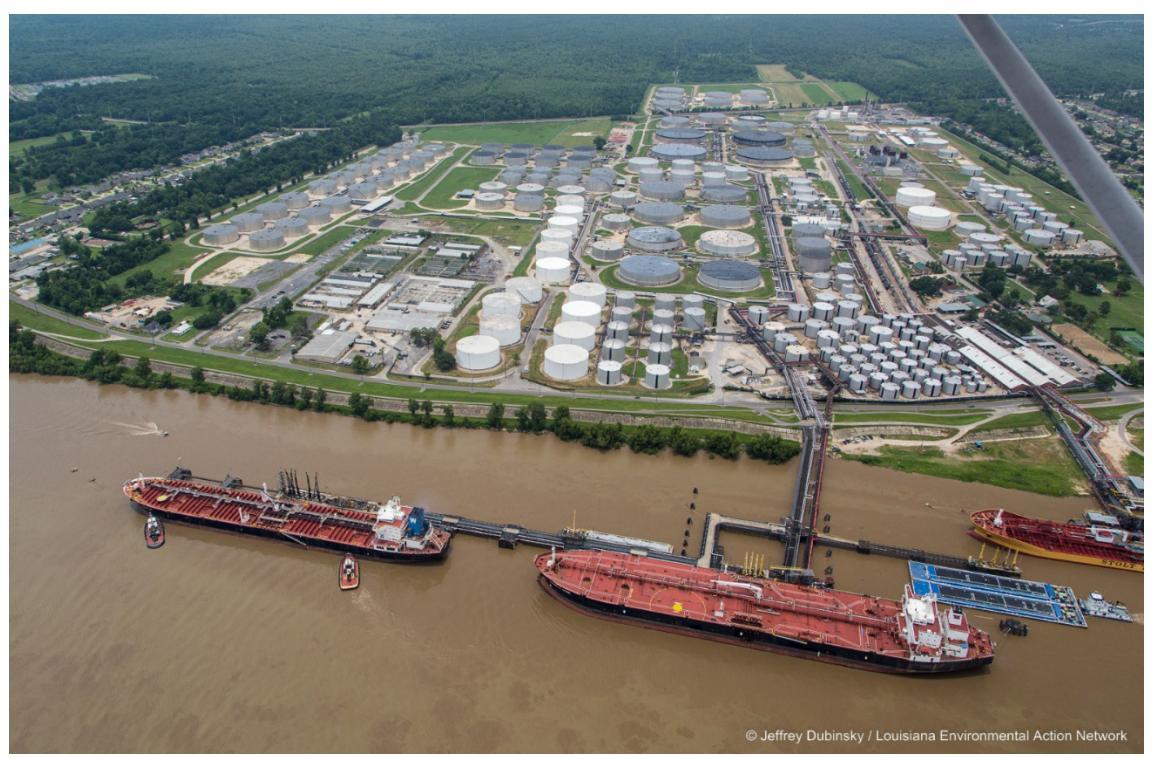
On April 3, 2023, at approximately 1:45 p.m., flammable vapor within a storage tank ignited, resulting in an explosion and a major fire at the International-Matex Tank Terminals ("IMTT") facility in St. Rose, Louisiana (**Figure 1**). The incident seriously injured two contractors and caused over \$15 million in property damage.

Figure 1. The IMTT facility in St. Rose, Louisiana. (Credit: Jeffrey Dubinsky / Louisiana Environmental Action Network)

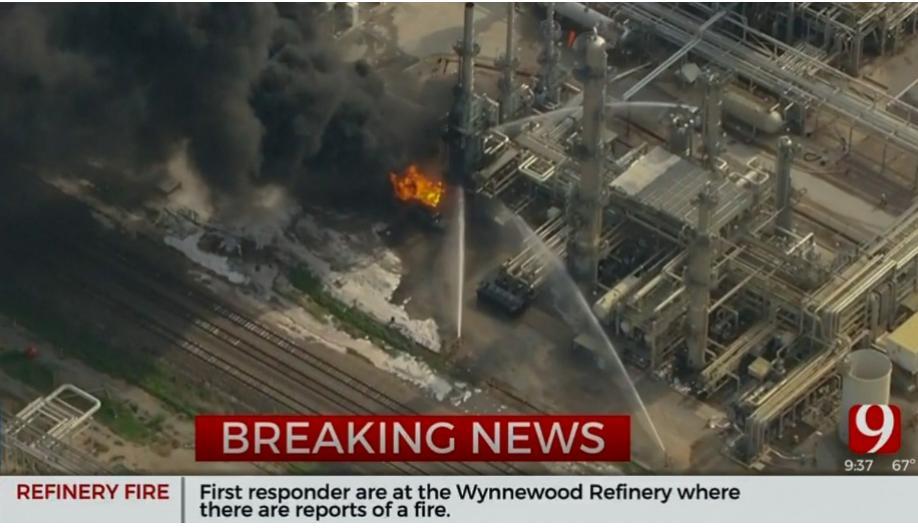
On May 23, 2023, at about 8:20 a.m., approximately 60,000 pounds of naphtha were accidentally released at the CVR Energy, LLC Wynnewood Refinery ("CVR Energy") in Wynnewood, Oklahoma. The released naphtha vaporized and ignited within seconds of the initial release. The fire fatally injured one CVR Energy employee and seriously injured another CVR Energy employee (**Figure 1**). CVR Energy estimated that the incident resulted in approximately \$8 million in property damage.

Figure 1. Emergency response to the fatal fire. (Credit: News 9)

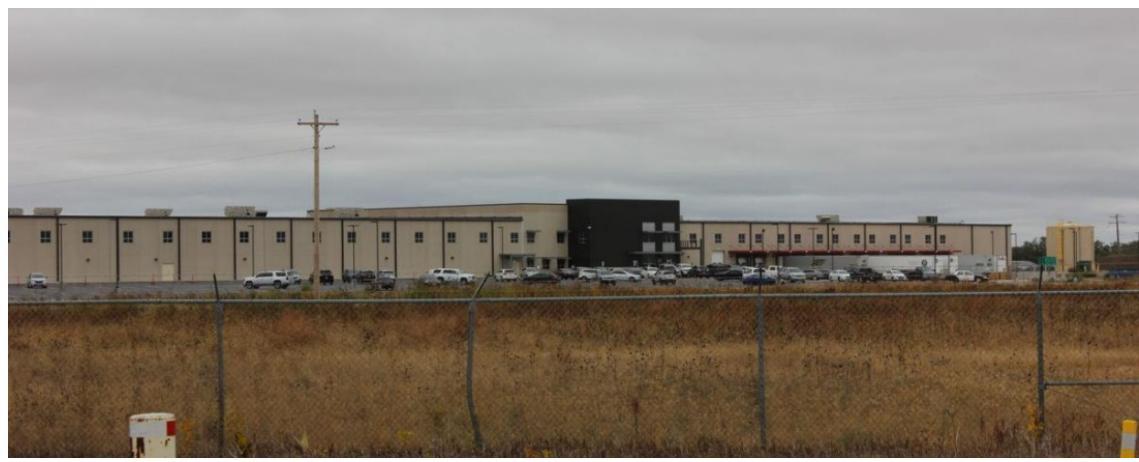
On October 13, 2023, at approximately 9:45 a.m., a mixture containing tetrazine and lead styphnate detonated at the Hornady Manufacturing Company's ("Hornady") facility in Alda, Nebraska (**Figure 1**). The explosion fatally injured one Hornady operator.

Figure 1. Hornady Facility. (Credit: Omaha World Herald)

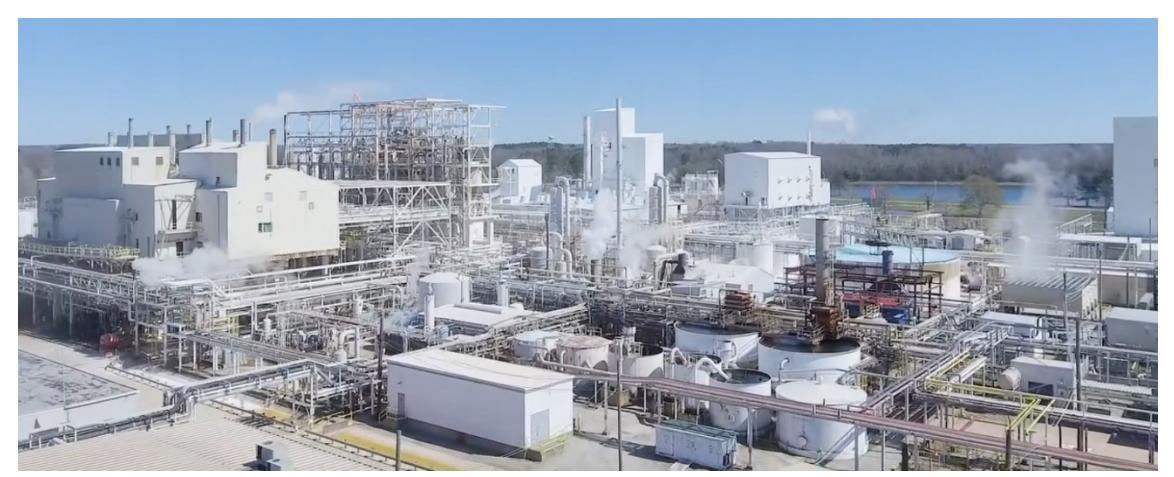
On February 13, 2024, at 11:59 p.m., a titanium tetrachloride and hydrogen chloride vapor mixture was accidentally released at the Tronox Hamilton facility ("Tronox") in Hamilton, Mississippi (**Figure 1**). Two Tronox employees were seriously injured when they inhaled some of this toxic vapor.

Figure 1. The Tronox facility in Hamilton, Mississippi. (Credit: Monroe Chamber of Commerce)

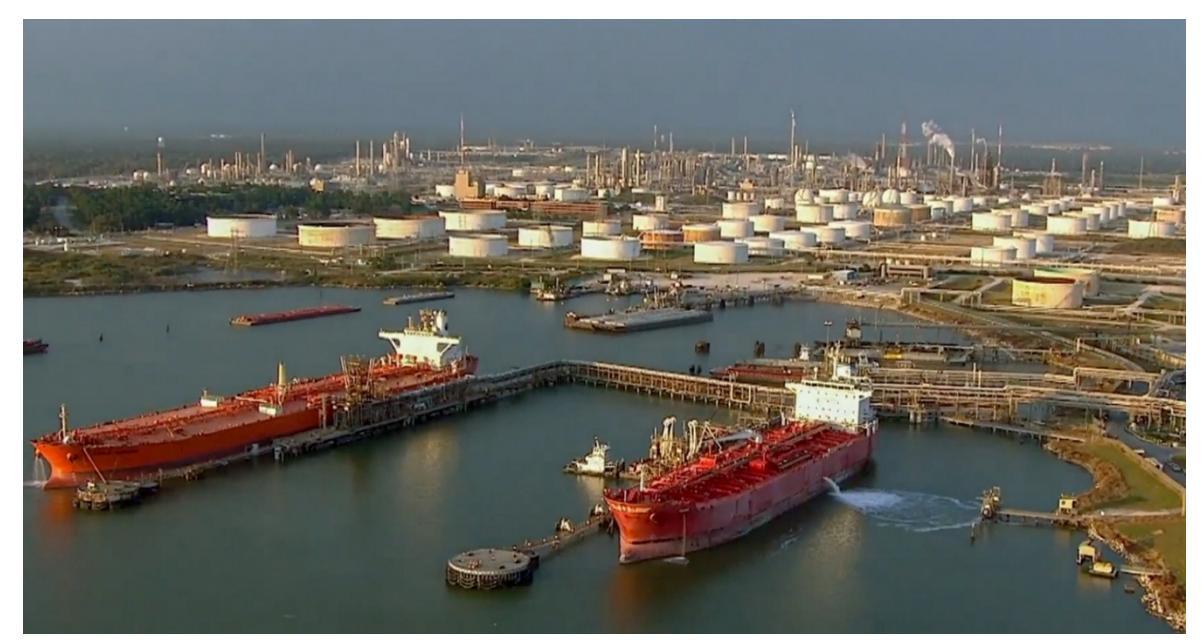
On March 17, 2024, at approximately 12:50 p.m., about 250,000 pounds of hydrogen and naphtha mixture were accidentally released into the firebox of a fired heater, where it ignited, creating a major fire at the ExxonMobil Corporation Refinery ("ExxonMobil") in Baytown, Texas (**Figure 1**). ExxonMobil estimated that the property damage from the incident was \$32 million.

Figure 1. The ExxonMobil facility in Baytown, Texas. (Credit: CNBC)
