# Chemical Safety and Hazard Investigation Board

Subject: Notation Item 896

3. CSB staff have prepared the attached proposed case study, including proposed recommendations, based upon their investigation of the three iron dust flash fires and hydrogen explosion that occurred between January 31, 2011, and May 27, 2011, at the Hoeganaes Corporation metal powder facility in Gallatin, Tennessee.

## 3.0 THE INCIDENTS

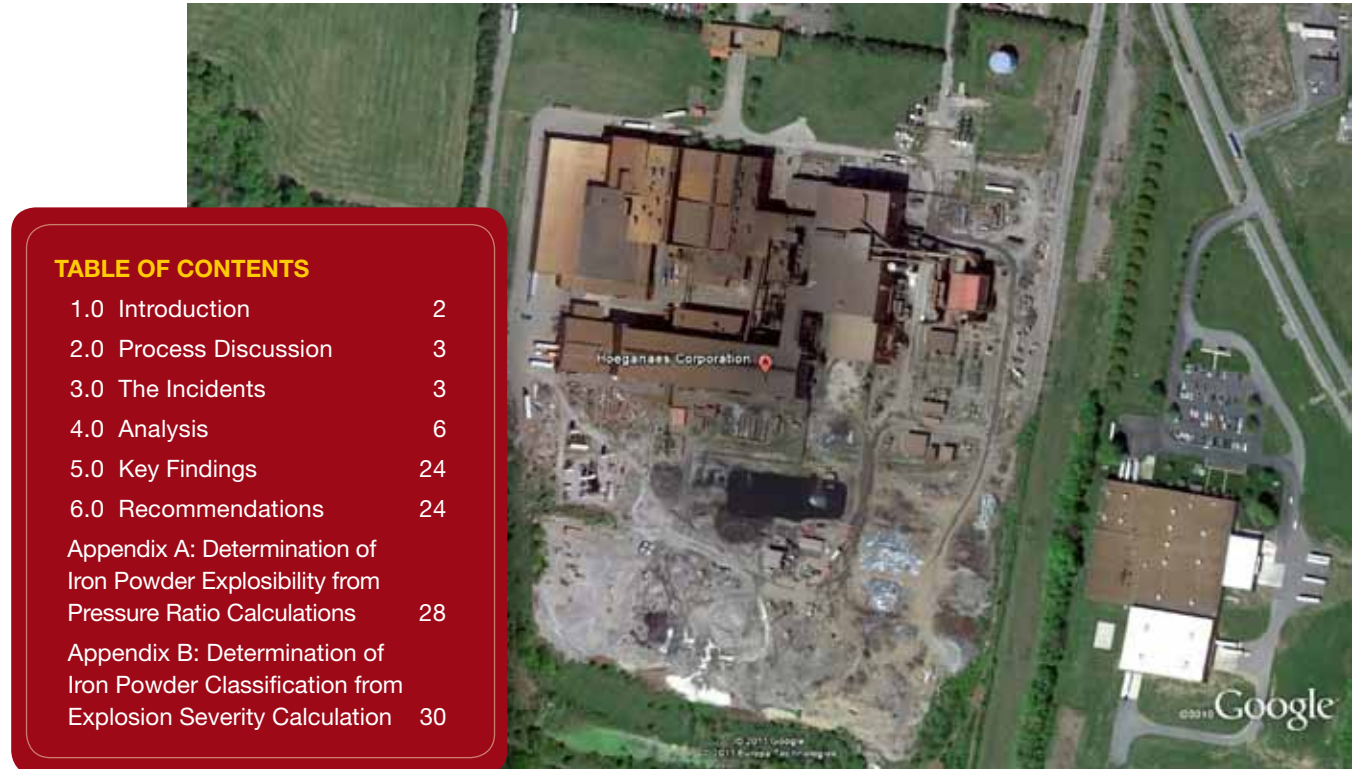
FIGURE 1

Satellite view of the Hoeganaes Gallatin facility.

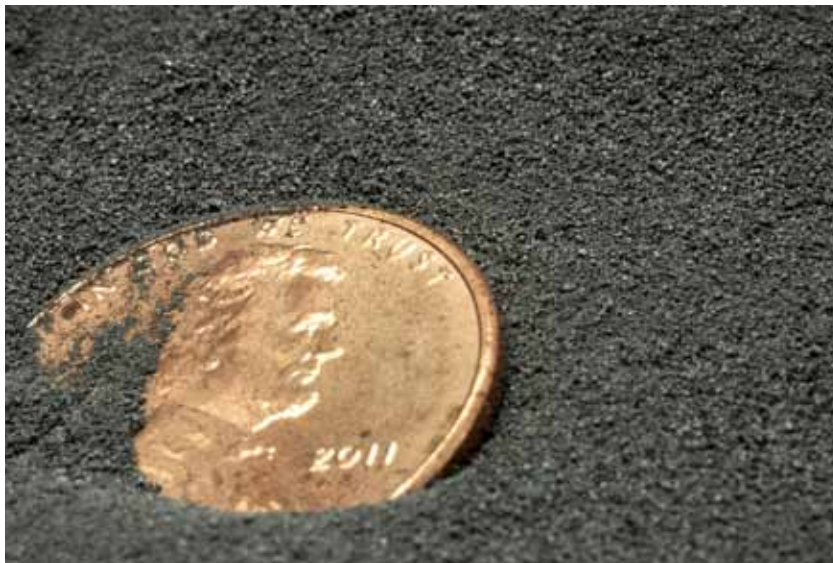
**FIGURE 2**

In the process of going through the furnace, the coarse powder becomes a thick sheet called “cake.” The cake is sent to a cake breaker and ultimately crushed into the fine PM product. The majority of the finished PM product has a particle diameter between 45-150 microns, or roughly the width of a human hair (Figure 2).

Fine PM collected from the Hoeganaes plant (penny shown for scale).

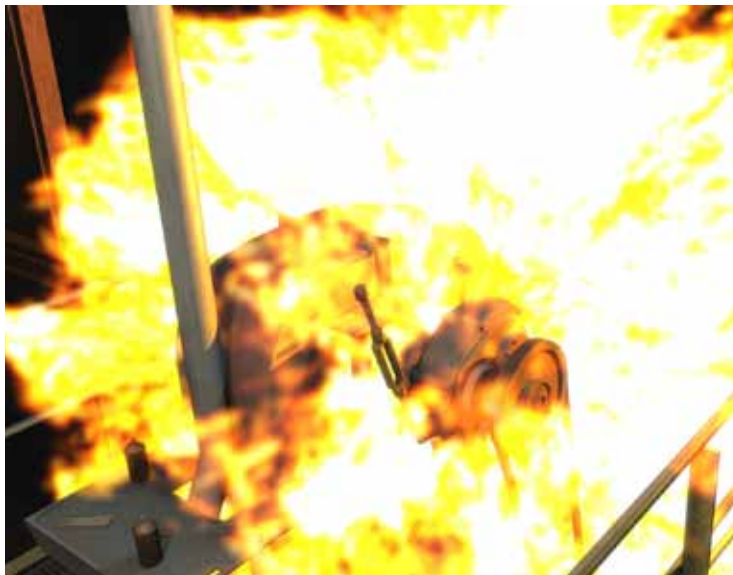
**FIGURE 5**

Based on their observations, they did not believe that the belt was off-track and requested, via radio, that the operator in the control room restart the motor (Figure 4). When the elevator was restarted, vibrations from the equipment dispersed fine iron dust into the air. During a CSB interview, one of the workers recalled being engulfed in flames, almost immediately after the motor was restarted.

Computer graphic of January 31 iron dust flash fire.

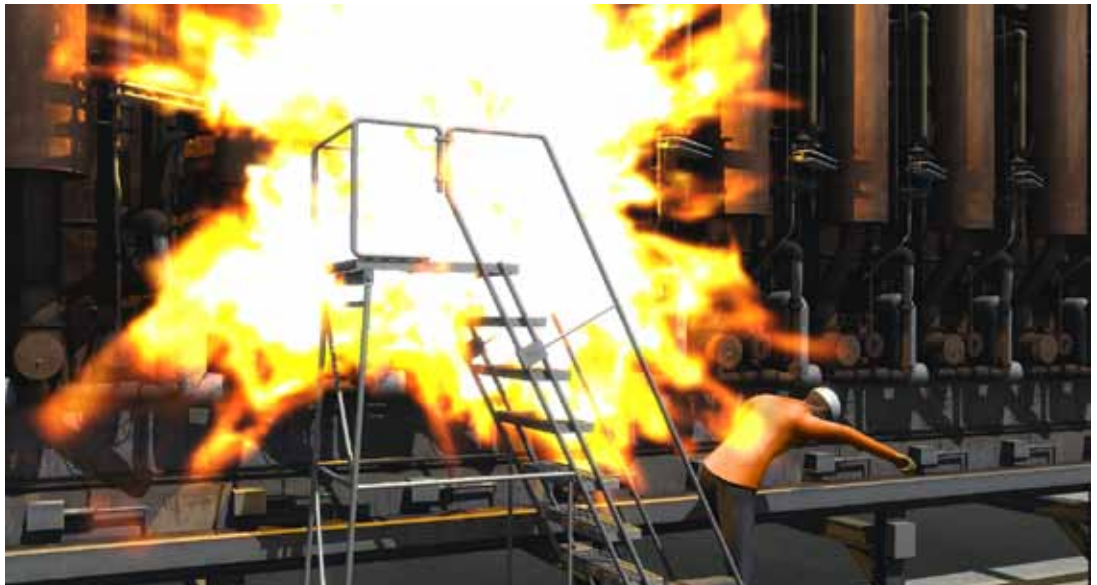
**FIGURE 8**

Computer graphic of March 29 iron dust flash fire.

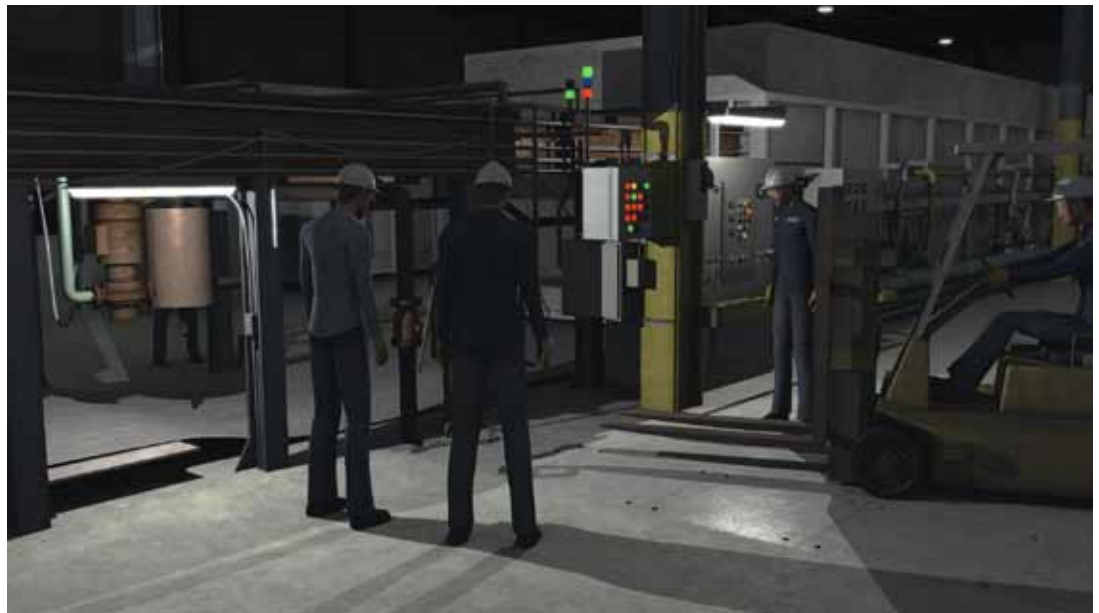
**FIGURE 10 (RIGHT)**

Computer graphic of maintenance crews starting to remove the trench covers using a forklift just prior to May 27 explosion.

Interviews with eyewitnesses indicate that just as the first trench cover was wrenched from its position by the forklift, friction created sparks, followed by a powerful explosion. Several days after the explosion, CSB investigators observed a large hole (approximately 3 x 7 inches) in a corroded section of piping that carried hydrogen and ran through the trench (Figure 11).

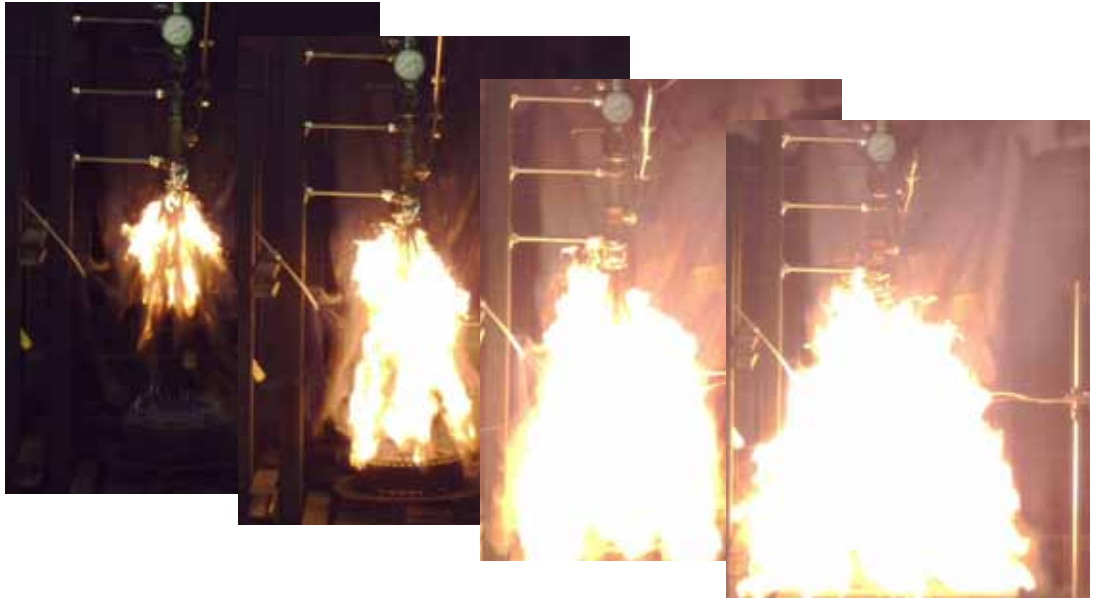
**FIGURE 14**

This test dispersed about 30 grams of iron dust—sampled from the baghouse<sup>9</sup> associated with the bucket elevator from the January 31, 2011, incident—above an 8 inch burner. Upon being released, the dust auto-ignites in air due to the heat given off from the burner below (Figure 14). An intense white flame was produced that reached a peak diameter of 18 inches.

CSB iron dust combustibility demonstration, see Section 4.1.1.1.
