# INVESTIGATION REPORT

## ALLIED TERMINALS, INC.– CATASTROPHIC TANK COLLAPSE

CHESAPEAKE, VIRGINIA

REPORT NO. 2009-03-I-VA

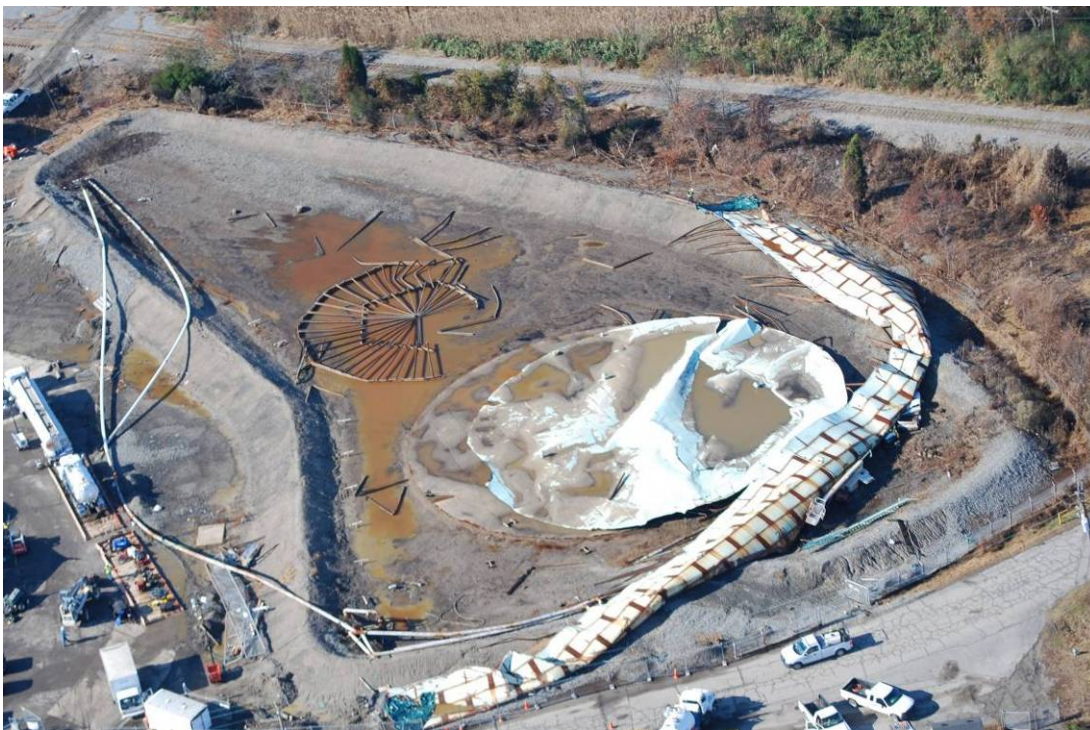
Figure 1. Allied collapsed tank and neighboring business.

On November 12, 2008, at about 2:20 pm, a 2-million-gallon nominal capacity liquid fertilizer tank catastrophically failed at the Allied Terminals, Inc. (Allied) facility in Chesapeake, Virginia (Figure 1). The tank split open vertically and nearly instantaneously released about 2.1 million gallons of liquid fertilizer. A welder and his helper were working on the opposite side of the tank as it collapsed. Both sustained serious injuries due to the collapsing tank and immersion in the liquid fertilizer. Employees from a neighboring business (shown in upper left of Figure 1) rescued the two workers.

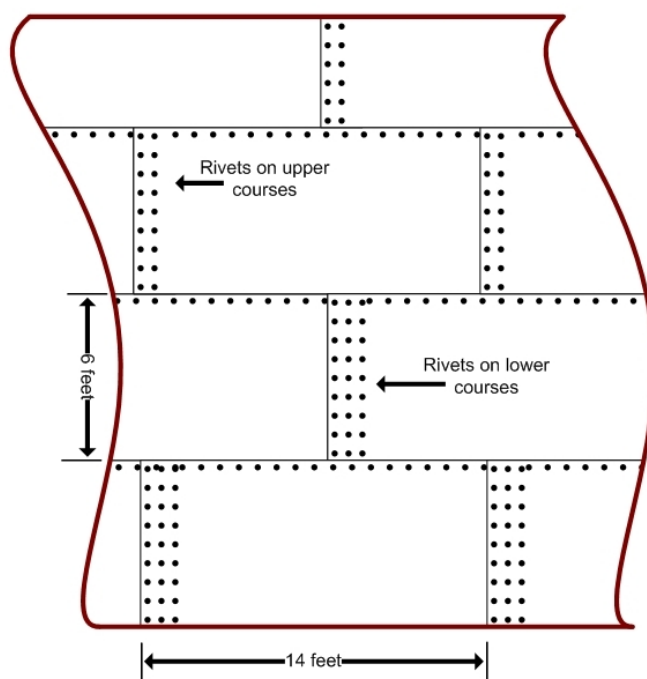
Figure 7. Tank 201 design prior to modification.

Tank 201, originally designed and constructed in 1929 for petroleum product storage, was 116 feet in diameter and about 30 feet high. The shell was constructed of overlapping riveted plates, each approximately 6 feet high and 14 feet long. The plates were joined end to end to form six rings (courses) that were stacked to form the tank. A single row of rivets joined the courses horizontally, while three vertical rivet rows joined the plate ends on the bottom two courses and two rows joined the plate ends on the upper four courses (Figure 7). Overlapping welded plates were used on the bottom and the cone-shaped roof. A second tank bottom was added inside the tank prior to Allied's purchase of the facility.
