U.S. CHEMICAL SAFETY AND HAZARD INVESTIGATION BOARD

INVESTIGATION REPORT

HONEYWELL INTERNATIONAL, INC.

REPORT NO. 2003-13-I-LA

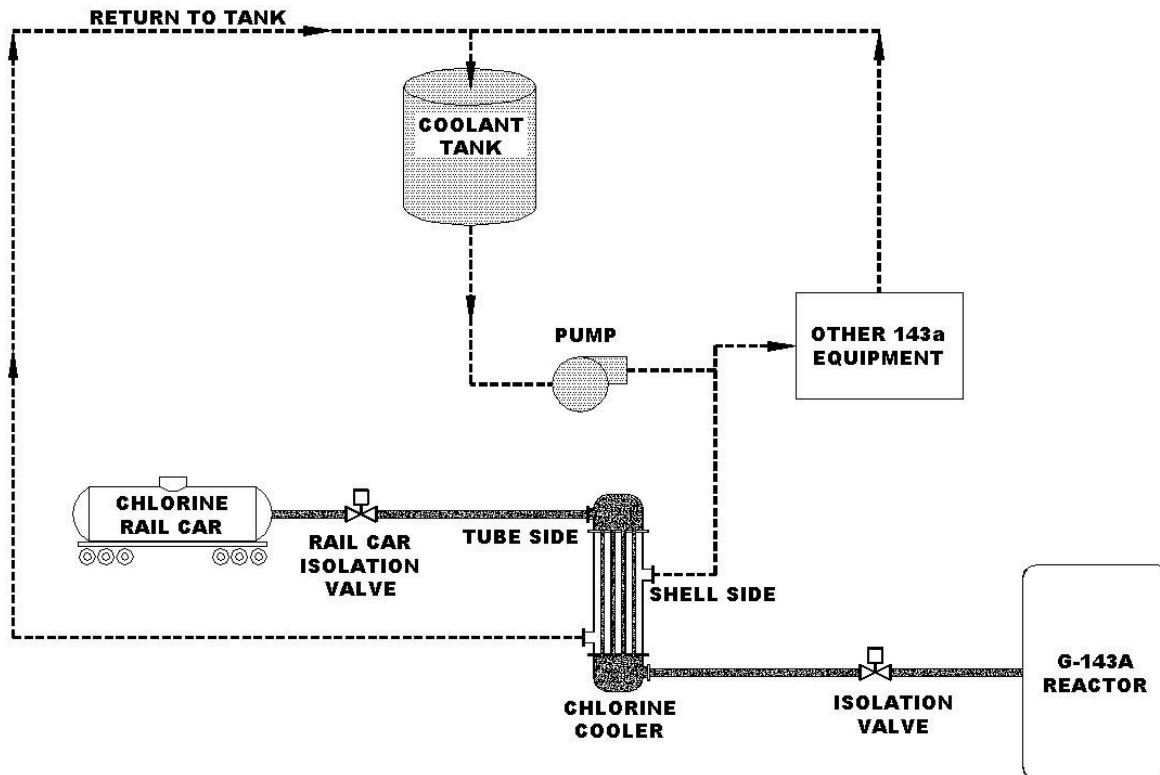
Figure 1. Simplified chlorine feed and coolant systems.

Honeywell uses chlorine as a raw material to make G-143a.³ The July 20 leak occurred in the system that feeds chlorine to the G-143a reactor. In this process—depicted in Figure 1—chlorine is fed to the reactor from a railcar through a cooler designed to ensure that the chlorine remains in the liquid phase.⁴ The railcar has an emergency shutdown system capable of isolating⁵ the railcar.

Liquid chlorine from the cooler flows through an isolation valve to the G-143a reactor. The reactor isolation valve is normally open when the plant is running. At the time of the incident, both the process automated shutdown sequence and manual shutdown procedures relied on this isolation valve to stop the flow of chlorine to the process. The shutdown system on the railcar was not part of the G-143a shutdown procedures.

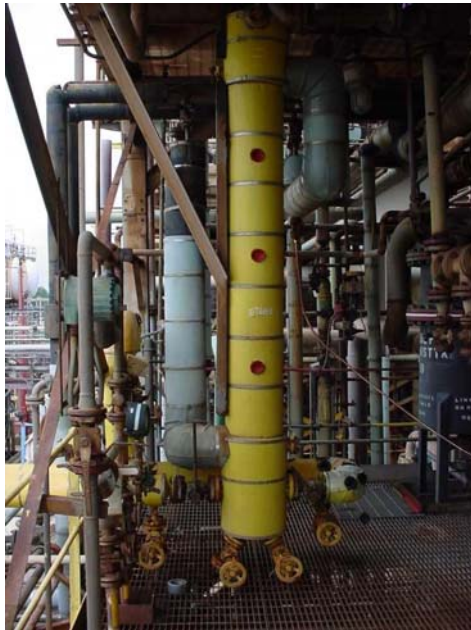
Figure 3. Vertical chlorine cooler in G-143a process.

The coolant—a chlorofluorocarbon refrigerant manufactured at the Baton Rouge facility—is continuously circulated in a loop through various pieces of equipment, including the chlorine cooler. A photograph of the cooler is shown in Figure 3.

The vertical chlorine cooler was an American Society of Mechanical Engineers (ASME)-code certified pressure vessel¹⁴ built and installed in 1986. It had a fixed tube design with 0.109-inch-thick tube walls.

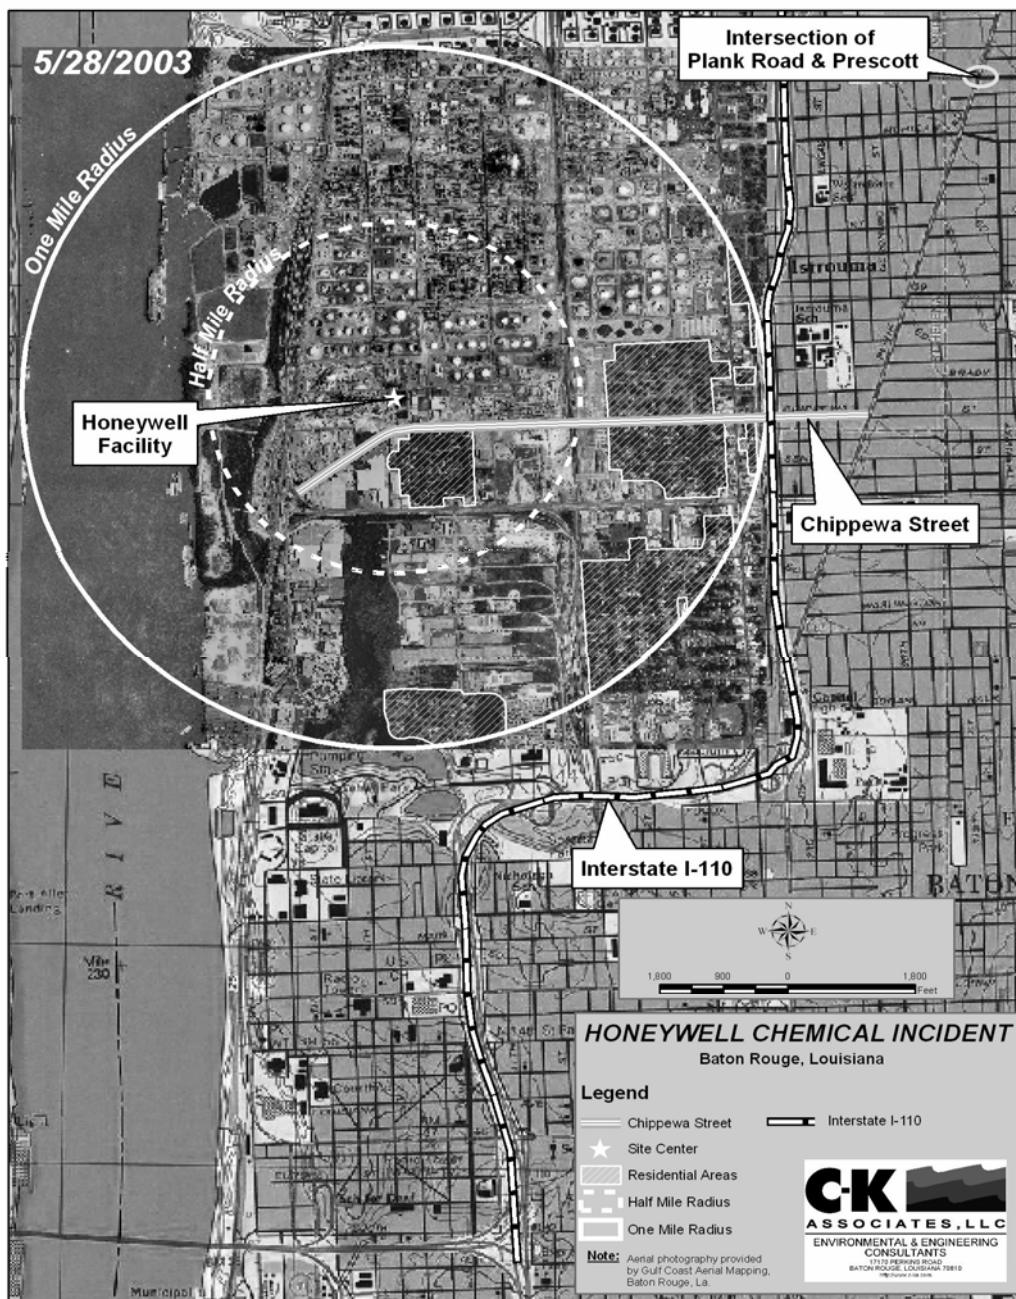
Figure 5. Overhead view of Honeywell facility and surrounding area.

At 4:00 am, the local fire department issued a shelter-in-place advisory for residents within a 0.5-mile radius of the plant (Figure 5). Community sirens were activated, and an auto dialer was used to notify these residents. The advisory remained in effect for 3 hours. At 7:09 am, the fire department downgraded the incident to level I (i.e., one with effects inside the plant only).

Although the shelter-in-place advisory was issued for residents within a 0.5-mile radius, residents outside this radius reported to CSB that they also heard the siren and were confused about what to do because they did not receive a call from the auto dialer.

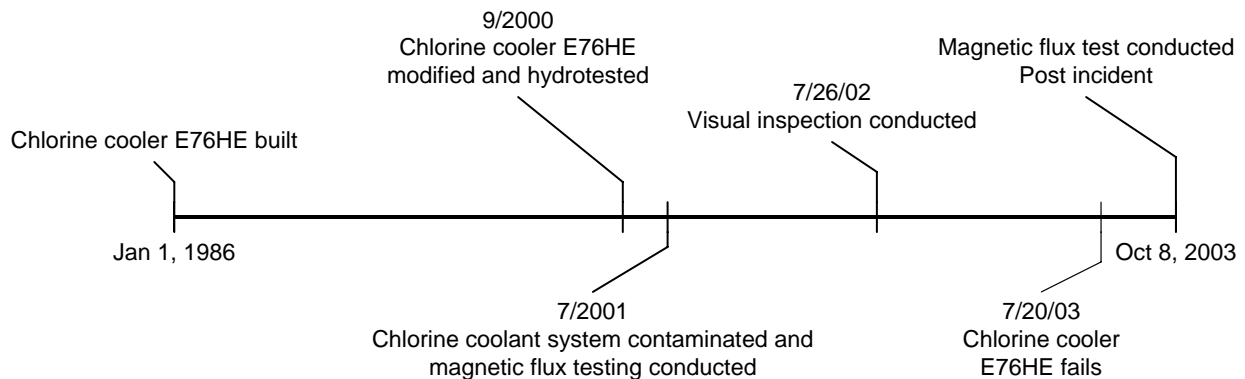
Figure 7. Chlorine cooler history.

Figure 7 shows key milestones in the history of the chlorine cooler.

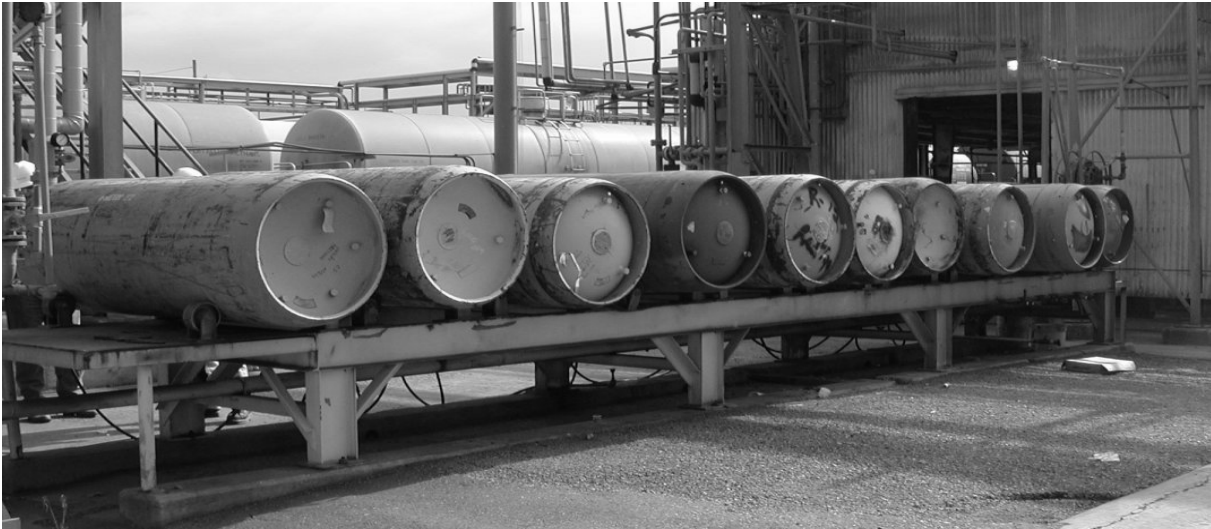
Figure 12. 1-ton refrigerant cylinder prep rack.

- Cylinders are placed on a rack, which holds 10, 1-ton cylinders (Figure 12).

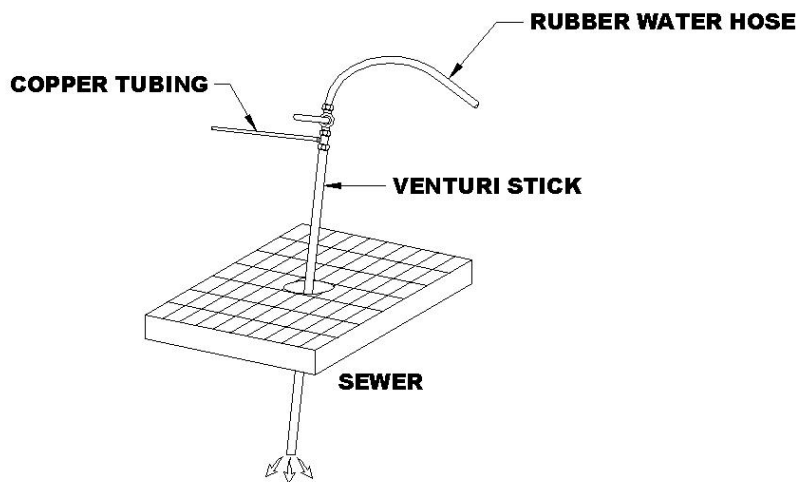
Figure 16. Venturi stick.

A venturi stick uses the same principle of operation as the spray application of fertilizer with a garden hose and attachment. In the Honeywell procedure, water flowing through a 1-inch pipe (venturi stick) creates a slight vacuum in attached tubing (Figure 16). The liquid (in this case, hydrogen fluoride) being

evacuated mixes with water and is discharged to the plant sewer. The plant also uses nitrogen to help push the liquid hydrogen fluoride out; however, the procedure does not specify how to secure the venturi stick or to select the appropriate nitrogen pressure to apply to the system.
