U. S. CHEMICAL SAFETY AND HAZARD INVESTIGATION BOARD

# INVESTIGATION REPORT

## PROPANE TANK EXPLOSION (2 DEATHS, 7 INJURIES)

Herrig Brothers Feather Creek Farm  
Albert City, Iowa  
APRIL 9, 1998

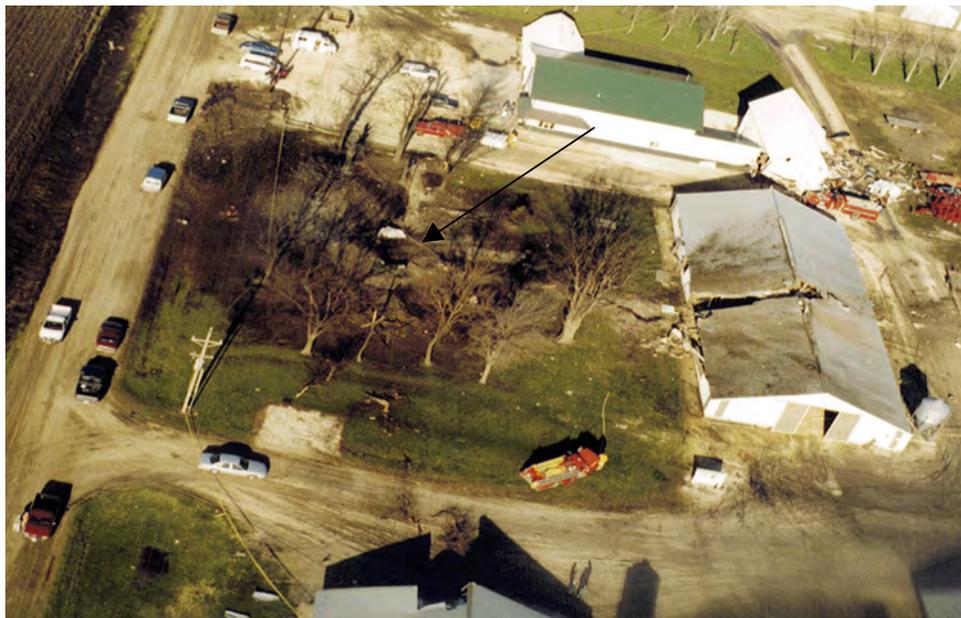
**Figure 1. Aerial View of the Farm on April 10, 1998**

On April 9, 1998, at approximately 11:28 pm, an 18,000-gallon propane tank exploded at the Herrig Brothers Feather Creek Farm (the farm) in Albert City, Iowa. The blast occurred less than half an hour after an all-terrain vehicle (ATV), driven by a minor without the owner's permission, damaged two aboveground propane pipes and a fire resulting from that accident engulfed the tank. The explosion that occurred at the farm is known as a Boiling Liquid Expanding Vapor Explosion or BLEVE.<sup>1</sup> Tank fragments produced by the BLEVE killed two volunteer fire fighters.<sup>2</sup> In addition, seven other emergency response personnel were injured, and several buildings were damaged by the blast. The arrow in Figure 1 points to the location of the tank prior to the blast.

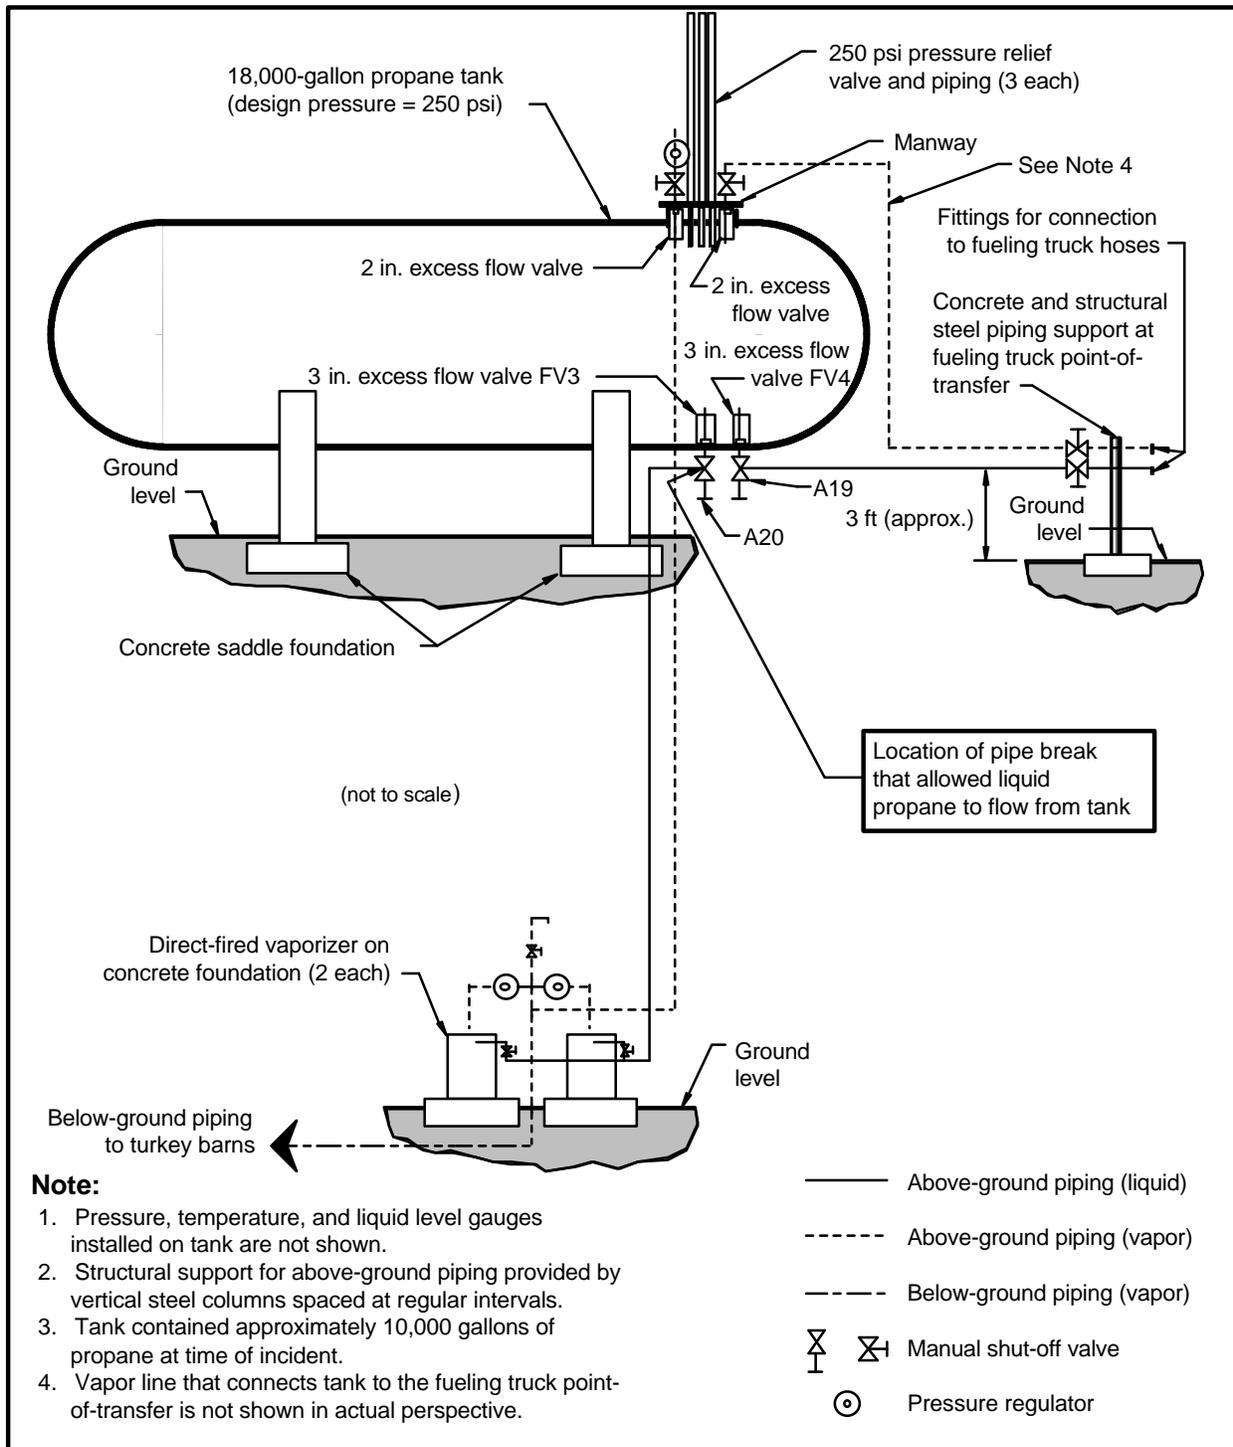
**Figure 6. Piping Diagram for the Propane Storage and Handling System**

During normal operations, liquid propane was withdrawn from the tank through the 3-inch excess flow valve (FV3 in Figure 6), past the open shut-off valve (A20 in Figure 6), and then into the ¾-inch outlet pipe to the vaporizers shown in Figure 7. These vaporizers used heat to convert the liquid propane into a gas. After passing through a pressure regulator, the propane gas was piped underground to the various space heaters and furnaces located in the buildings on the farm.

The liquid line (which measured approximately  $\frac{3}{4}$ -inch inside diameter) was completely severed from the tank at the location where it was connected to a manual shut-off valve directly beneath the tank (see Figure 6, item A20). An excess flow valve protecting the liquid line (see Figure 6, item FV3) failed to function, and propane leaked out of the tank at the point of the break. As the liquid propane sprayed out of the tank, it rapidly changed to vapor. Propane vapor may have also leaked from the damaged vapor line.<sup>8</sup> Propane from the damaged pipes formed a cloud, and within a few minutes this propane vapor ignited. Although the source of ignition was not conclusively established, the likely source was the direct-fired vaporizers.<sup>9</sup> A fire, fed by the broken liquid line, began burning vigorously under the tank.

Shut-off valves A19 and A20, used on the liquid propane piping lines (see Figure 6), were rated for 400-psi service at temperatures up to 150°F. However, pressure required to cause failure is usually at least twice the rated operating pressure. Shut-off valves A19 and A20 did not fail by overpressurization. Observed damage was probably caused by impact following the explosion.

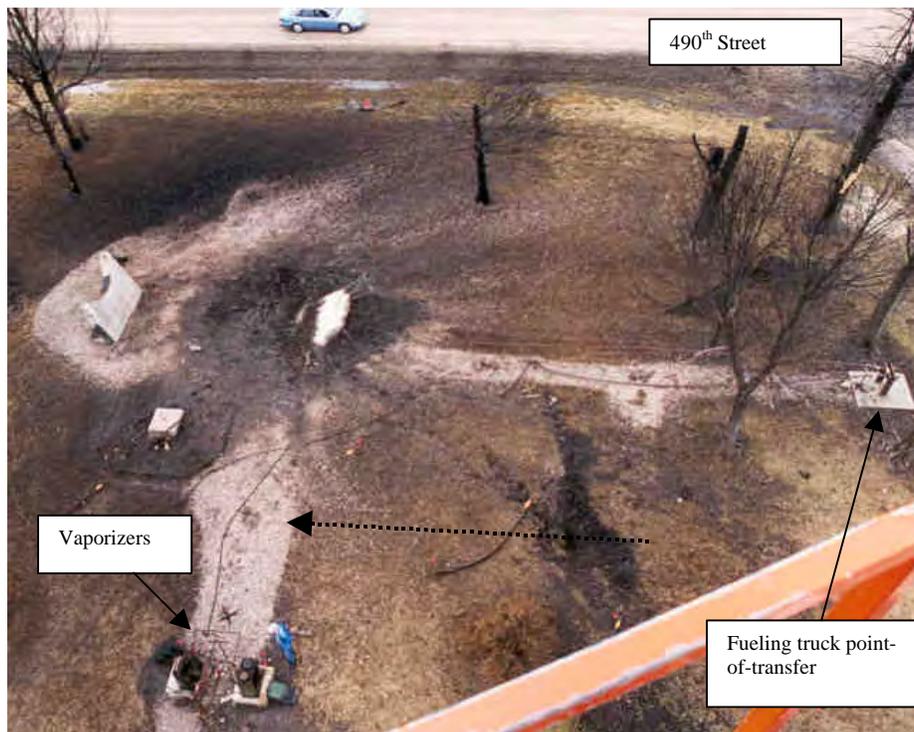
Figure 7. Aerial View of Tank Area

On cold winter days, as much as 1,000 gallons of propane were required to heat the buildings and structures on the farm. Based on this usage, fueling truck deliveries occurred as often as every week during severe winter months. When a fueling truck arrived at the farm, it parked in the gravel area located west of the propane tank (see Figure 2, item 8). The dotted arrow in Figure 7 below represents the approximate course of the ATV prior to striking the propane lines.

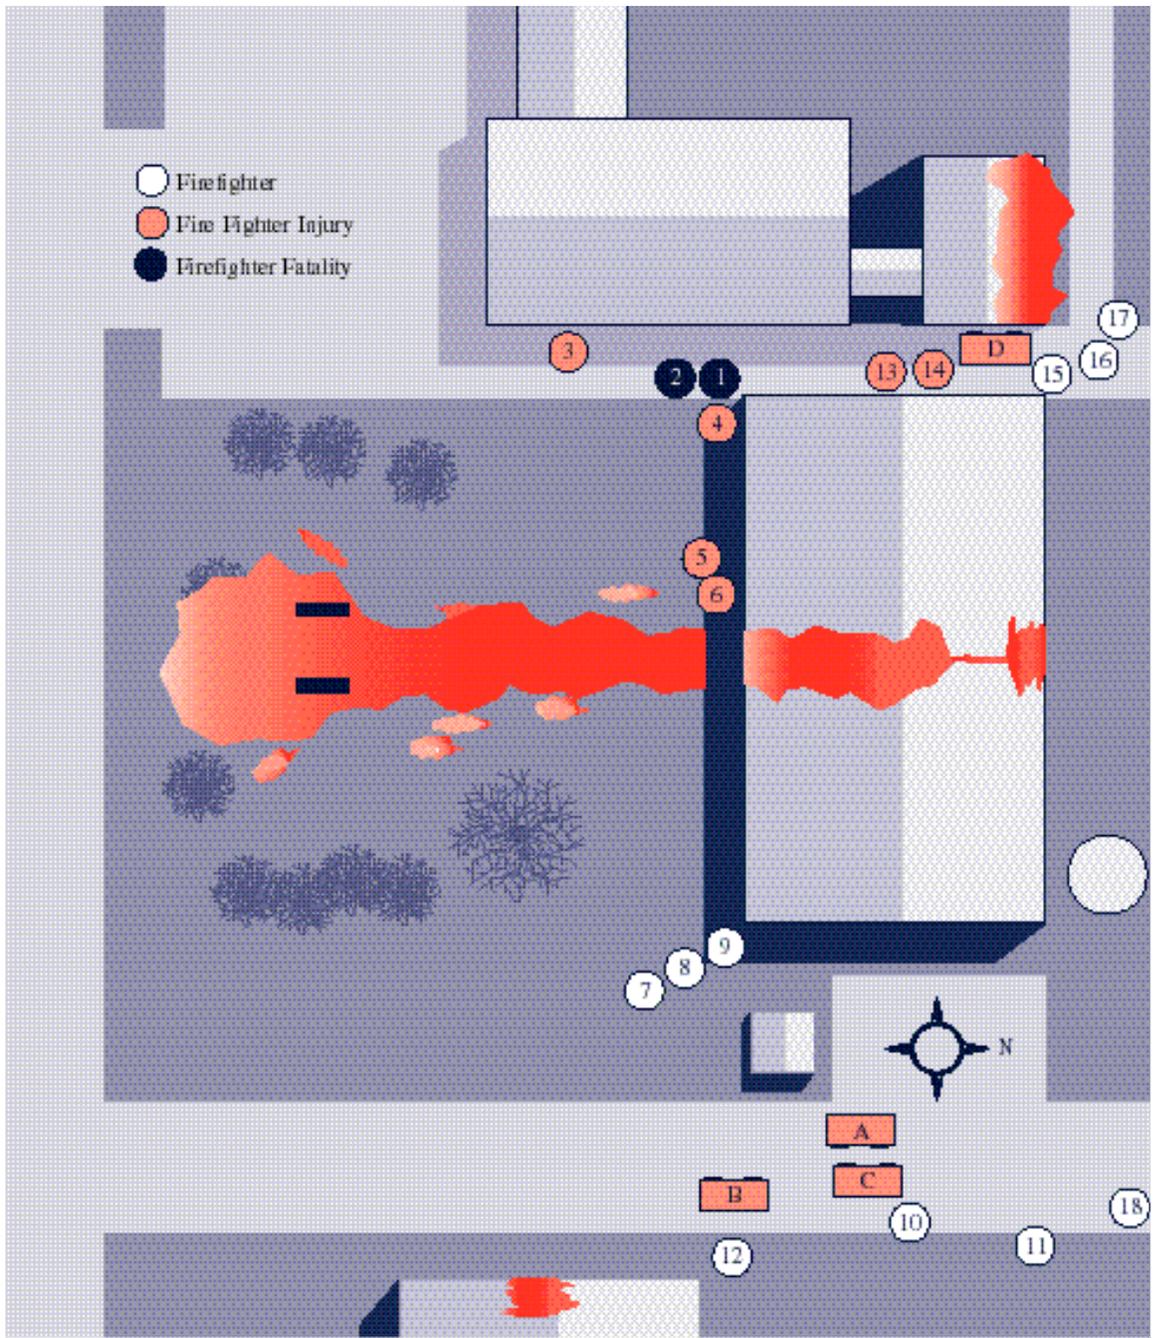
**Figure 8. Fire fighters (numbers) and Response Vehicles (letters) at the Time of the Blast (not to scale)**

killing two volunteer firemen. The Iowa State Medical Examiner listed the cause of death in each instance as massive trauma to all body systems. The fire fighters who died were located about 100 feet from the northwest side of the tank, as depicted in Figure 8 (numbers 1 and 2). The tank piece that struck two of the fire fighters narrowly missed the Fire Chief (see Figure 8, number 4). Another large piece of the tank was propelled directly north, just missing two other fire fighters (see Figure 8, numbers 5 and 6). Seven emergency response personnel sustained injuries as a result of the explosion. These injuries ranged from scrapes and bruises to severe burns.<sup>15</sup> This explosion easily could have caused numerous additional fire fighter fatalities.

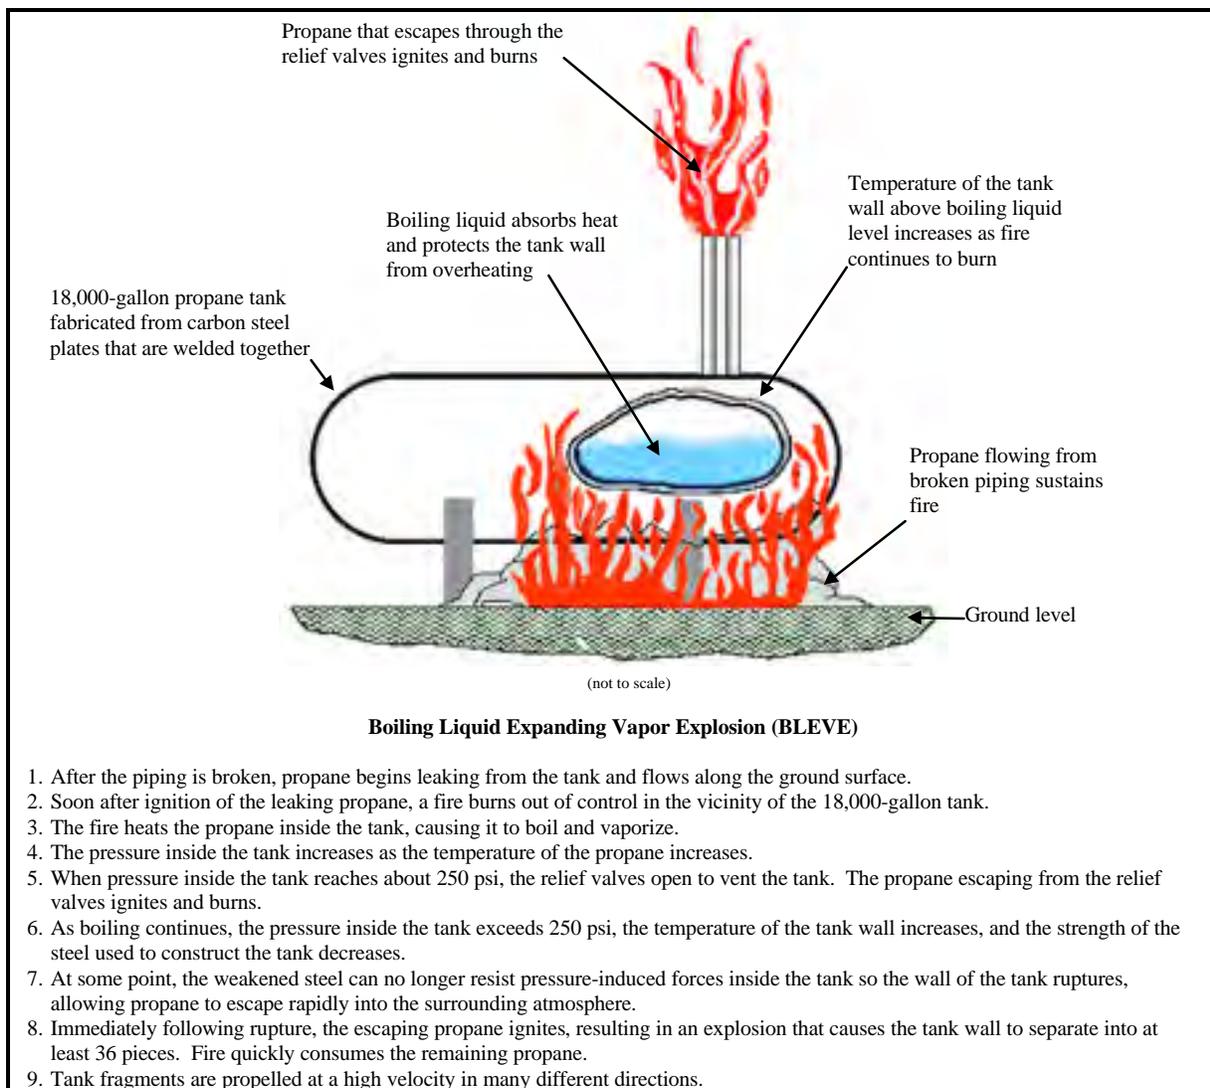
**Figure 9. BLEVE**

Immediately after the initial fracture in the tank wall, the following events occurred within moments. The remaining propane inside the tank began escaping into the surrounding atmosphere, where it vaporized almost instantaneously. As the liquid and vapors escaped, the tank wall continued tearing, allowing even more propane to escape. The propane ignited, and the explosion occurred. Tank fragments were propelled in all directions. Figure 9 shows the conditions that produced the BLEVE.<sup>18</sup>

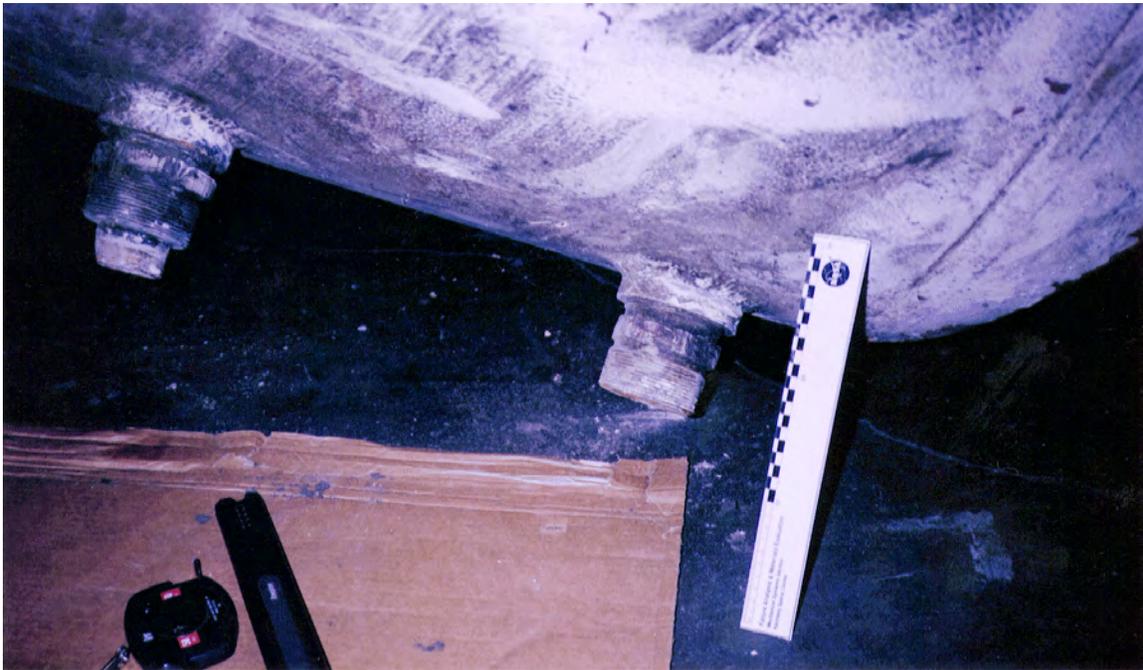
FIGURE 1

The two liquid excess flow control valves in the tank section prior to removal for testing purposes.

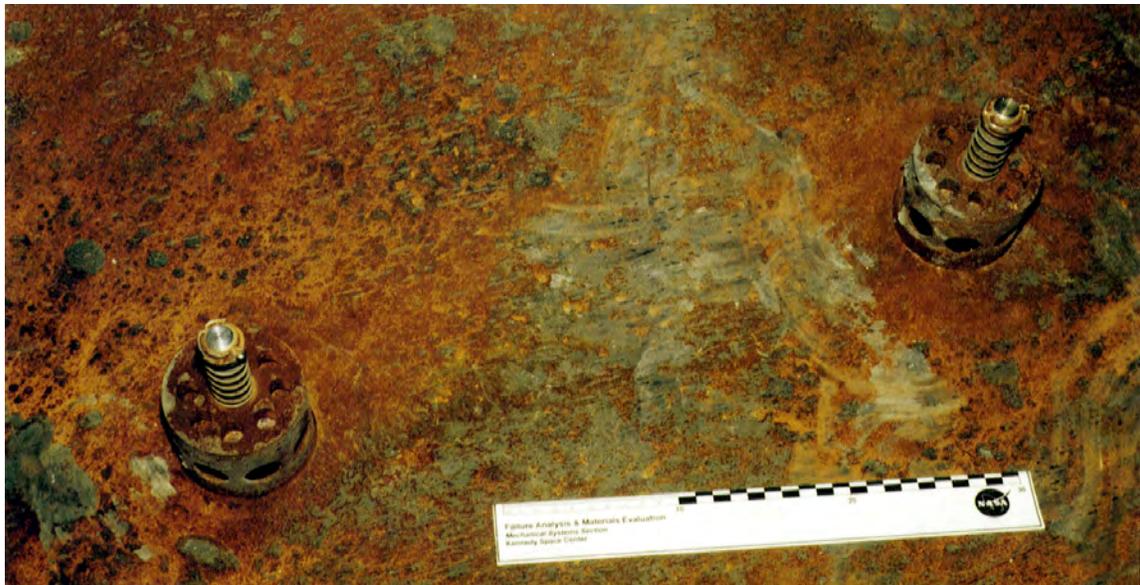
FIGURE 2

The two liquid excess flow control valves as seen from the interior side of the tank section.

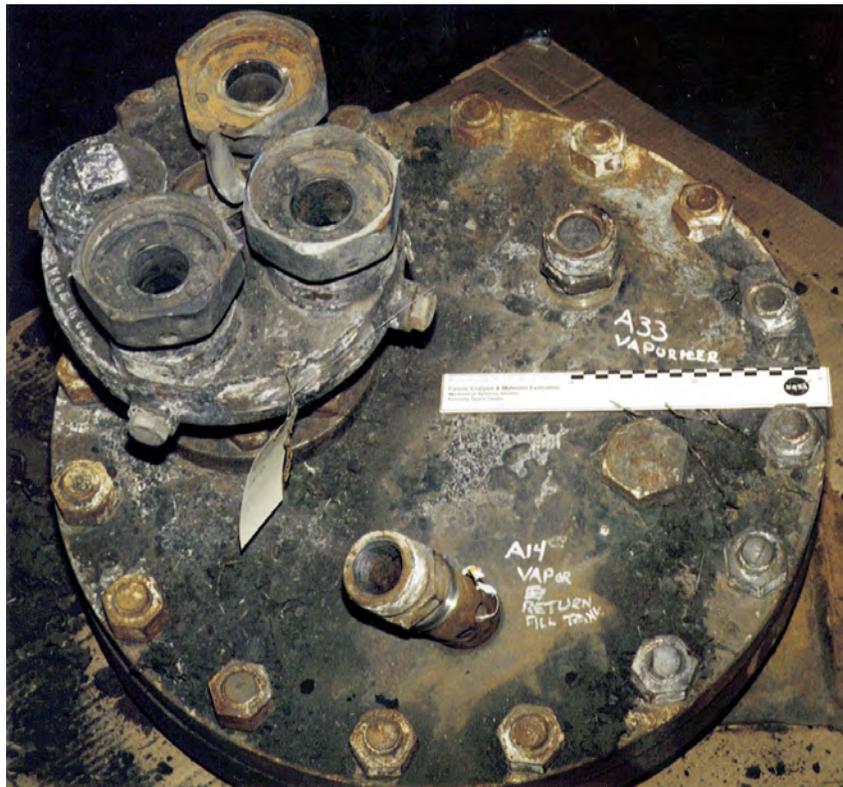
FIGURE 6

Propane tank man-way cover as seen in the Des Moines, Iowa storage warehouse. Vapor excess flow control valves are labeled A14 and A33. Three pressure relief body shells can be seen on the elevated connection plate.

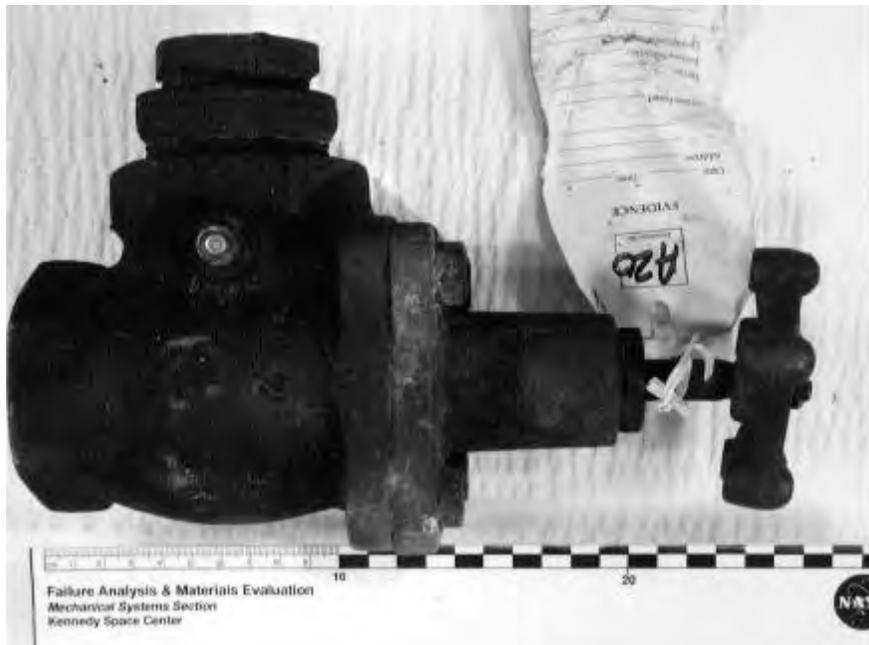
FIGURE 10

The lower view is the hand valve A20 as-received in the laboratory.

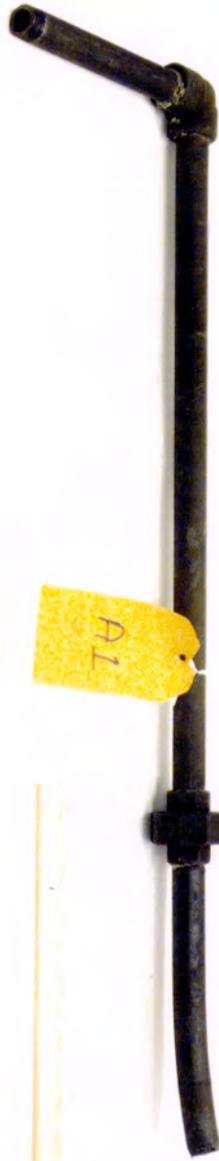
FIGURE 29

View of the pipe that fed liquid propane to the vaporizer units.
