U.S. CHEMICAL SAFETY AND HAZARD INVESTIGATION BOARD

# INVESTIGATION REPORT

## PETROLEUM PRODUCTS FACILITY INCIDENT

**THIRD COAST INDUSTRIES**

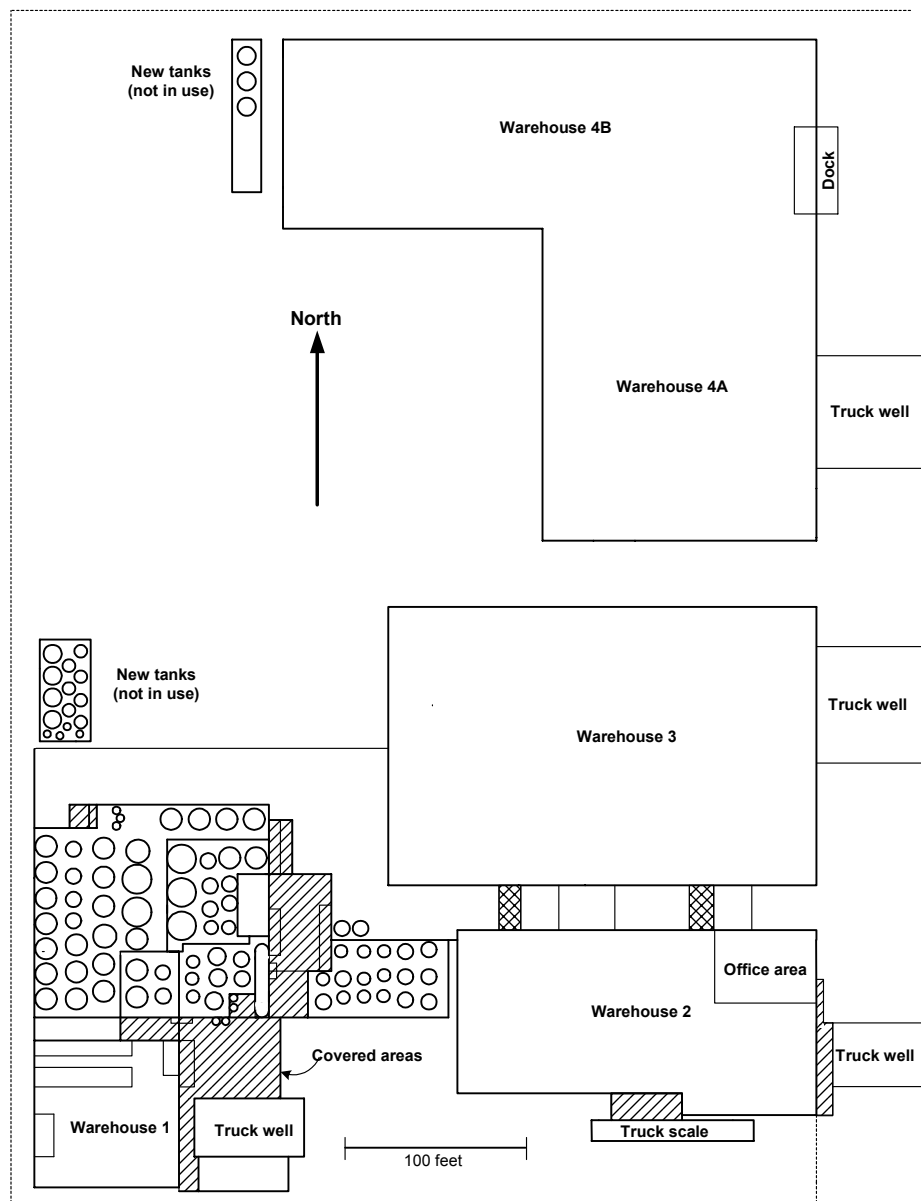
Figure 1. Layout of Third Coast Industries facility.

Third Coast Industries was located on West Clover Lane, in an unincorporated section of Brazoria County, near Friendswood and Pearland, Texas, approximately 18 miles southeast of downtown Houston.<sup>2</sup> The company was formed in 1987 and began operations in 1988. Figure 1 shows the layout of the facility.

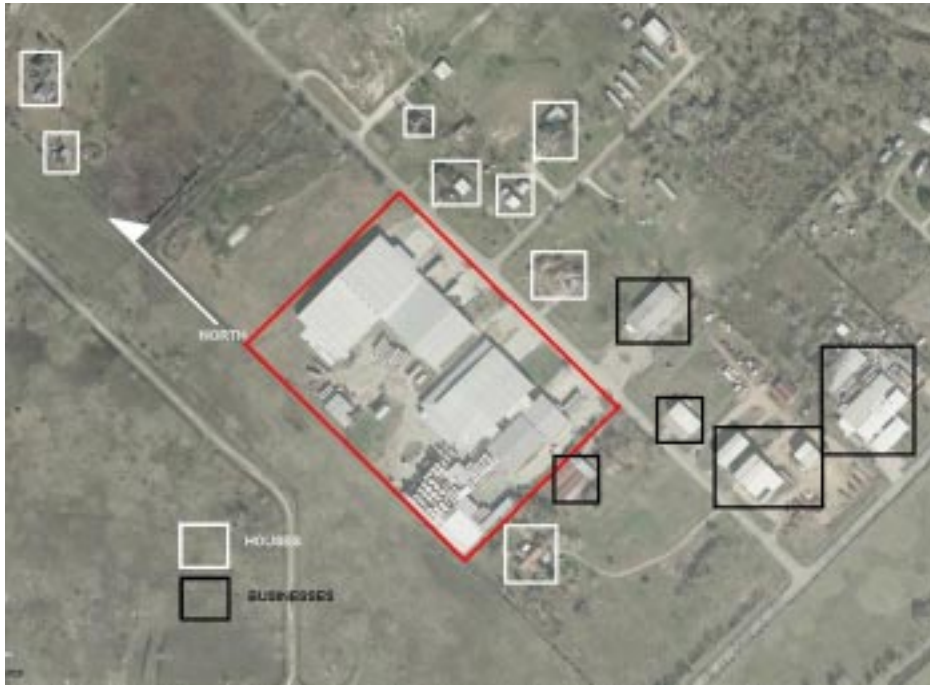
Figure 2. Third Coast facility, prior to fire.

At the time of the fire, Third Coast employed 100 people at the Friendswood site. (The only other Third Coast facility—Third Coast Terminals—is located within the city limits of Pearland, Texas.) Figure 2 presents an aerial view of the site, showing nearby homes and businesses.

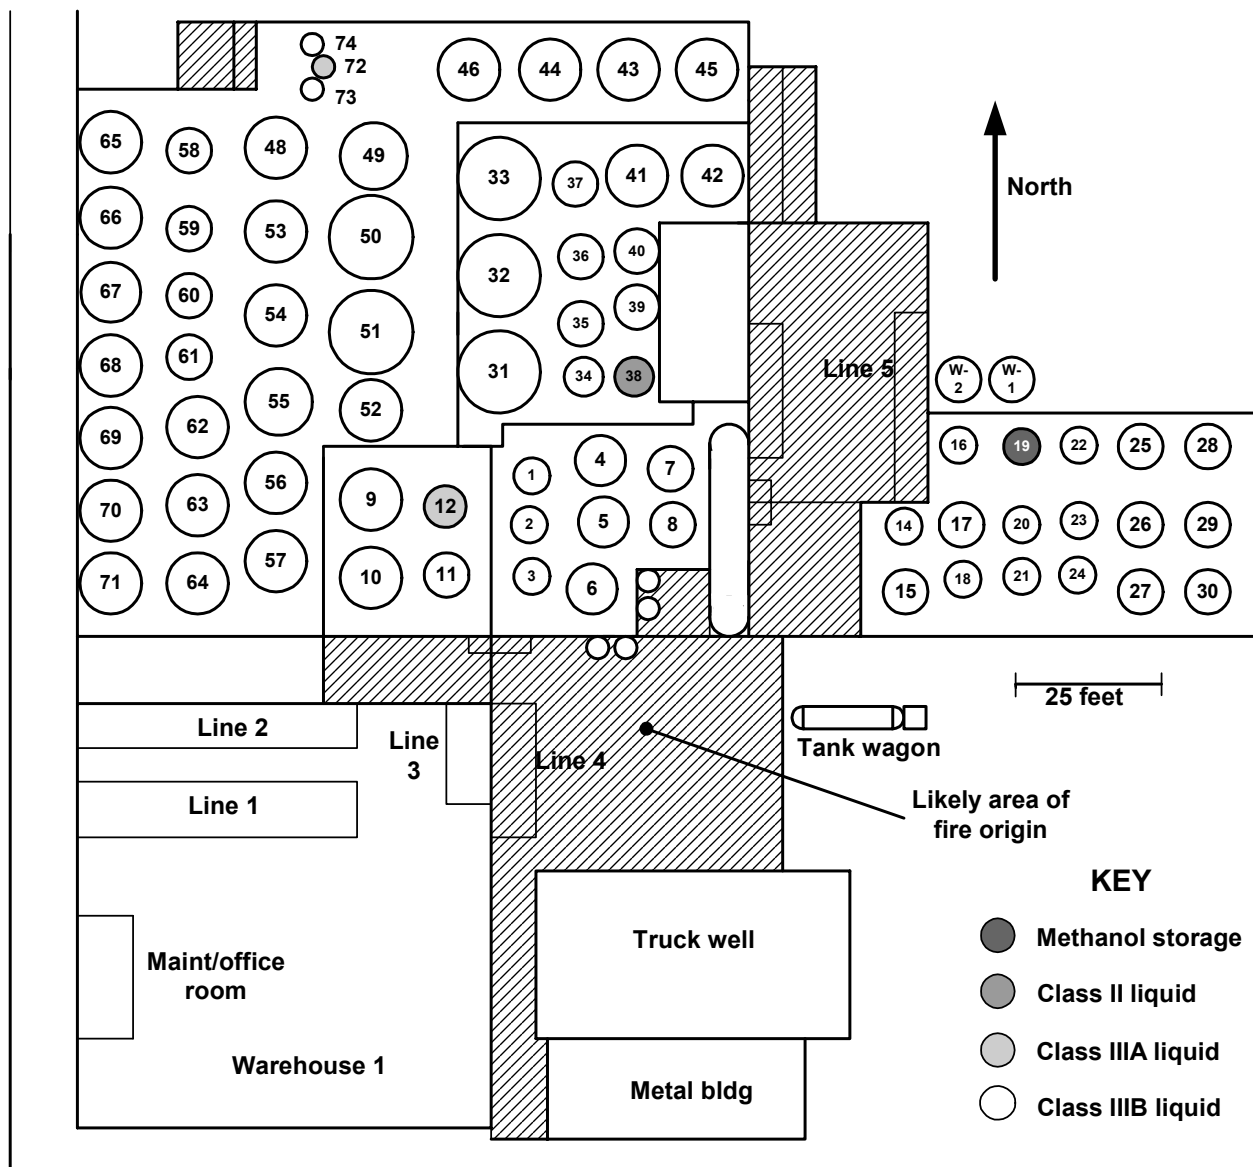
Figure 3. Third Coast storage tank farm.

Seventy-four storage tanks were in use at the time of the fire (Figure 3). Another 18 storage tanks were installed, but not in use. The tanks were divided among five diked areas. The rudimentary diking generally consisted of two courses of hollow masonry blocks. Although most of the tanks contained Class IIIB liquids, both raw materials and bulk finished products, the following liquids were also stored onsite:

- In Tank 19: 4,400 gallons of methanol (flash point 52°F), a Class IB material used in the production of windshield washer fluid.
- In Tank 38: 3,500 gallons of mineral spirits, a Class II material (flash point 105°F).

- In Tanks 12 and 72: 9,500 gallons of a Class IIIA petroleum distillate (flash point 150°F) and 1,050 gallons of an automatic transmission fluid (flash point 198°F), respectively.
