U.S. CHEMICAL SAFETY AND HAZARD INVESTIGATION BOARD

HYDROGEN SULFIDE EXPOSURE

No. 2003-02-C-OH
September 2003

ENVIRONMENTAL ENTERPRISES, INC.

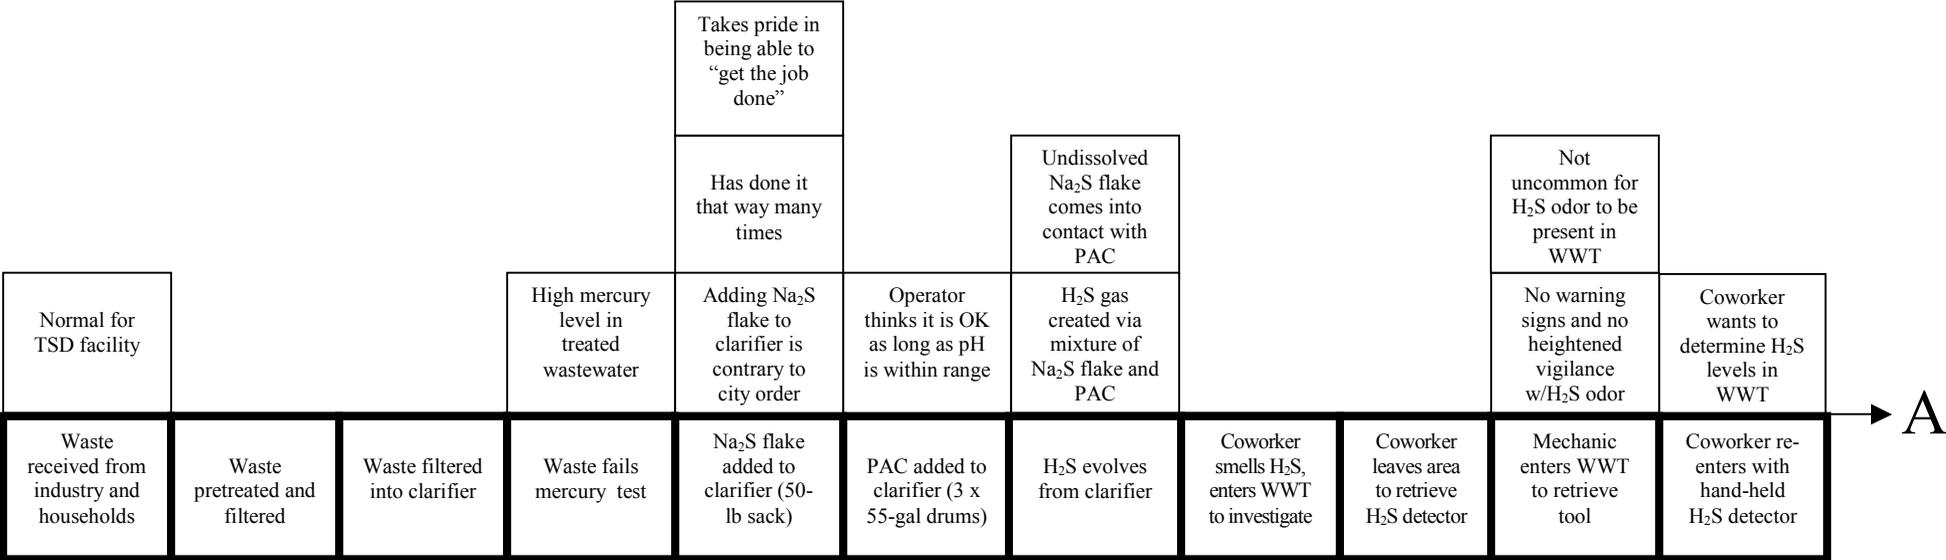
CSB investigators used a modified fault tree approach to analyze the information from this incident. The investigative team identified several contributing factors, as noted below. Refer to Figure 5 for the event tree and to Figure 6 for the event timeline.

- ◆ Operating procedures and operator training were inadequate. The WWT operator did not have written instructions or training on the proper treatment of wastes, the importance of using a properly designed treatment tank, or the consequences of treating waste in the open-topped clarifier.

- ◆ Management had not implemented controls to limit access to the WWT area during treatment or to notify facility personnel that WWT operations might present a hazard.

- ◆ Communication was inadequate to inform facility personnel of the hazards of H₂S. Employees did not respond appropriately when they smelled the characteristic odor because they did not fully appreciate the dangers of H₂S. Furthermore, employees were not warned when waste treatment operations had the potential to release H₂S. This lack of awareness of the hazards of H₂S is also evidenced by the fact that several employees entered the WWT area immediately after the incident, without respiratory protection.

- ◆ EEI had not implemented a mechanical integrity program to provide for calibration, inspection, and maintenance of the H₂S detector. The detector was not functioning on the day of the incident and failed to warn employees of a dangerously high H₂S concentration in the WWT area.

CSB concludes that the lack of effective management systems contributed to this incident, resulting in a near-fatal H₂S exposure.
