U.S. CHEMICAL SAFETY AND HAZARD INVESTIGATION BOARD

INVESTIGATION REPORT

T2 LABORATORIES, INC.

RUNAWAY REACTION

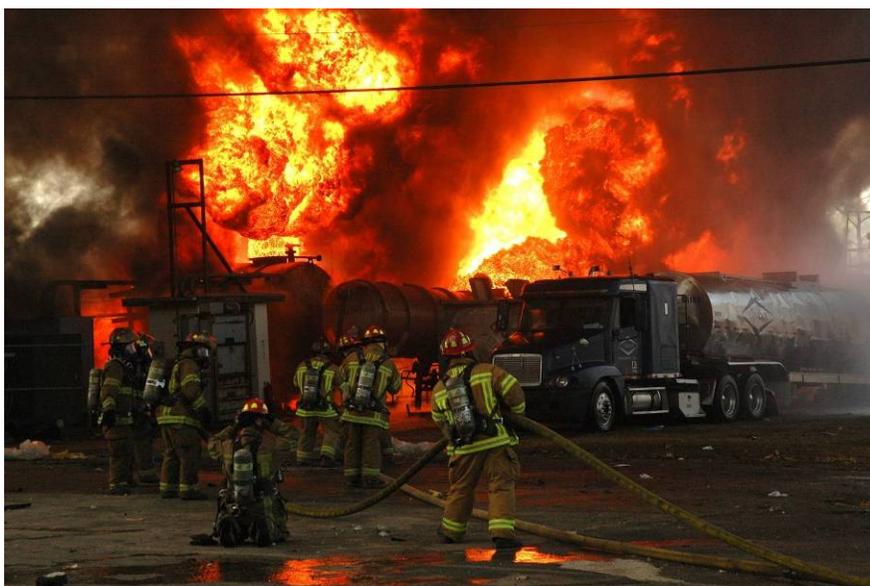
Figure 3. JFRD responders in SCBA battle fire.

JFRD completed a hazard analysis using material safety data sheets (MSDSs) from the T2 website.⁹ The incident commander (IC) ordered a half-mile evacuation radius, closing Faye Road and an adjacent railroad track. The IC ordered full personal protective equipment, including bunker gear¹⁰ and self-contained breathing apparatus (SCBA) for all personnel entering the area. About 90 firefighters from JFRD, the U.S. Naval Air Station Mayport Fire Department, and the Jacksonville International Airport Fire Department responded to the incident, battling the fire for many hours as stored solvents burned (Figure 3). Despite the large amounts of toxic MCMT and water-reactive sodium metal stored onsite, no responders were injured.

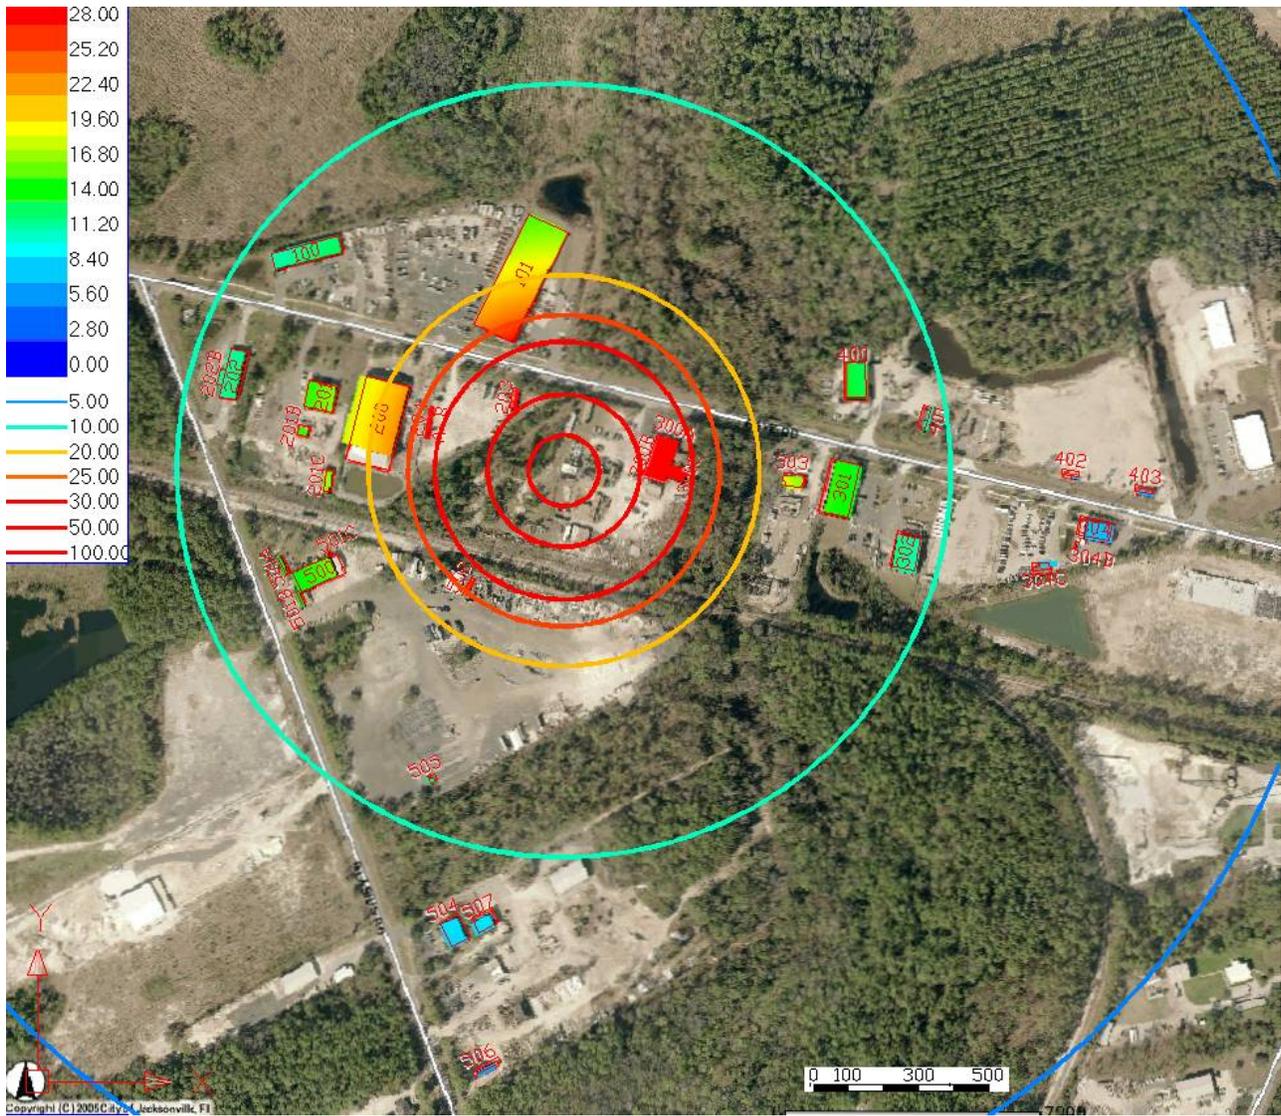
Figure 14. Free-Field Impulse Contours for Estimated TNT Yield of Explosion.

The CSB conducted laboratory testing of the chemical reaction used in the T2 process, recreated the most likely scenario, and calculated the pressure relief capacity necessary to safely vent the uncontrolled reaction. The CSB also conducted a community damage survey of the 32 structures damaged by the blast, using the data collected to estimate the amount of TNT necessary to produce a blast of equivalent magnitude.

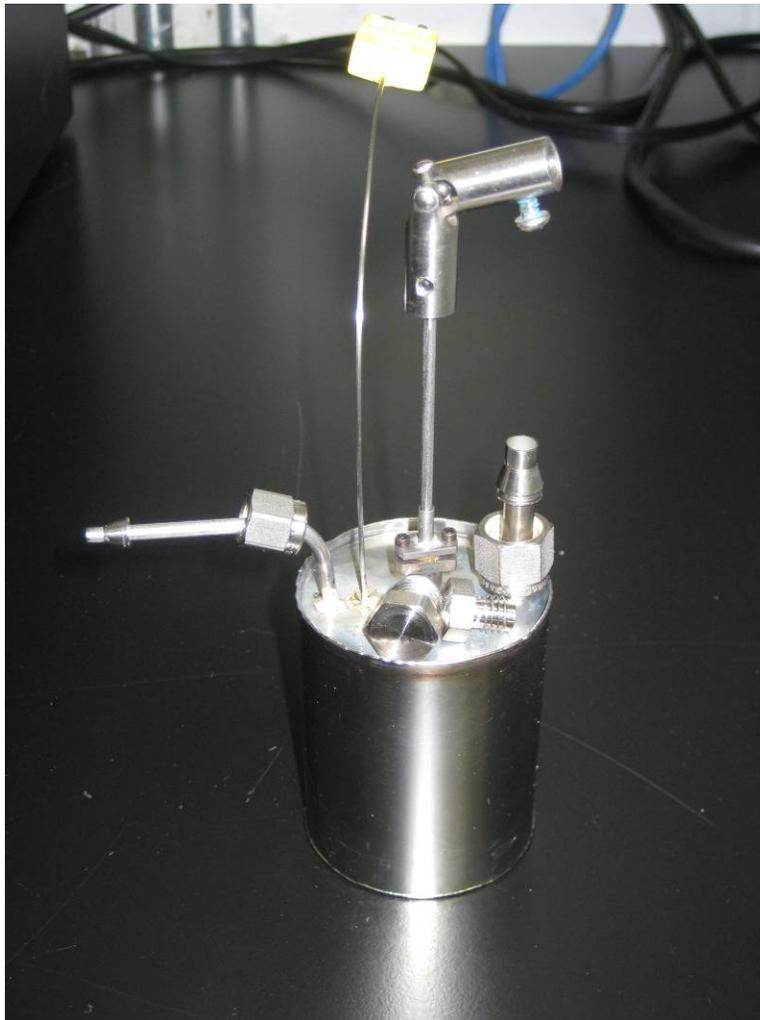
Figure 15. New VSP2 Test Cell.

Therefore, to more closely match the conditions at T2, the CSB ran a second series of six tests using the larger VSP2 test cell (Figure 15).

The VSP2 mimics the T2 facility's physical arrangement more closely and can accommodate more intense stirring to improve mixing of the chemical components. The VSP2 also incorporates baffles in the test cell which provide turbulence and shear in the liquid. These features reduced the molten sodium droplet size and increased contact between the molten sodium and the MCPD, similar to the mixer in the T2 reactor.
