# **FINAL INVESTIGATION REPORT**

## **CARIBBEAN PETROLEUM TANK TERMINAL EXPLOSION AND MULTIPLE TANK FIRES**

### **CARIBBEAN PETROLEUM CORPORATION (CAPECO)**

REPORT NO. 2010.02.I.PR

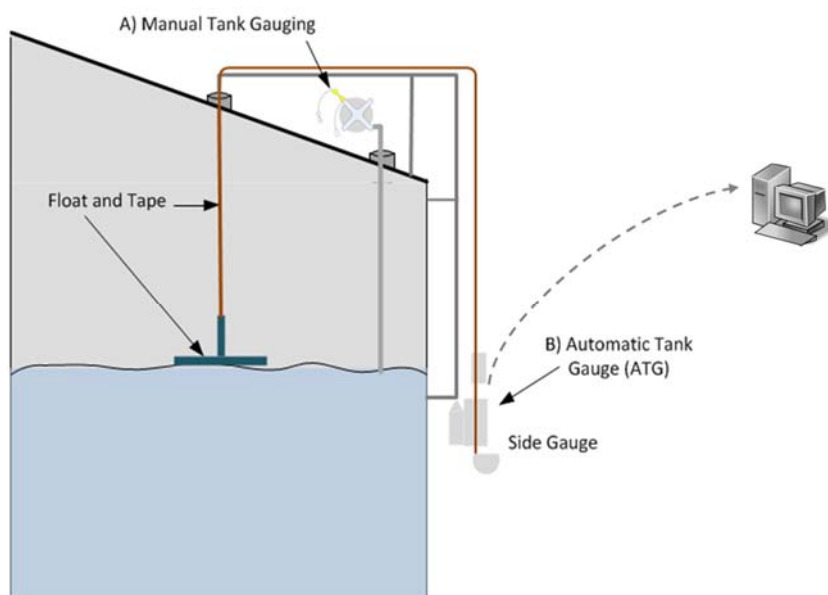
- 3) Multiple physical causes likely contributed to Tank 409 overfill:
  - Malfunctioning of the tank side gauge or the float and tape apparatus during filling operations led to recording of inaccurate tank levels;

Figure 3: Manual and Automatic Tank Gauging. (A) Manual Gauging requires an operator to use a tape and measure to determine the liquid levels inside the tank. (B) Automatic Tank Gauging (ATG) requires an operator to read a level measurement from a tank gauge mounted to the side of the tank.

Prior to the start and end of filling operations, the independent inspector manually measured the fuel tank levels by lowering a gauging tape<sup>12</sup> into the tank. (Figure 3.) A CAPECO operator

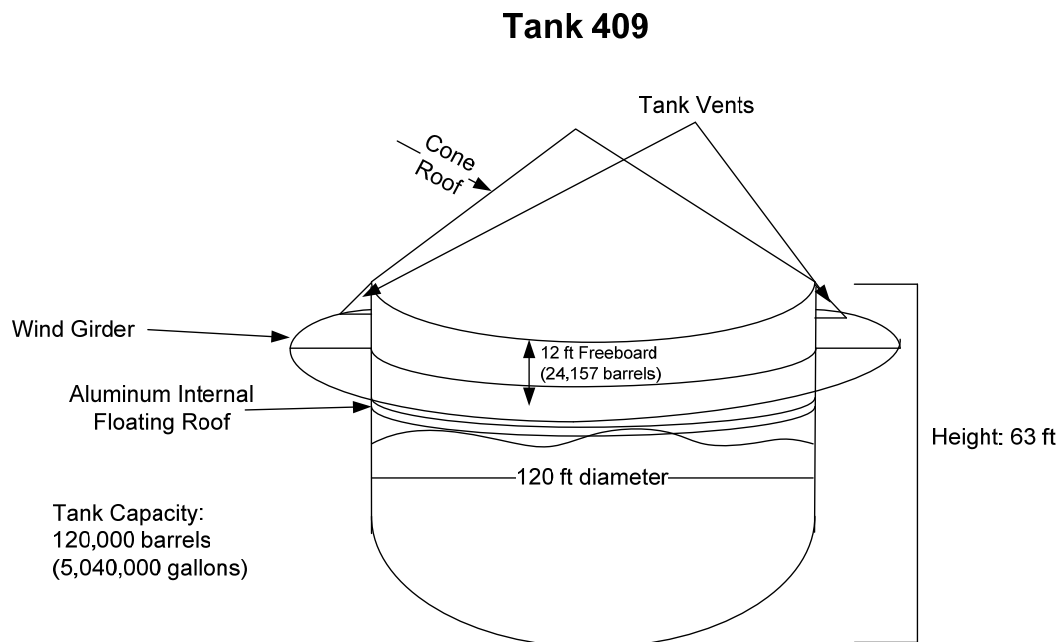
Figure 14: Tank 409 Specifications

Tanks 409 and 410 were located within the same secondary containment dike.<sup>23</sup> Similar to the Buncefield incident,<sup>24</sup> during the overflow, gasoline sprayed from the tank vents, hitting the Tank 409 wind girder and aerosolized,<sup>25</sup> forming a vapor cloud.<sup>26</sup> A CSB topographic survey of the site shows that Tanks 409 and 411 were located at the highest point within the tank farm area, allowing the vapor cloud to spread to lower lying areas in the direction of the WWT (Figure 7). See Figure 14, Tank 409 Specifications.

The destruction of the Tank 409 internal floating roof in the explosion prevented the CSB from determining if it failed during filling operations. Therefore, internal floating roof failure might have contributed to the overfilling of Tank 409. The roof construction of Tank 409 was subject to numerous operational limitations. Tank 409 had a fixed cone roof with an aluminum internal floating roof (IFR), and a freeboard<sup>71</sup> of 12 feet (24,157 bbls). (See Figure 14 for Tank 409 specifications.) Aluminum IFRs are prone to corrosion when exposed to caustic liquids but sufficient for petroleum and organic materials. An internal floating roof can fail by means of turbulence,<sup>72</sup> roof submersion,<sup>73</sup> seal issues, and fatigue.<sup>74</sup>

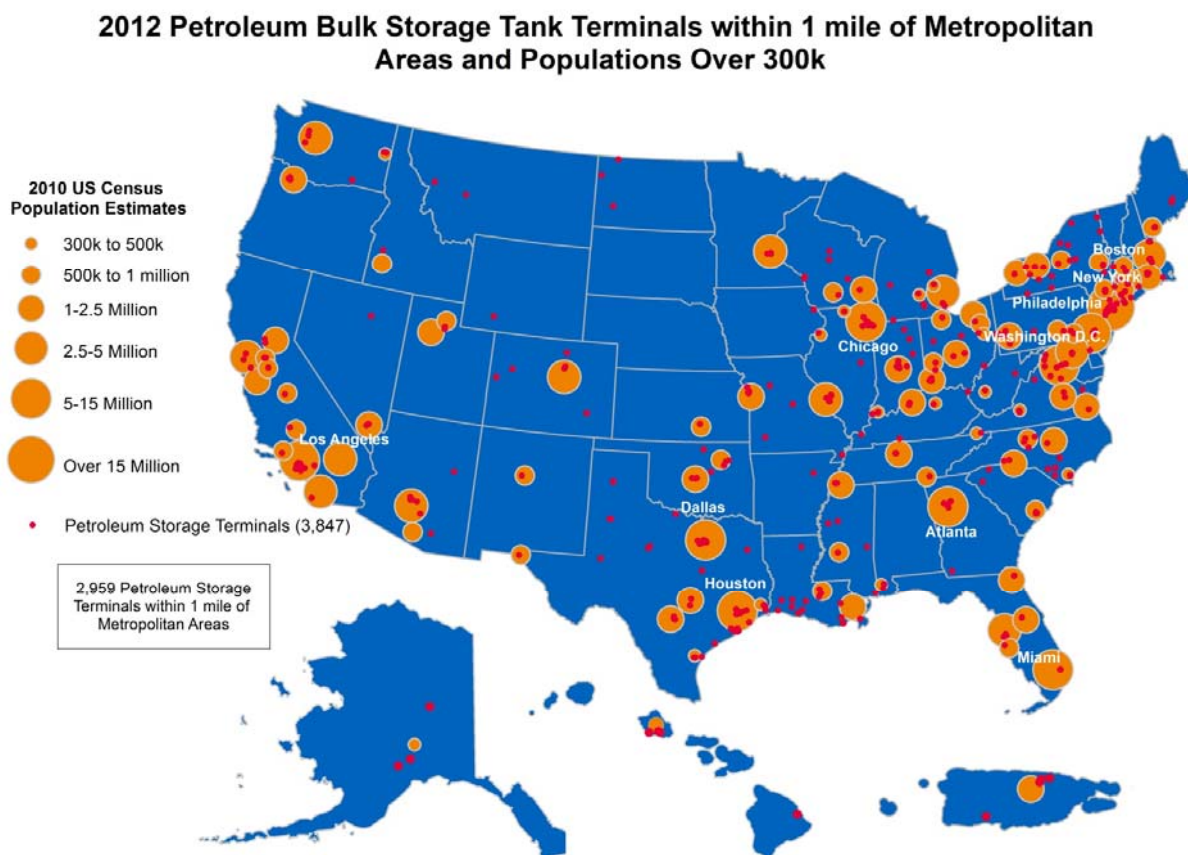
Tank terminals are located throughout the US in both rural and urban areas. Figure 16 illustrates the location of bulk petroleum tank terminals in all 50 states in 2012. In 2009, 3,807 bulk liquid storage facilities registered a release with the EPA Toxic Release Inventory (TRI).<sup>87,88</sup> The CSB mapped 3,847 bulk petroleum storage tank terminal locations obtained from the EPA TRI database for 2012 and found 2,959 bulk petroleum storage terminals within one mile of communities with over 300,000 residents (Figure 16).

Figure 16: Tank terminals distributed across the US in 2012 in proximity to 2010 population data.  
(EPA TRI Database, 2012)

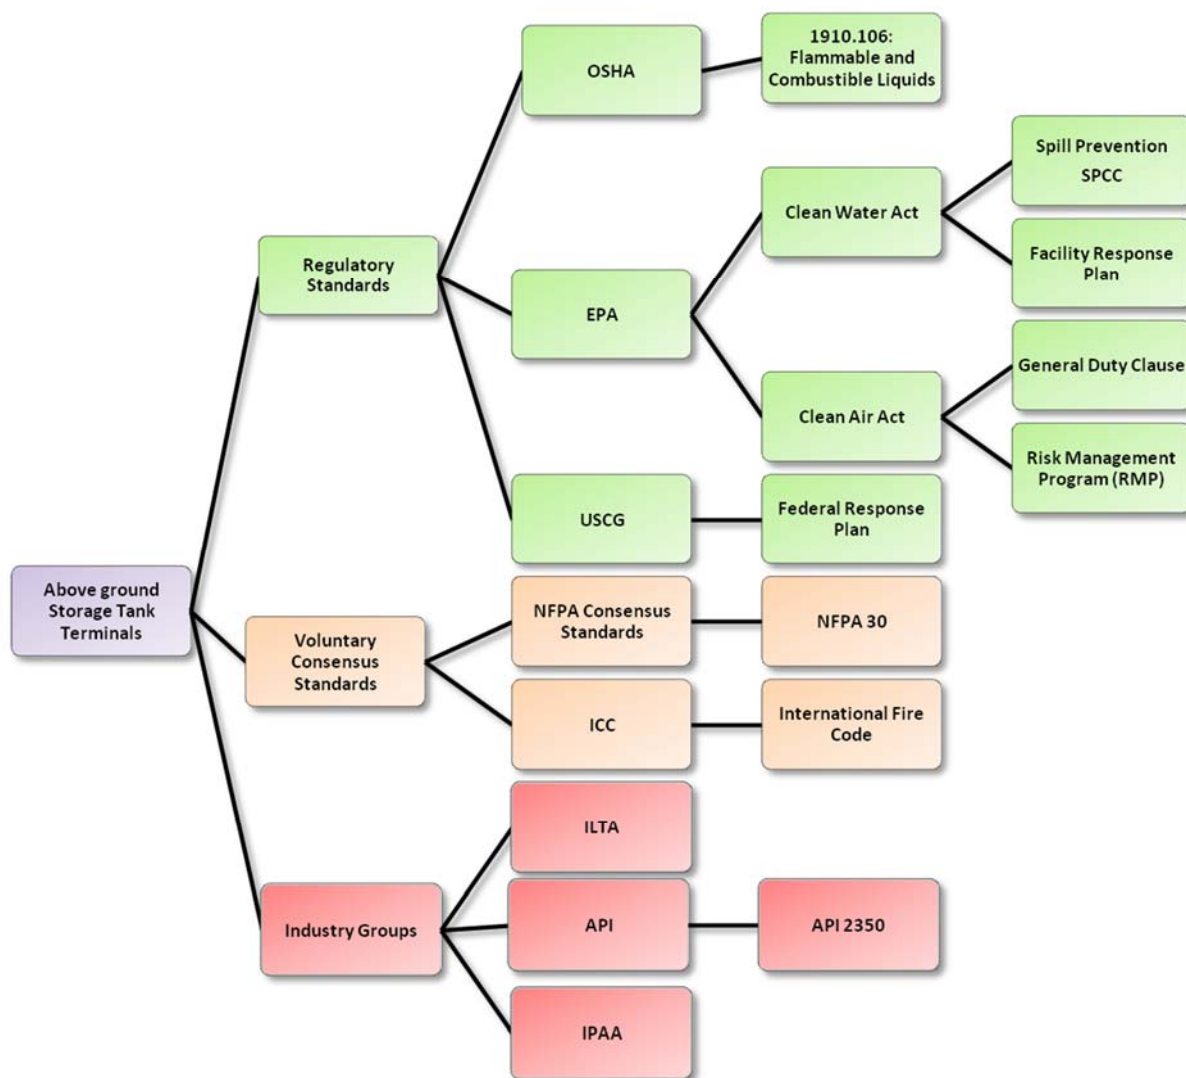
The CSB determined that existing regulatory, industry, and consensus standards do not adequately protect workers and the public from the dangers posed by bulk petroleum storage tank terminals. The following section discusses shortcomings of the regulatory, standard and recommended practice framework governing this industry. (See Figure 17.)

Figure 17: Many regulatory policies, voluntary and consensus standards contain safety requirements or recommendations for bulk petroleum aboveground storage tanks, but not all are required, and storage tank facilities are not generally covered by the RAGAGEP provisions of the OSHA PSM and EPA RMP programs. The voluntary industry and consensus standards could be considered RAGAGEP, if the process or facility were covered under these programs.
