Investigation Report

Published: December 2019

KEY ISSUES:

On May 24, 2017, an explosion occurred at the Midland Resource Recovery (MRR) facility in Philippi, West Virginia, killing two workers^a and severely injuring another worker. The founder and president of MRR was one of the victims. The CSB initiated an investigation of the incident and deployed an investigative team on May 28, 2017. While the CSB was investigating this incident, the MRR facility experienced a second explosion, on June 20, 2017. This explosion fatally injured a contractor^b employed by Specialized Professional Services, Inc. (SPSI). MRR had hired SPSI to perform investigation and mitigation work at its Philippi facility following the May 24, 2017, explosion.

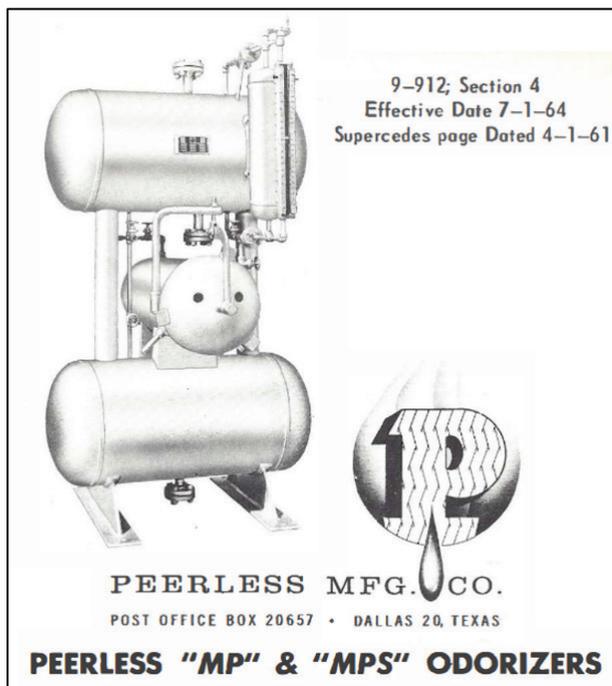
Figure 1. Peerless MP Odorizer. This figure, adapted from a 1964 Peerless Manufacturing Company parts price list, shows a Peerless MP Odorizer. (Credit: MRR).

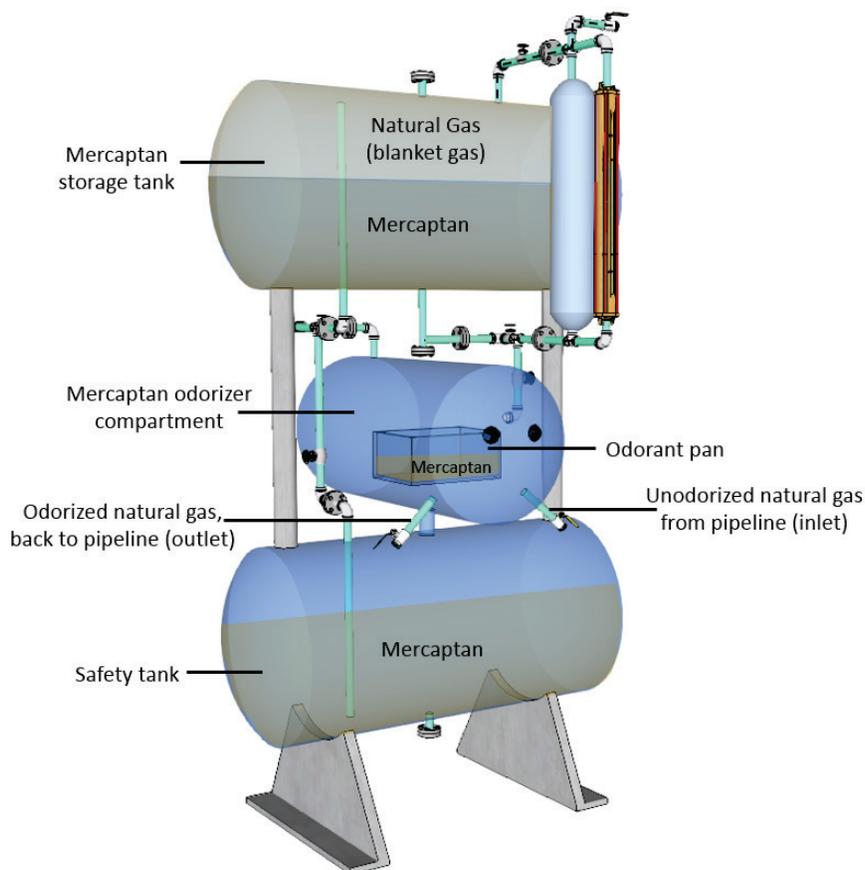
Peerless metering-type gas odorizers as Peerless MP Odorizers are constructed of three tanks with interconnected piping (Figure 2). The top tank is the storage tank that contains mercaptan to be introduced to the pipeline. The middle tank is the odorizer compartment, where unodorized natural gas enters the tank, is odorized, and exits the tank to be routed back to the pipeline. The bottom tank is a safety tank, providing overflow protection for both the top and middle tanks. The odorizers involved in both the May 24, 2017 and June 20, 2017, incidents were MP 85 units, with a nominal odorant capacity of 85 gallons.^a MRR stated to the CSB that before the May 24, 2017, incident the company had successfully removed the mercaptan smell from more than 150 MP style vessels.

Figure 2. Peerless MP Odorizer. This graphic shows some of the piping and internal equipment associated with a Peerless MP Odorizer. (Credit: CSB).

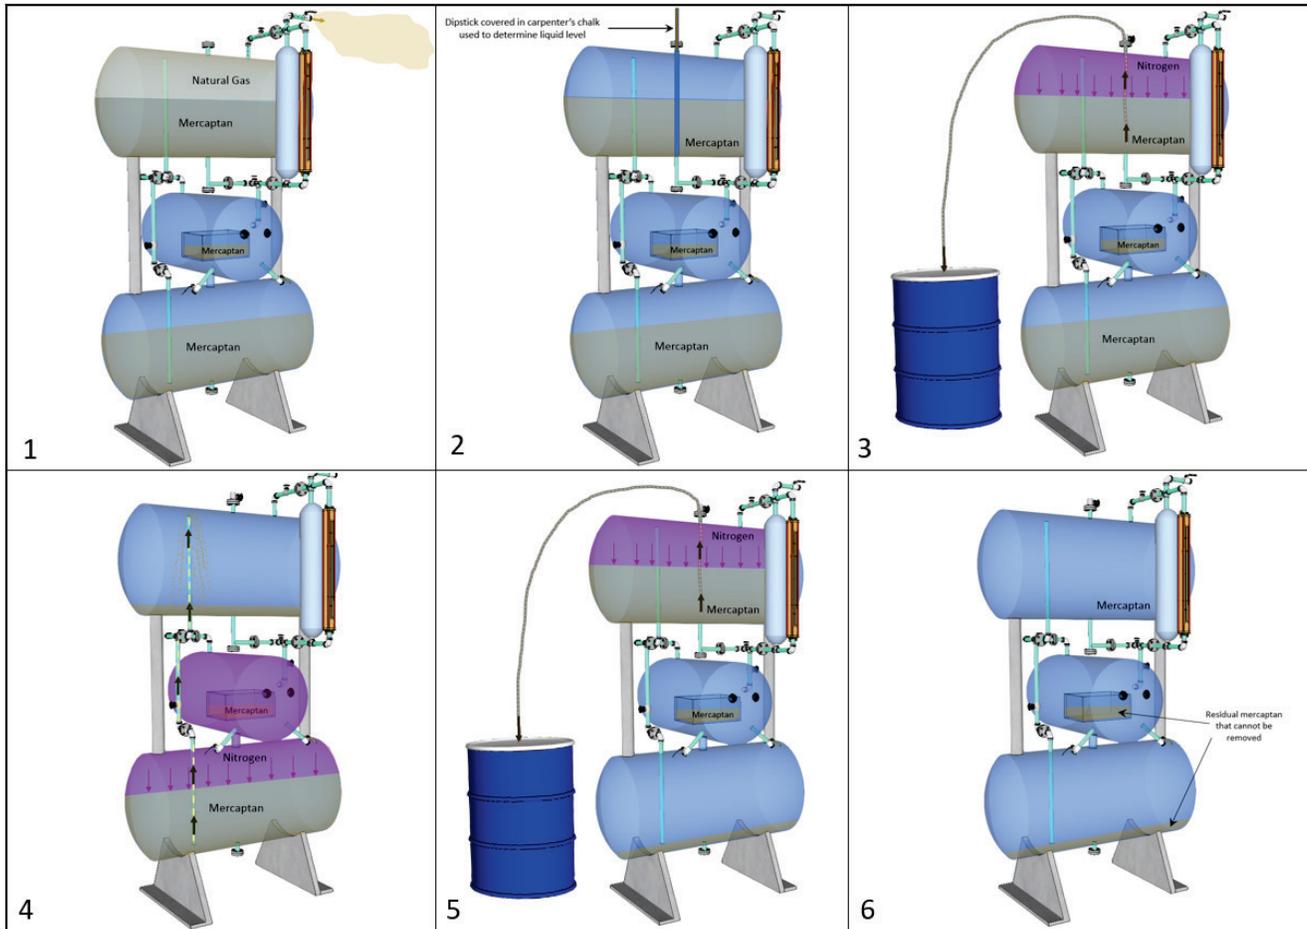
MRR technicians do not perform any testing to analyze or characterize what chemicals are present in the MP odorizer. Also, due to the design of the odorizer itself and the decommissioning process MRR established, MRR technicians do not have a way to remove all the uncharacterized liquid from the bottom chamber or the middle chamber.^a

Figure 3. Odorizer Decommissioning and Draining. These graphics outline the steps MRR technicians typically performed to drain liquid from MP odorizers tanks in preparation for transport and chemical treatment. (Credit: CSB).

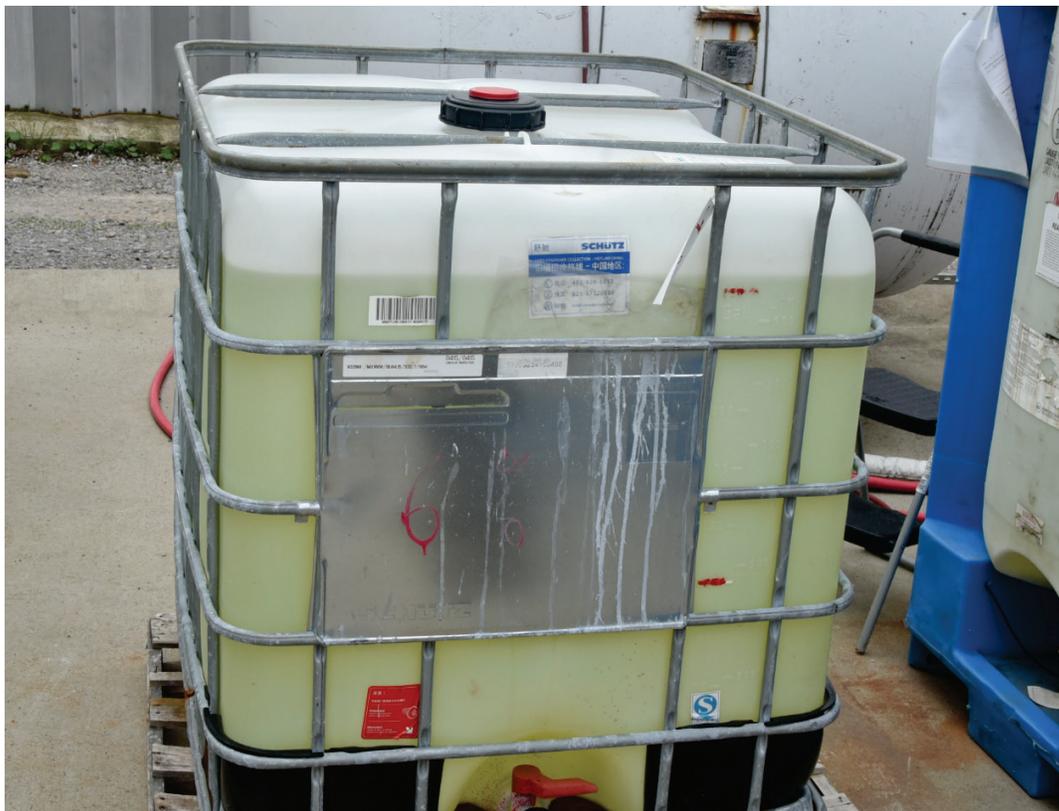
Figure 4. Sodium Hypochlorite Tote. This picture shows one of the totes at MRR that contained sodium hypochlorite. (Credit: CSB).

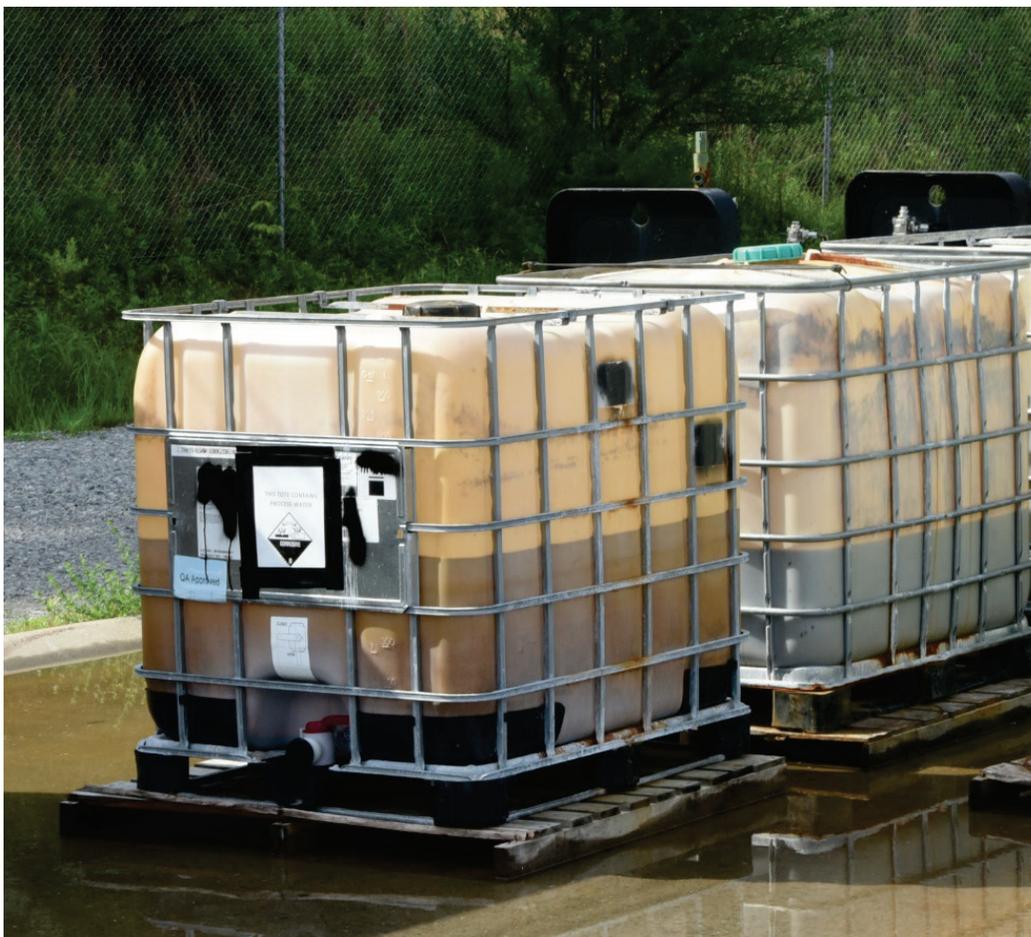
Figure 5. Process Water Totes. This picture shows totes at MRR containing “process water” that MRR technicians have pumped out of treated odorizer equipment. (Credit: CSB).

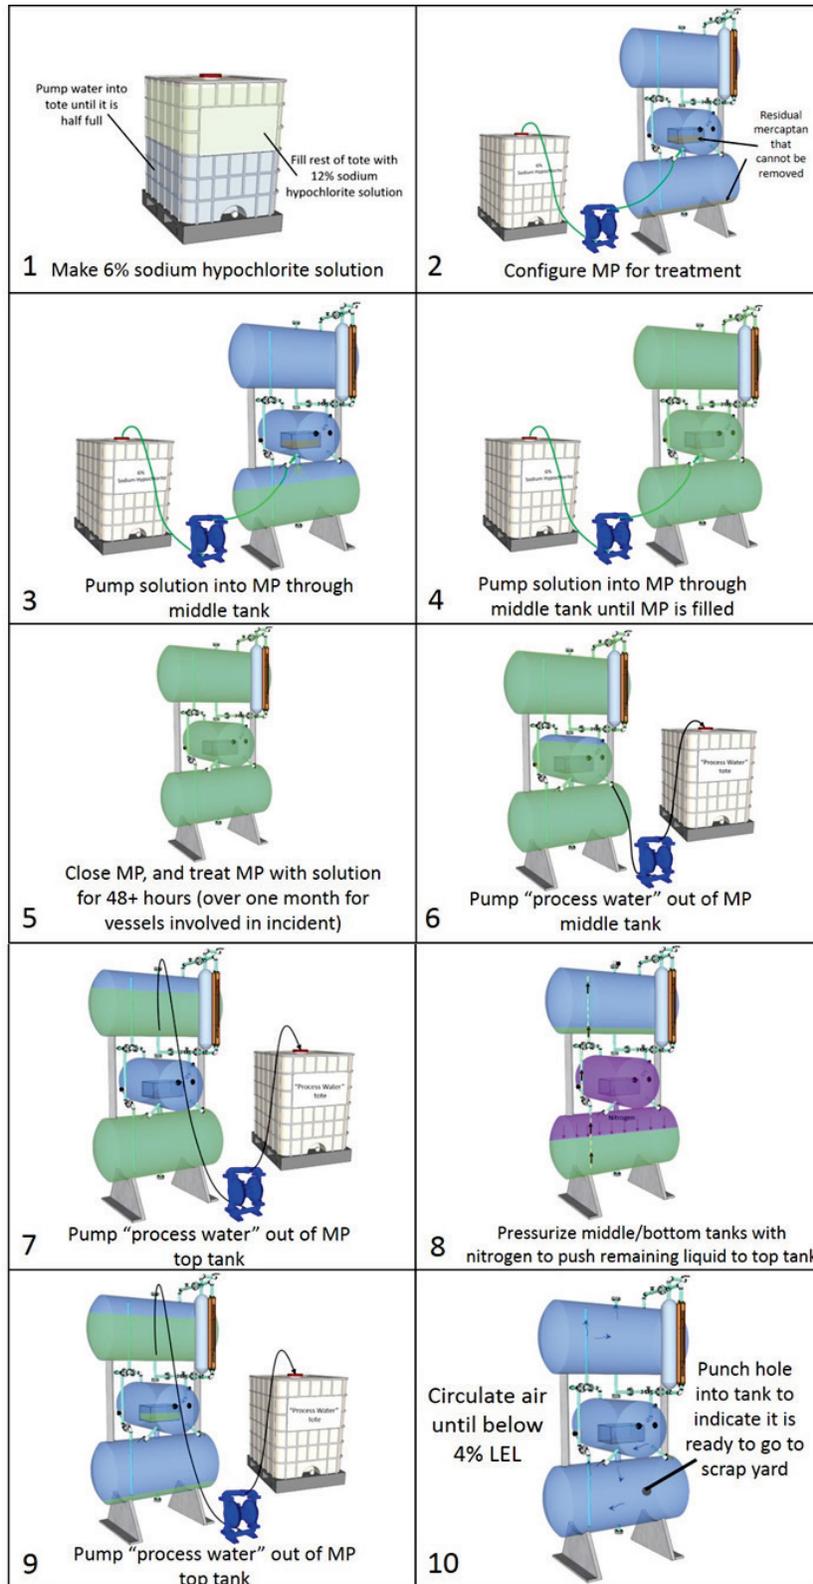
Figure 6. Chemical Treatment. This graphic depicts the typical steps MRR technicians perform to chemically treat MP odorizers to remove the smell of mercaptan from the steel. (Credit: CSB); LEL refers to the Lower Explosive Limit.

MRR technicians typically observed an operating pressure of -0.25 to 5 psig during the chemical treatment process. The tanks are rated at 125 to 1,000 psig. MRR therefore did not install pressure relief on the tanks because the company thought it was not needed.

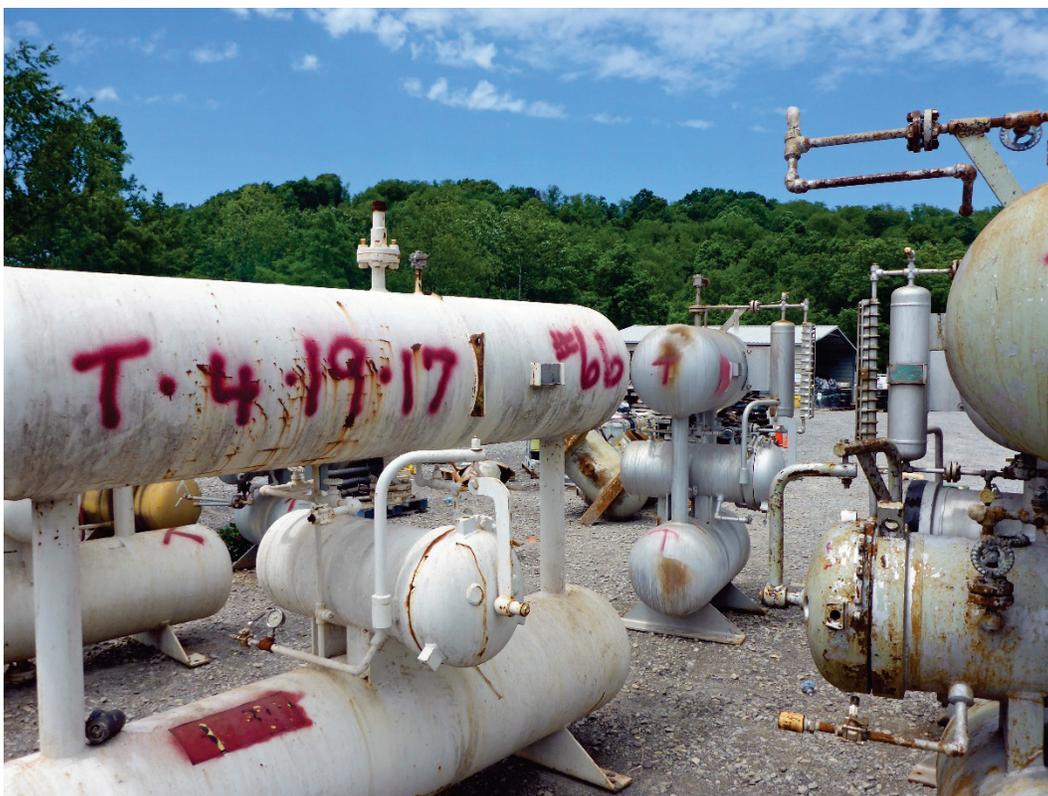
Figure 7. Treatment Status. This photo shows how MRR technicians used red spray paint to record the date the MP was chemically treated, April 19, 2017. (Credit: CSB).

^a MRR asserted that the company “also used a tag system for MP style vessels, including written logs showing when they were treated, drained, purged and scrapped.” The CSB investigation revealed, however, that for half of these 16 MP odorizers (8 of 16), MRR lacks records showing when the company chemically treated the equipment or which MRR technicians performed the chemical treatment.

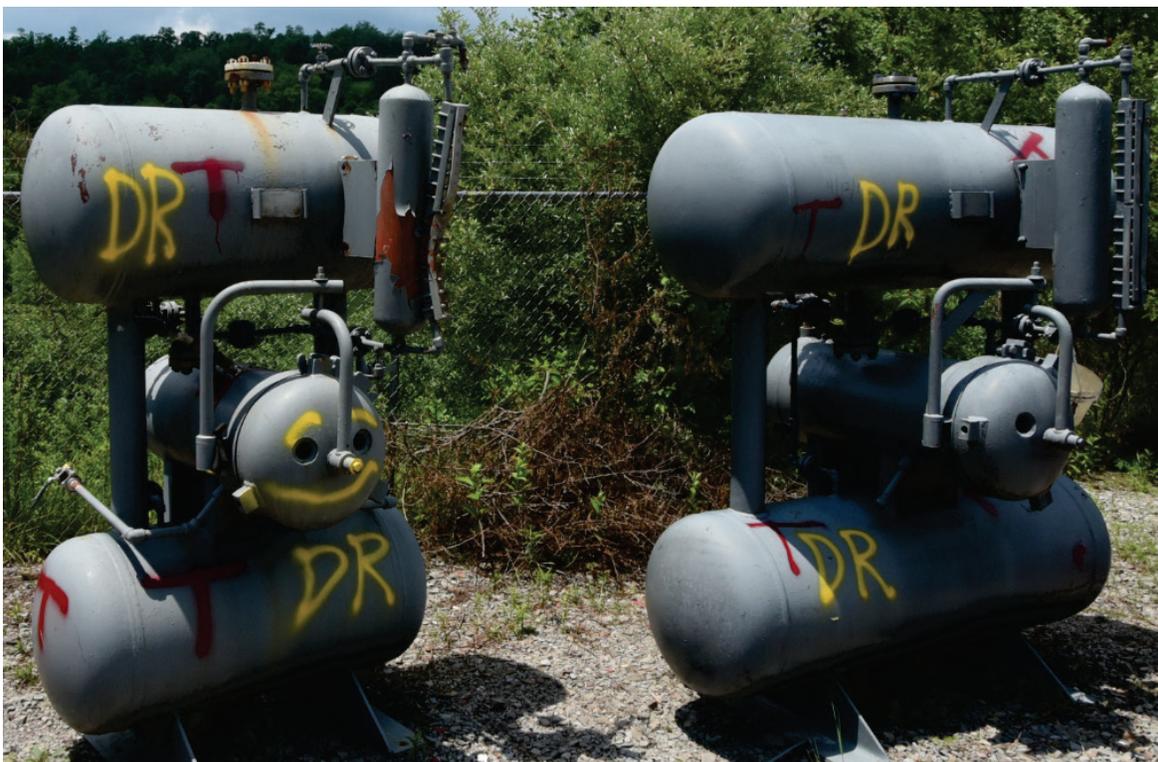
In May 2017, after roughly one month of chemical treatment with the sodium hypochlorite, MRR personnel began draining the treated MP odorizers. Spray paint markings (Figure 8) and equipment connections indicated that three of the 16 treated MP odorizers had been drained.

Figure 8. Drained Status. This photo shows how MRR technicians spray painted odorizer equipment with a “D” or a “DR” for *drained* (in yellow) after they drained the sodium hypochlorite treatment solution from the odorization equipment. (Credit: CSB).
