Factual Update

October 29, 2020

Incident Summary

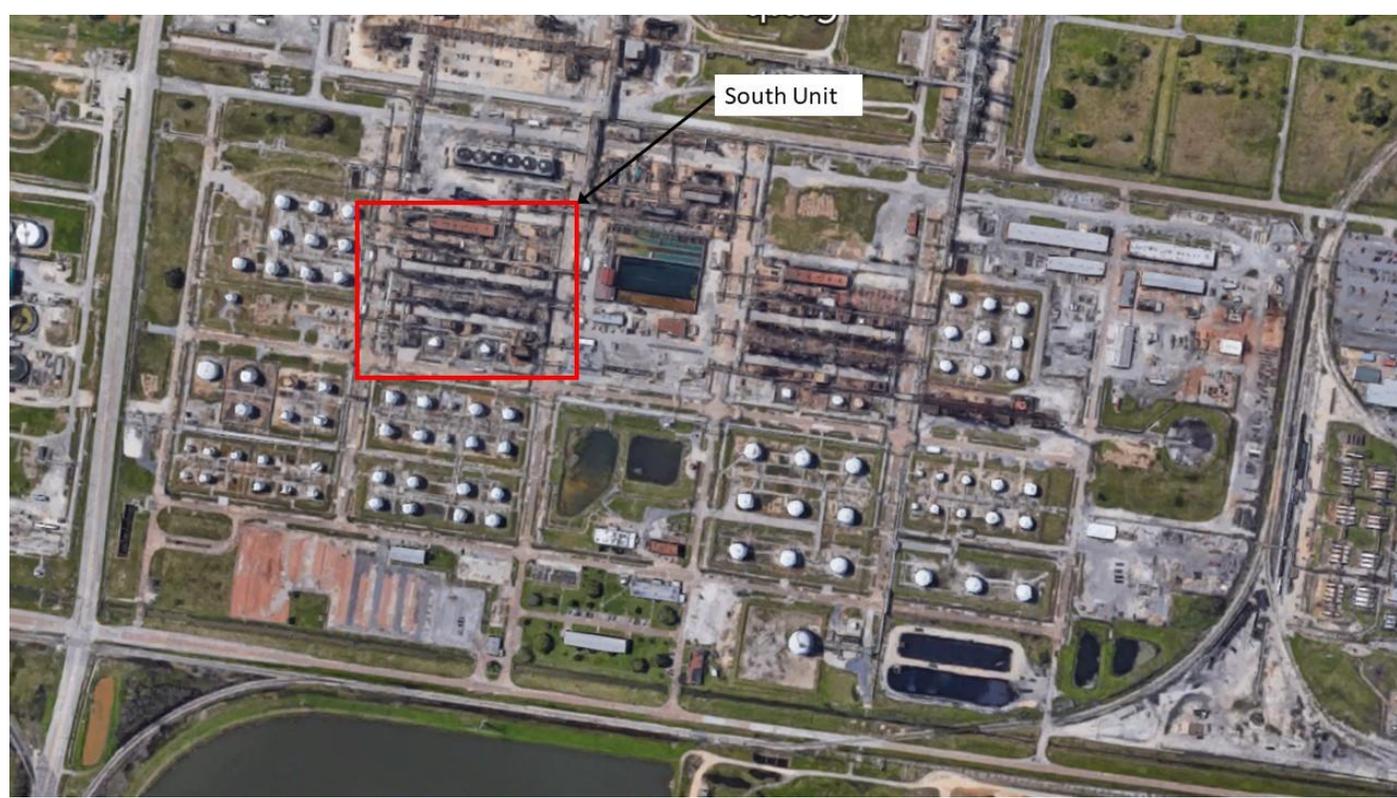
Figure 1. TPC PNO facility prior to the incident. (Credit: Google Maps)

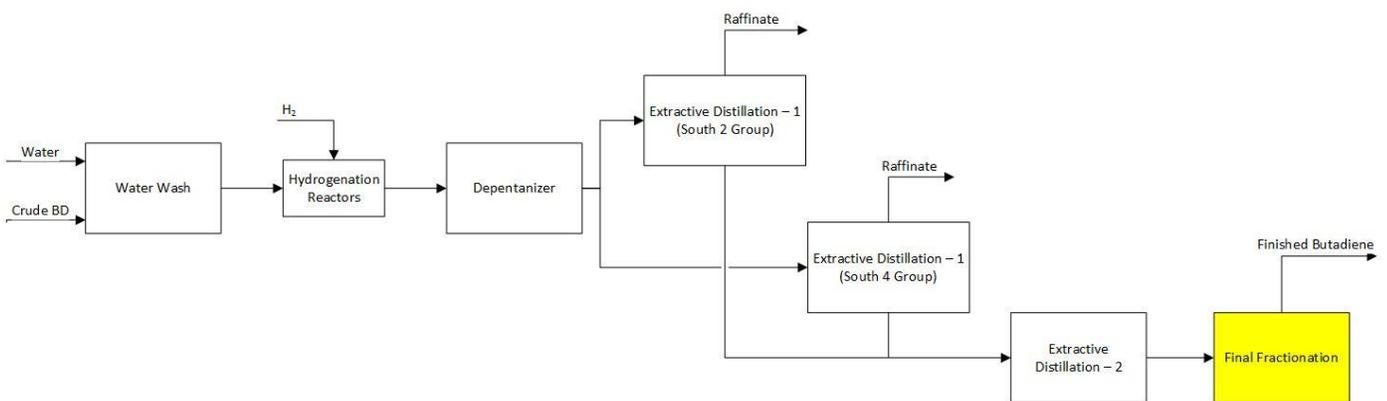
- **Figure 2** shows a block flow diagram of the butadiene production process at TPC PNO. Crude butadiene ranging from 35 to 75 percent purity proceeds through multiple production phases. After the final fractionation phase, the 1,3-butadiene is at 99.8 percent purity, where it is sent to storage tanks for shipping. The loss of containment occurred in the final fractionation phase.

Figure 2. Block flow diagram of the butadiene production process at TPC PNO. The highlighted area shows where the loss of containment occurred. (Credit: CSB)
