U.S. CHEMICAL SAFETY AND HAZARD INVESTIGATION BOARD

# INVESTIGATION REPORT

## E.I. DUPONT DE NEMOURS & CO., INC.

BELLE, WEST VIRGINIA

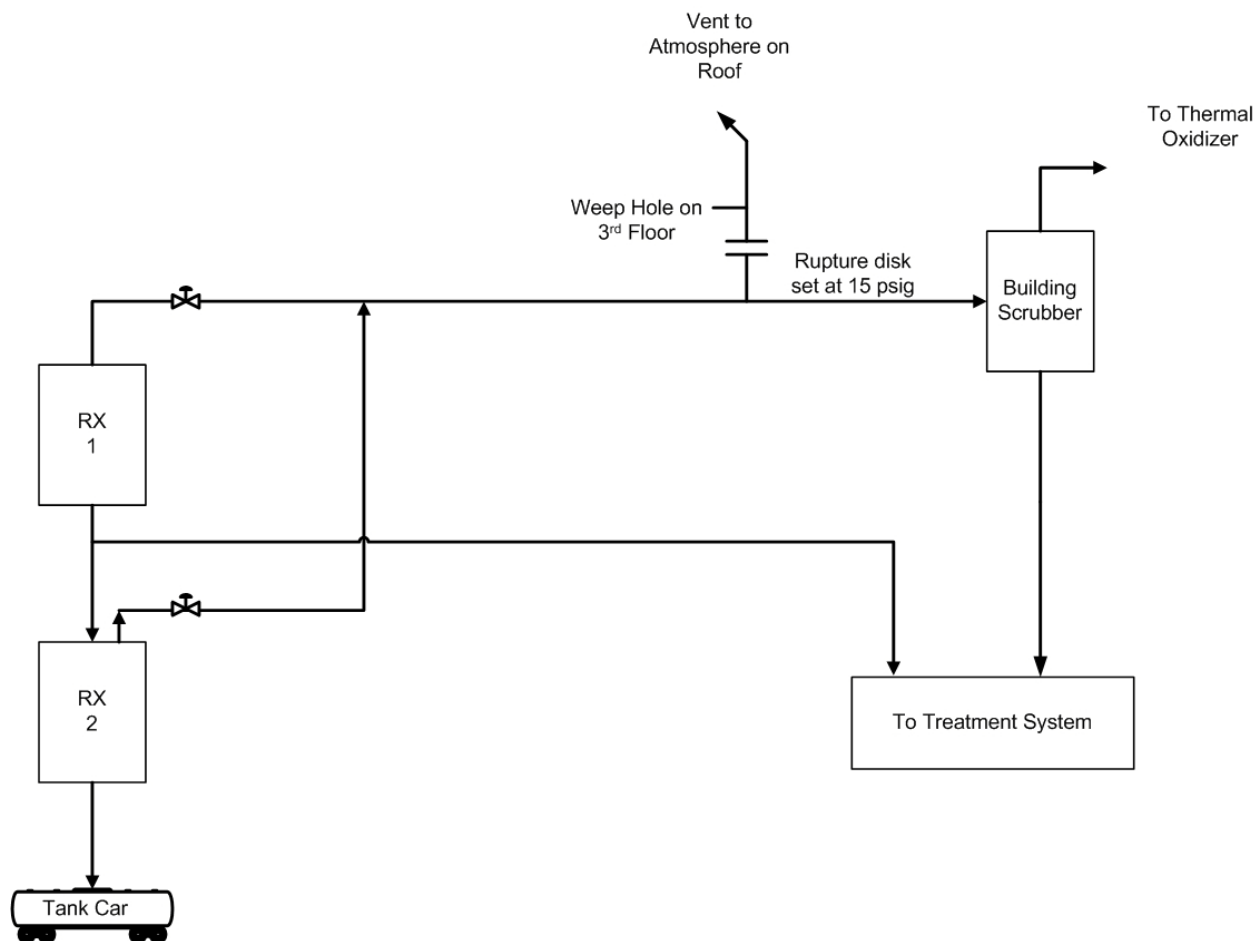
The Belle plant's F3455 unit manufactures the intermediate F3455, a chemical that is shipped to another DuPont facility to make the herbicide Velpar<sup>®</sup>. Due to the exothermic reaction in the first reactor, dissolved methyl chloride vaporizes and normally exits through the reactor vent line along with carbon dioxide, nitrogen, and trace amounts of dimethylamine (DMA) vapor through a process scrubber and then to a thermal oxidizer for emission control. To avoid damage to the scrubber<sup>6</sup> if excessive pressures occur, a piping connection upstream of the vent line is routed to a rupture disc that will burst and allow venting outside on the roof of the building which contains two reactors (Figure 2). However, due to a lack of safety considerations during installation, a 0.5-inch weep hole<sup>7</sup> was placed on the vent line inside the building; consequently, dangerous chemicals vent inside the building if the rupture disc bursts.

Figure 2. Simplified thermal oxidizer and rupture disc block flow diagram

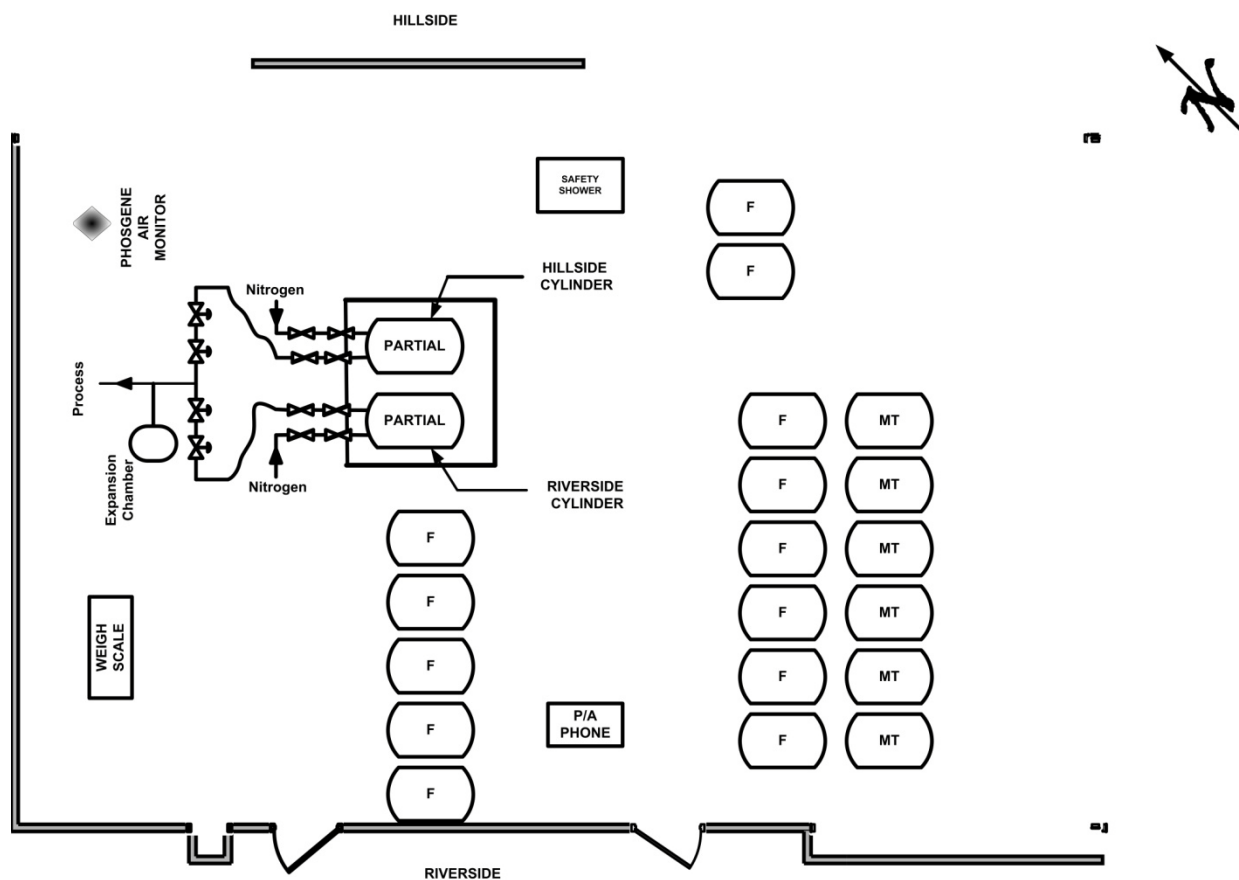
Figure 12. Phosgene shed and full (F) and empty (MT) cylinder locations on day of incident (not to scale)

During normal operation, two cylinders are staged on weigh scales and each is connected to the process with two 0.25-inch diameter by 48-inch long PTFE-lined, 304 stainless steel overbraid hoses. One hose transfers liquid phosgene to a steam vaporizer and one provides 70-psig nitrogen to the cylinder. The scales record the weight of the in-service cylinder and when the container is nearly empty, an alarm notifies the board operator, who then directs operators to switch to a full cylinder. This switch is completed by opening valves to the full cylinder and closing valves to the empty cylinder. The hoses remain coupled in this operation, and plant SOPs do not require enhanced PPE such as a fully encapsulated suit and breathing air. Under normal operating conditions, the process consumes two to three cylinders of phosgene per day.

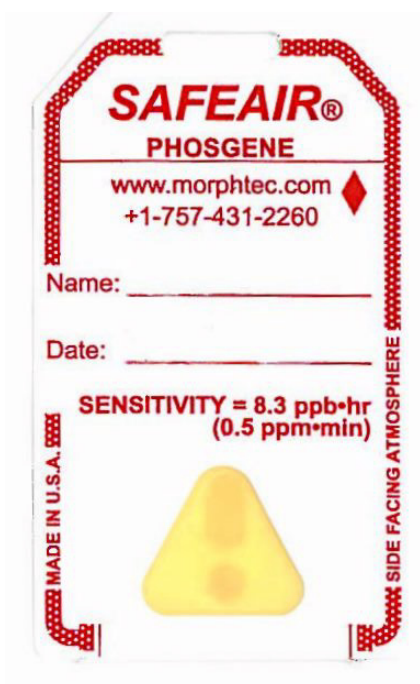
Figure 13. SafeAir Phosgene Dosimeter Badge<sup>37</sup>

Immediately after the operator was sprayed, he called for assistance on the SLM unit public address phone in the phosgene shed. A coworker who responded to the call noticed that the victim's phosgene dosimeter badge (Figure 13) was discolored, indicating an exposure. The coworker directed the exposed worker to a plant truck to transport him to the plant's medical center for assessment and treatment. As they drove to the medical center, the two workers were met by the Shift Supervisor and the exposed worker was transferred to the shift supervisor's vehicle to complete the trip. While en route to the plant's medical center, the front gate guard was radioed and advised to call Metro 9-1-1 and request that an ambulance respond for a medical emergency. The exposed worker, while at the medical center waiting for the ambulance, chose to wash his face and hands, but there is no evidence or record that he was placed in a safety shower to wash off, as instructed by the emergency procedures, or that any decontamination activity took place beyond the hand and face washing. He was given a change of coveralls to put on in exchange for the work clothes he was wearing. The gate guard called Metro 9-1-1 at 1:59 p.m., requesting transport for a medical emergency patient to the hospital. The 9-1-1 dispatcher asked if there was a chemical release; however, the gate guard, who was unaware of the situation, responded that there was no release and that the response was for a medical emergency. As part of the Metro 9-1-1 emergency response protocol, the dispatcher asks for specific information to ensure that responders are as informed as possible prior to arrival at the scene. At 2:03 p.m., an ambulance was dispatched from the KCEAA. At 2:08 p.m., responding EMTs asked Metro dispatchers if more information was available about the victim. When Metro called DuPont to get more information, the line was busy. EMTs also wanted to know if there was a chemical exposure, but Metro 9-1-1 could not get that information from DuPont. Six minutes later, the EMTs arrived at the DuPont gates.

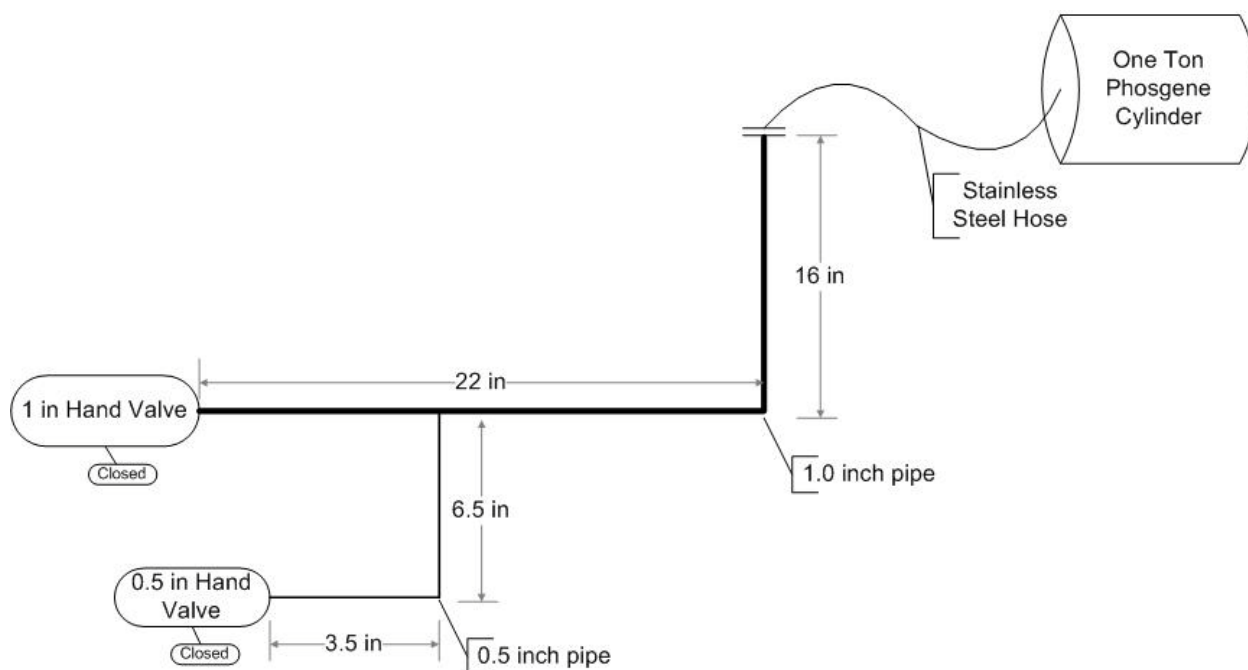
Figure 18 shows the hose and piping dimensions and the maximum amount of phosgene present in the piping system associated with the hose failure.

Figure 18. The hose and piping system that supplied phosgene for the release

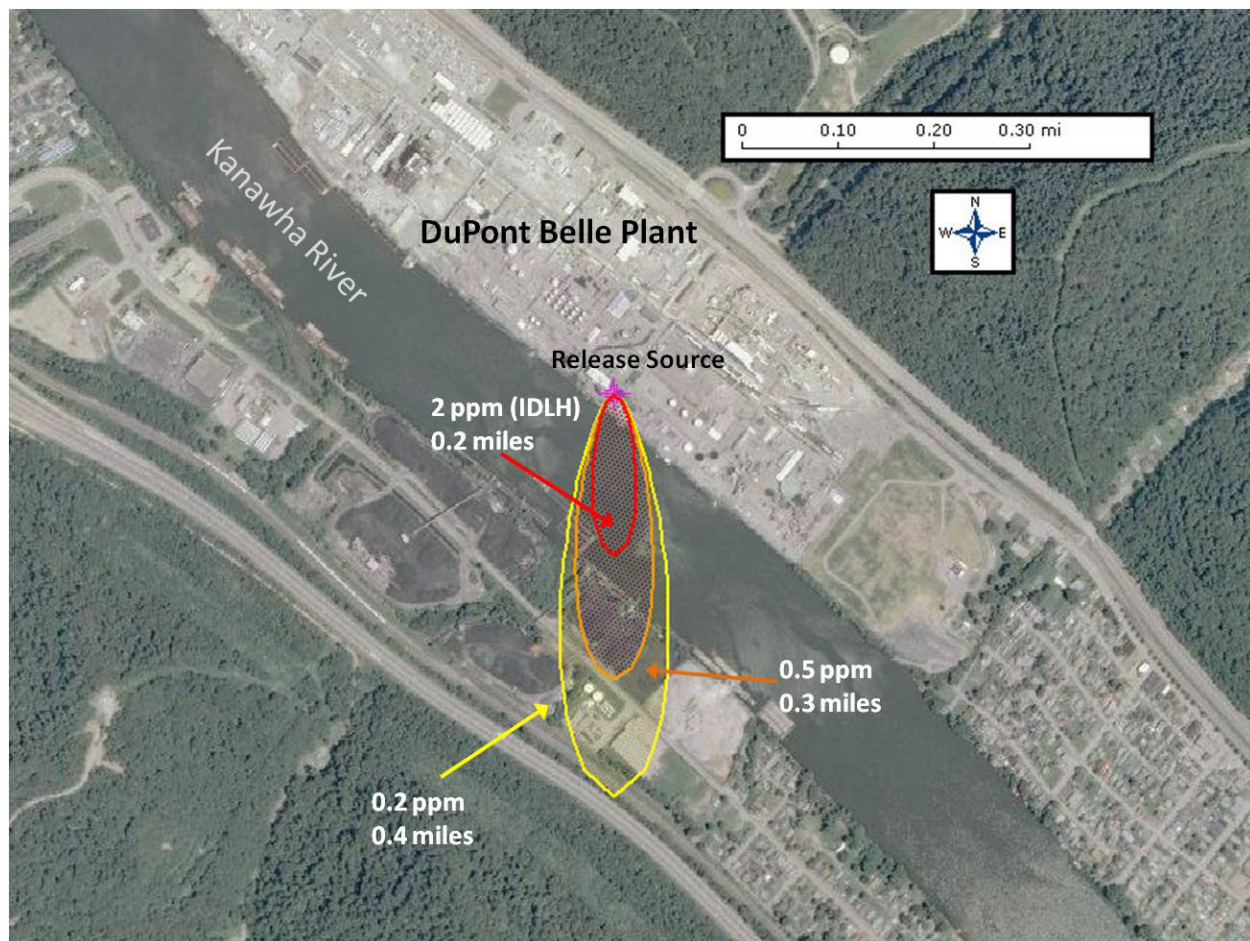
The ALOHA program generated a display of concentration “threat zones” over a distance downwind from the source of the release. Using the EPA MARPLOT program, threat zones are displayed over a satellite map of the area using a GIS interface (Figure 19).

Figure 19. ALOHA estimate of phosgene concentrations with MARPLOT GIS overlay

The release estimates from the ALOHA program are based on the weather conditions recorded at the Charleston Yeager Airport around the time of the January 23, 2010, phosgene release, but may not accurately represent atmospheric conditions at the plant. The ALOHA program also does not consider the topography or terrain surrounding the plant. The fence line monitors south and southwest of the phosgene shed recorded phosgene concentrations between 0 and 0.27 ppm, suggesting phosgene vapor may have traveled south of the DuPont Belle plant fence line toward the river. The ALOHA threat zone overlay in Figure 19 displays a model of the worst case release conditions indicating that IDLH concentrations of phosgene could have been present on the Kanawha River shortly after the release and lower concentrations could have traveled across the river. The community reported no odors or exposure symptoms the afternoon of the phosgene release incident.
