# Fire During Hot Work at Evergreen Packaging Paper Mill

Canton, NC | Incident Date: September 21, 2020 | No. 2020-07-I-NC

## Investigation Report

Published: September 24, 2021

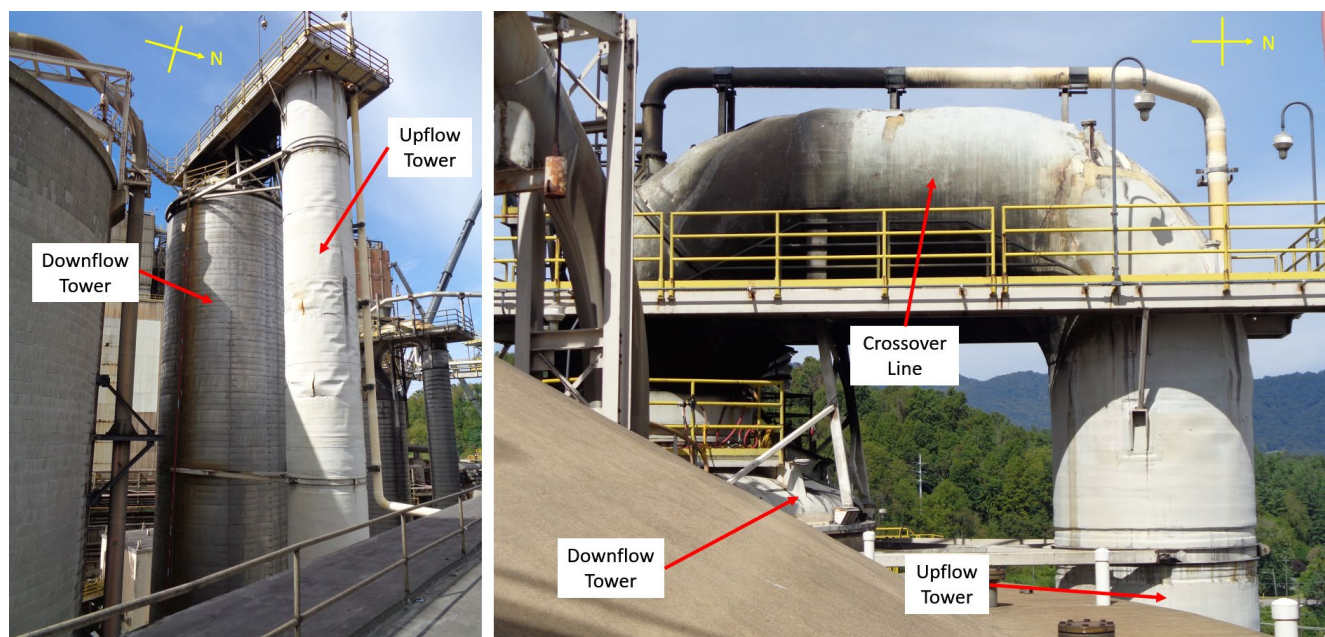
The incident occurred in one of Evergreen's bleaching units, called the #2 Fiber line bleaching unit, which removes color from wood pulp to make white paper products. The bleaching process occurs in three reaction stages. Each stage consists of a pair of process vessels: the first, called the "upflow tower" and the second, called the "downflow tower." The two vessels are connected at the top by a large diameter pipe, called the "crossover line" (Figure 1).

Figure 1. Typical bleach reaction stage at Evergreen. (Credit: CSB.)

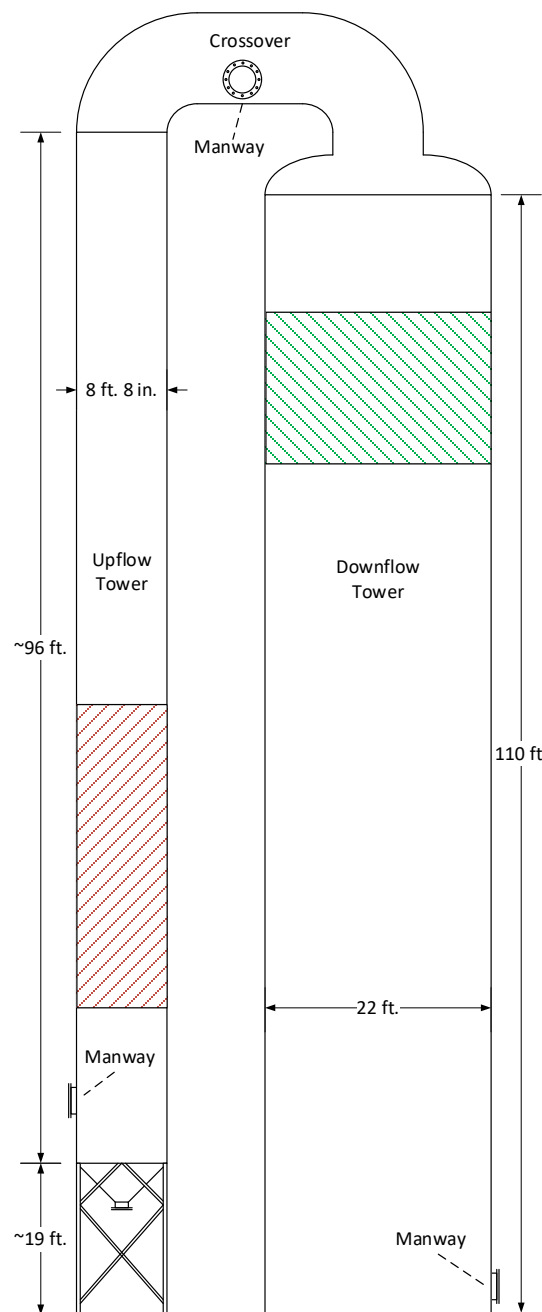
The #2 Fiber line D2 upflow tower was constructed of fiber-reinforced plastic (FRP) and was approximately 96 feet tall and almost nine feet in diameter (**Figure 3**). The downflow tower was constructed of a carbon steel shell, lined internally with a urethane membrane covered with fireclay acid brick laid in vinyl ester mortar. The downflow tower was 110 feet tall and roughly 22 feet in diameter. These two towers were connected by a crossover line, which was approximately the same diameter as the upflow tower, and which was also constructed of FRP.

Blastco’s scope of work for the shutdown was, among other tasks, to perform FRP maintenance on four upflow towers in Evergreen’s bleaching units. For the #2 Fiber line D2 upflow tower, Blastco’s work scope was to repair approximately 30 feet of FRP, illustrated with red shading in **Figure 3**. This scope of work involved grinding away old material until acceptable base material was found, followed by applying alternating sheets of new fiberglass with layers of resin, until the desired thickness was reached. To accomplish this work, traditional scaffolding was built up from the ground to the entry manway of the upflow tower, which was located 23 feet above the ground. Inside the tower, additional scaffolding platforms were assembled so that workers could access the entire inside surface that was to be repaired.

**Figure 3.** Diagram of the #2 Fiber Line D2 towers. (Credit: CSB.)

Rimcor's scope of work was to re-line approximately 15 feet of the #2 Fiber line D2 downflow tower, illustrated with green shading in **Figure 3**. This work involved using pneumatic jackhammers to remove the old brick, mortar, and urethane membrane, and abrasive blasting to remove residual membrane material, until the bare steel shell was exposed. Once the steel subsurface was prepared, the next step involved applying new membrane material and lastly installing the new brick lining. To accomplish this, Rimcor used a special kind of scaffolding, called a "suspended" scaffolding, inside the downflow tower. This scaffolding consisted of a circular engineered steel scaffold with wooden decking, suspended from mounting points on the roof of the vessel via steel cables. Workers entered the tower via the manway at ground level and assembled the scaffolding platform inside the tower. Once the platform was built and suspended, six workers simultaneously used cable winches to slowly raise the platform to the desired height. Moving the platform was a slow process—it took six workers approximately four hours to raise the platform to Rimcor's work location inside the downflow tower. The platform had a barricaded hole in the middle which workers used along with a hoist to raise and lower tools, materials, and other workers, via chairlift, to and from the platform. At the time of the incident, two Rimcor workers were inside the upflow tower performing abrasive blasting operations.<sup>a</sup>

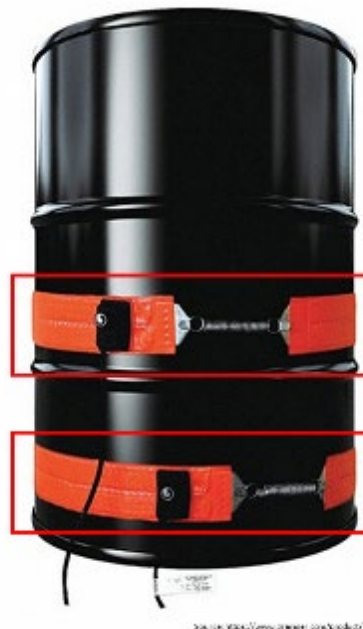
Third, Blastco employees told the CSB that on other jobs, to address the long gel times resulting from cold temperatures, they would apply heating bands to the 55-gallon resin drum to improve the cold weather performance of the resin (**Figure 7**).

**Figure 7.** Drum heaters. (Credit: Grainger [18].)

Blastco performed a post-incident inventory of its two job trailers and located two drum warmers. According to Blastco, the two drum heaters were located separately, one on each trailer. According to an employee, the company had recently begun renovating and reorganizing one of the trailers but was not yet finished at the time Blastco's work at Evergreen started. The employee stated that when he went to locate the heat bands on the night of the incident, the bands were not in their normal location and he could not locate them on the trailers.

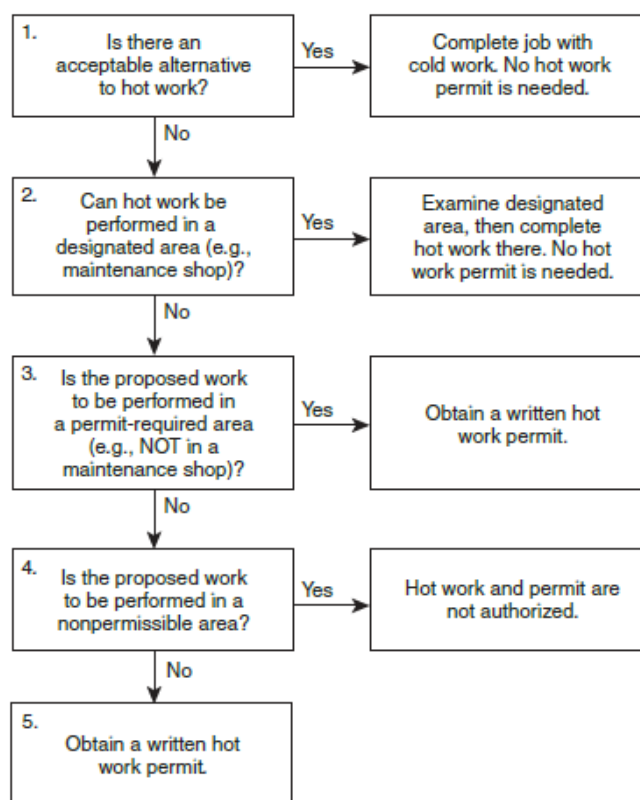
NFPA guides companies and workers to avoid hot work—in this case, the use of the heat gun—altogether if there is a suitable alternative. NFPA 51B contains a decision tree (**Figure 11**) for hot work permitting, encouraging users to ask the question “Is there an acceptable alternative to hot work [10, p. 13]?”

As discussed in Sections 1.8 and 2.2, Blastco workers attempted several alternatives to hot work. According to Blastco, the company had two drum heating bands available at the time of the incident. However, the two heaters were stored separately on Blastco’s two job

**Figure 11.** NFPA hot work decision tree. (Credit: NFPA [10].)

trailers, at least one of which was undergoing renovation and reorganization. According to a Blastco worker, the reorganization was not complete at the time of the trailer's use for the job at Evergreen. The worker stated that when they searched for drum heating bands, the bands were not in their usual location, and that they could not locate the bands. The worker resorted to using a heat gun instead.
