U.S. Chemical Safety and Hazard Investigation Board

Fire During Hot Work at
Evergreen Packaging Paper Mill
Canton, North Carolina
September 21, 2020

Investigation Presentation

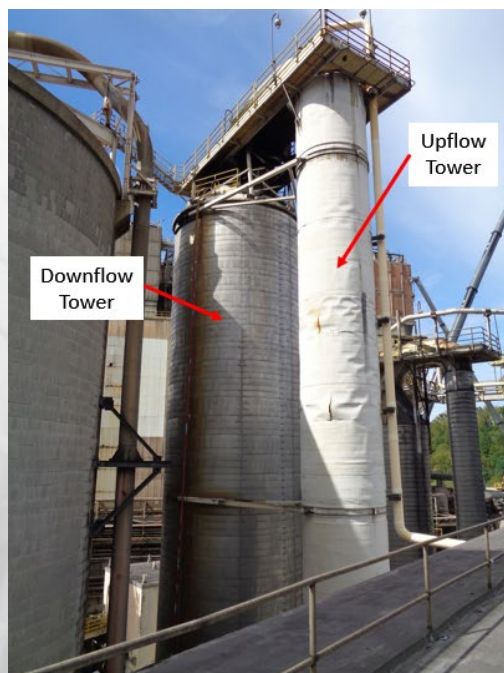
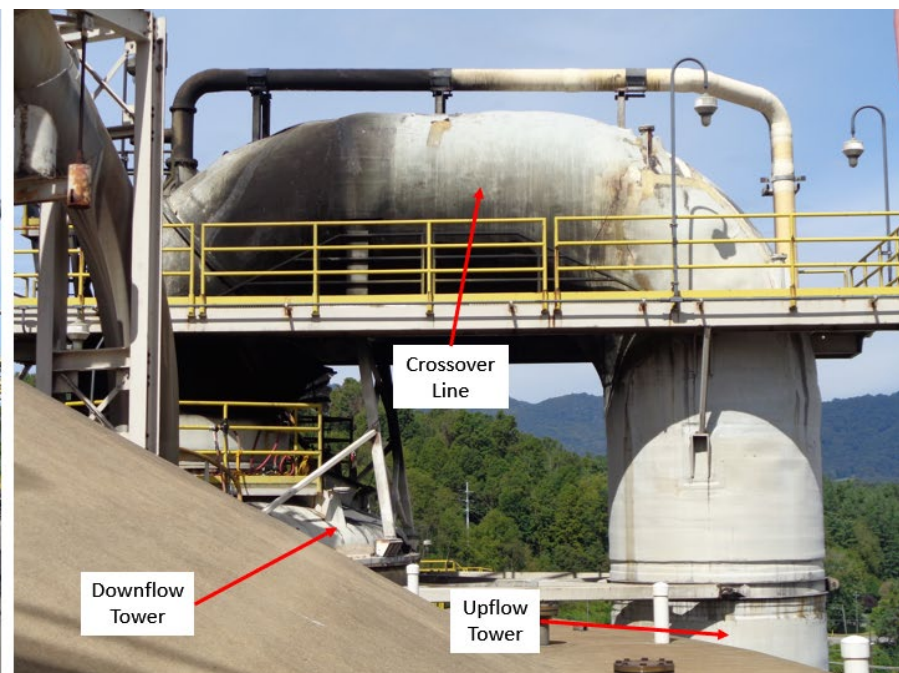
- Incident occurred in one of the mill's pulp bleaching units
- Bleaching process occurs in three reaction stages
- Each stage consists of two process vessels, called “upflow” and “downflow” towers, connected by “crossover line”
- Bleaching chemicals mixed with pulp
- Pulp whitens as it flows through

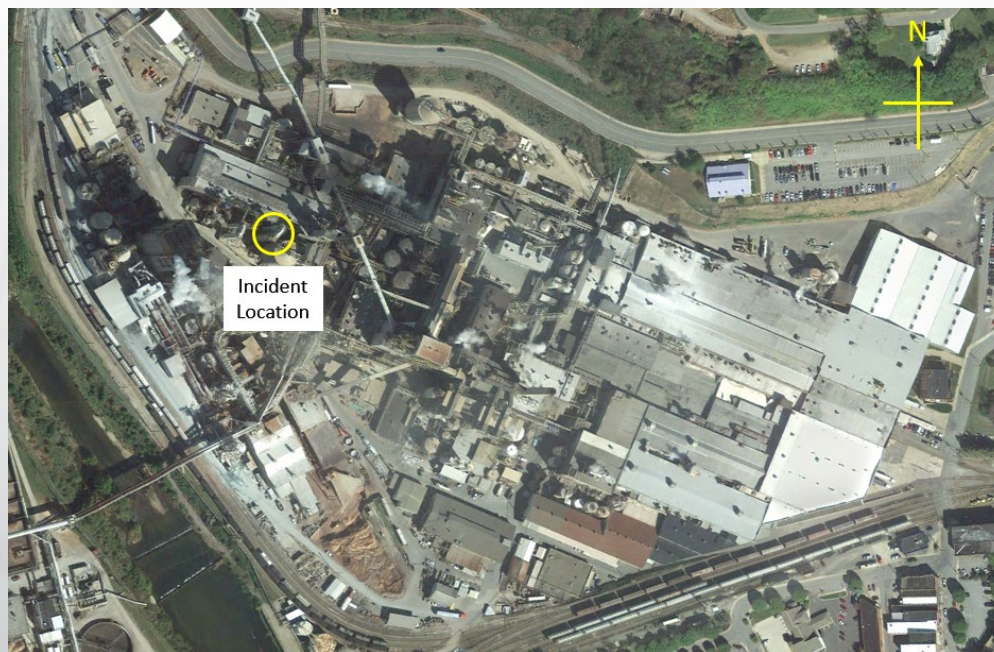
- Pulp bleaching process is corrosive by design
- The upflow tower, downflow tower, and crossover line were constructed of corrosion-resistant materials
- Periodic maintenance is required to the inside surface of the towers
- Evergreen was conducting a planned, facility-wide shutdown, called a “cold mill outage”

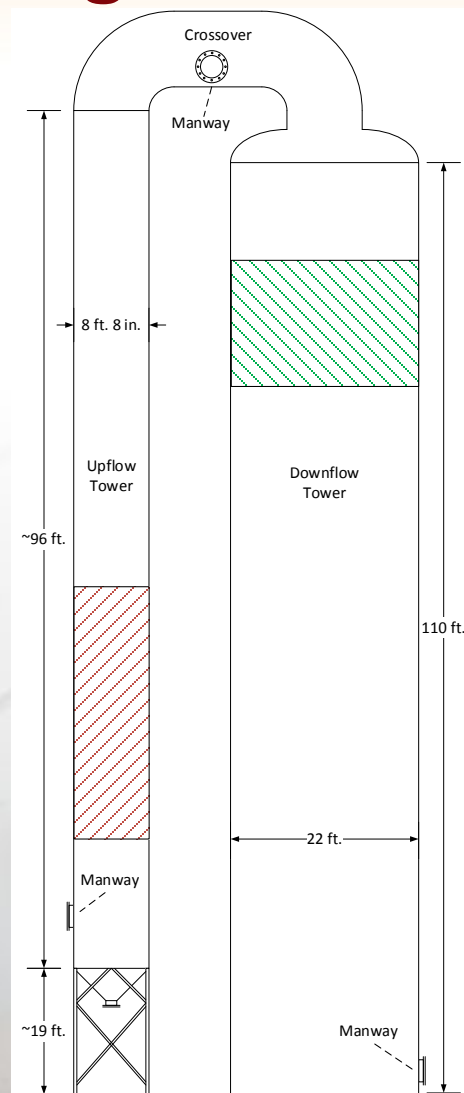
- Two contract companies hired to perform maintenance work in the #2 Fiber Line D2 upflow and downflow towers
- Blastco worked in the upflow tower (red shading)
- Rimcor worked in the downflow tower (green shading)

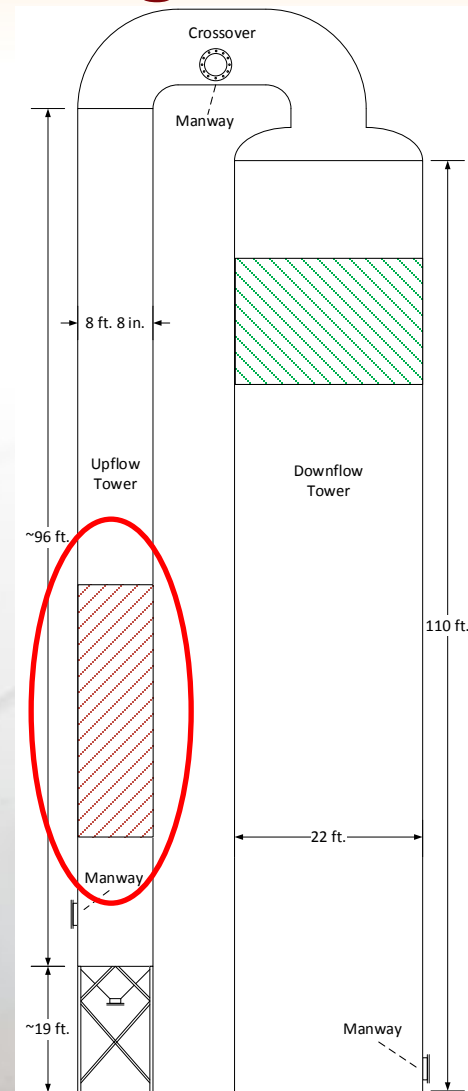
- Upflow tower constructed of fiber-reinforced plastic, or FRP
- Blastco first removed damaged material using grinders
- Blastco replaced with epoxy vinyl ester resin and fiberglass
- Using paint rollers, Blastco applied resin to the walls of the upflow tower
- Blastco then alternated layers of resin and fiberglass

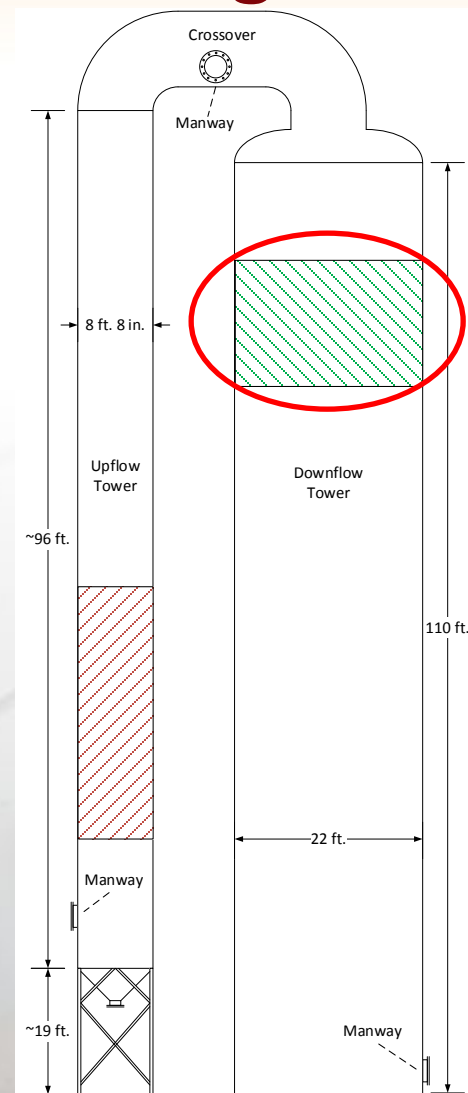
- The downflow tower was constructed of carbon steel lined with fireclay acid brick
- Rimcor removed damaged brick lining and abrasive blasted steel surface to prepare it for new brick
- Rimcor worked on a scaffolding platform suspended from the roof of the tower
- At time of incident, Rimcor was abrasive blasting

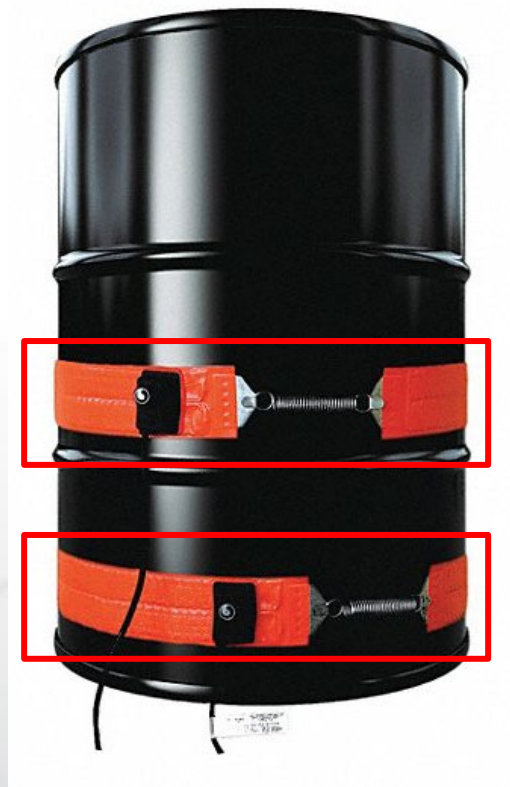
- Blastco had acceptable alternatives to using the heat gun to warm the resin inside the confined space
- When the Blastco workers obtained the heat gun, they first looked for drum heating bands but could not find them
- Temperatures during the day were in the mid-60s (degrees Fahrenheit)
- Blastco did not have standard operating procedures for addressing poor resin performance
