Investigation Report

Published: October 11, 2022

SAFETY ISSUES:

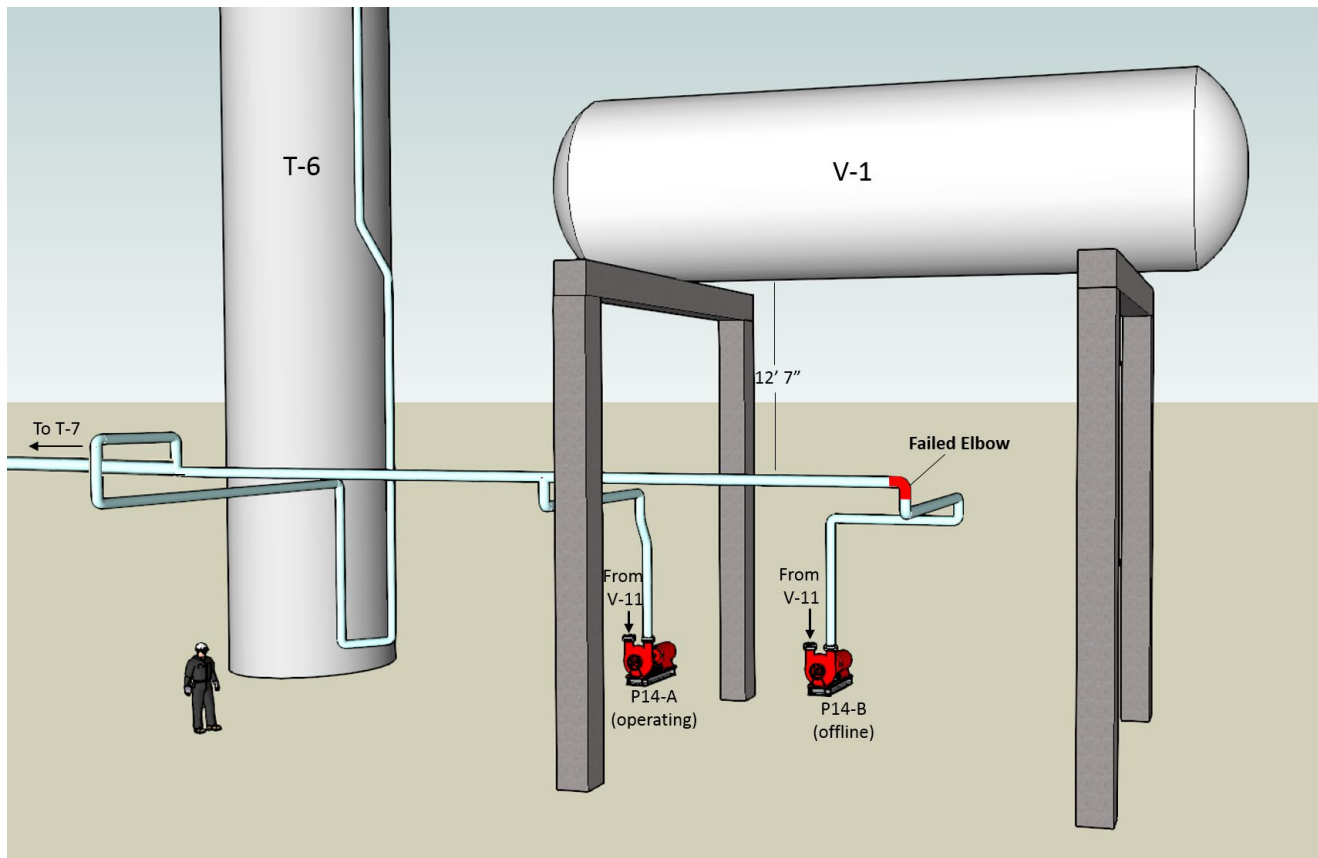
As will be described in this report, this incident occurred when a pipe elbow ruptured in the HF alkylation unit. The elbow was part of the piping between V-11, the depropanizer accumulator, and T-6, the depropanizer distillation column and T-7, the propane stripper (**Figure 5**). The elbow was on the discharge piping from a pump (one of two pumps in this system labeled P14-A and -B) that was not operating at the time of the incident. At the time of the event, this piping was at a pressure of about 380 psig and a temperature of about 100°F. The approximate design composition of process fluid in the piping is shown in **Table 1**.

Figure 5. Model of the piping circuit containing the failed elbow. (Credit: CSB)

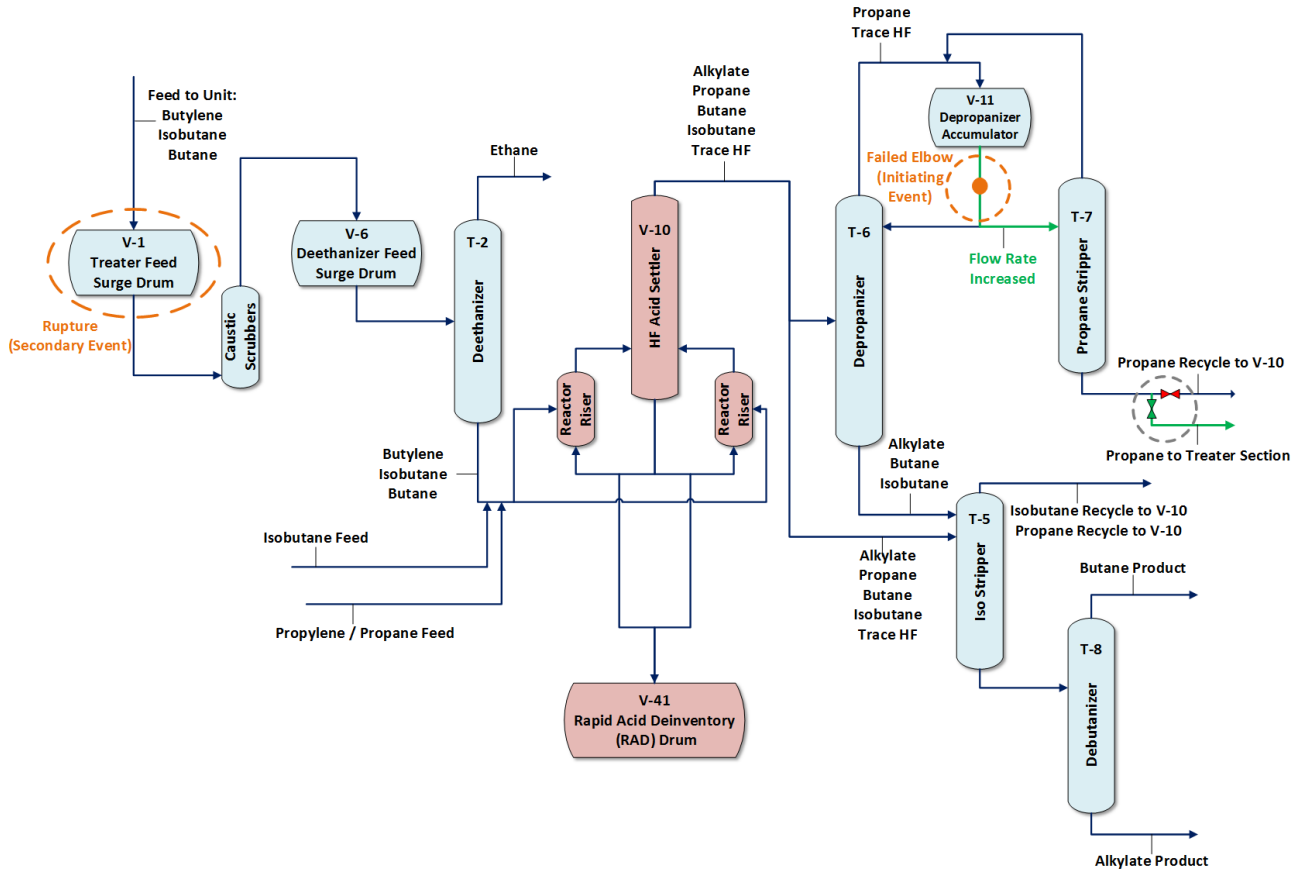
As part of this same operation, at 3:55 a.m. the control room operator increased the feed to the T-7 propane stripper from 73 barrels per hour (bph) to 78 bph. Five minutes later, at 4:00 a.m., the control room operator further increased the feed to the T-7 propane stripper, from 78 bph to 80 bph (Figure 6). There were no abnormal process deviations or upsets recorded during this operation.

Figure 6. Process changes made immediately before the incident. (Credit: CSB)

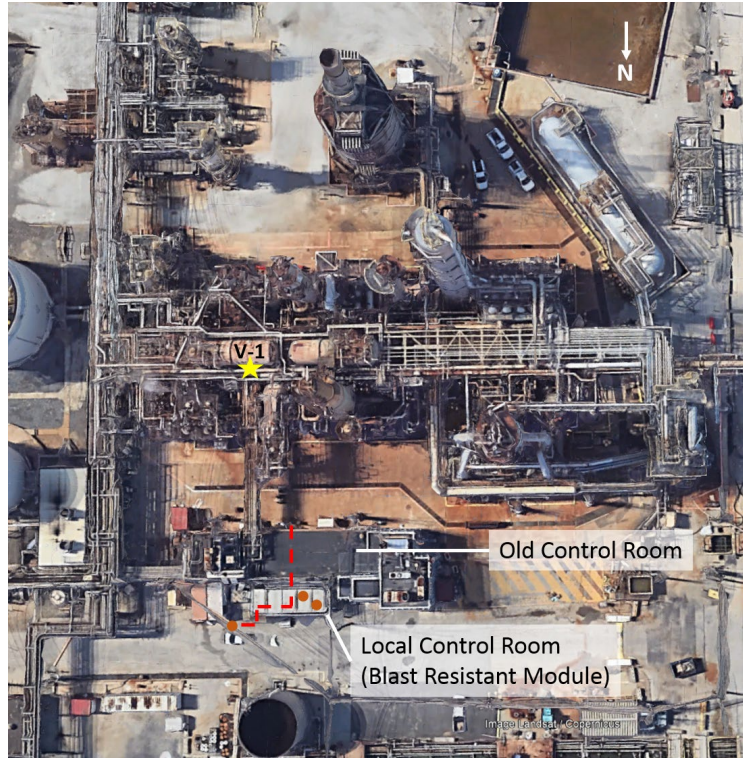
In total, there were three field operators in the alkylation unit at the time of the incident (field operator 1, field operator 2, and field operator 3). Field operators 1 and 2 were inside the HF alkylation unit’s blast resistant local control room (“local control room”), and field operator 3 was just outside the local control room. Field operator 3 heard a “bang” and all heard a roaring noise, described by field operator 2 as if something high pressure “let go.” Upon hearing the noise, field operator 3 went through the local control room and the old control room and opened the door to the unit (**Figure 8**). Field operator 3 saw a large vapor cloud at least 10 feet high, which had engulfed part of the unit (**Figure 9**). Based on the approximate design composition of process fluid in the piping, this vapor cloud was composed of about 95% propane and 2.5% HF, the balance being other hydrocarbons (see process fluid composition in Section 1.3). Field operator 3 then immediately ran back to the local control room and called the emergency response line to report the release. In **Figure 8** below, the orange circles show the locations of the field operators. The red line depicts the path taken by field operator 3 to see the release. The yellow star is the location of the ruptured pipe elbow, where the release originated.

Figure 8. Locations of field operators at the time of the release. (Credit: Google Earth with annotations by CSB)

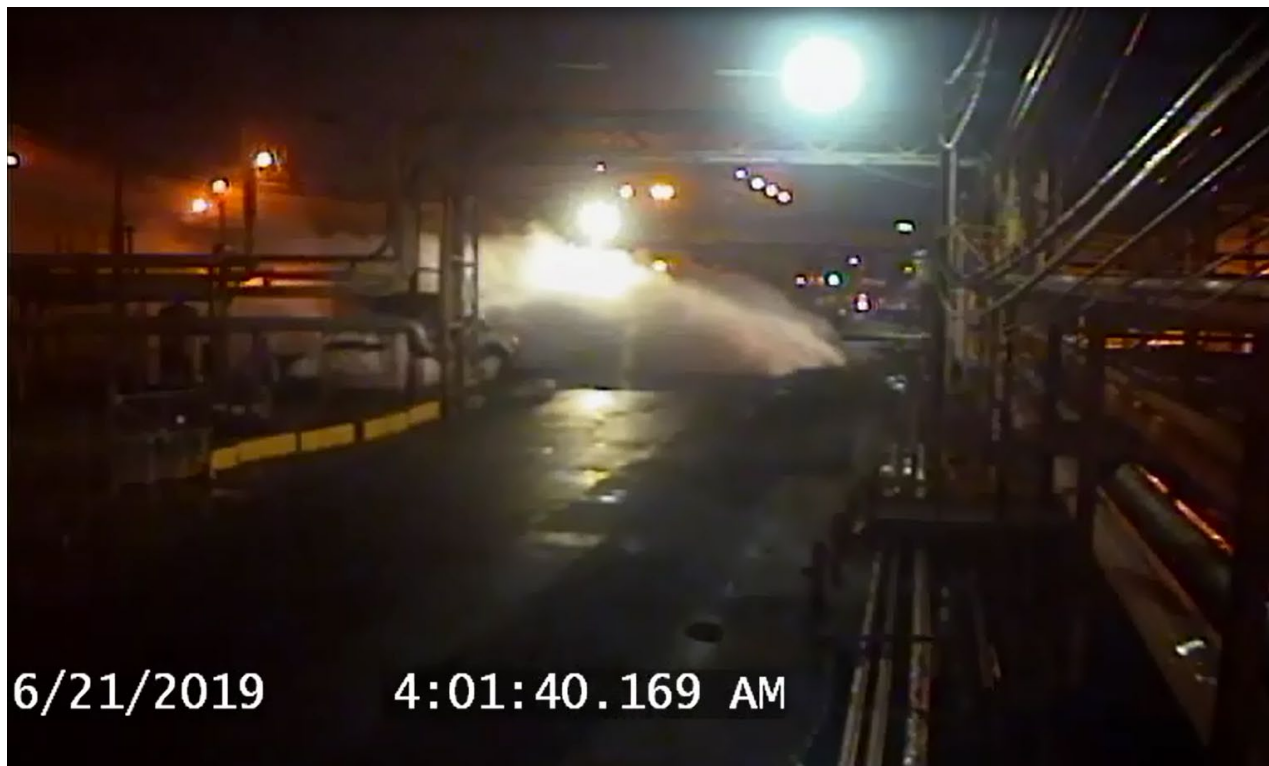
Figure 9. Security camera footage of leaking process fluid forming a large ground-hugging vapor cloud that surrounded some sections of the unit. (Credit: PES)

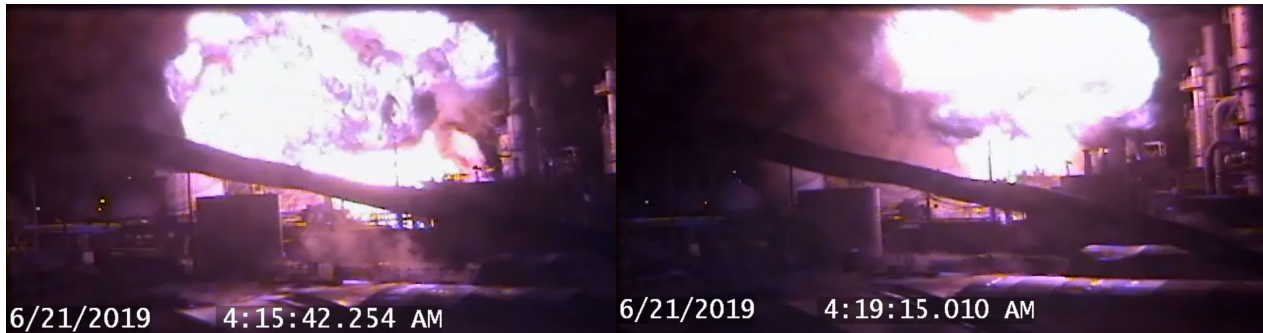
At 4:15 a.m. an explosion occurred in the unit (**Figure 11**). Based on the fact that the unit was operating normally before the elbow rupture and that there was fire in the unit at the time of this explosion, it appears to have been a secondary event caused by the fire. Another explosion occurred at 4:19 a.m., which also appears to have been an additional secondary event caused by the fire.

Figure 11. Surveillance video stills of explosions in the unit. (Credit: PES)

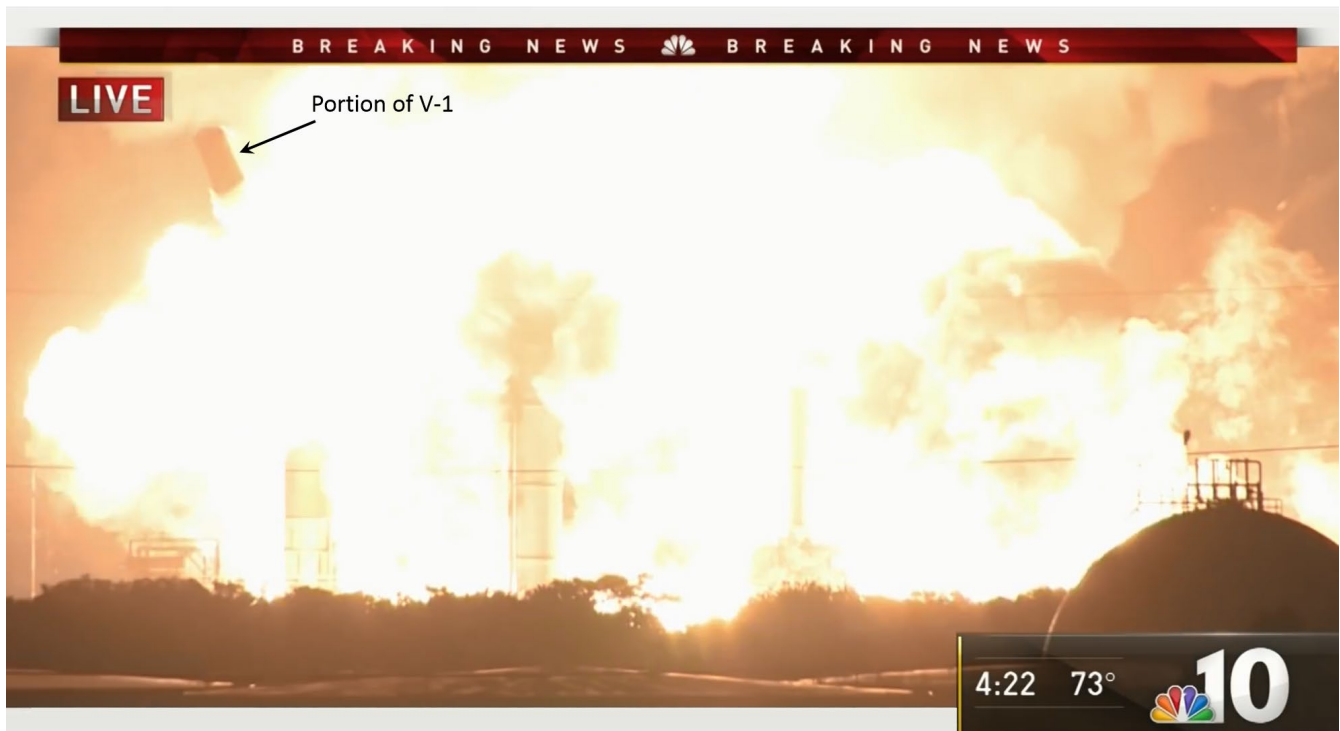
At 4:22 a.m., a third, and the largest, explosion occurred when the V-1 treater feed surge drum, containing primarily butylene, isobutane, and butane, violently ruptured (**Figure 12** and **Figure 13**). A fragment of the vessel weighing approximately 38,000 pounds flew across the Schuylkill River, and two other fragments, one weighing about 23,000 pounds and the other 15,500 pounds, landed in the PES refinery (**Figure 14**). This was also a secondary event caused by the fire. In **Figure 14**, the fragment 1 photo was taken after the fragment was recovered from the bank of the river and relocated to the PES refinery. The deformation of fragment 1 appears to be consistent with the deformation expected from its impact with the riverbank.

Figure 12. Video still of the V-1 explosion. (Credit: NBC10 Philadelphia [16] with annotations by CSB)

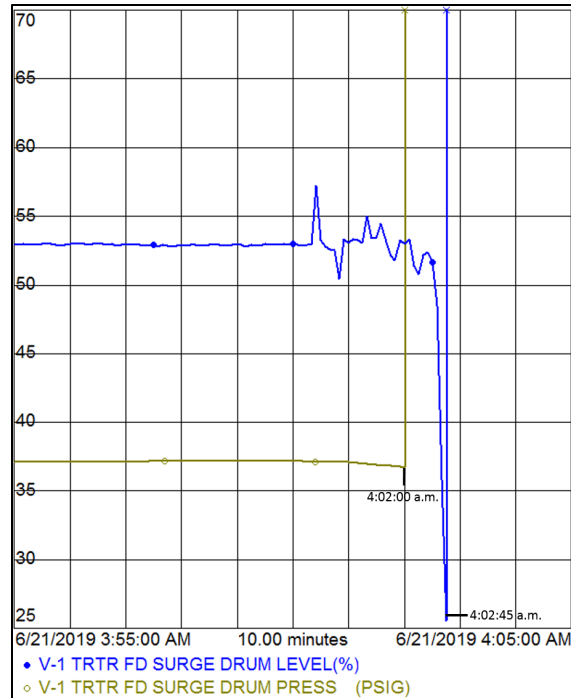
At the start of the incident, V-1 was about 53% liquid-full of primarily butylene, isobutane, and butane, and the internal pressure was 37 psig.^a The V-1 pressure indicator's last reading was at 4:02:00 a.m., and then failed at about the time of ignition. The level indicator's last reading was at 4:02:45 a.m. before failing during the fire, last indicating that V-1 was about 25% liquid-full, but this reading may not be reliable due to the fire's effect on the instrumentation.^b The V-1 pressure and level data are shown in **Figure 20**. V-1 was not equipped with thermal insulation for protection from fire.

^b The last liquid level reading measured in V-1 was 25.5 %, at 4:02:45 a.m. This value is not a reliable indication of the liquid level, however, because the data shows the liquid level dropped from about 52% full to 25.5% full in about 15 seconds, which is unlikely. The ongoing fire likely affected this measurement to read an incorrect value.

Figure 20. V-1 internal pressure and level before and during the incident. (Credit: CSB)

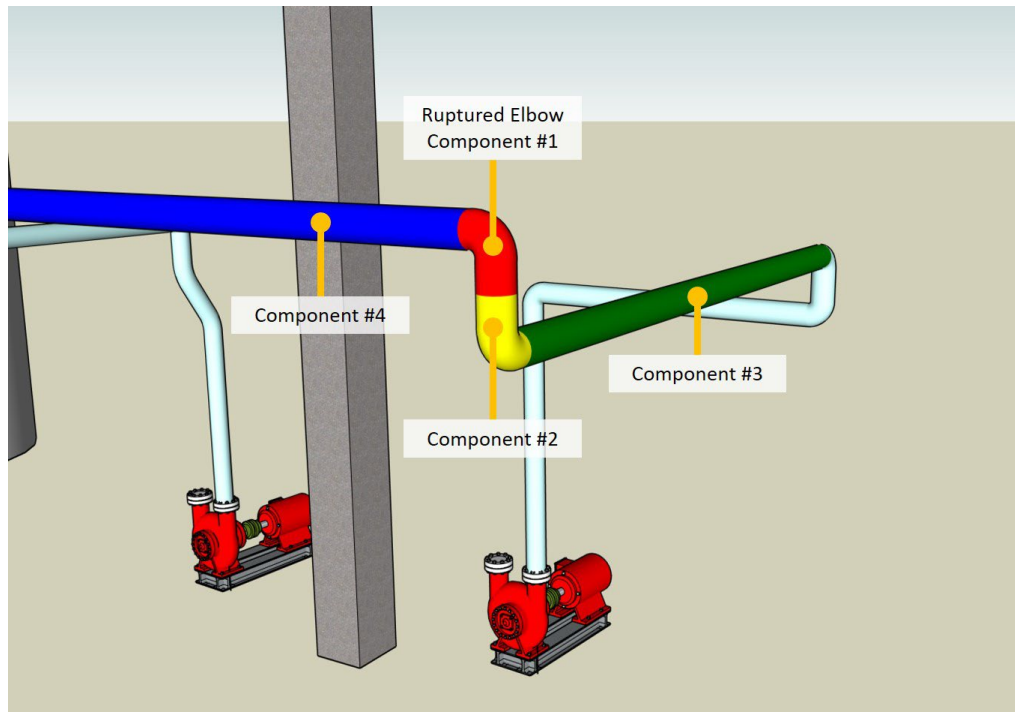
As shown in **Table 3** below, post-incident testing found that the ruptured elbow contained nickel and copper content that far exceeded the 2003 NACE technical paper's recommended composition limits, while adjacent piping components did meet these recommended limits and were not thin. The piping locations relative to the ruptured elbow are shown in **Figure 23**.

Figure 23. Depiction of the location of the four piping segments discussed in this report. (Credit: CSB).

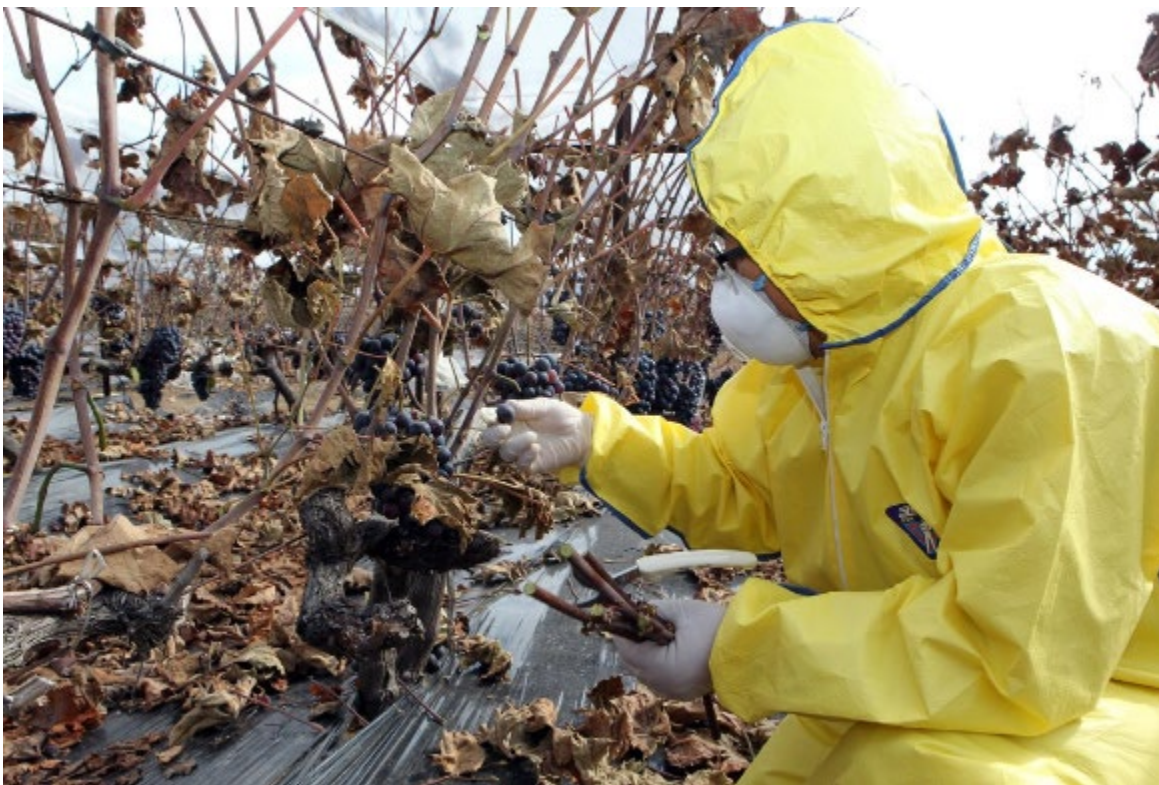
On September 27, 2012, over 17,000 pounds of hydrogen fluoride gas released from a chemical plant in South Korea. Five workers were killed, 18 workers were injured, and over 12,000 people from the surrounding area reported injuries. The South Korean government reported that it would pay \$33.4 million in compensation to citizens and local businesses [45]. The HF release damaged more than 500 acres of farmland (**Figure 31**) and affected 3,200 livestock animals. The South Korean government designated the area affected by the release as a “special disaster zone” [46].

Figure 31. Photo of damaged crops following September 27, 2012, hydrogen fluoride release in South Korea. (Credit: Yonhap News Agency [47])

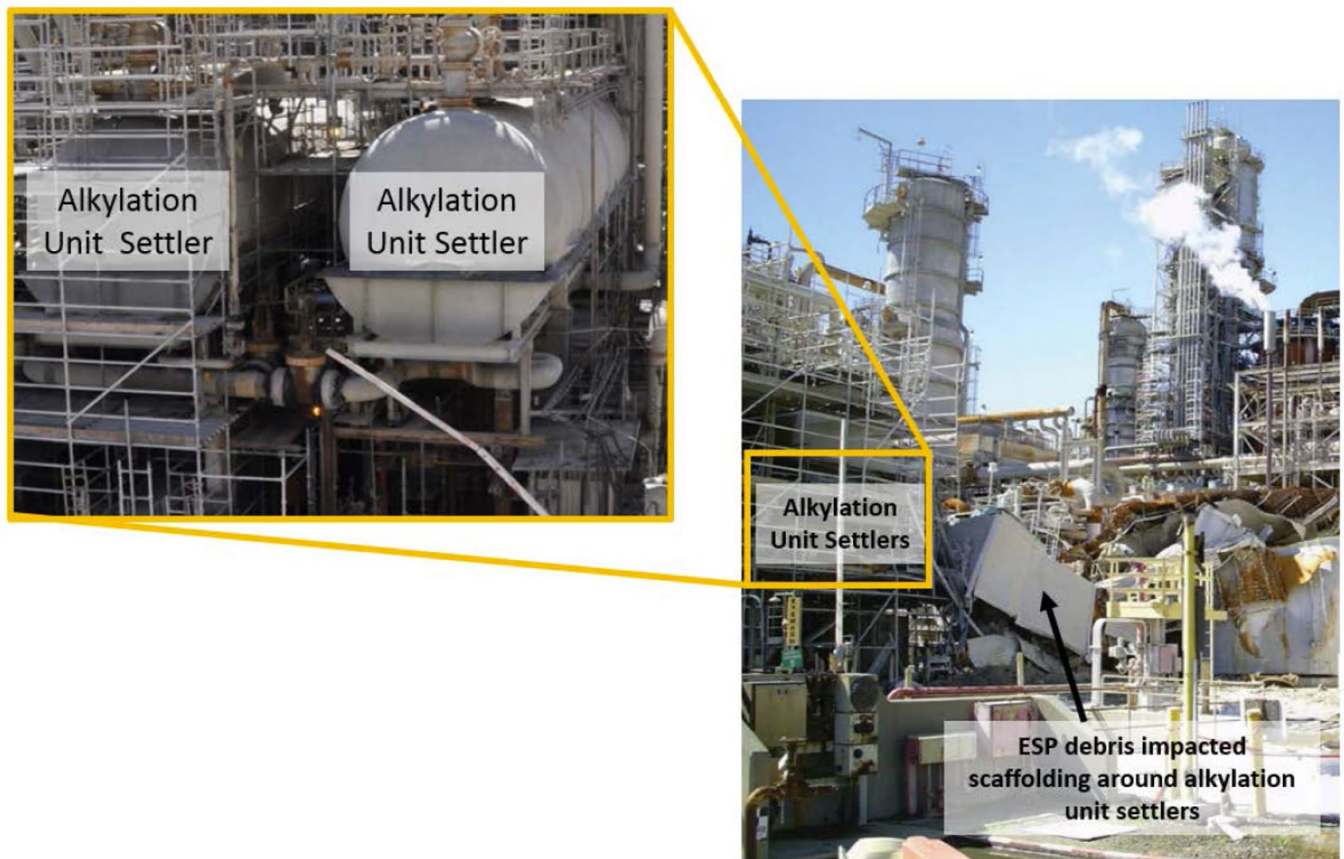
On February 18, 2015, an explosion occurred in the ExxonMobil Torrance, California refinery’s electrostatic precipitator (ESP), a pollution control device in the fluid catalytic cracking unit that removes catalyst particles. As a result of this incident, a near-miss event occurred in the modified HF alkylation unit when explosion debris nearly hit tanks in close proximity to the ESP, each containing HF, water, hydrocarbons, and a chemical additive intended to reduce the amount of HF vaporized during a loss of containment event (**Figure 32**). ExxonMobil denied CSB requests for safety information pertaining to the potential release of HF, including a request for “records relating to the documented or asserted degree of HF vapor suppression for modified HF, and industry and/or Mobil/ExxonMobil studies, experiments, modeling of modified HF and its effectiveness in suppressing vapor compared to unmodified HF.” The CSB issued subpoenas for this information and pursued enforcement in U.S. federal district court [48].^a In December 2019, the U.S. Ninth Circuit Court of Appeals ruled that ExxonMobil must produce this information to the CSB [49].^b ExxonMobil produced this information to the CSB on March 20, 2020. Section 2.4.2.2 discusses the safety information in these documents.

Figure 32. Explosion debris from the February 18, 2015, ExxonMobil Torrance Refinery explosion came in close proximity to the alkylation unit’s HF settlers. (Credit: CSB [48]).

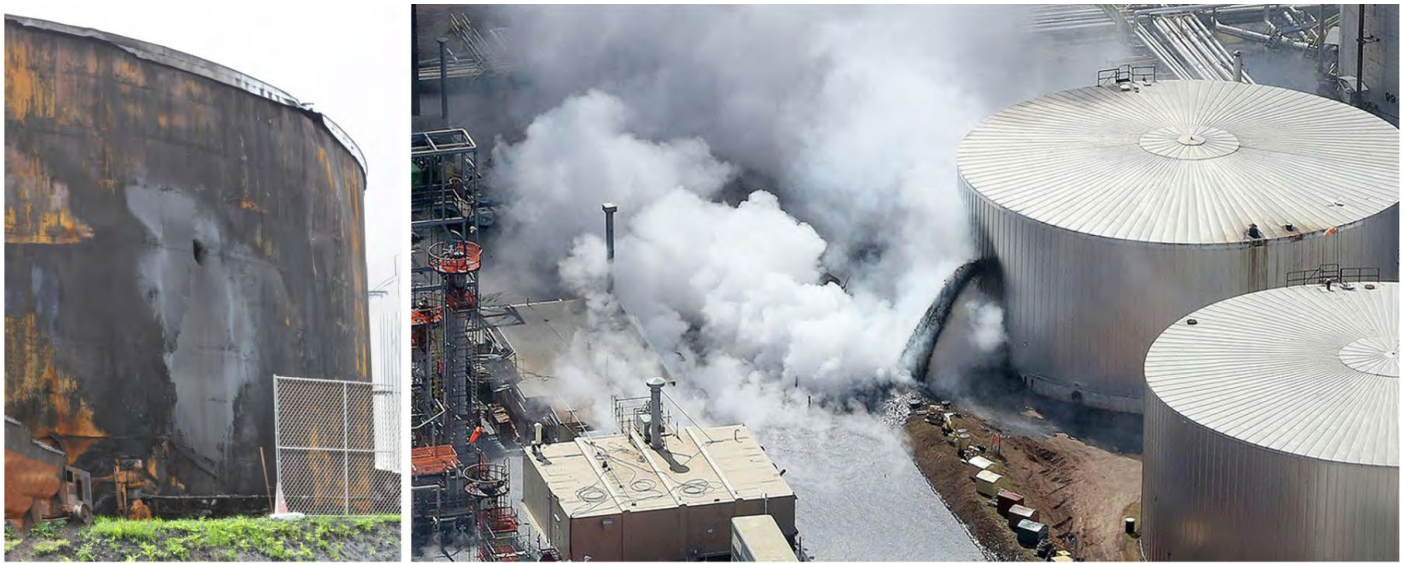
On April 26, 2018, an explosion occurred at the Superior Refinery Company LLC refinery in Superior, Wisconsin (“Husky Superior Refinery”) in the refinery’s fluid catalytic cracking unit. Debris from the explosion flew about 200 feet, and impacted a large, nearby, aboveground storage tank containing about 50,000 barrels of asphalt, puncturing the side of the steel tank and spilling more than 15,000 barrels of hot asphalt into the refinery (**Figure 33**). This released asphalt ignited about two hours after the explosion, creating a large fire [50].

Figure 33. Post-incident photographs of the leaking asphalt storage tank at the Husky Superior Refinery. (Left photo credit: CSB. Right photo credit: Duluth News Tribune [50])

The Husky Superior Refinery uses hydrofluoric acid in its alkylation unit. The hydrofluoric acid storage tank is located about 150 feet from the equipment that ruptured in the explosion. Neither the hydrofluoric acid tank nor the water curtain equipment surrounding the hydrofluoric acid tank, used to provide water suppression in the event of an acid leak, were impacted by explosion debris, but they were located closer to the ruptured equipment than the asphalt tank that was punctured by the explosion debris [50]. The CSB considers this a near-miss event—it is possible that the hydrofluoric acid equipment could have been punctured by explosion debris.
