# Investigation Report

Published: October 11, 2022

## U.S. Chemical Safety and Hazard Investigation Board

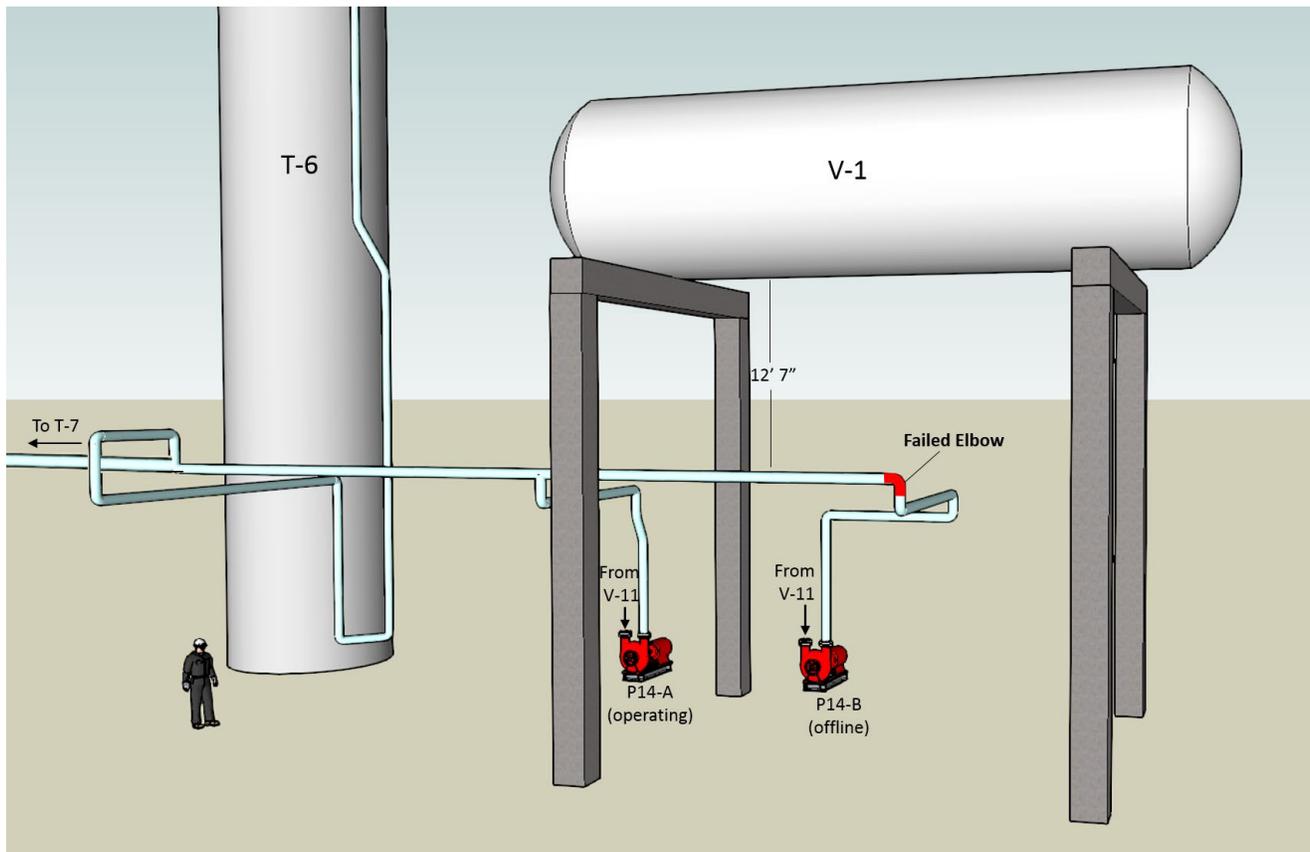
As will be described in this report, this incident occurred when a pipe elbow ruptured in the HF alkylation unit. The elbow was part of the piping between V-11, the depropanizer accumulator, and T-6, the depropanizer distillation column and T-7, the propane stripper (**Figure 5**). The elbow was on the discharge piping from a pump (one of two pumps in this system labeled P14-A and -B) that was not operating at the time of the incident. At the time of the event, this piping was at a pressure of about 380 psig and a temperature of about 100°F. The approximate design composition of process fluid in the piping is shown in **Table 1**.

Figure 5. Model of the piping circuit containing the failed elbow. (Credit: CSB)

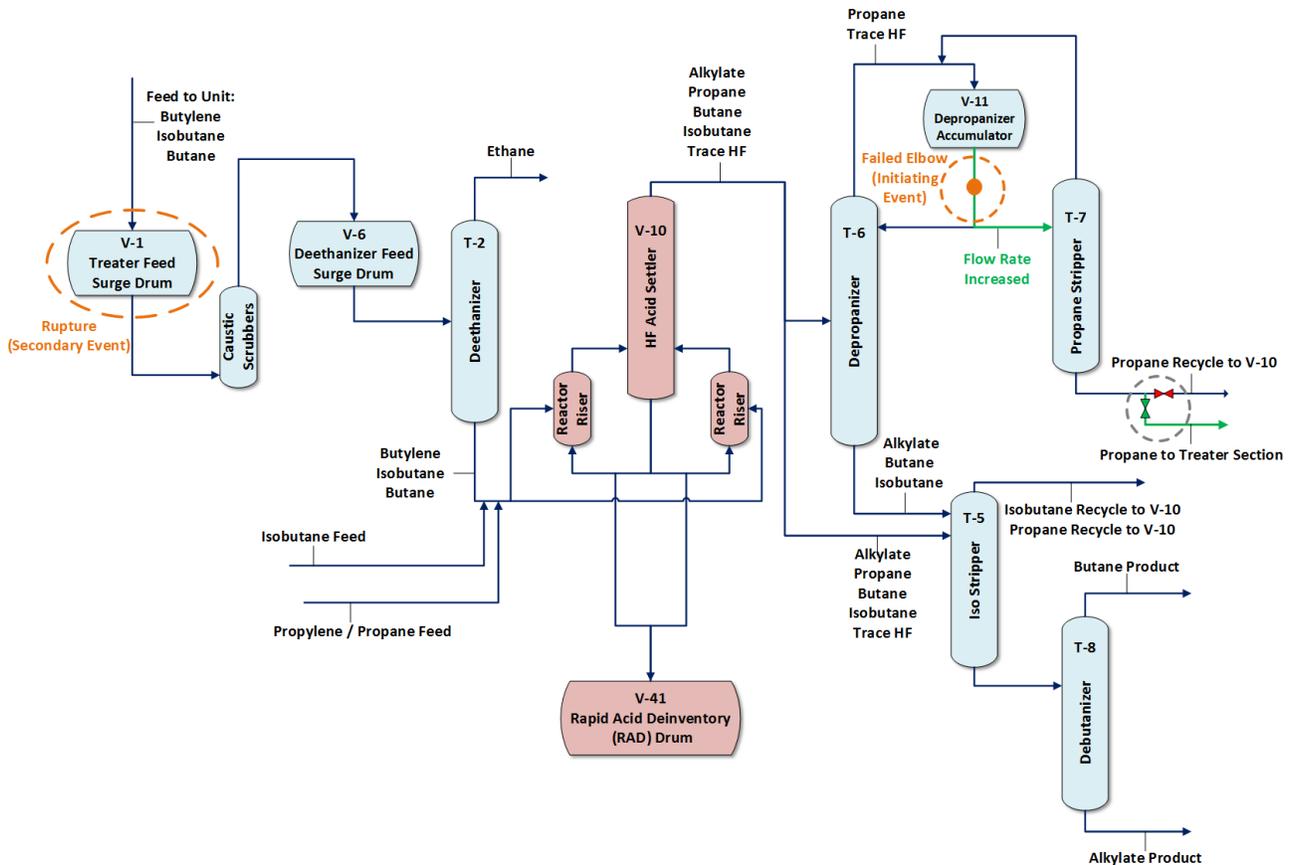
As part of this same operation, at 3:55 a.m. the control room operator increased the feed to the T-7 propane stripper from 73 barrels per hour (bph) to 78 bph. Five minutes later, at 4:00 a.m., the control room operator further increased the feed to the T-7 propane stripper, from 78 bph to 80 bph (Figure 6). There were no abnormal process deviations or upsets recorded during this operation.

**Figure 6.** Process changes made immediately before the incident. (Credit: CSB)

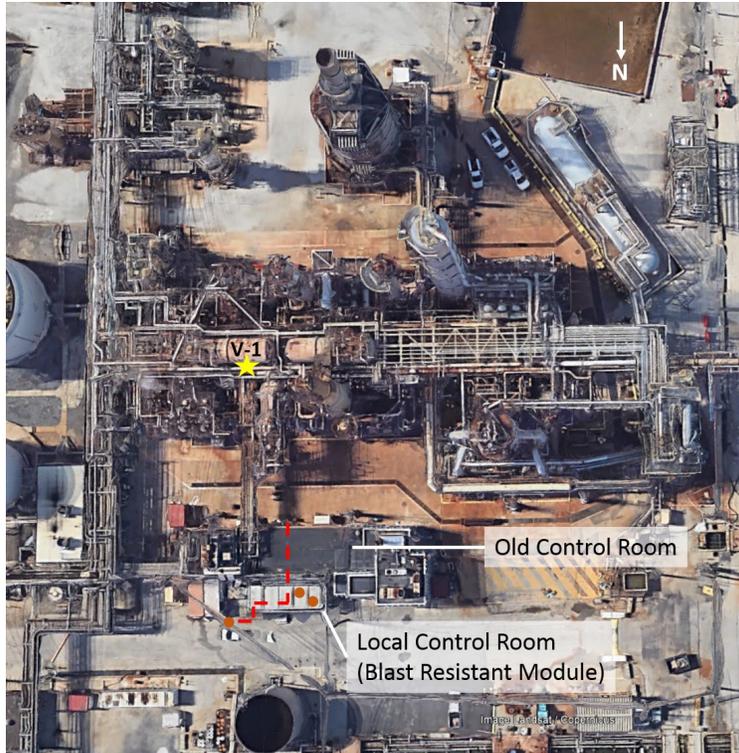
In total, there were three field operators in the alkylation unit at the time of the incident (field operator 1, field operator 2, and field operator 3). Field operators 1 and 2 were inside the HF alkylation unit’s blast resistant local control room (“local control room”), and field operator 3 was just outside the local control room. Field operator 3 heard a “bang” and all heard a roaring noise, described by field operator 2 as if something high pressure “let go.” Upon hearing the noise, field operator 3 went through the local control room and the old control room and opened the door to the unit (**Figure 8**). Field operator 3 saw a large vapor cloud at least 10 feet high, which had engulfed part of the unit (**Figure 9**). Based on the approximate design composition of process fluid in the piping, this vapor cloud was composed of about 95% propane and 2.5% HF, the balance being other hydrocarbons (see process fluid composition in Section 1.3). Field operator 3 then immediately ran back to the local control room and called the emergency response line to report the release. In **Figure 8** below, the orange circles show the locations of the field operators. The red line depicts the path taken by field operator 3 to see the release. The yellow star is the location of the ruptured pipe elbow, where the release originated.

Figure 8. Locations of field operators at the time of the release. (Credit: Google Earth with annotations by CSB)

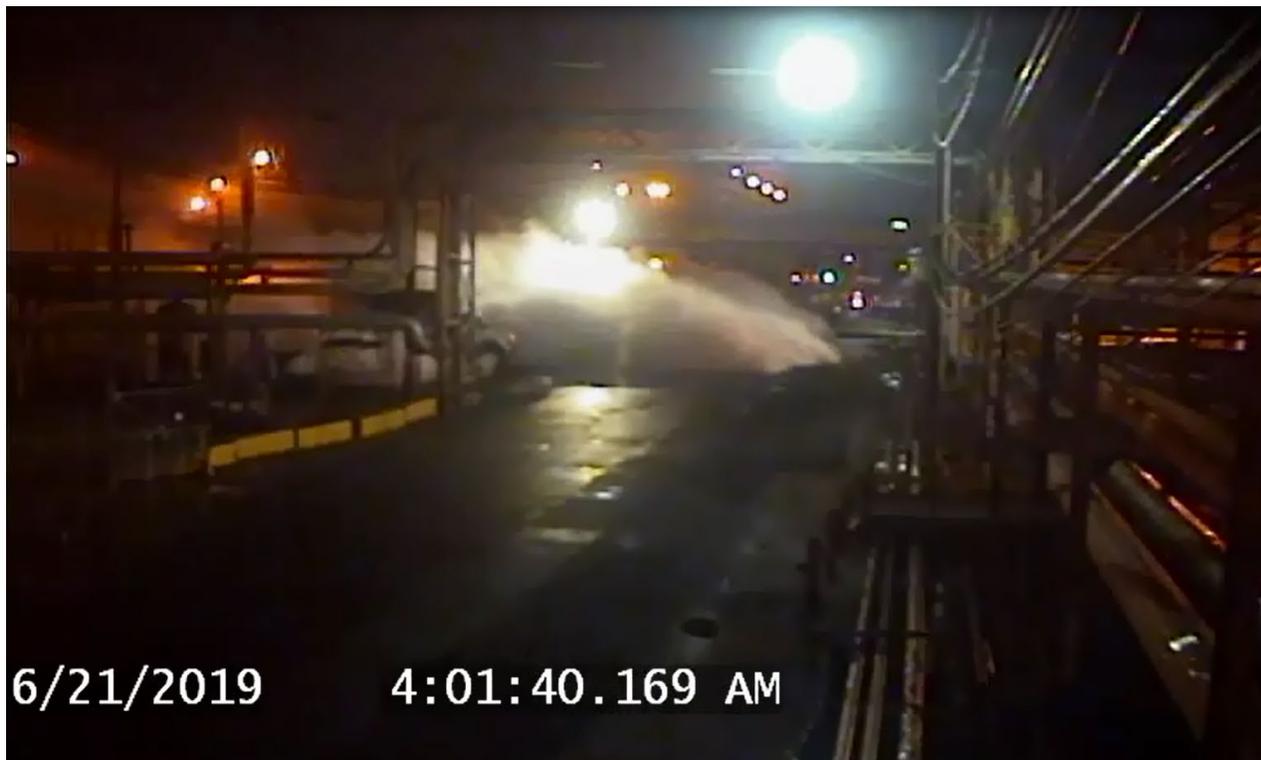
Figure 9. Security camera footage of leaking process fluid forming a large ground-hugging vapor cloud that surrounded some sections of the unit. (Credit: PES)

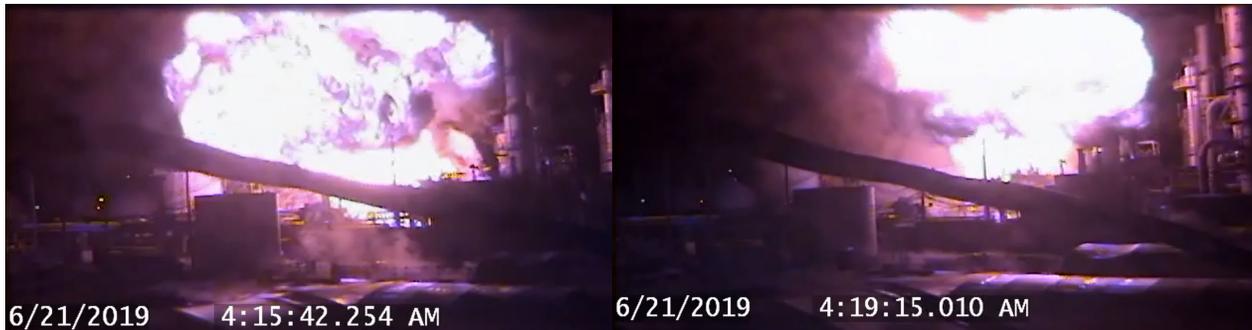
At 4:15 a.m. an explosion occurred in the unit (**Figure 11**). Based on the fact that the unit was operating normally before the elbow rupture and that there was fire in the unit at the time of this explosion, it appears to have been a secondary event caused by the fire. Another explosion occurred at 4:19 a.m., which also appears to have been an additional secondary event caused by the fire.

**Figure 11.** Surveillance video stills of explosions in the unit. (Credit: PES)

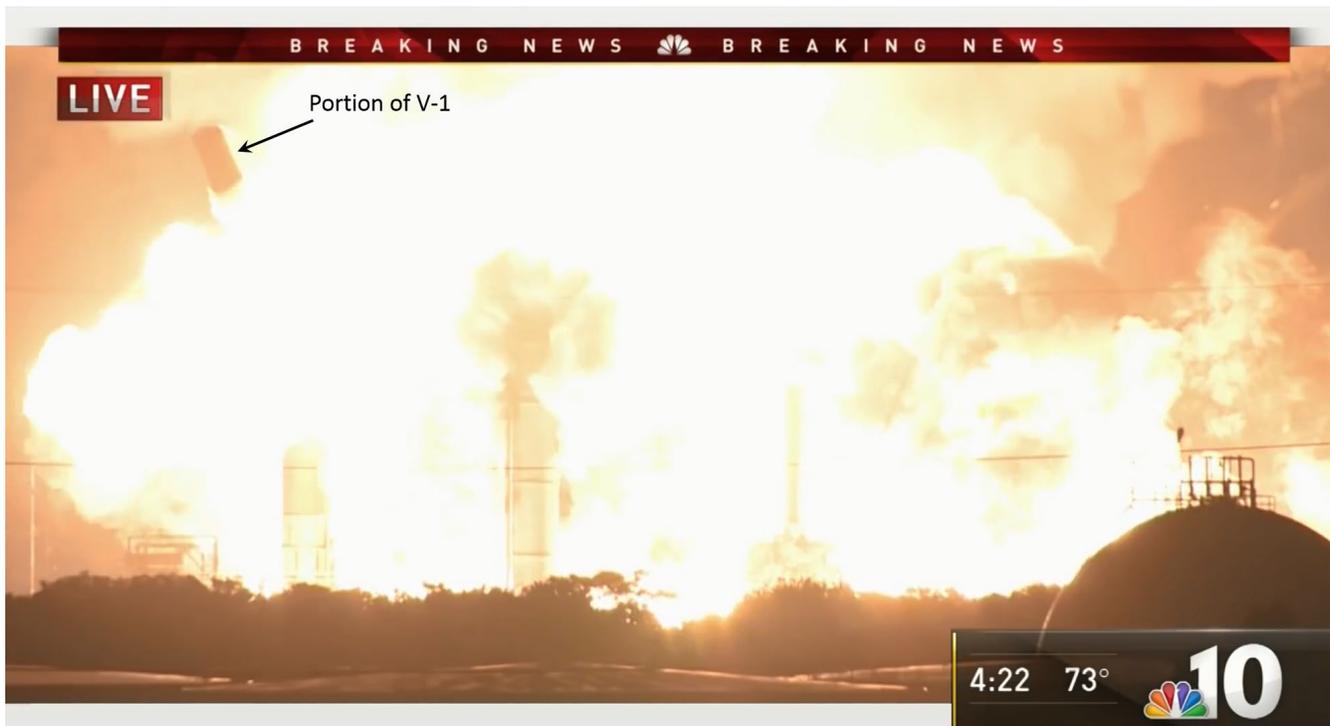
At 4:22 a.m., a third, and the largest, explosion occurred when the V-1 treater feed surge drum, containing primarily butylene, isobutane, and butane, violently ruptured (**Figure 12** and **Figure 13**). A fragment of the vessel weighing approximately 38,000 pounds flew across the Schuylkill River, and two other fragments, one weighing about 23,000 pounds and the other 15,500 pounds, landed in the PES refinery (**Figure 14**). This was also a secondary event caused by the fire. In **Figure 14**, the fragment 1 photo was taken after the fragment was recovered from the bank of the river and relocated to the PES refinery. The deformation of fragment 1 appears to be consistent with the deformation expected from its impact with the riverbank.

**Figure 12.** Video still of the V-1 explosion. (Credit: NBC10 Philadelphia [16] with annotations by CSB)

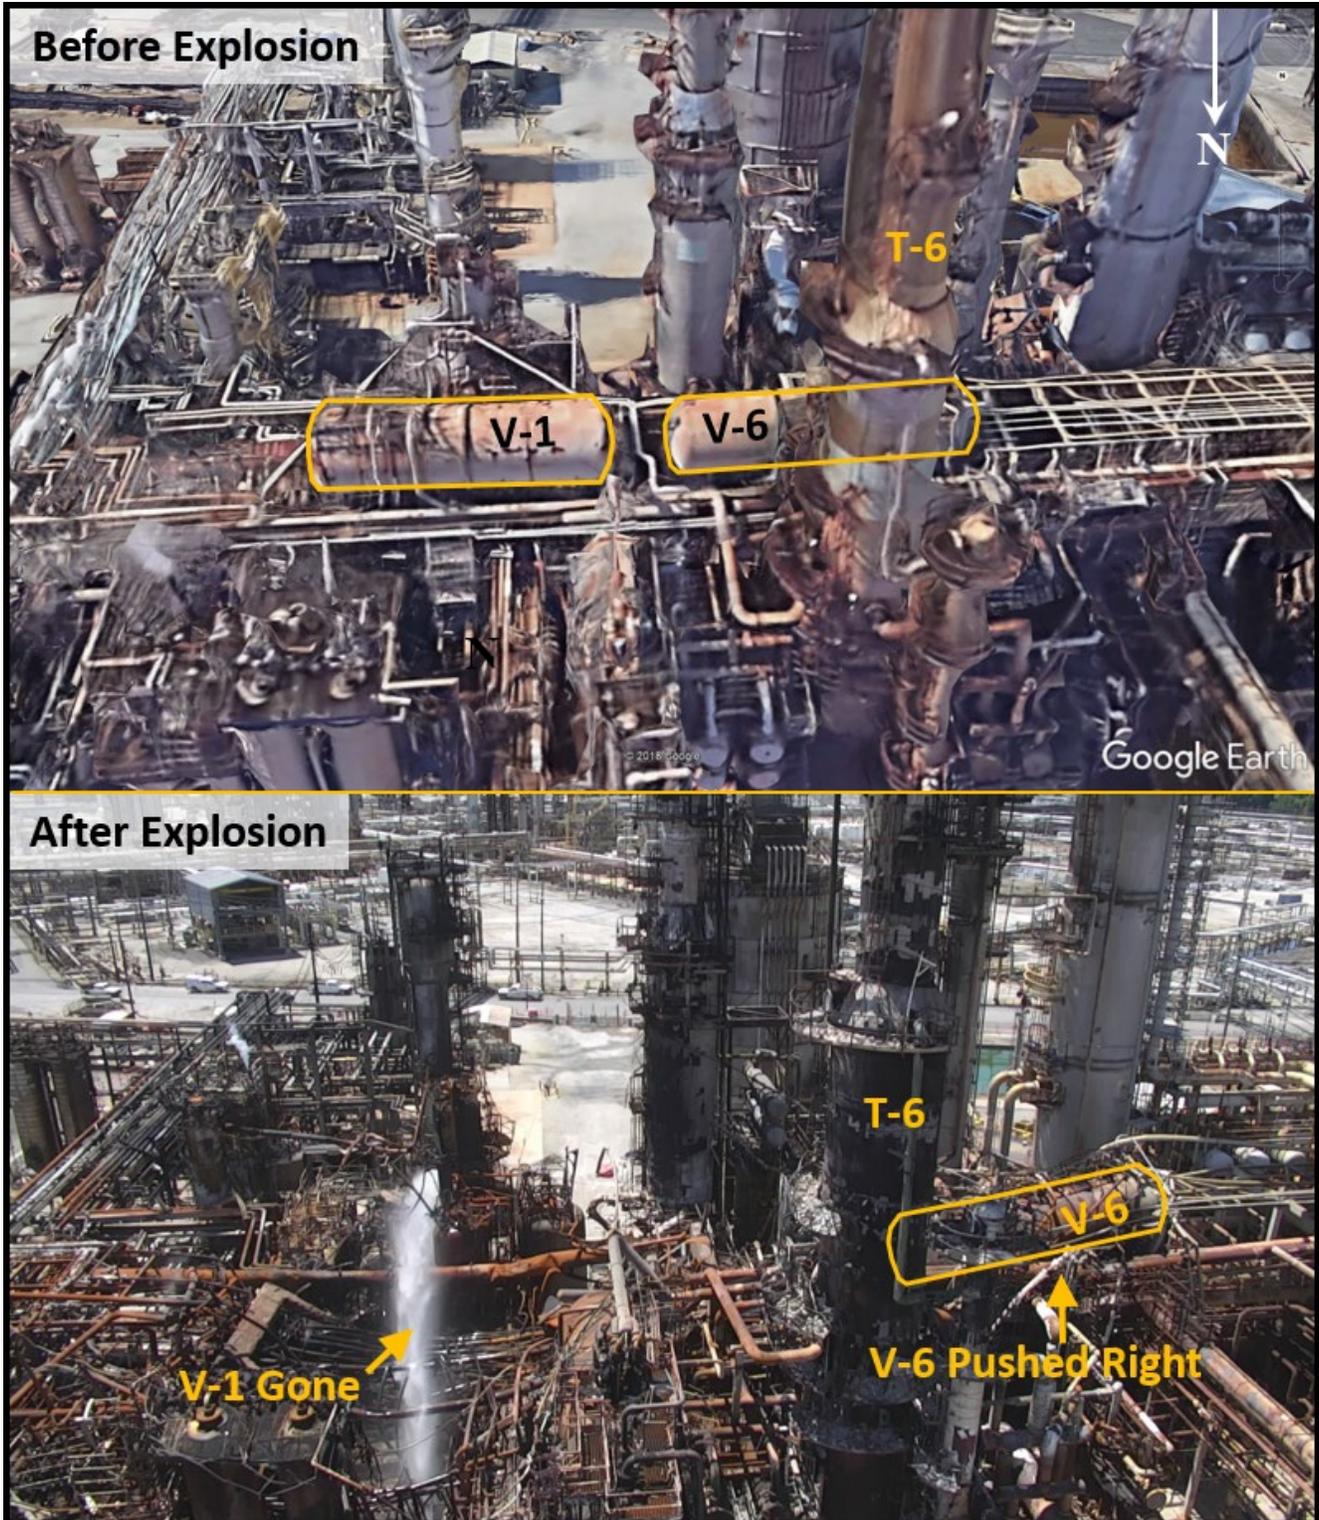
Figure 13. Comparison of the incident scene pre-incident and post-incident. (Top photo credit: Google Earth. Bottom photo credit: PES. annotations by CSB)

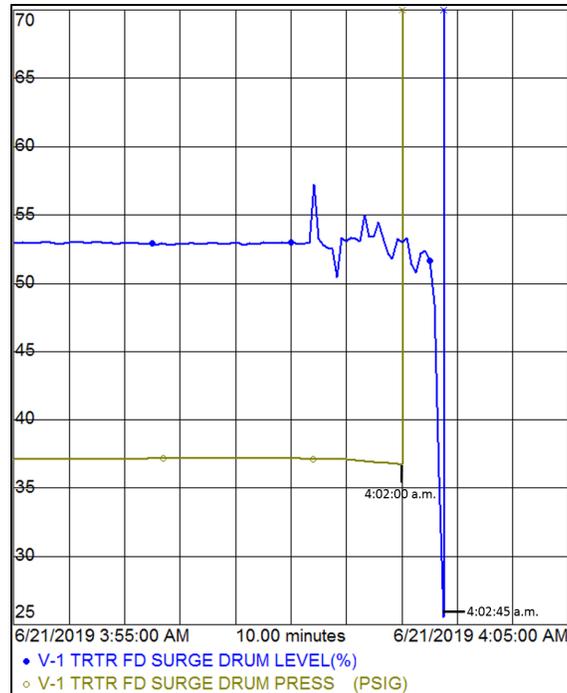
At the start of the incident, V-1 was about 53% liquid-full of primarily butylene, isobutane, and butane, and the internal pressure was 37 psig.<sup>a</sup> The V-1 pressure indicator's last reading was at 4:02:00 a.m., and then failed at about the time of ignition. The level indicator's last reading was at 4:02:45 a.m. before failing during the fire, last indicating that V-1 was about 25% liquid-full, but this reading may not be reliable due to the fire's effect on the instrumentation.<sup>b</sup> The V-1 pressure and level data are shown in **Figure 20**. V-1 was not equipped with thermal insulation for protection from fire.

<sup>b</sup> The last liquid level reading measured in V-1 was 25.5 %, at 4:02:45 a.m. This value is not a reliable indication of the liquid level, however, because the data shows the liquid level dropped from about 52% full to 25.5% full in about 15 seconds, which is unlikely. The ongoing fire likely affected this measurement to read an incorrect value.

Figure 20. V-1 internal pressure and level before and during the incident. (Credit: CSB)

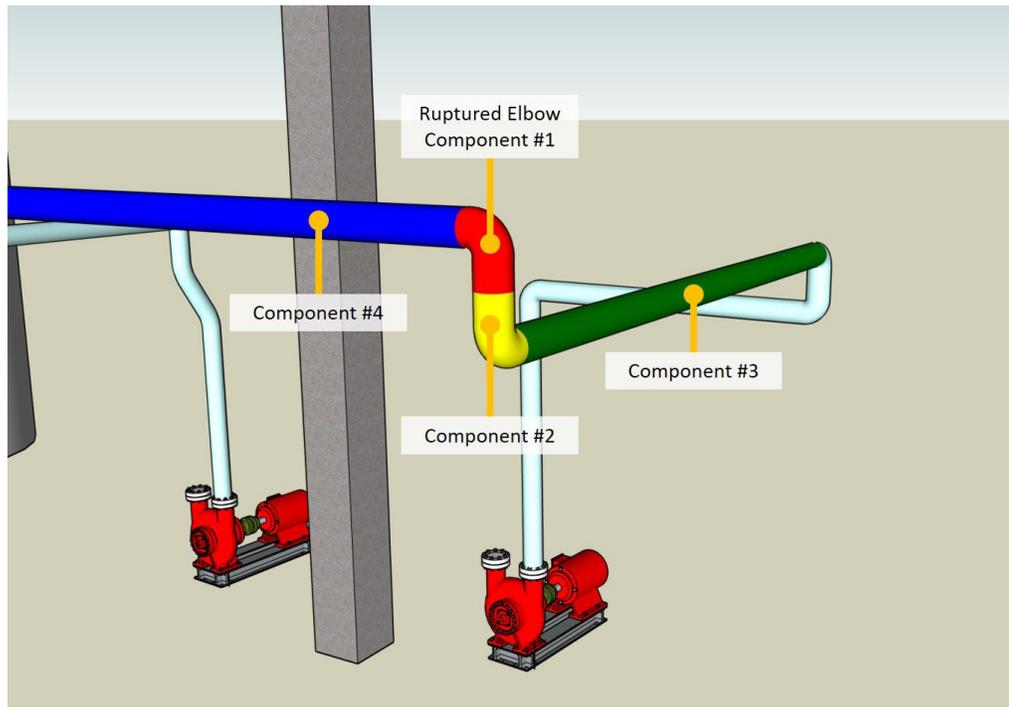
As shown in **Table 3** below, post-incident testing found that the ruptured elbow contained nickel and copper content that far exceeded the 2003 NACE technical paper's recommended composition limits, while adjacent piping components did meet these recommended limits and were not thin. The piping locations relative to the ruptured elbow are shown in **Figure 23**.

**Figure 23.** Depiction of the location of the four piping segments discussed in this report. (Credit: CSB).

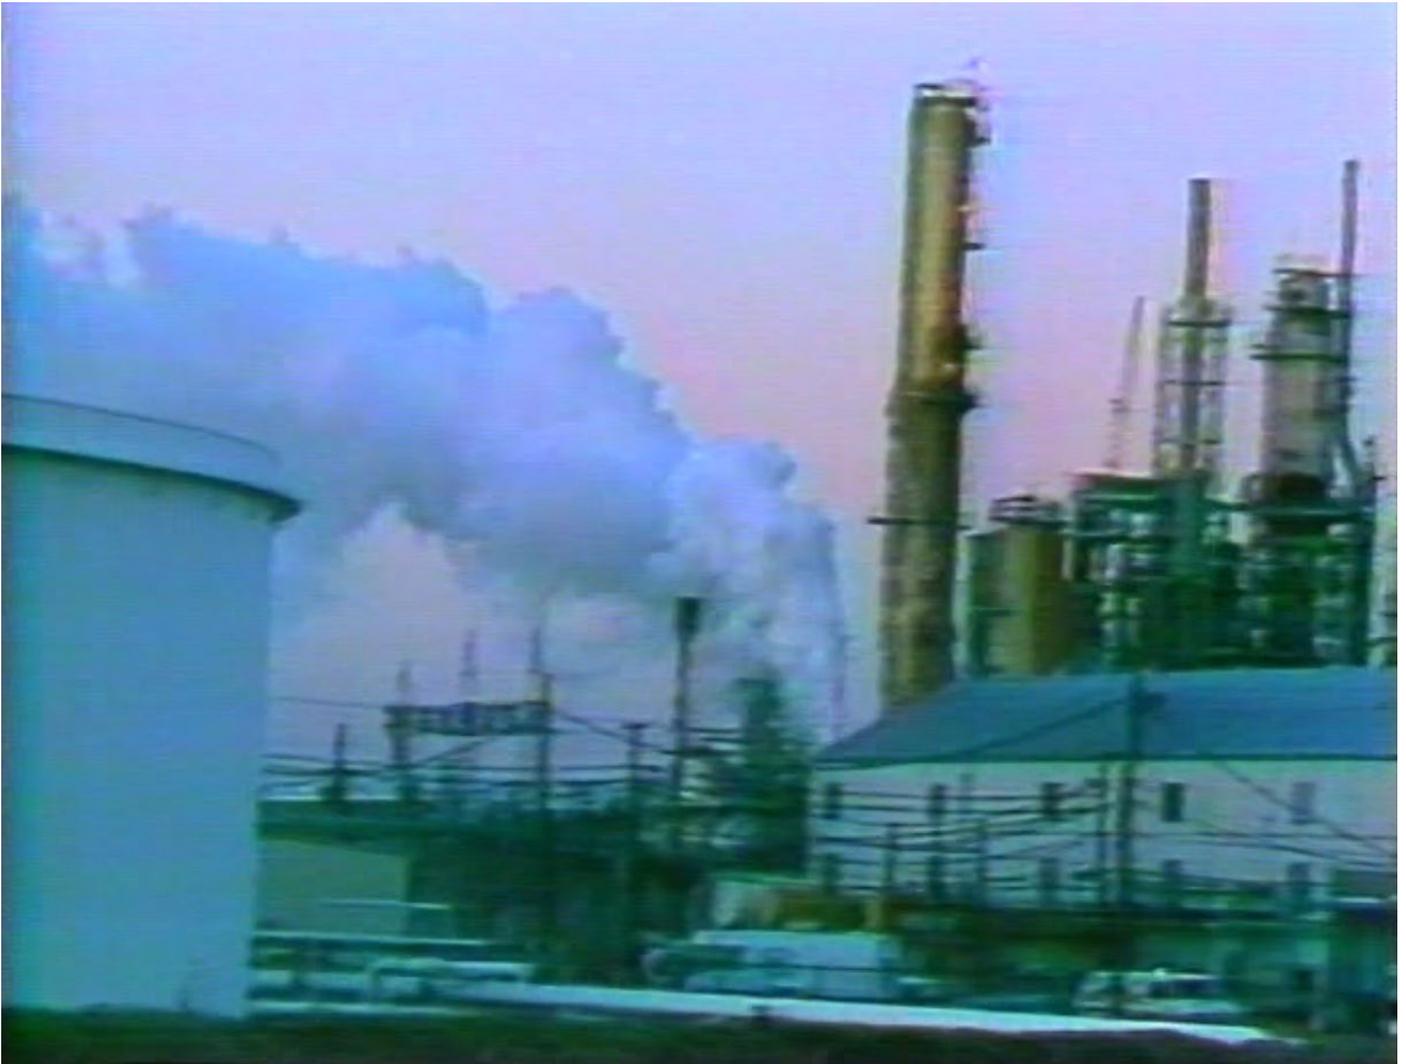
On October 30, 1987, hydrofluoric acid was released from the Texas City, Texas Marathon oil refinery (**Figure 30**). During a unit turnaround, a crane was used to lift heavy equipment over a vessel containing hydrofluoric acid. Marathon miscalculated the weight of the equipment and overloaded the crane, causing the crane to tip over. The heavy equipment dropped from the crane and fell onto the HF vessel, severing a 4-inch HF acid loading line and a 2-inch pressure relief line. About 30,000 to 53,000 pounds of HF were released [38, p. 113]. About 4,000 people were evacuated as a result of the hydrofluoric acid release [39]. Over 1,000 residents in the

A sprinkler designed to control a hydrofluoric acid release was damaged by the crane. A siren intended to sound during the emergency was also rendered inoperable when the event knocked out the power for the siren. About 600 people sued Marathon for long-term damage to their health [40]. This incident drew nationwide attention to the use and safety of HF in refineries [38, p. 113].

**Figure 30.** Video capture of the October 30, 1987, hydrofluoric acid release at the Marathon oil refinery in Texas City, Texas. (Credit: ABC News, 20/20 [40])

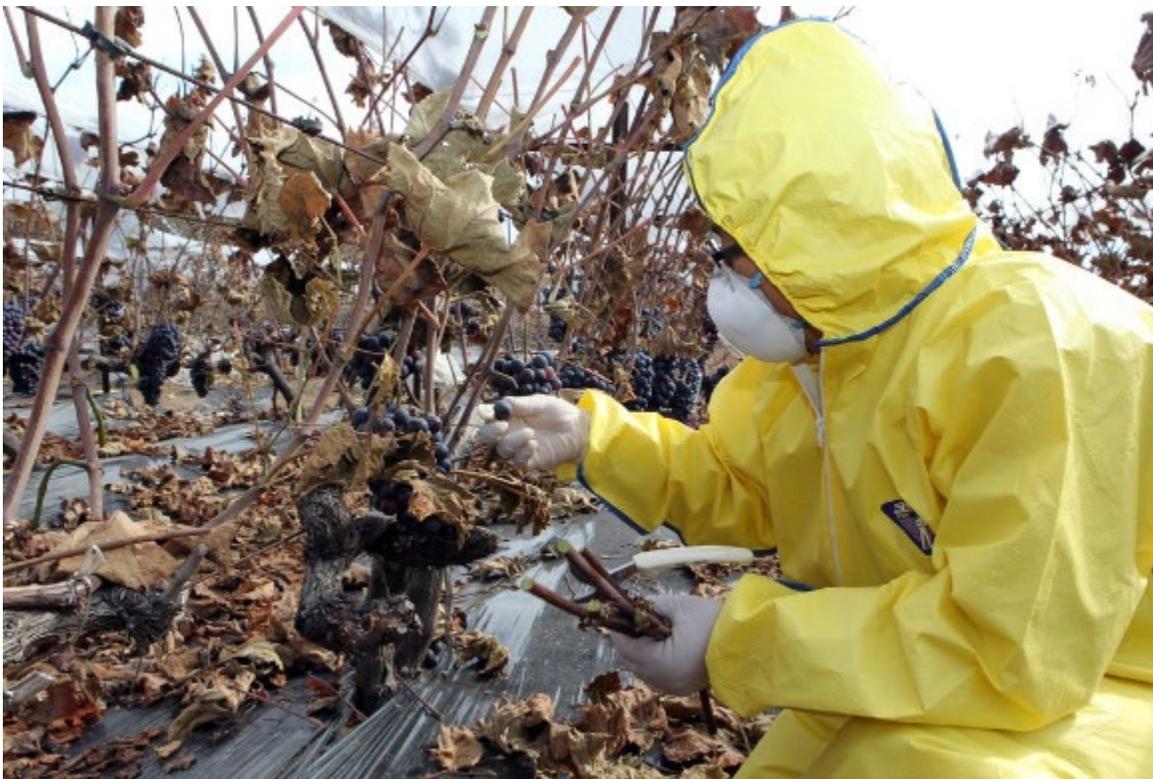
On September 27, 2012, over 17,000 pounds of hydrogen fluoride gas released from a chemical plant in South Korea. Five workers were killed, 18 workers were injured, and over 12,000 people from the surrounding area reported injuries. The South Korean government reported that it would pay \$33.4 million in compensation to citizens and local businesses [45]. The HF release damaged more than 500 acres of farmland (**Figure 31**) and affected 3,200 livestock animals. The South Korean government designated the area affected by the release as a “special disaster zone” [46].

**Figure 31.** Photo of damaged crops following September 27, 2012, hydrogen fluoride release in South Korea. (Credit: Yonhap News Agency [47])

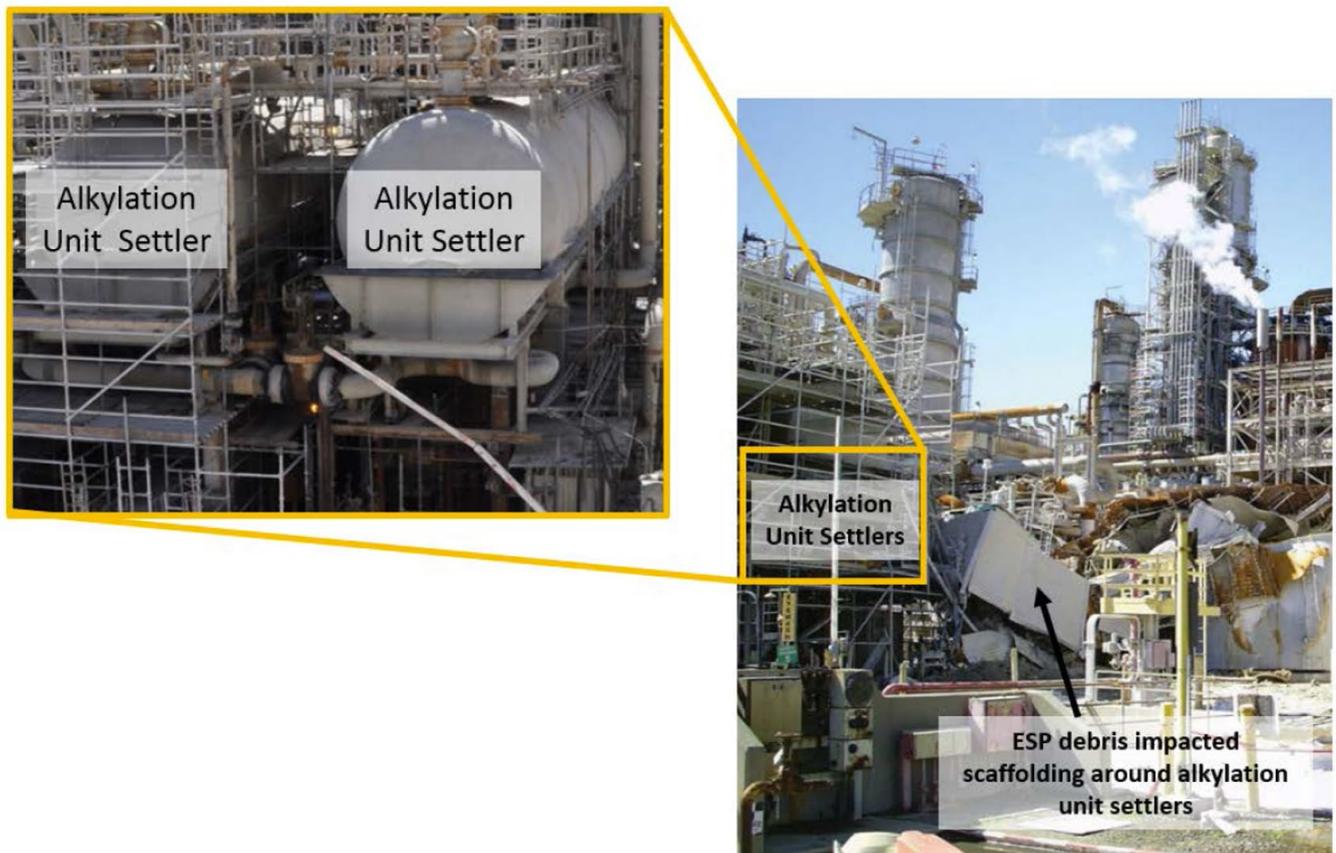
On February 18, 2015, an explosion occurred in the ExxonMobil Torrance, California refinery’s electrostatic precipitator (ESP), a pollution control device in the fluid catalytic cracking unit that removes catalyst particles. As a result of this incident, a near-miss event occurred in the modified HF alkylation unit when explosion debris nearly hit tanks in close proximity to the ESP, each containing HF, water, hydrocarbons, and a chemical additive intended to reduce the amount of HF vaporized during a loss of containment event (**Figure 32**). ExxonMobil denied CSB requests for safety information pertaining to the potential release of HF, including a request for “records relating to the documented or asserted degree of HF vapor suppression for modified HF, and industry and/or Mobil/ExxonMobil studies, experiments, modeling of modified HF and its effectiveness in suppressing vapor compared to unmodified HF.” The CSB issued subpoenas for this information and pursued enforcement in U.S. federal district court [48].<sup>a</sup> In December 2019, the U.S. Ninth Circuit Court of Appeals ruled that ExxonMobil must produce this information to the CSB [49].<sup>b</sup> ExxonMobil produced this information to the CSB on March 20, 2020. Section 2.4.2.2 discusses the safety information in these documents.

**Figure 32.** Explosion debris from the February 18, 2015, ExxonMobil Torrance Refinery explosion came in close proximity to the alkylation unit’s HF settlers. (Credit: CSB [48]).

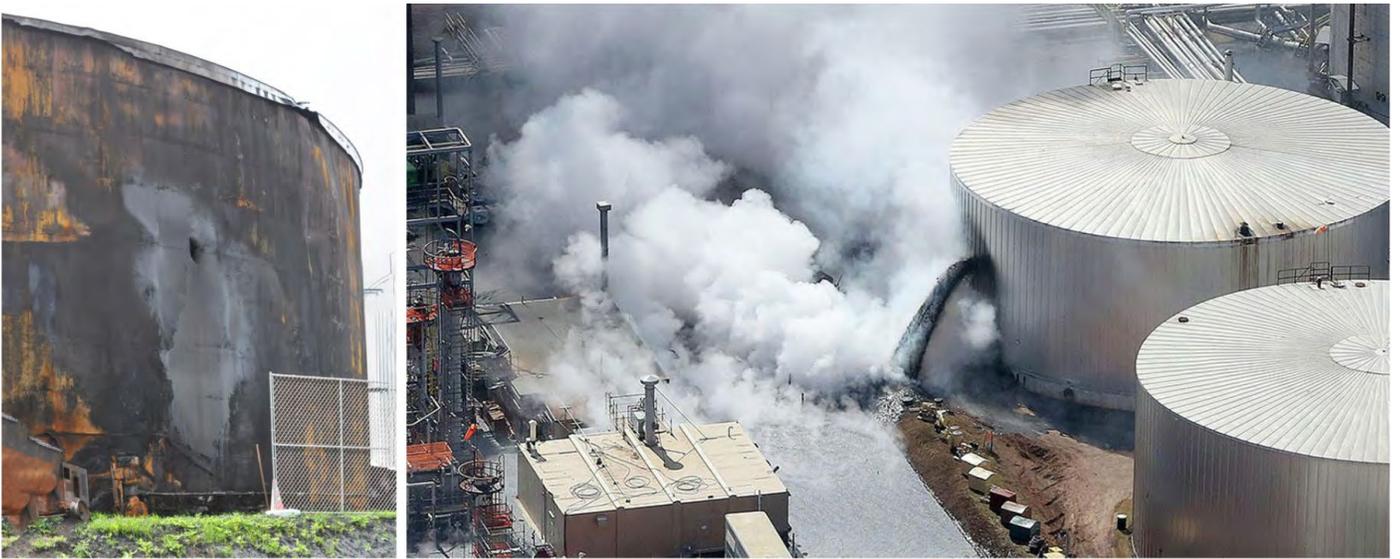
On April 26, 2018, an explosion occurred at the Superior Refinery Company LLC refinery in Superior, Wisconsin (“Husky Superior Refinery”) in the refinery’s fluid catalytic cracking unit. Debris from the explosion flew about 200 feet, and impacted a large, nearby, aboveground storage tank containing about 50,000 barrels of asphalt, puncturing the side of the steel tank and spilling more than 15,000 barrels of hot asphalt into the refinery (**Figure 33**). This released asphalt ignited about two hours after the explosion, creating a large fire [50].

**Figure 33.** Post-incident photographs of the leaking asphalt storage tank at the Husky Superior Refinery. (Left photo credit: CSB. Right photo credit: Duluth News Tribune [50])
