## Perspectives on Containment Wall Failure at ITC Deer Park, Texas

Fire at First & Second 80's Tank Farm at  
Intercontinental Terminals Company  
Event of March 17, 2019 at Deer Park, Texas

April 24, 2023

Atlas Engineering, Inc.  
551A Pylon Drive  
Raleigh, NC 27606  
Firm License #: C-1349

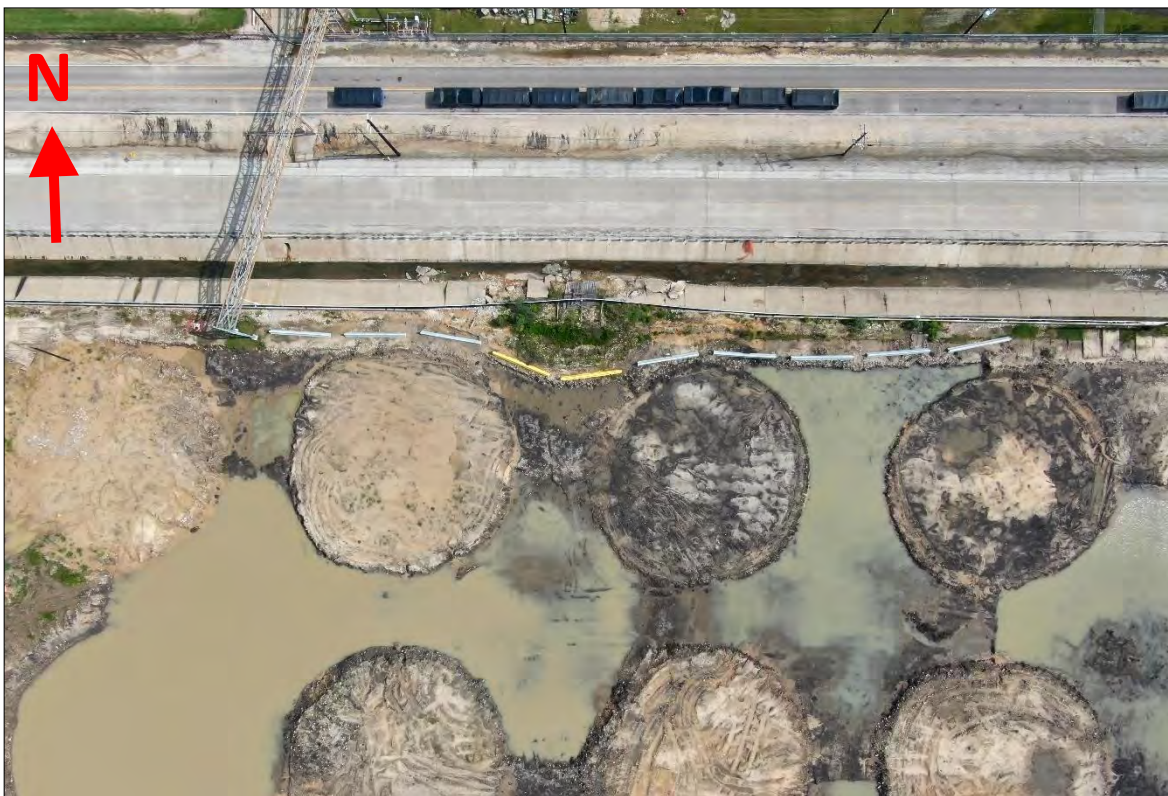
At the time of our site visit, remediation measures had been performed. These included draining the product and water from the site as well as removal of the existing tanks and above-grade piping. The top surface of the soil inside the containment area appeared to have been significantly disturbed by these initial remediation measures. The additional soil brought in to construct the containment remained in place. New T-rail Jersey barriers were in place, likely to prevent equipment involved in the remediation of the tank farm from entering the section of the breach. The elevated pipes that were located just outside the tank farm wall had additional temporary supports added where the original supports were disturbed in the breach. Erosion ditches at the area of the breach had been backfilled. Some sections of the damaged concrete slab that had lined the drainage ditch between the tank farm containment wall and Tidal Road had been removed, as well as sections of the damaged portion of the containment wall. The immediate area of the breach was thoroughly disturbed from the remediation and stabilization operations. However, sections adjacent to the breach along the containment wall appeared to remain minimally disturbed since the incident (Photo 10).

**Photo 10:** Aerial view of side during July 7, 2021 site visit

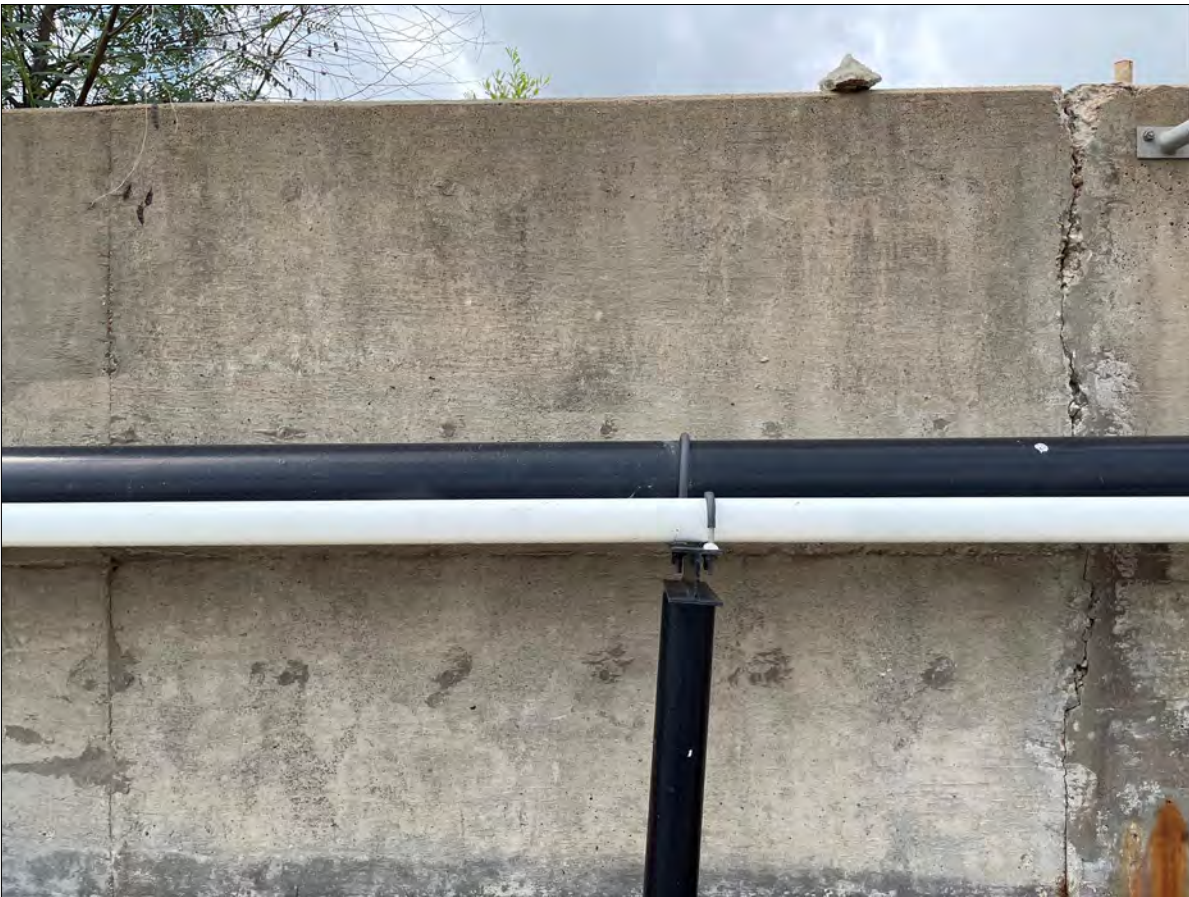
The containment wall was a cast-in-place concrete wall 8-inches thick and extending above the interior grade of the tank farm approximately 4 feet. The depth of the containment wall into the soil was not able to be determined at this visit. The wall had impressions from a panelized formwork system and through-wall break-off form ties, or snap-ties, spaced regularly in the horizontal and vertical direction, indicating it was constructed free-standing with a panelized formwork system on each face (photo 12). The wall was reinforced with two layers of deformed mild-steel reinforcing bars. The wall was cast in sections, with a construction joint every 40 feet. The joints were formed with a shear-key at the joint and a ribbed-wing centerbulb PVC waterstop incorporated into the construction joints to prevent liquids from leaking through the wall at the joints (photo 13 & 14).

**Photo 12:** North concrete retaining wall, outside face. Form tie marks on wall

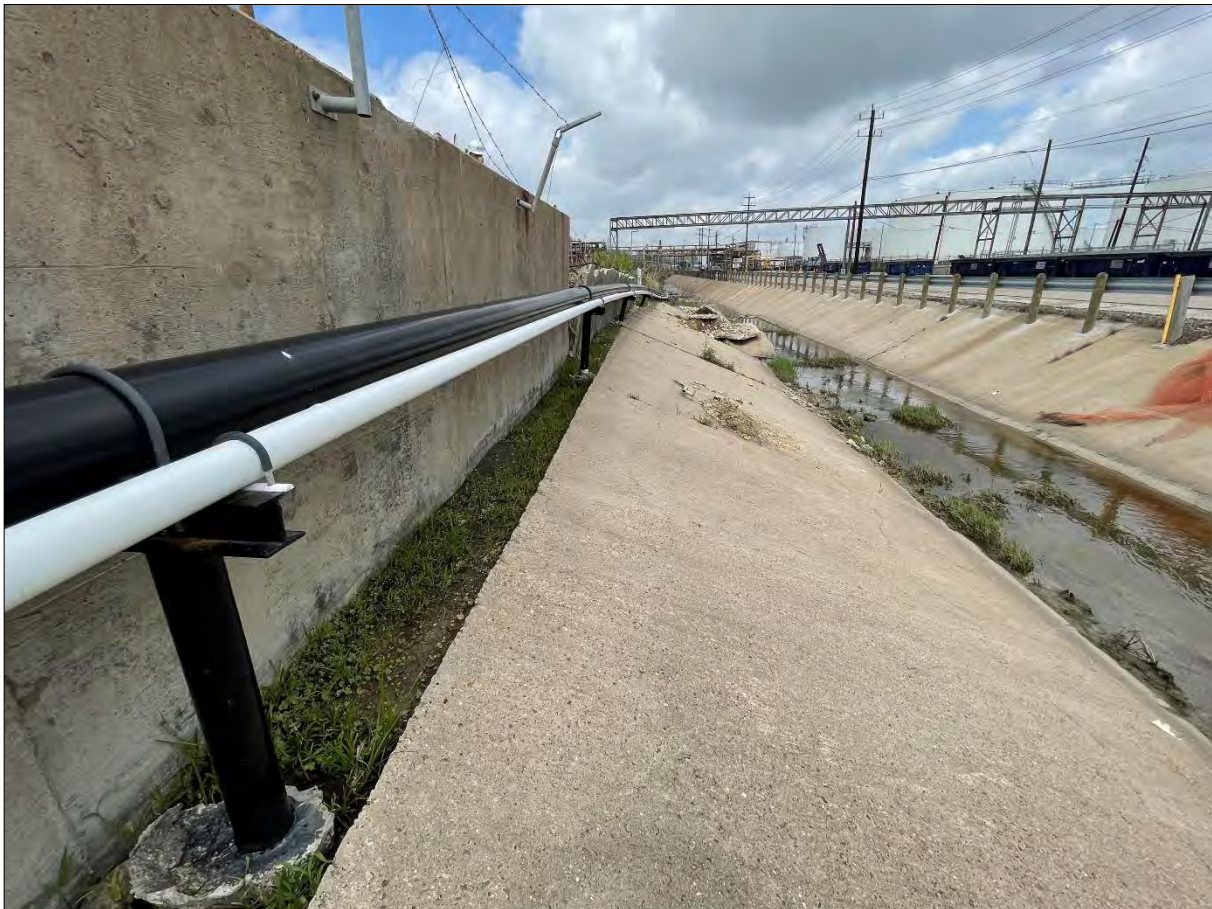
The drainage ditch between the containment wall and Tidal Road was a concrete-lined structure with a flat bottom and sloped side walls (photos 15 & 16). The concrete slab was approximately 4-inches thick, with welded-wire-reinforcement observed at broken sections of the concrete, typically located near the bottom of the slab. The concrete slabs were cast in sections, with construction joints between the slabs (photo 17). The welded-wire reinforcement did not span across the construction joints. Holes through the slab were observed along the bottom edge of the sloped side-wall slabs, appearing to have the purpose of providing drainage of groundwater from behind the side slab into the drainage ditch. In the areas adjacent to the breach that appeared un-disturbed, sections of the sloped sidewall concrete slab had buckled upward in the middle of the slab.

**Photo 15:** Drainage Ditch, undamaged section at north-east corner, looking west

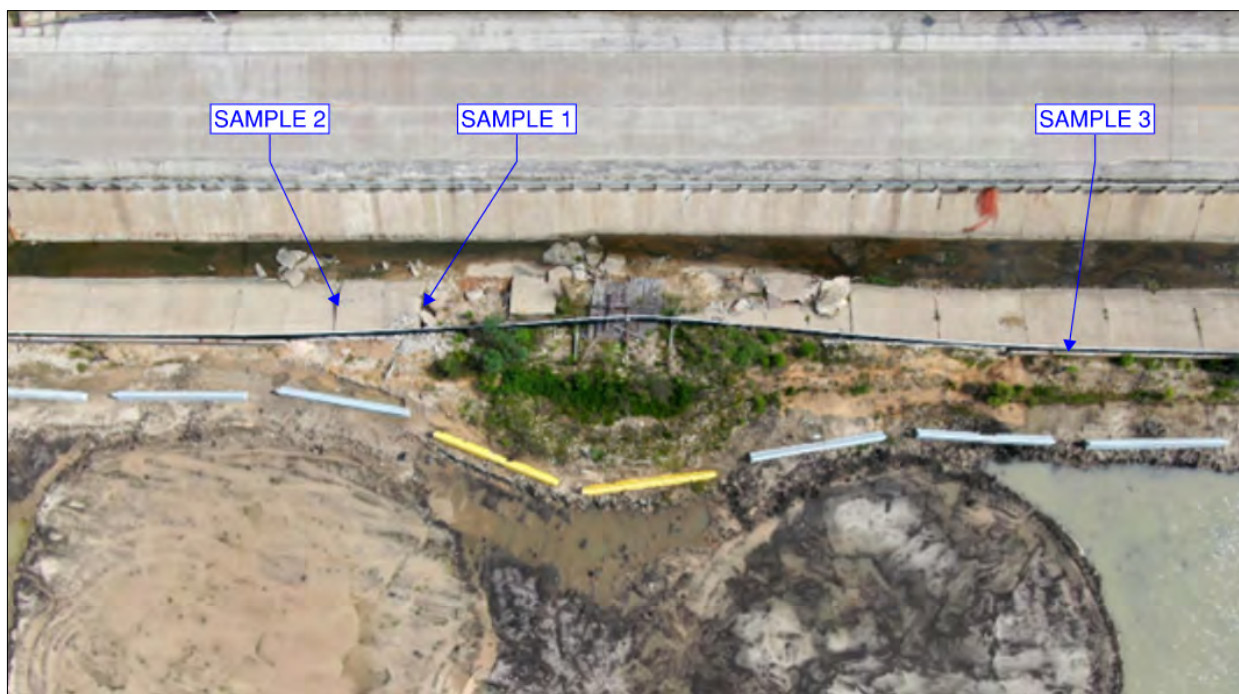
During this visit, three isolated soil samples were taken with a hand trowel at a shallow depth from areas assumed to be soils existing at the time of the breach with locations shown in photo 18. Sample 1 was taken on the north side of the containment wall just west of the breach, at a location beneath a buckled slab of the drainage ditch (photo 19). Sample 2 was taken on the north side of the containment wall, further west of the breach, at a location beneath a buckled slab of the drainage ditch (photo 20). Sample 3 was taken on the north side of the containment wall, east of the breach, in an area that was not disturbed by the shifting wall of the breach (photo 21). No samples were taken inside the containment area since it appeared that the soil surface had been significantly disturbed during remediation efforts at the site and would therefore not be representative.

**Photo 18:** Soil Sample Locations relative to breach in containment wall

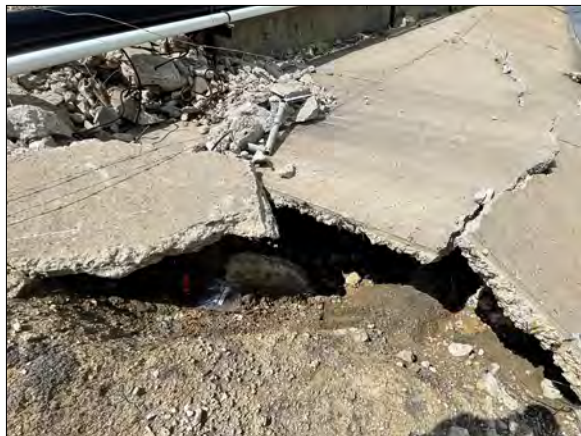
**Photo 19:** Location of Sample 1

Sample 1 appears to be a stiff mottled tan and gray silty deltaic clay. Its classification would be most likely “CH” when classified in accordance with the Unified Classification system. Sample 2 appears to be a dark gray deltaic clay, also likely to be classified as a CH. Sample 3 appears to be a moist soft gray marine clay CH. Both Samples 1 and 2 appear to have been disturbed and are poorly consolidated, whereas Sample 3 is fine grained and well consolidated. Samples 1 and 2 are assumed to be typical of the soils located underneath the sloped side slab of the drainage ditch. Sample 3 is assumed to be similar to the soils inside the containment area at the containment wall. The soil in Samples 1 and 2 appears to be moderately sensitive. Soil sensitivity is a characteristic describing the loss of soil strength when changing from an undisturbed natural condition to a disturbed condition through excavation and re-compaction. Soils with higher sensitivity lose a greater proportion of their strength when disturbed. Sample 3 appears to have a high shrink-swell potential, or a potential to change volume as water content in the soil changes. Soil swelling can increase the pressure on retaining walls considerably higher than normal pressures.
