# Investigation Report

**Published: April 24, 2023**

On August 27, 2020, extreme winds from Category 4 Hurricane Laura caused severe damage to buildings storing chemical formulations comprised primarily of trichloroisocyanuric acid (TCCA) at the Bio-Lab, Inc. Lake Charles (Bio-Lab) facility in Westlake, Louisiana, located in the southwestern area of the state. TCCA-based formulations are chlorinating agents often used as a sanitizer to kill algae and bacteria in large volumes of water, predominantly swimming pools and hot tubs, and sold in tablet, stick, and granular forms. In large bodies of water, the TCCA formulation is soluble and breaks down slowly, releasing available chlorine in the water to sanitize contaminants. When a TCCA-based formulation instead comes in contact with or is wetted/moistened by a small amount of water and does not dissolve, it can experience a chemical reaction, generating heat and causing the decomposition of the chemical, which in turn produces toxic chlorine gas and can produce explosive nitrogen trichloride. After the buildings at the Bio-Lab facility were damaged by Hurricane Laura winds, rainwater contacted the TCCA-based formulation stored insid

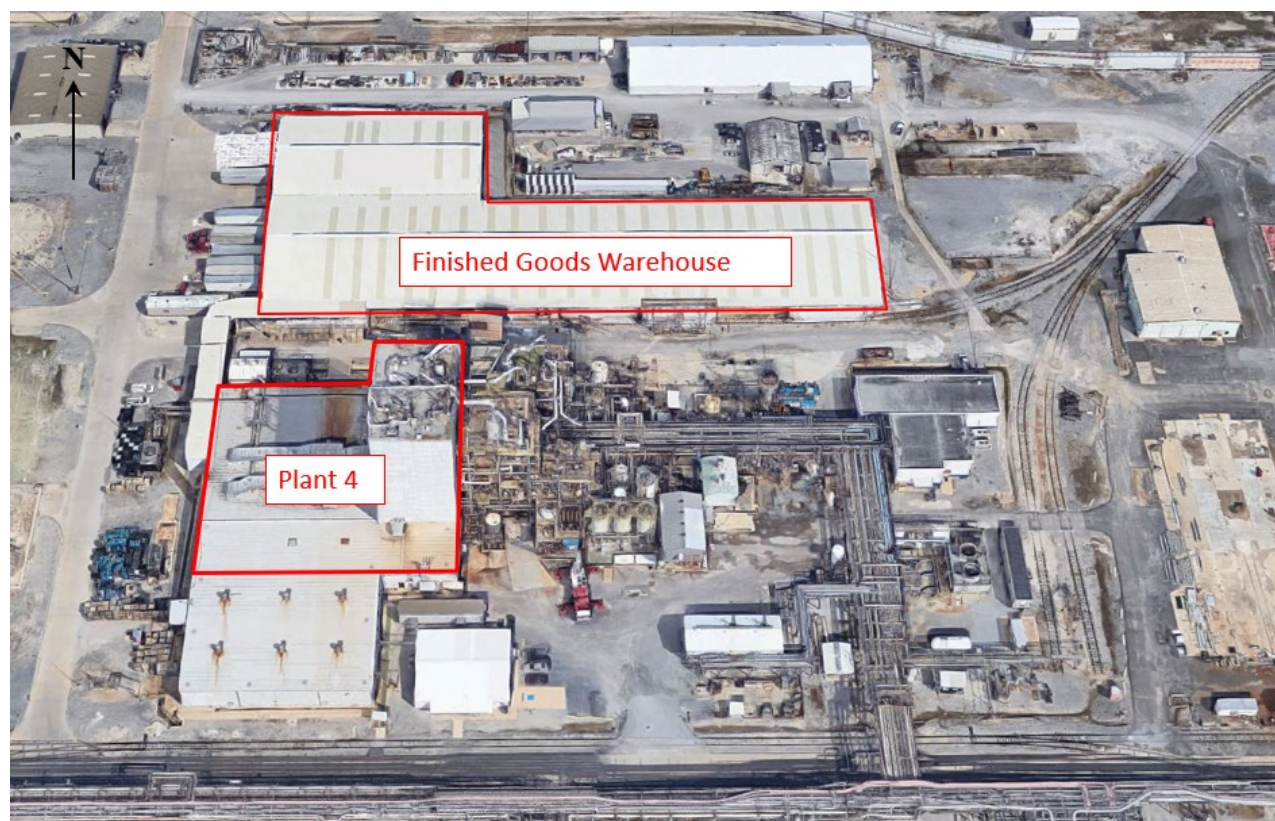
**Figure 1.** Overhead view of a portion of the Bio-Lab facility with red denoting buildings involved in the incident. (Credit: Google Earth, annotations by U.S. Chemical Safety and Hazard Investigation Board (CSB))

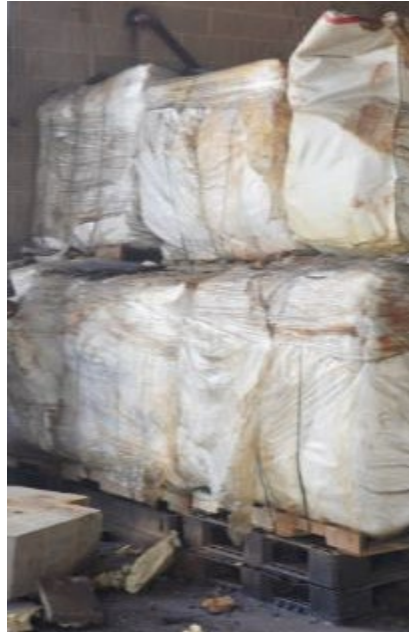
Nine employees assigned to the Bio-Lab Hurricane Crew<sup>b</sup> reported to the facility on August 25, 2020, around 5:00 p.m. Each crew member had specific job assignments, including securing loose items that could become hazardous during the hurricane (e.g., by being propelled by wind), placing sandbags at entrances to prevent floodwater entry, and other tasks defined in the hurricane plan. To protect the remaining TCCA-based formulation and other products from potential floodwater, the Hurricane Crew raised the materials above floor level by placing the material on triple-stacked pallets (**Figure 5**).<sup>c</sup>

**Figure 5.** Product stacked as a precaution from floodwater. (Credit: CSB)

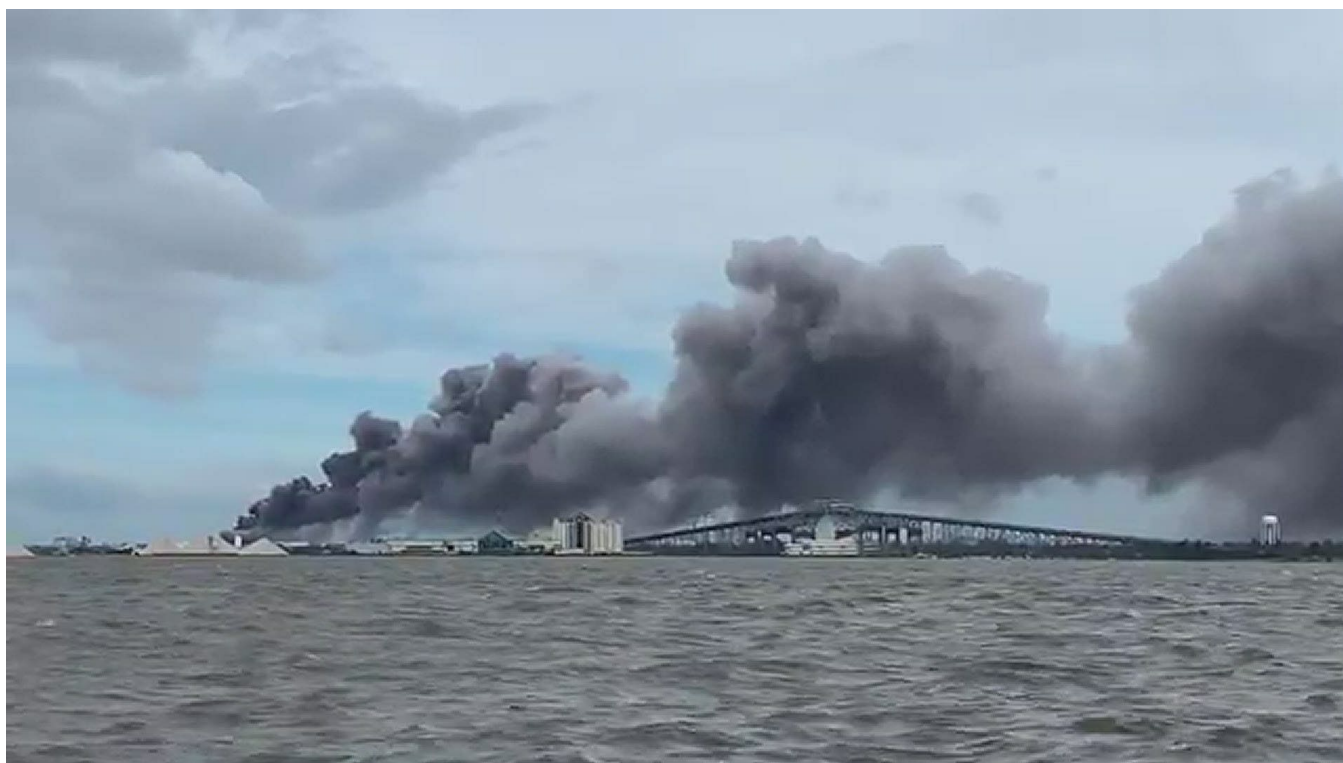
**Figure 8.** Photo of plume from decomposition in Bio-Lab Plant 4 approaching the Calcasieu River Bridge near the facility. (Credit: CBS 4WWL [23])

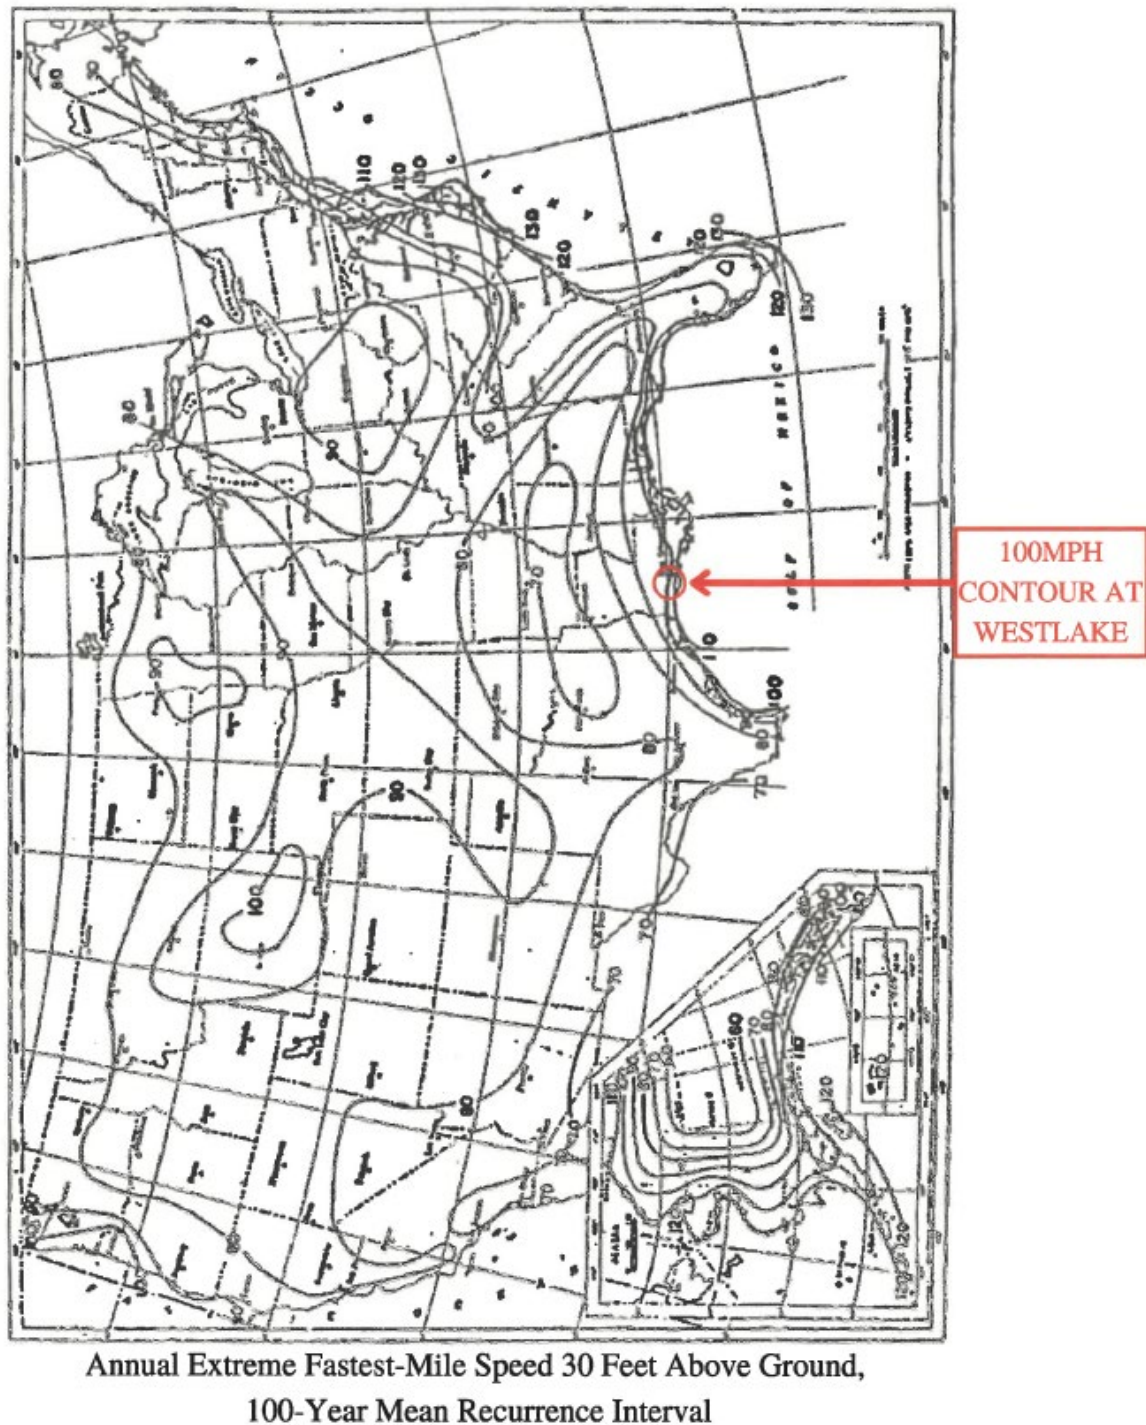
The CSB's discussions with building officials in the Calcasieu Parish and the Cities of Westlake and Lake Charles, Louisiana, suggest that general design standards in the area during the 1970s were largely deferred to the architects and engineers involved. Representatives from the Calcasieu Parish told the CSB that licensed designers in the Parish would potentially look to standard engineering practices, including the prevailing Standard Building Code, for design guidance in the absence of official state adoption of the code. The Standard Building Code in use in 1979 was the 1974 revision of the 1973 edition. Basic design wind speeds are shown in Chapter 12 of that Code, with the Westlake / Lake Charles area falling close to the 100-mph wind speed contour for building design (see **Figure 15** and **Appendix D**).

**Figure 15.** Basic design wind speeds in the prevailing Standard Building Code in 1979, the year the Bio-Lab facility was constructed. (Credit: 1974 Standard Building Code, annotations by CSB)

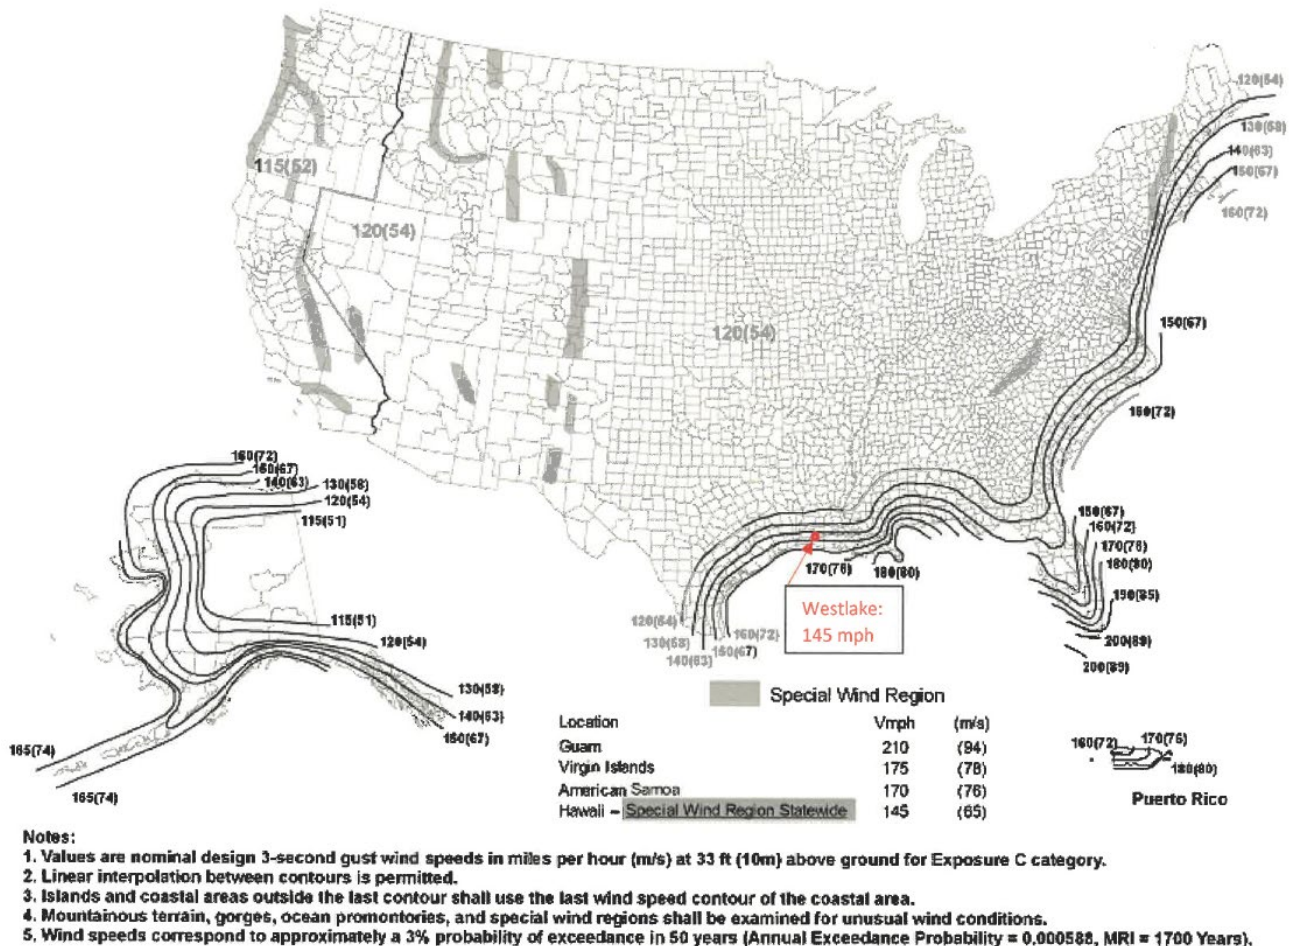
buildings and other structures in the state consistent with the public health, safety, and welfare of its citizens [28].” At the time of the incident (and at present), the LSUCCC adopted the 2015 version of the International Building Code, with amendments,<sup>a</sup> as the Louisiana State Uniform Construction Code [29]. Under the 2015 International Building Code requirements for Risk Category IV buildings, the Bio-Lab facility would be required to withstand 145 mph winds (see **Figure 16** and **Appendix D**).

**Figure 16.** 2015 International Building Code Fig 1609.3(2), Design Wind Speeds for Risk Category III and IV Buildings. (Credit: 2015 International Building Code, annotations by CSB)

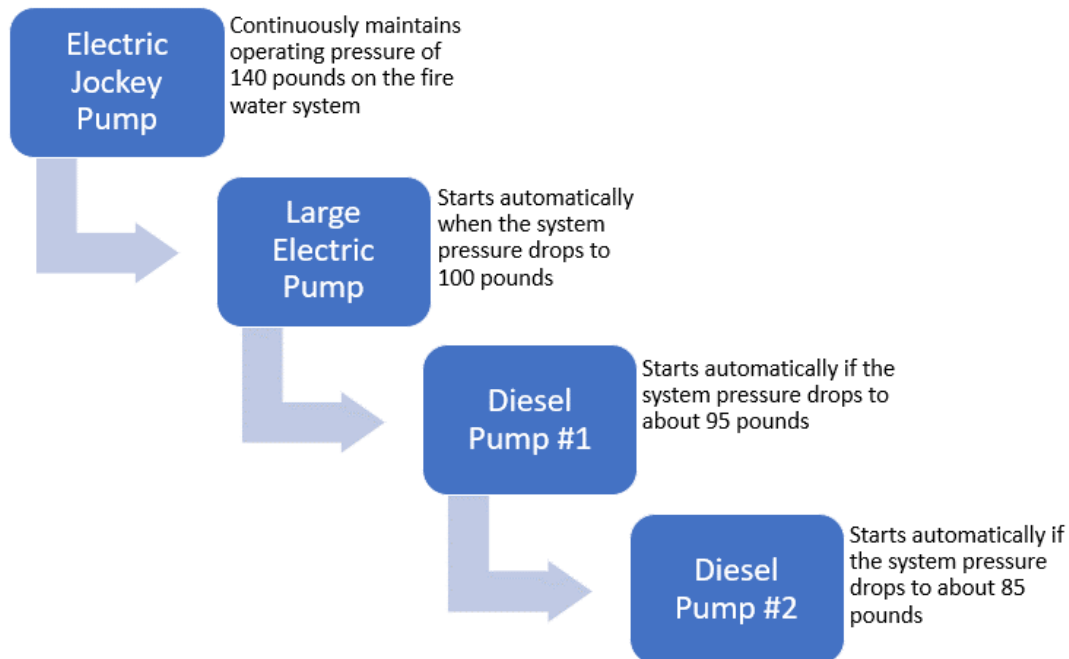
**Figure 18.** Bio-Lab's fire water pumps automatic start-up sequence. (Credit: Bio-Lab, illustration by CSB)

Hurricane Laura damaged a power grid, causing the Bio-Lab facility and the surrounding area to lose electrical power. Bio-Lab personnel attempted to turn on the rental backup generator to operate the fire protection system. Initially, they could not activate the rental generator, and as a result, neither the electric jockey pump nor the large electric pump could be operated. Later, another employee successfully turned on the generator, but it still could not supply power to the electric pumps. The employees did not have a manual or operating procedure to reference for the rental generator. In addition, one of the diesel pumps was nonfunctional before the hurricane made landfall, resulting in only one fire water pump—a diesel pump—available for use to respond to the decomposition and fire. Once the Fire Department arrived, they also experienced difficulties priming their pump, as discussed in Section 2.3.2. With only one fire water pump, the facility could not achieve adequate pressure to apply water to the decomposing TCCA-based formulation. The incident could not be controlled until the contracted third-party emergency responders arrived, set up their equipment, and successfully flowed sufficient water to the decomposing TCCA-based formulation. The problems with the Bio-Lab fire protection system resulted in a lengthy delay of around five and a half hours before productive emergency response operations began. During this delay, the TCCA-based formulation continued to decompose, releasing large clouds of decomposition products, including chlorine.

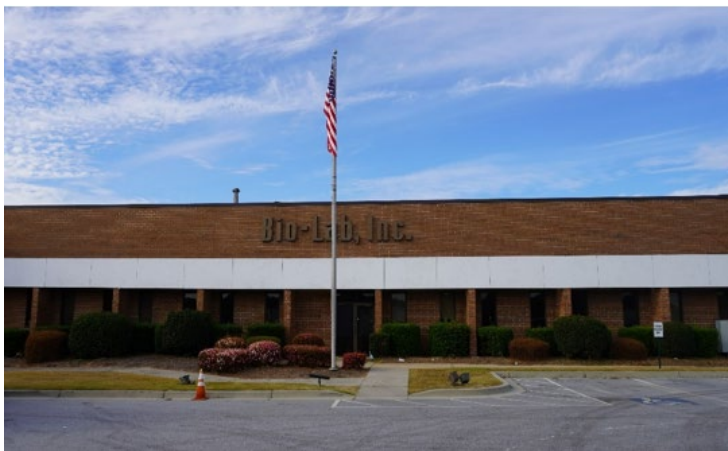
**Figure 21.** Bio-Lab Conyers Plant 6, where the incident occurred. (Credit: CSB)

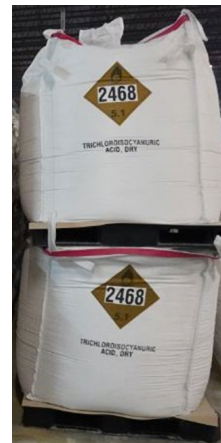
**Figure 22.** Super sacks storage method inside the Bio-Lab Conyers Plant 6. (Credit: CSB)

<sup>a</sup> Bio-Lab stores the TCCA-based formulation products on wood or plastic pallets inside Plant 6. Worker #1 told the CSB that the TCCA-based formulation stored in the area was sitting on wood pallets, similar to exemplar stacked bags shown in **Figure 22** where the reaction and decomposition occurred. The CSB confirmed the height of two wood pallets. One measured approximately seven inches high, and the other was about five inches.

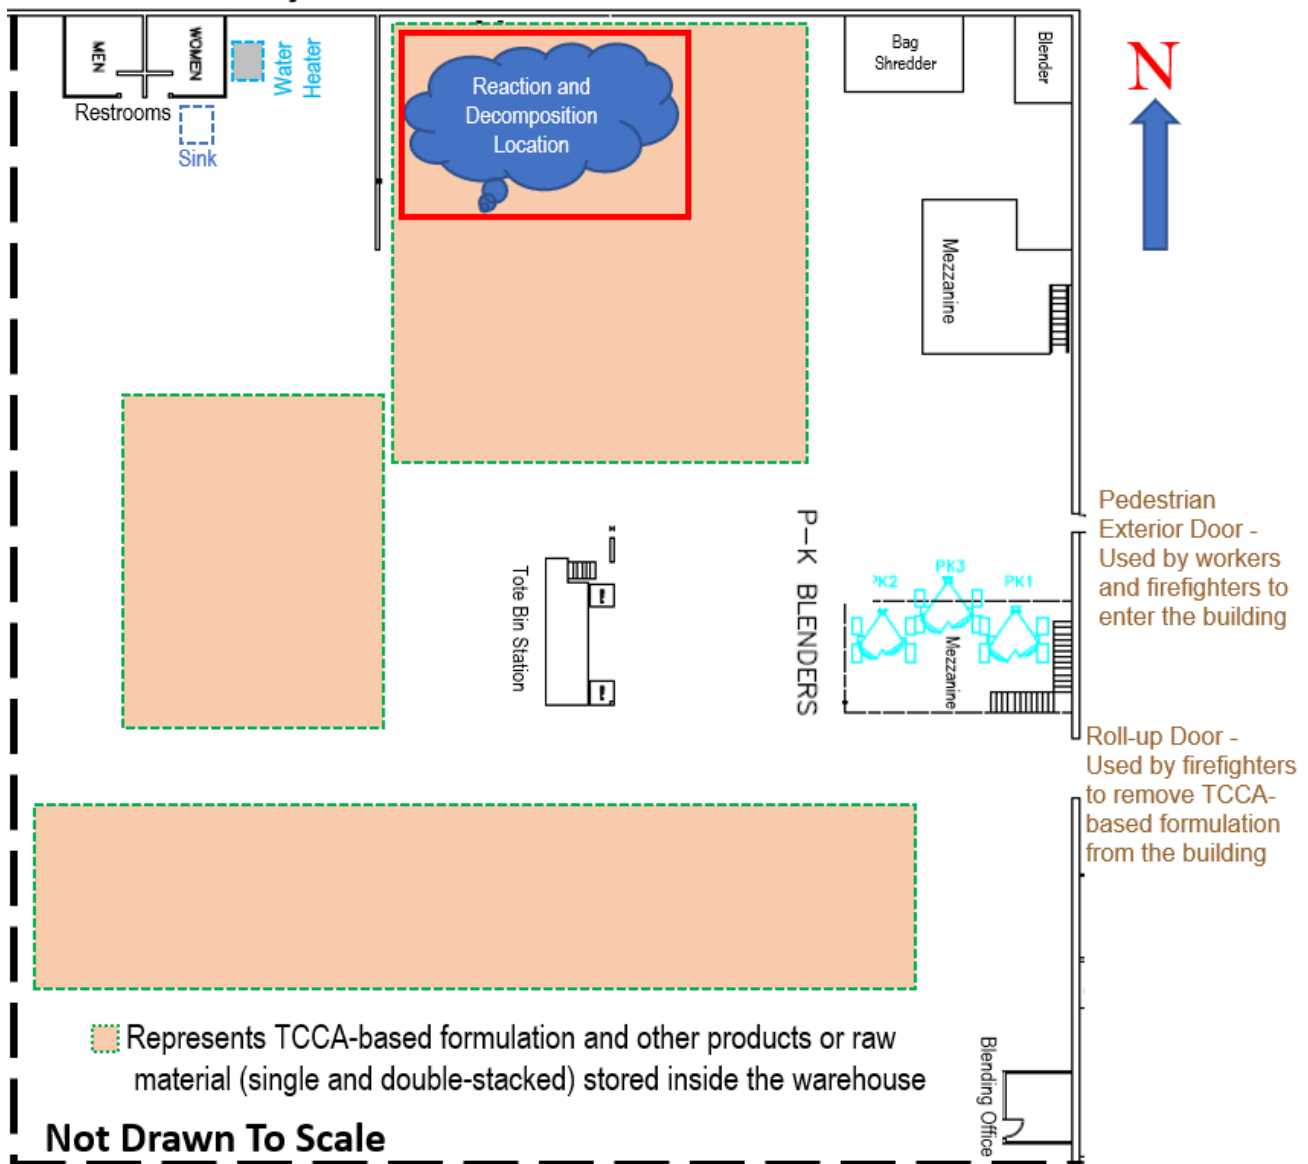
## Bio-Lab Conyers Plant 6 North Wall with Exhaust

**Figure 23.** The configuration of a section of Plant 6 and the incident location (red box). (Credit: Bio-Lab Conyers, annotations by CSB)

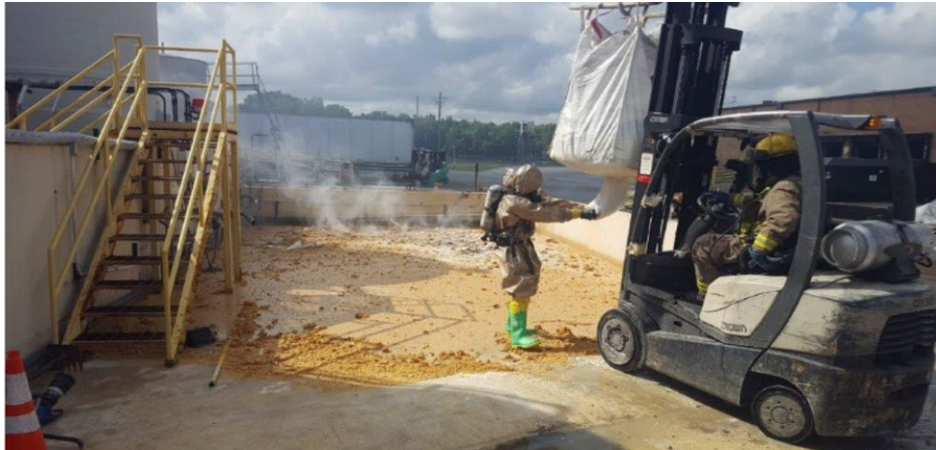
According to the Rockdale County Fire Department, “access to the decomposing pallets was hindered by other surrounding poorly stacked pallets of materials.” The Fire Department also established an external decontamination area (**Figure 26**) and moved decomposing materials to this area using forklifts and skid steers<sup>a</sup> to stop the chemical reactions inside the building.<sup>b</sup>

**Figure 26.** External decontamination area outside the Bio-Lab Conyers Plant 6. (Credit: Bio-Lab Conyers)

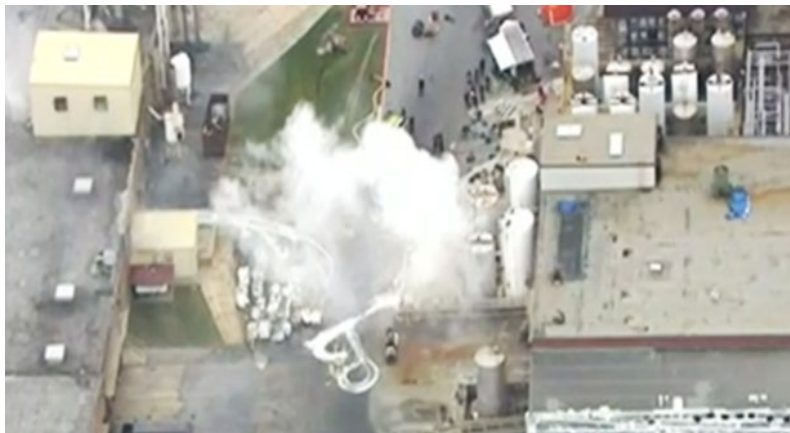
**Figure 27.** Decomposition products, including chlorine, releasing from the Bio-Lab Conyers facility on September 14. (Credit: WSB-TV Channel 2 Atlanta)

The Fire Department temporarily closed a portion of Georgia Interstate 20 (I-20) from approximately 7:00 a.m. to 1:00 p.m. while chemical plumes were emitting from the Bio-Lab Conyers facility (**Figure 27**). Post-incident, nine firefighters were taken to the hospital for evaluation after inhaling hazardous vapors, and were subsequently released.

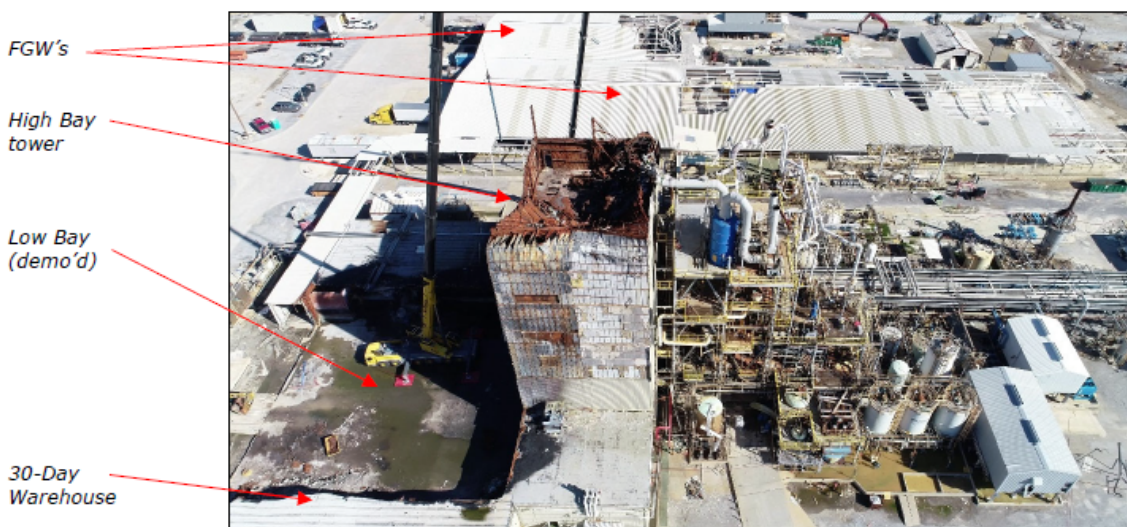
We observed conditions at five damaged buildings at the facility soon after the event. The A-Z Building and the two FGW structures suffered substantial wind damage but were repairable. The Plant 4 Low Bay was destroyed by fire and had been demolished at the time of our site visit. The Plant 4 High Bay tower had severe structural damage. The High Bay was not safe to enter, and was not repairable.

*Overview, looking north (Atlas UAV, 9/30/2020)*

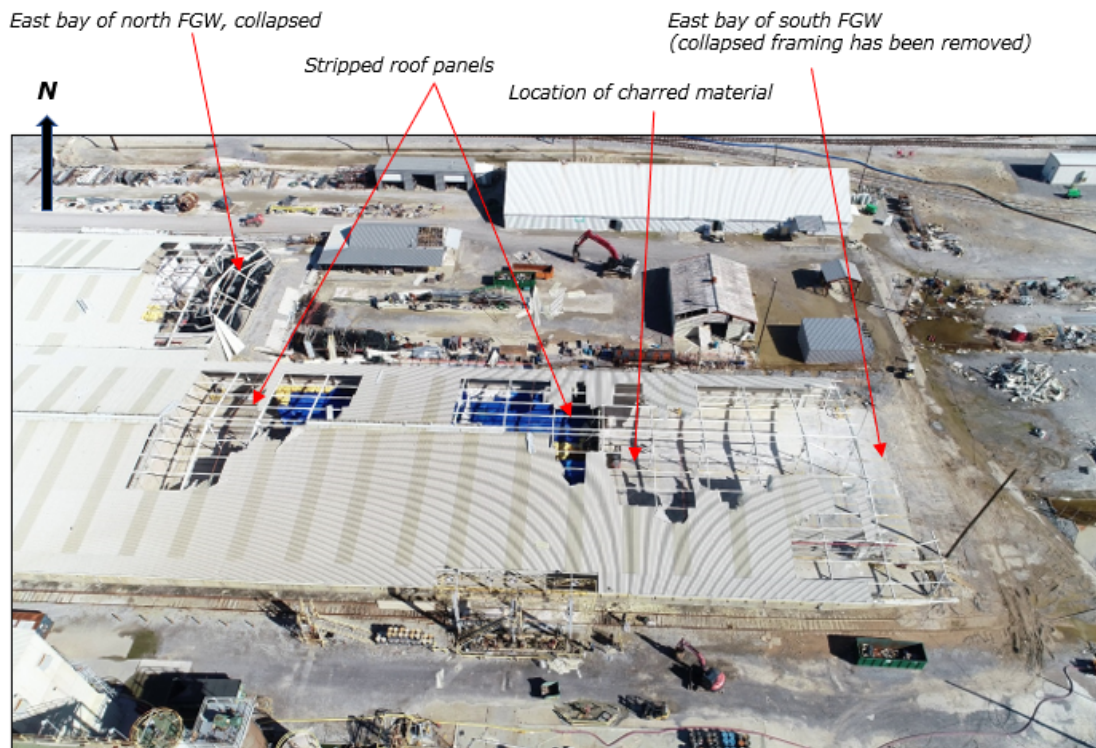
*Finished Goods Warehouses (Atlas UAV, 9/30/2020)*

**Wind Damage** – At both FGW's, the columns at the eastern end-walls collapsed to the west, falling into the eastern building bay and buckling roof purlins and wall girts as they fell. We examined the column bases at these end-walls and found severe corrosion at the anchor bolts. Several anchor bolts had corroded in two, leaving the end-wall columns unattached to the slab, and less able to resist wind loads.

**Fire Damage** – Most debris had been cleared away at the time of our site visit. Photos taken earlier by CSB show a pile of debris on the southern FGW floor that included charred wood pallets, wall panels with char marks, and melted storage bags. The CSB documented that heavy white smoke emerged from this area soon after the storm. The charring, melted bags, and smoke likely resulted from an exothermic reaction between the stored chemical and the rainwater that entered the FGW through the breached roof and wall. At the time of our site visit, we saw no sign of fire damage to structural members at the FGW's.

**Post-Incident Condition** – The buildings were damaged but the structures were relatively stable. Hazards included loose overhead panel debris, damaged framing at the eastern bays, and hanging wires. It was feasible to repair these buildings.

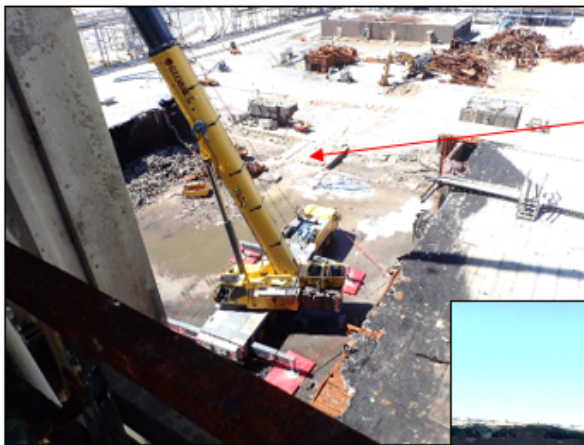
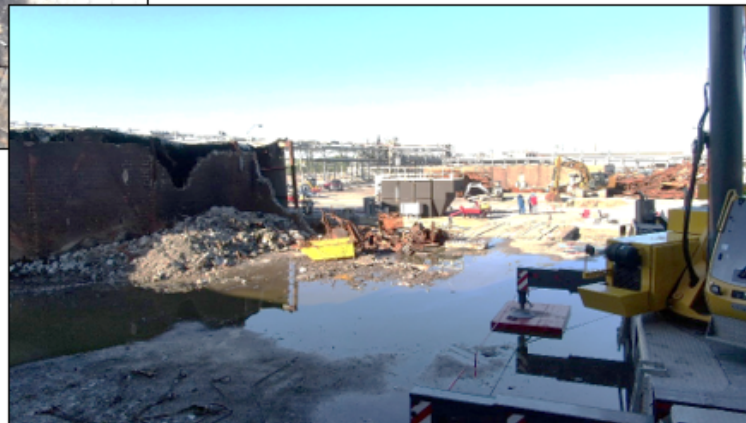
Our information on the Low Bay building is limited. The CSB supplied us with two foundation drawings dated 1977-78, but no other structural plans were available. Most of the Low Bay collapsed during the fire and had been demolished by the time of our site visit. Our understanding of the building is based on earlier photos made by the CSB, and our observations of nearby structures that remained standing, including a small northern section of the Low Bay and the 30-Day Warehouse to the south.

*View from High Bay stair,  
looking SW (Atlas, 9/29/2020)*

*View looking west (Atlas UAV, 9/30/2020)*

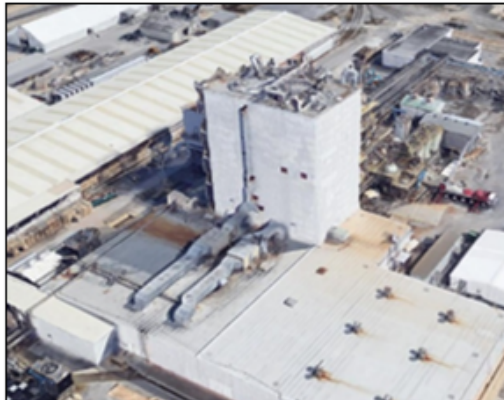
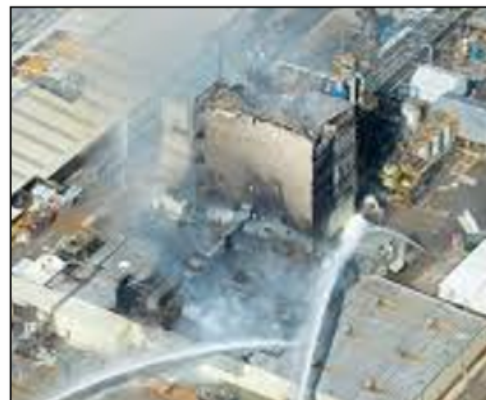
*Views of High Bay tower, looking northeast*

*Pre-event (GoogleEarth)*

*Firefighting (late August, A/P News)*

**Wind Damage** – At the south exterior wall, most of the outer layer of corrugated steel wall paneling had been torn away, as well as the insulation. The inner layer of paneling remained largely intact. Both layers of the wall paneling remained generally intact at the other three sides of the tower. Possible wind damage to the roof and upper wall panels could not be ascertained, as these parts had been destroyed by fire.

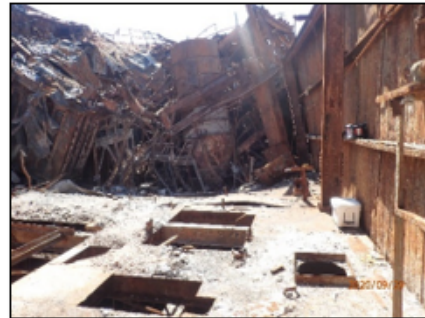
*4<sup>th</sup> floor level, from  
north stair (Atlas 9/29/2020)*

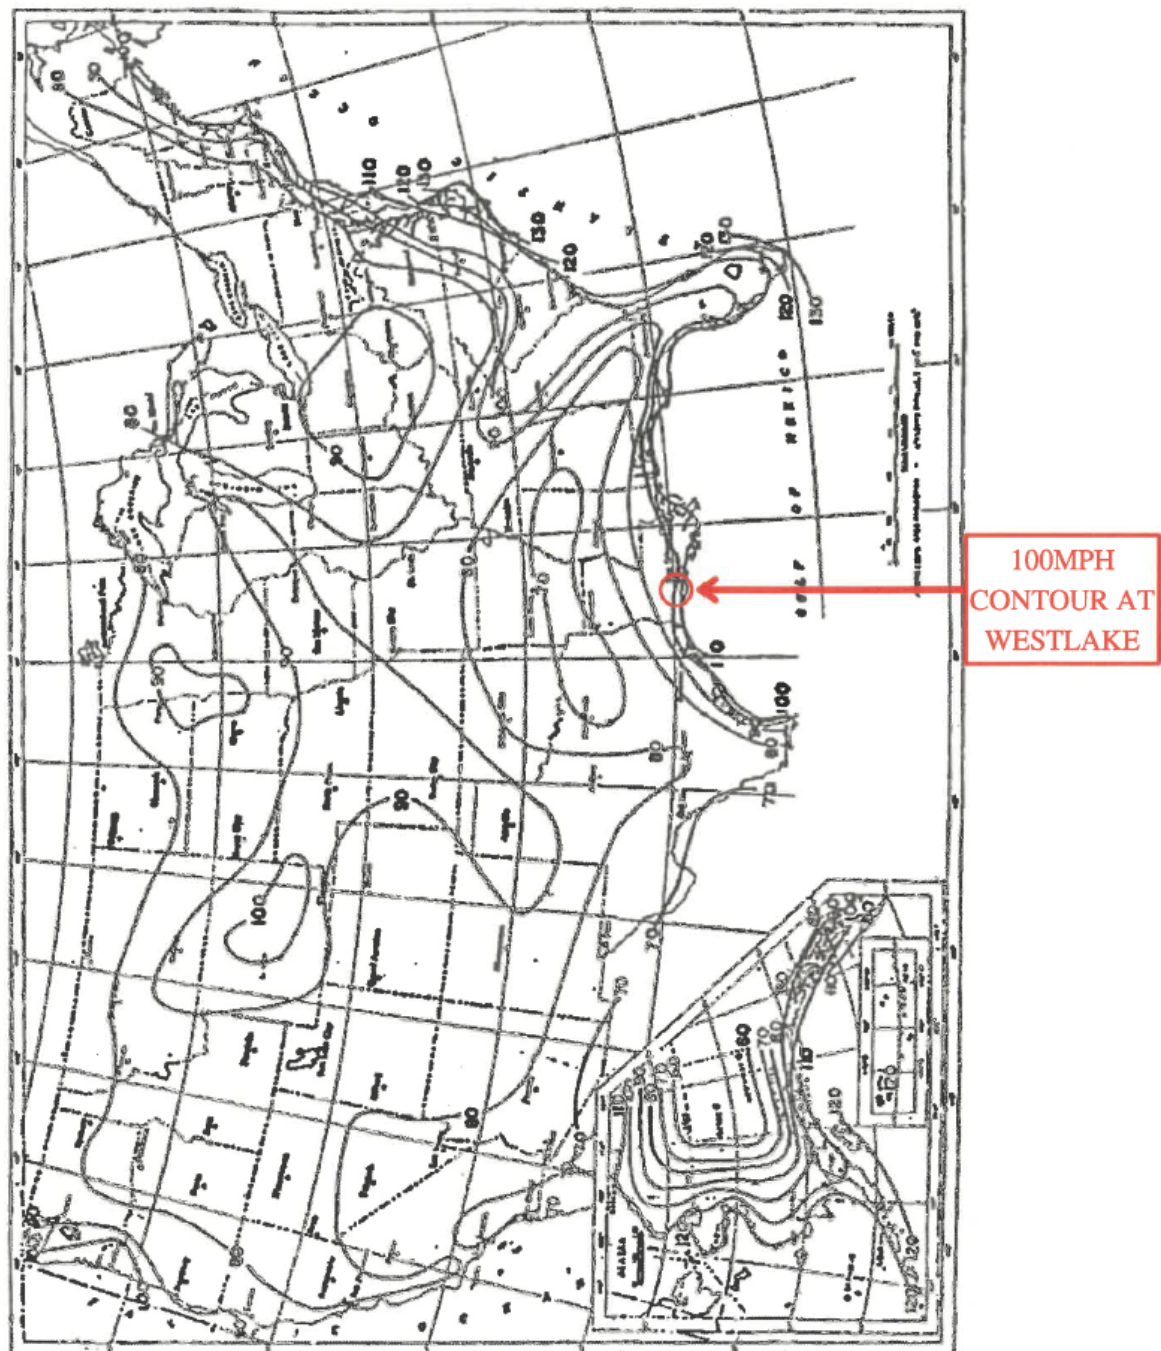
**Attachment 2: Wind map, 1974 Standard Building Code (SBC)****FIGURE 1205.1 - BASIC WIND SPEEDS IN MILES PER HOUR**

The SBC in use in 1978 was the 1974 revision of the 1973 edition. Basic design wind speeds are shown in Chapter 12, on figure 1205.1, with the Westlake area falling close to the 100 mph wind speed contour (see Attachment 2).

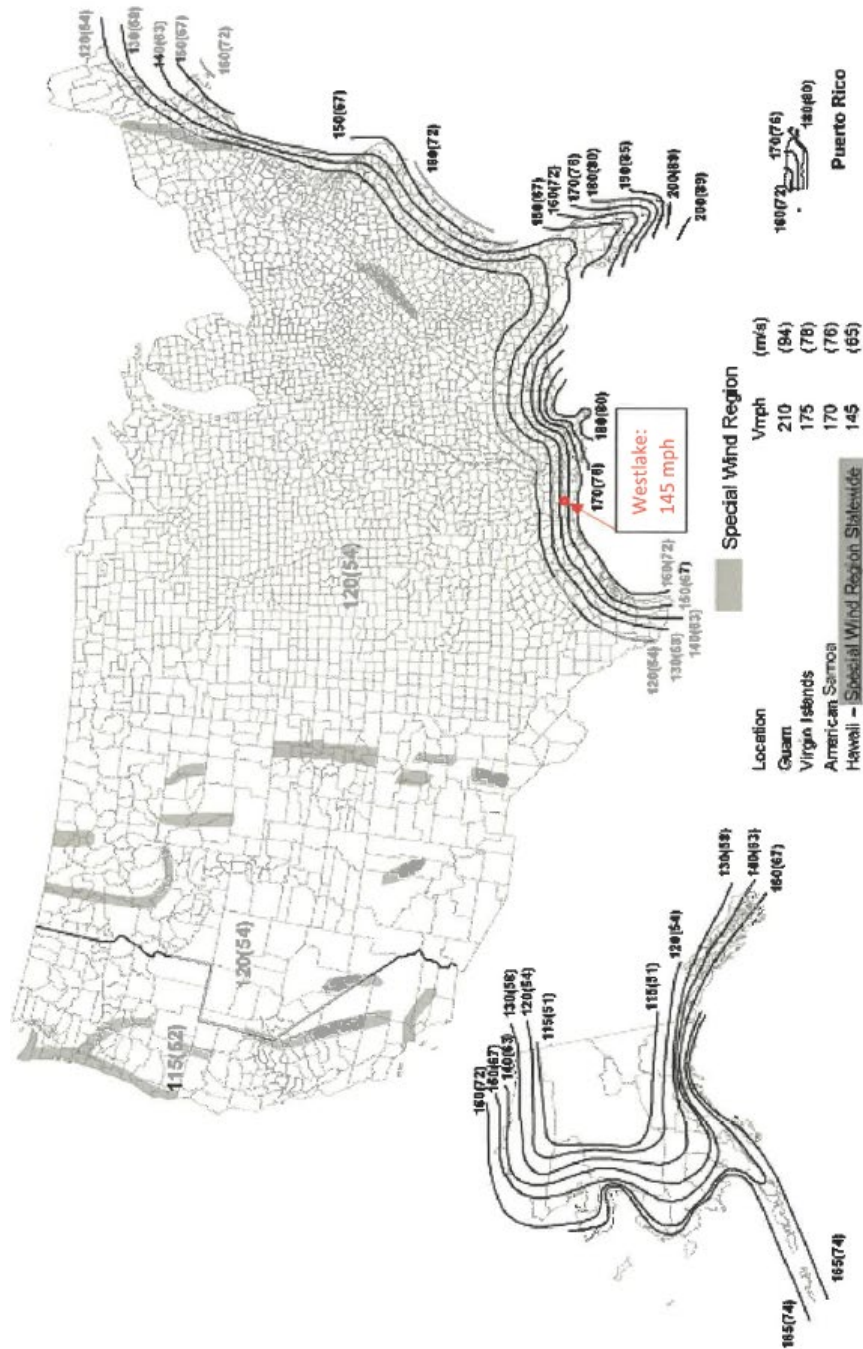
## Attachment 4: Wind map, 2015 International Building Code Fig 1609.3(2)

For Risk Category IV buildings like those at the Bio-Lab site, the 2015 IBC design windspeed is 145 mph, in accordance with IBC Figure 1609.3(2) (see attachment 4).
