Explosion, Molten Salt Eruption, and Fatal Injury at TS USA Liquid Nitriding Facility

Chattanooga, Tennessee | Incident Date: May 30, 2024 | No. 2024-01-I-TN

Investigation Report

Published: June 2025

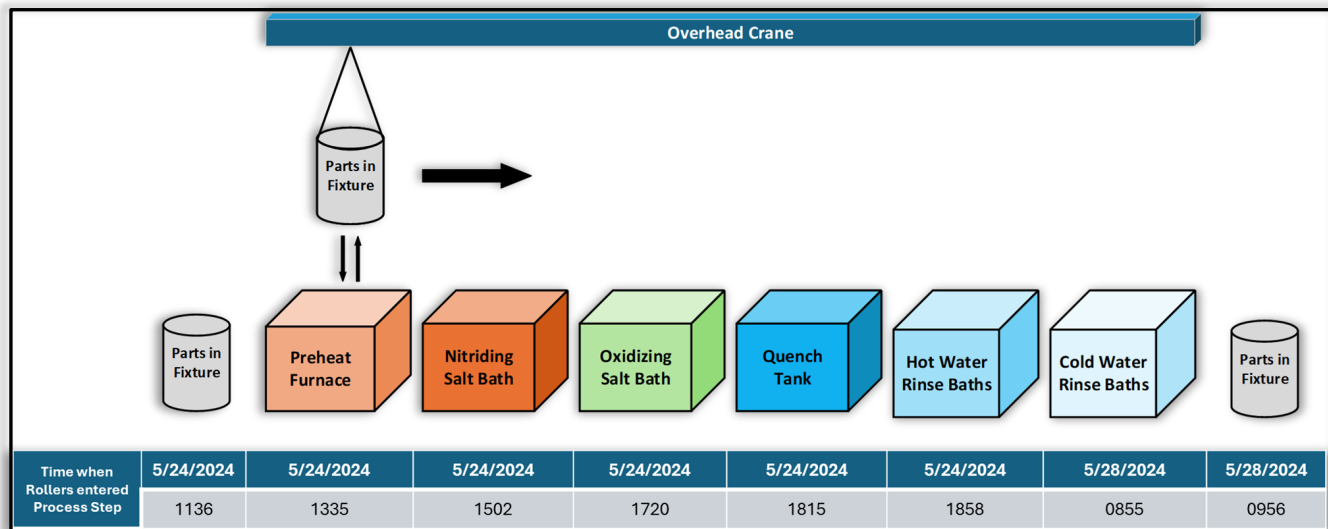
Figure 8. Timeline of initial nitriding processing of rollers. (Credit: CSB)

By the end of the day, the rollers had been processed through the nitriding bath and were placed in the rinse bath. On May 28, 2024, at approximately 9:56 a.m., the rollers were removed from the rinse baths to drain. A timeline of the initial processing steps is shown in **Figure 8**.

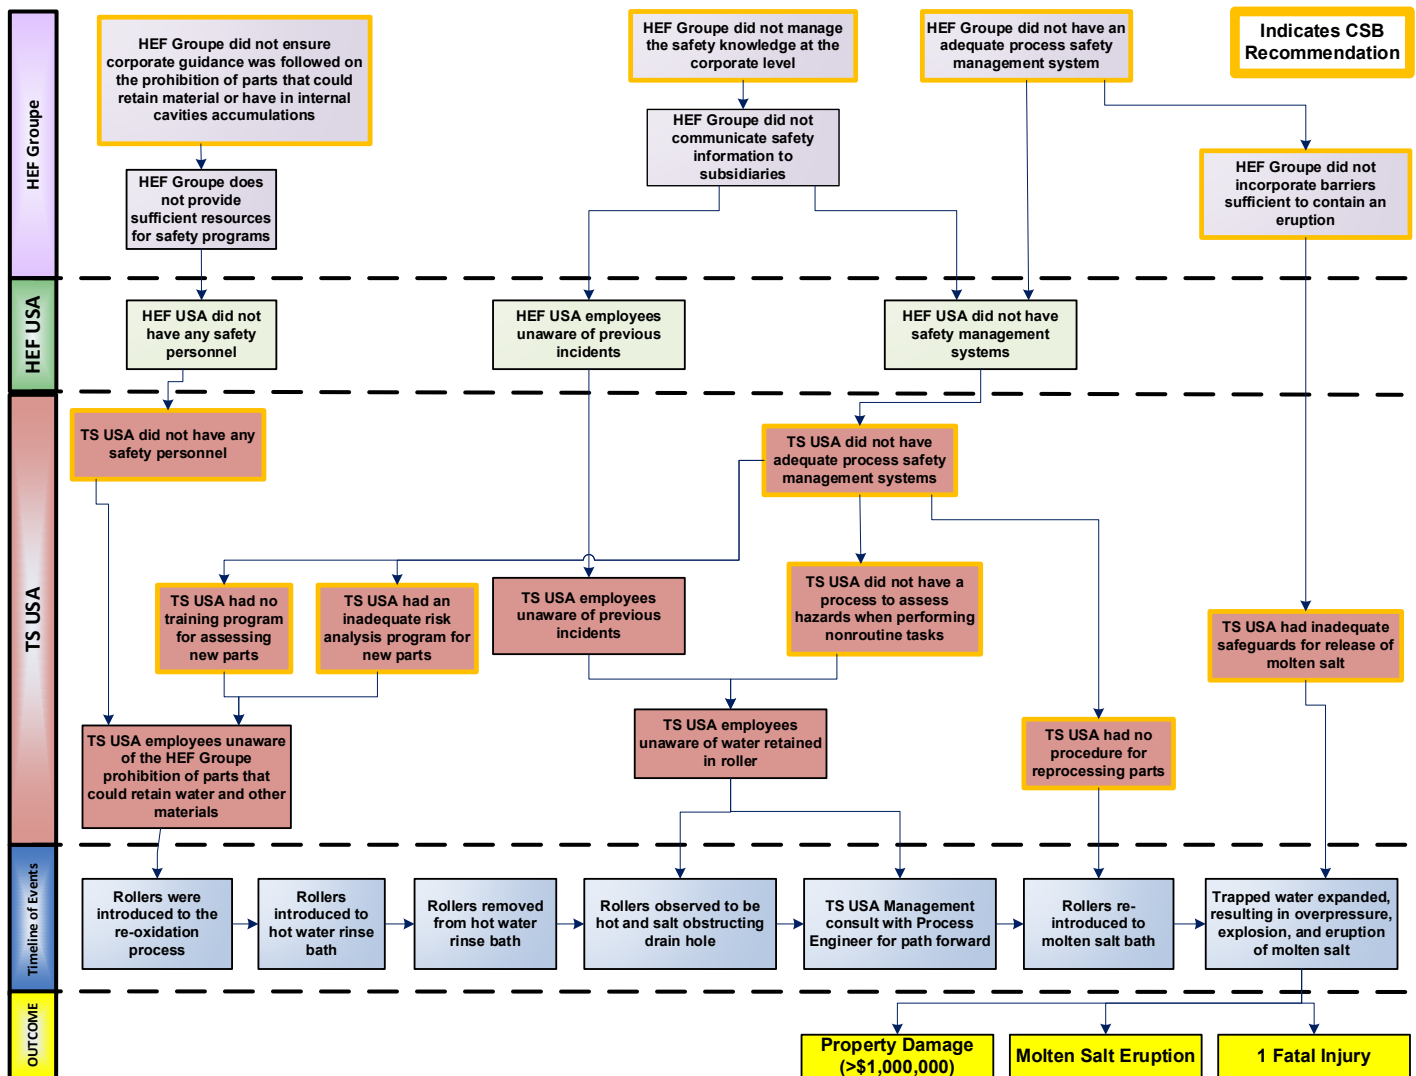
APPENDIX A—SIMPLIFIED CAUSAL ANALYSIS (AcciMAP)

The CSB determined that the cause of the incident was the introduction of water contained in the roller cavity to the 800°F oxidizing salt bath. The hot salt caused the water to expand and boil in the cavity of a roller, which resulted in an overpressure, a steam explosion, and a molten salt eruption.

Contributing to the incident was TS USA's lack of awareness of the accumulation hazards associated with parts containing cavities. These cavities presented accumulation hazards when processed in the nitriding line. Also contributing to the incident were TS USA's and HEF Groupe's insufficient process safety management systems, which did not include adequate procedures, training, hazard analyses, and incident investigations. Also contributing to the incident was HEF Groupe's ineffective corporate governance and safety knowledge management, which did not ensure that critical safety information was communicated and accessible to all TS USA facilities, including details of prior safety incidents and the results of those investigations.
